Architectural Heritage and seismic vulnerability: mapping the available knowledge to reduce damage during an emergency

Enrica Brusa¹, Claudio Chesi², Stefano Della Torre³

Topic: T4.4. Management and maintenance of vernacular architecture

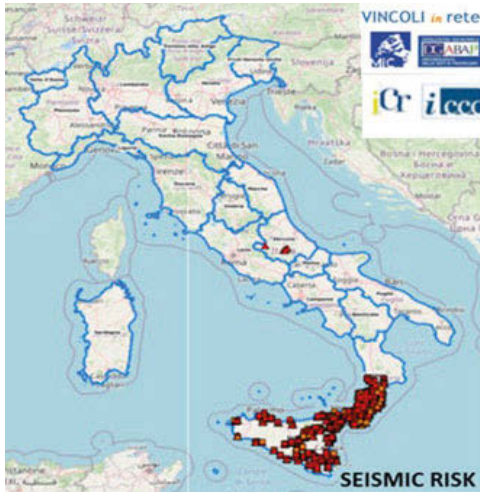
Fig. 2. An example from the Italian 'CdR'. The map shows the areas where the seismic risk has already been assessed.

information system developed to map, on a cartographic basis, what are the assessed risk conditions for the architectural and archaeological immovable heritage. The system evaluates the risk of each item by assessing its vulnerability and the hazard of the area. These parameters allow for the evaluation of the level of danger from environmental, hydrogeological or seismic risk.

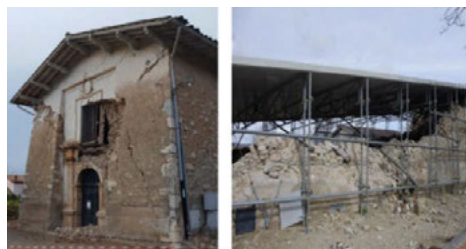
Fig. 3. The church of *S. Antonio Abate* after the earthquake of 24th August 2016 (left) and in 2017, after its collapse (right) (Source: <https://frascadorinorcia-noprofit.webnode.it/galleria-immagini/> (a); <https://www.iluoghidelsilenzio.it/frascaro-norcia-pg/> (b)).

Sant'Antonio Abate is a small church in the countryside near Norcia, whose construction started in the 15th century. The church had great artistic and cultural interest with frescoes and polychrome wooden statues from the 16th and 17th centuries inside and a carved stone portal on the façade, which dated back to the middle of the 16th century. After the earthquake of 24th August, the most evident damage occurred in the carved stone portal, where part of both the lintel and the upper masonry collapsed partially. Cracks had also opened at the impost blocks of the cross vaults inside the church, and the collapse of the portal made the building inaccessible.

After that event, both the damage surveys and the assessment of the technical countermeasures were promptly defined by the functionaries of the MiC, who started the first intervention less than two weeks after 24th August. In September, the NFB also carried out the initial countermeasures, which involved the securing of the collapsed portion of the façade. It was also planned to construct shoring systems on the external walls, hooping them with steel cables and wooden beams in order to prevent the façade from overturning. These countermeasures were not started at the same time or promptly, probably due to some logistical problems, such as the lack of availability of the NFB specialised teams, who were entirely engaged in other securing work. On 26th and 30th October, when the main aftershocks occurred, the church had not yet been completely secured: only the countermeasures that were designed to strengthen the collapsed part of the façade had been finished. Thus, the church of Sant'Antonio Abate suffered an irreversible worsening of the previous damage: it collapsed almost entirely, with only part of the apse wall surviving thanks to the presence of the sacristy dwelling that stood behind it.

That earthquake had caused damage on the cross vaults and the opening of some deep cracks, both in the external walls and below the belfry. After that event, the church had been restored by consolidating the extrados of the cross vaults with a reinforced concrete layer and by inserting cement mortar and armed perforations, both in the perimeter walls and in the portal of the façade⁶.

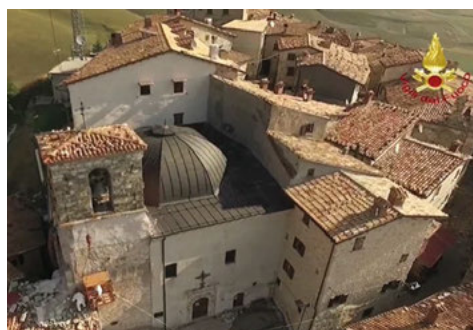
Fig. 5. The provisional intervention on the bell tower of *Santa Maria Assunta*, realized by the MiC and the NFB (© *Vigili del Fuoco*) (Source: <https://www.vigilfuoco.tv/umbria/perugia/norcia/messa-sicurezza-chiesa-smaria-assunata>).

The ministerial officers reacted promptly in this case as well, carrying out the damage surveys at the beginning of September and arranging the recovery of movable heritage to the temporary warehouses that had been set up for restoration – thanks also to the help received from the NFB. The functionalities of the superintendence, coordinated by the UCCR Umbria, defined the necessary countermeasures for the bell tower, aiming to consolidate the ruined portion of the masonry and to hoop steel tie-rods all around the belfry. The first part of the intervention was carried out by the NFB in mid-September, but there is no evidence of other countermeasures being realised to contain the damage inside the church, nor other provisional works outside. After the earthquakes of October, both the bell tower and the church have unfortunately completely collapsed, as well as many other buildings of the hamlet, which had already suffered a great deal of damage on 24th August. It was, however, possible to save the wooden polychrome altar that was inside the large wall niche used as an apse, which had remained intact even after the collapse in October.
