An architectural catalogue for the study of traditional building features from their seismic behaviour in the 2016 Central Italy earthquake

Luca Sbrogiò¹, Ylenia Saretta², Maria Rosa Valluzzi³

¹University of Padova, Department of Cultural Heritage, Padova, Italy, luca.sbrogio@unipd.it e-mail;

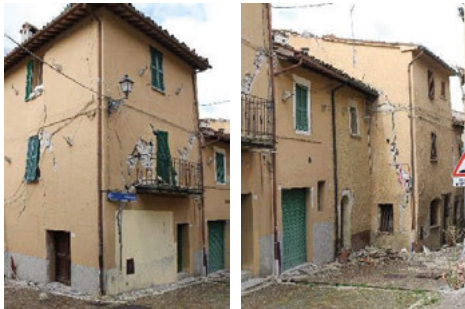
Fig. 1. Terrace in Castelsantangelo sul Nera: damage on head unit (left), overturning of façade in jutting unit (right)

The position of a building within a block determines the mutual buttressing effect: corner and end units showed higher damage than internal

ones as they lack of it (Fig. 1, left). The façades of clogging units, i.e., those built between already existing buildings, were often not properly connected to the adjacent ones. Misaligned cells in plan are exposed to corner overturning as well (Fig. 1, right). These situations, strictly connected to construction processes, favored the first mode mechanisms (overturning of walls and corners) (Fig. 2).

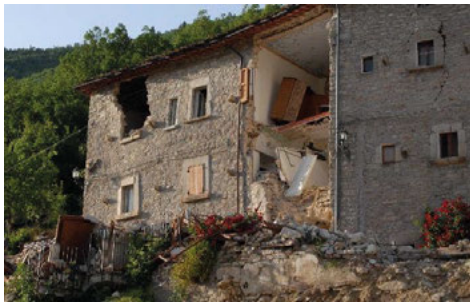
Fig. 2. Overturning of façade in a clogging unit (Noeria)

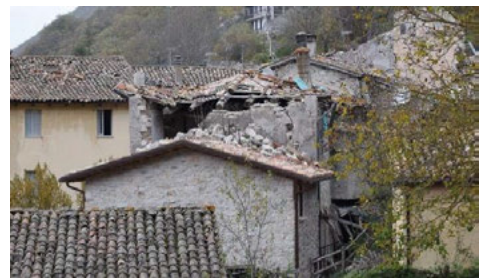
Fig. 3. Overturning of standing walls (Castelsantangelo sul Nera)

As regard the elevation, some units stand higher than the eave line of the surrounding ones and, therefore, have free walls on one or both sides. As these latter were generally unrestrained by tie rods, they suffered of out-of-plane mechanisms, causing damage also to the roof of the adjacent units (Fig. 3). A unit higher on both sides than the neighboring ones was the most unfavourable situation.

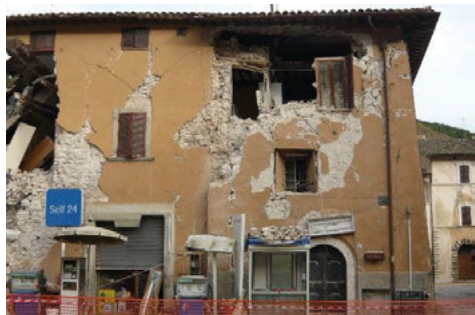
Fig. 4. Crumbling of masonry and shear damage owing to misaligned openings (Visso, courtesy of Eng. Falsetti)

In the study area these factors were often combined, resulting in severe damage patterns (Fig.

4). Conversely, provided that masonry quality is good, a well-arranged façade system, i.e., squat piers and an even distribution of openings ensured an overall behaviour with minor damage.

Façades are made of undressed or roughly cut stones, randomly laid in poor mortar (lime and/or clay); their cross-section is divided in two or three leaves, without bonding stones. Overall, the poor masonry quality (Borri et al., 2020) eased both the crumbling of walls, owing to the lack of connections in the cross-section, and first-mode mechanisms, owing to poor interlocking between walls. Crumbling took place before any damage mechanism could activate, and it interested the outward layer of a wall, especially when r.c. roofs and tie beams were added to the building. Damage associated to crumbling is severe and often determines the loss of a building (Fig. 4).

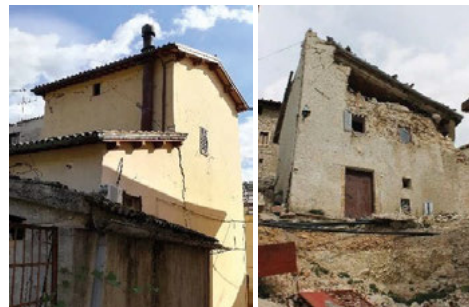
Fig. 5. Left: pounding owing to staggered roofs (Pieve Torina); right: masonry crumbling and r.c. roof collapse (Campi Alto)

ii) ‘Standardized’ interventions, which were applied starting from the 1970s, in compliance with seismic codes and handbooks, prescribing rigid floors (Sbrogiò et al., 2022). Standardized r.c. elements replaced existing floor joists and roof beams, and r.c. tie beams were added to connect the walls at floor and roof levels. These interventions, which added mass and stiffness to the horizontal structures, were not compulsorily associated with the strengthening of the bearing walls, which crumbled, resulting in severe damage (Fig. 5 right). The available strengthening solution for masonry walls was a cement plaster reinforced with a steel mesh.
