Assessment of vulnerability of earthen vernacular architecture in the Iberian Peninsula to natural risks. Generation of an analysis tool.

Keywords: earthen architecture, vulnerability, natural risks, Iberian Peninsula

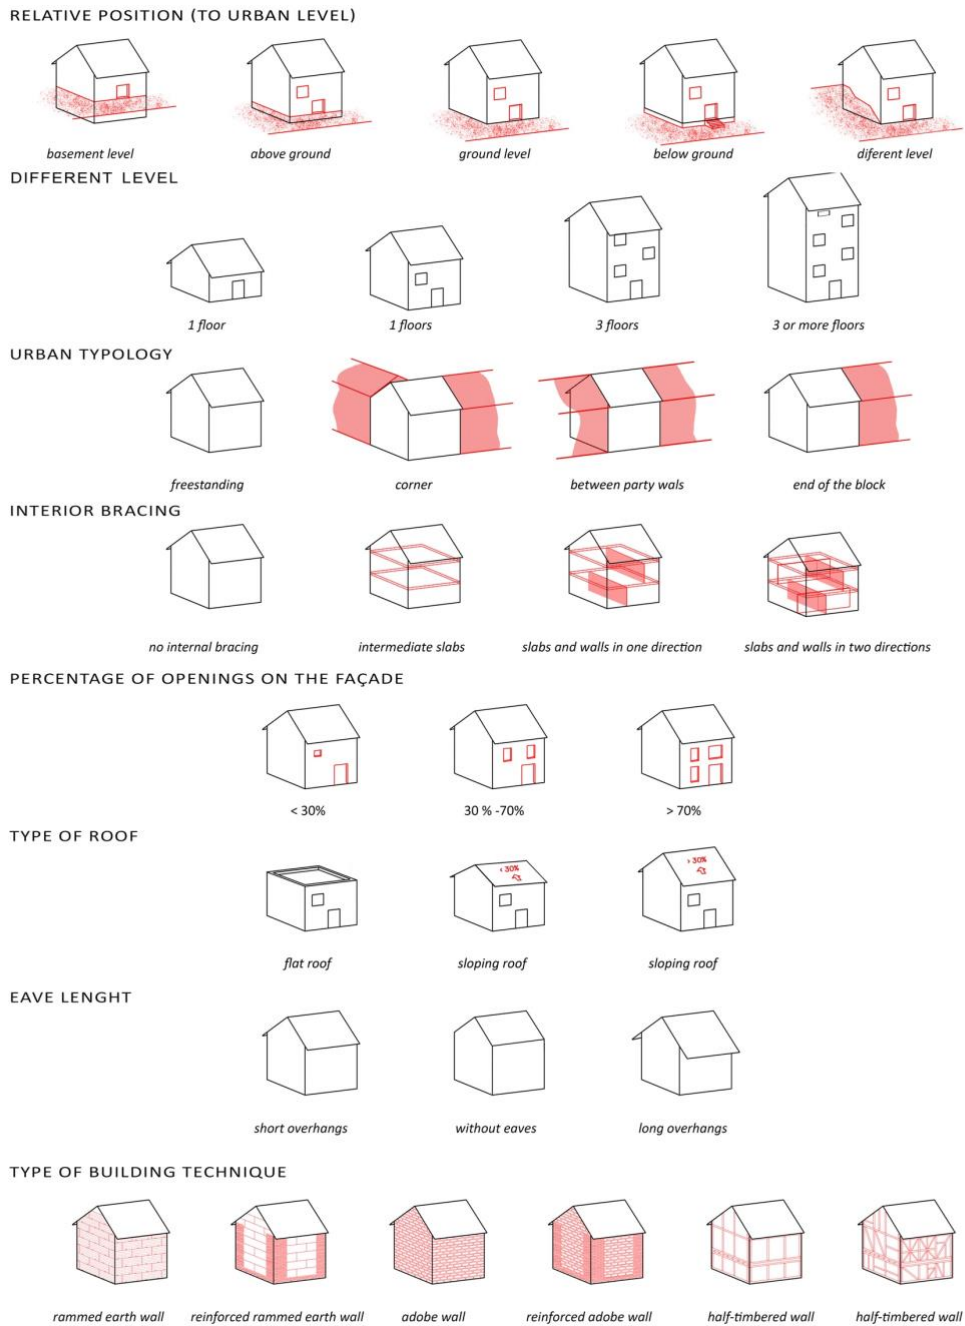
Figure 1. Schematic examples of the characteristics analysed

Characteristics taken into account include the number of floors above ground, the geometrical proportion on the floor plan, occupied surface of the floor plan, percentage of surface occupied by openings in relation to the total surface of the façade, type of roof, type of eave, the presence or absence of vertical protection in addition to the rendering of the constructions on the exterior façades, characteristic bracing between structural elements, and the type and composition of the vertical constructive system.

Specific focus is placed on the characteristic of the composition of the vertical constructive systems, as the study focuses on earthen built architecture, contemplating the different variants found in the Iberian Peninsula. Based on previous projects, such as Terra Europae in Europe and Res-tapia and Sostierra in the Iberian Peninsula (14), a classification system was set up to group constructive systems which use earth as a main component, as rammed earth, adobe and half-timber systems. In addition, these three systems can be found in combination, used as reinforcements or supplements which can lead to a variation in the mechanical and resistance characteristics in relation to the predominant system. Thus, this analysis has observed both the specific type of system and whether it has been combined or supplemented.

The constructive and material characteristics show the most specific characteristics of the construction, such as the materials used in the plinth, rendering, and the specific variant of rammed earth, adobe or half-timber used.

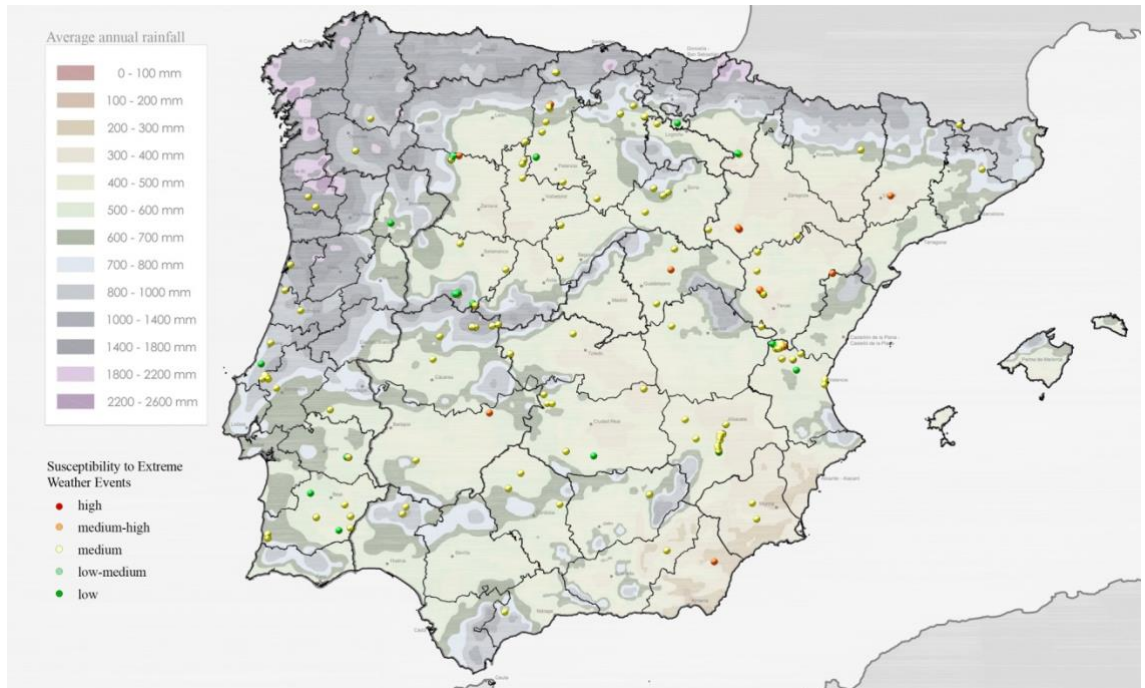
Figure 5. Risk map for rainfall intensity (annual mean rainfall (1971-2000), identifying the susceptibility index of case studies. Source: Atlas Climático Ibérico. Atlas Nacional de España. Ministerio de Medio Ambiente y Medio Rural y Marino, Gobierno de España

In terms of the probability of the risk of extreme weather conditions it is also seen that the majority of cases displays a medium level of susceptibility. Analysis of the rainfall intensity shows that the cases defined with the highest levels of susceptibility are in the lower-risk areas.

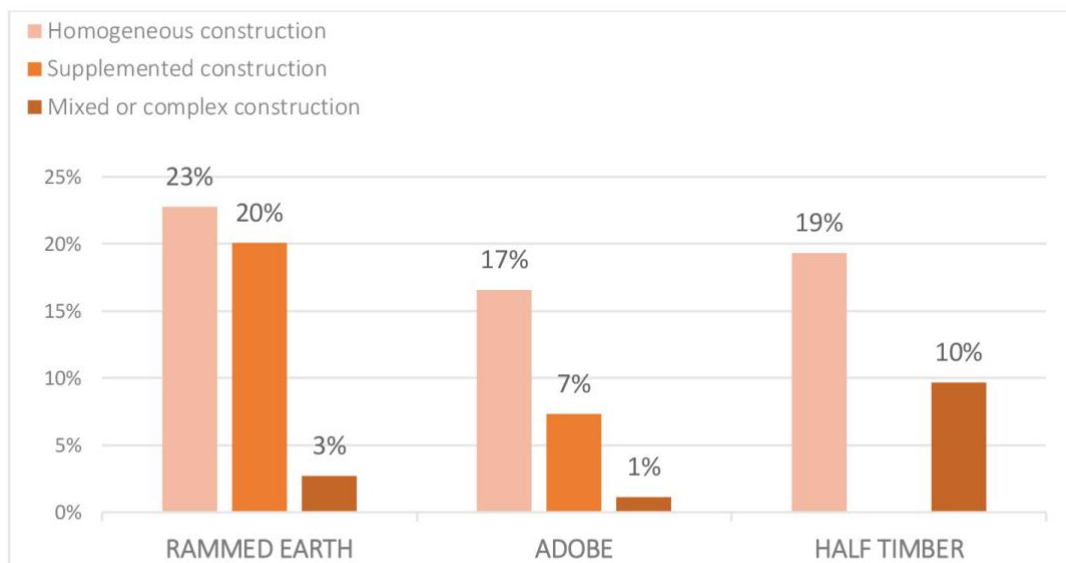
Figure 6. Classification of case studies analysed by constructive technique.

The database used for the analysis consisted of a total of 258 buildings belonging to earthen built vernacular architecture: 46% of cases in rammed earth, 26% in adobe, and 29% in half-timber, while 59% of the total were homogeneous constructions, that is to say, they used the constructive system without supplements or reinforcements in other materials or techniques.

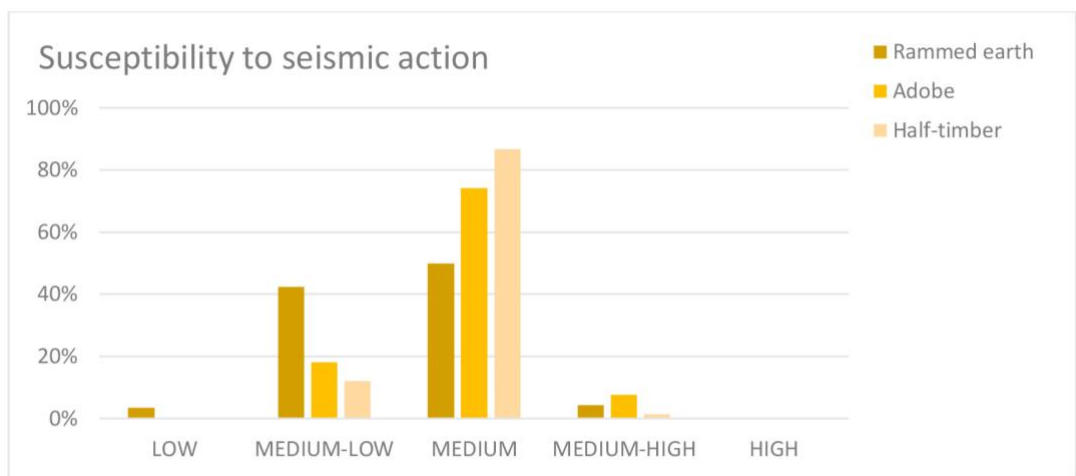
Figure 8. Evaluation of the level of susceptibility in the event of seismic action.

The susceptibility of constructions to vulnerability to seismic action, according to the analysis carried out, is mostly at the low and medium-low thresholds. Most of the cases built with half-timber systems and adobe walls with a medium level of susceptibility and the cases with rammed earth as their main system mostly fall within the categories of medium-low and medium risk.

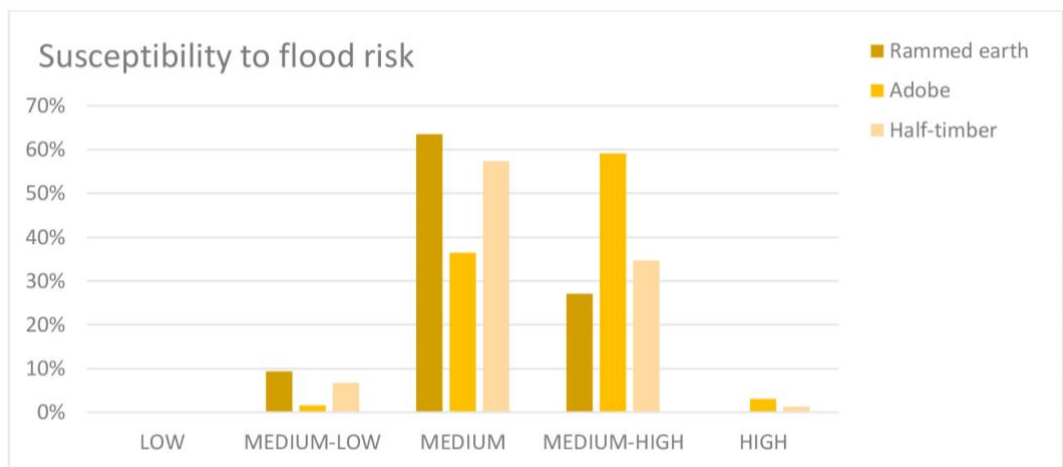
Figure 9. Assessment of the level of susceptibility to flood risk

Against the flood risk, the data analysed show that the level of susceptibility for most cases is medium and medium-low, with adobe systems showing the highest percentage with a high level of susceptibility.
