Long and close-range terrestrial photogrammetry for rocky landscape deformation monitoring

Miriam Cabrelles¹, [José Luis Lerma](mailto:jllerma@cgf.upv.es)¹, Luis García-Asenjo¹, Pascual Garrigues¹, Laura Martínez²

¹ Department of Cartographic Engineering, Geodesy and Photogrammetry, Universitat Politècnica de València, Camino de Vera s/n, 46022 Valencia, Spain, (micablo@doctor.upv.es; jllerma@cgf.upv.es; lugarcia@cgf.upv.es; pasgarta@cgf.upv.es)

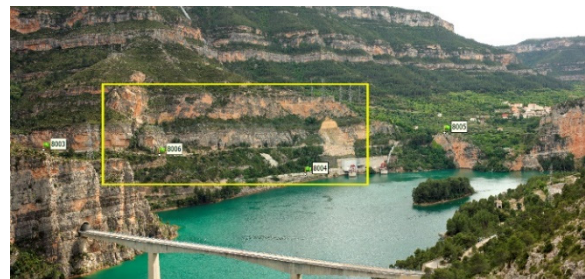
Figure 1. Overall view of the site area. The area to be monitored is displayed in yellow. Location of the 4 CPs used in the 5th and 6th photogrammetric campaigns.

The target area is a broad cliff (650 m long, 200 m high and 300 m wide) facing the north side of a flat-topped hill in Cortes de Pallás, Spain (Figures 1 and 2). In 2015,

The first camera was used for both close-range and long-range images taken along the roads from both shorelines and from the bridge crossing the reservoir and connecting the shorelines, while the second camera was only used for acquiring the long-range images targeting both the CPs and the ChPs (Figures 1 and 2).

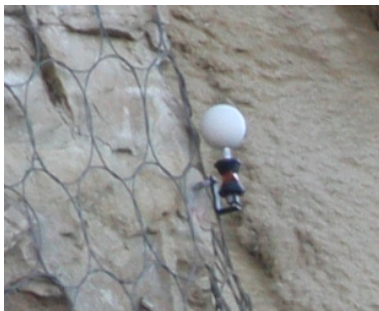
Figure 3. ChPs on the slope.

CPs were materialised by big white spheres (\varnothing 500 mm) temporarily set up on top of the concrete pillars, while ChPs were materialised by small white spheres (\varnothing 145 mm) which are installed on top of 360° prisms permanently attached to the cliff (Figure 3). The software used for the photogrammetric processing was Agisoft Metashape.

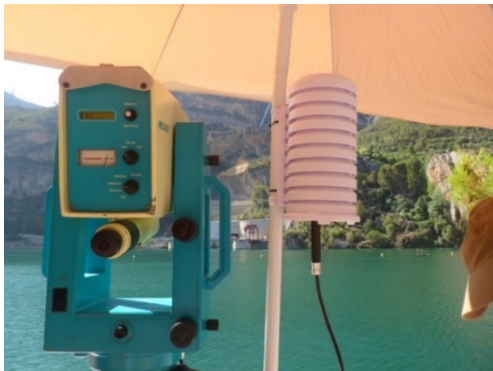
Figure 5. Kern ME5000 Mekometer on pillar equipped with a parasol and a data-logger for dry and wet temperatures as well as air pressure.

The measurement of each distance takes approximately two minutes while the observer measures the meteorological parameters using a traditional Thies Clima Assmann-Type psychrometer (± 0.2 K) and a Thommen 3B4.01.1 aneroid barometer (± 0.3 hPa). Additionally, all the pillars were equipped with a data-logger Testo 176P1 and a parasol (Figure 5).
