Vercher Sanchis, JM.; Gil Benso, E.; Mas Tomas, MDLA.; Lerma Elvira, C. (2013).
Diagnosis / Intervention criteria in damaged slabs by severe corrosion of prestressed joists.
Journal of Performance of Constructed Facilities. (04014040).
doi:10.1061/(ASCE)CF.1943-5509.0000515.

Diagnosis / Intervention criteria in damaged slabs by severe corrosion of prestressed joists

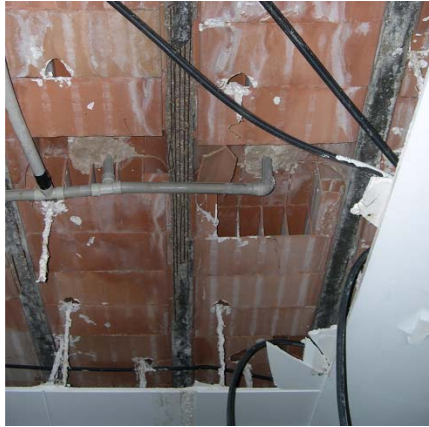
Fig. 1. Joists with the active reinforcement corroded – only the remaining rust can be seen

During surveys, some cases are found in which slabs are supported by joists that have suffered corrosion along all of the lower reinforcement. Strangely, there is not serious pathology in the floors or walls and the deflections are not excessive. In some cases, pathology has been found by removing the false ceiling, as is the case in Fig. 1, which shows a residential dwelling in Benigánim (Valencia). Only the rust is visible in the photograph, due to the pre-stressing wires are completely corroded. A few broken wires hanging can still be observed.

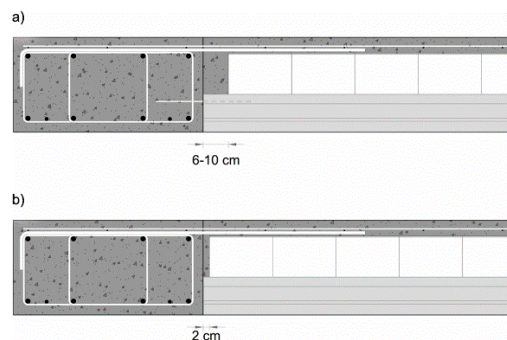
Fig. 2. Constructive detail in maximum shear area. a) Safe detail; b) Dangerous detail without separation between beam and vaults or shear reinforcement

Another very crucial aspect in surveillance work when the project data are being studied is the analysis of the constructive detail in the maximum shear area of the joists, where they reach the beams. Since in this research flat beams slabs are discussed, which are the most common in Spain, the aspects that must be analysed in the construction detail are shown in Fig. 2: the separation between the beam and the vaults, the negative reinforcement of the joists and the presence or absence of shear reinforcement. It is very important to rule out the possible shear failure. The collapse is dominated by shear in small spans with high loads. If exists shear reinforcement in this area or sufficient separation between the vaults and beam, there are not shear problems. If any of the above options do not appear, it is necessary to check that the negative reinforcement at the joists are working in tensile. This is an indication that there is not shear problem. If the guarantee that this reinforcement is working in tensile does not exist, it is necessary to calculate the ultimate shear load of uncracked and no degraded section. Many times the estimation of the height of the crack is risky, and a structural reinforcement of the side of safety is carried out. Above all, when the expert observes a shear problem, must underpin and leave immediately, because of the possibility of brittle fracture. In cases studied in this paper, it has been found that the collapse is not governed by the shear. It is governed by bending.

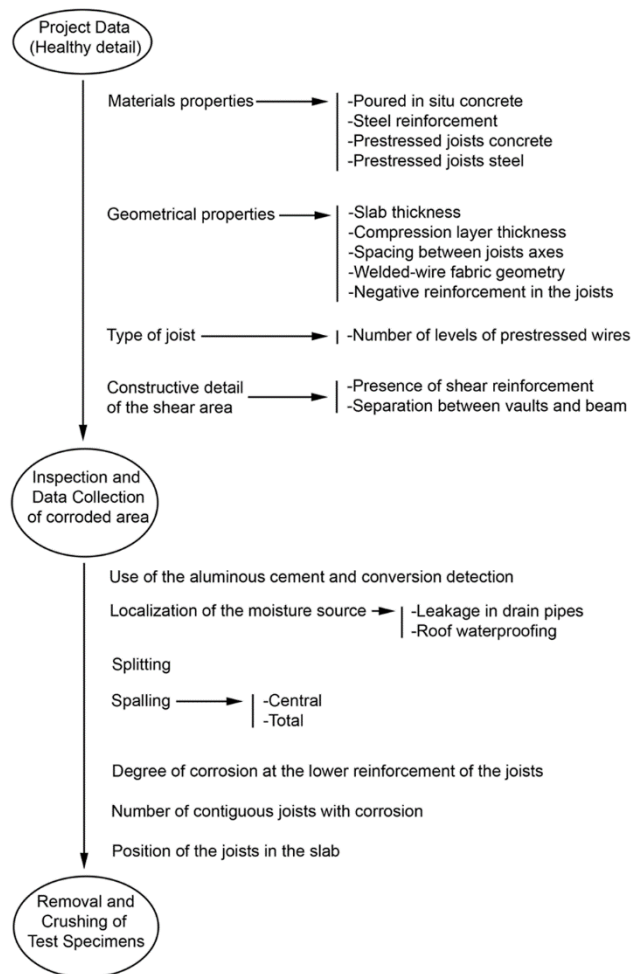
Fig. 3. Items to be followed in surveillance task

The number of contiguous joists with corrosion and their position in the slab are very crucial to make a correct diagnosis. This paper presents cases with 1, 2, 3 or all the joists corroded in a bay, in the different possible positions of a slab.

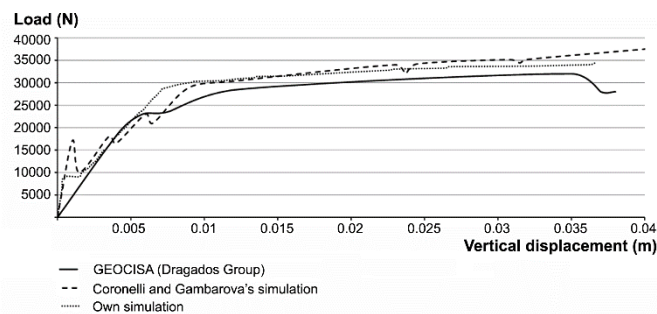
Fig. 6. Load-displacement curves for specimen 11.5 in the test made by Rodríguez, Ortega, and Casal; the Coronelli and Gambarova's study, and our simulation

Coronelli and Gambarova simulate the corrosion by reducing the section of concrete and steel and decreasing the strength of both materials. As a sample, Fig. 6 shows the correlation between the results for specimen 11.5 obtained by our simulation, the Coronelli and Gambarova's simulation and the original test or Rodríguez et al.

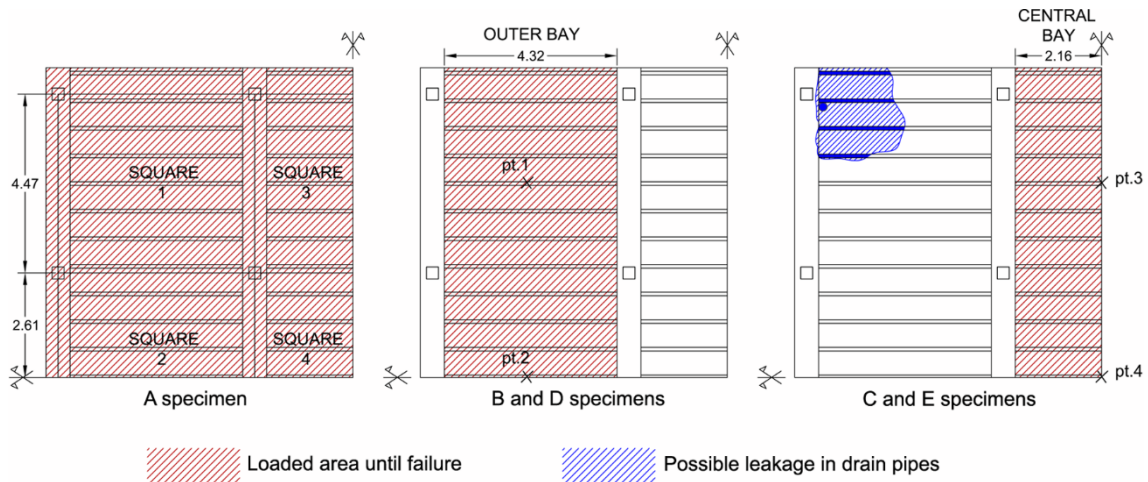
Fig. 7. Bays, squares and significant points of the model

Cases A, B and C are specimens of 30 cm thickness slabs, and cases D and E are 25 cm thickness slabs models. Fig. 7 presents the nomenclature of bays, squares and representative points.

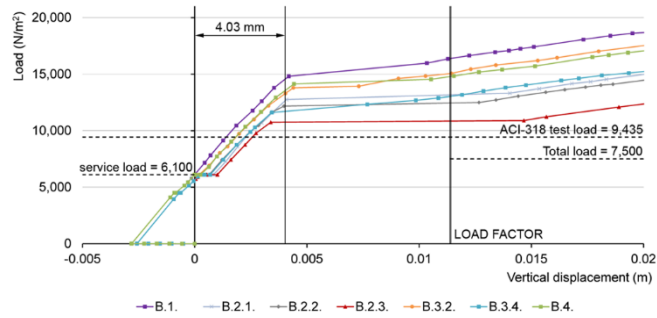
Fig. 8. Load-vertical displacement curves at point 2 for B specimens (30 cm thickness slabs)

All the possibilities are simulated (Vercher 2013), but the table 3 and table 4 show the results of the most representative ones in order to maintain the paper extension. The points 2 and 4 are the dominant in the outer and central bay respectively. The study is also carried out in points 1 and 3, but no additional information is provided and so they are not shown. In turn, point 2 is more dominant than point 4 because it has more deflection for the same load. Fig. 8 represents load-

vertical displacement curves of B specimens, which have 30 cm thickness slabs and corrosion appears in the outer bay.

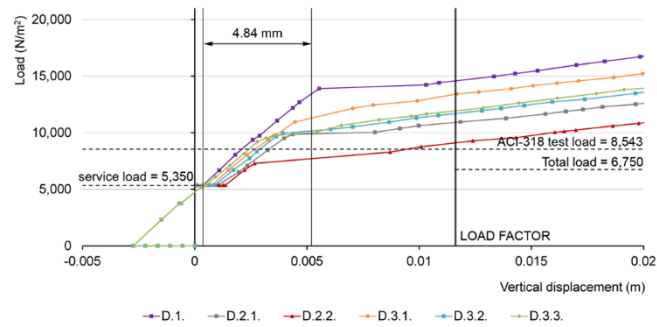
Fig. 9. Load-vertical displacement curves at point 2 for D specimens (25 cm thickness slabs)

Fig. 9 and Fig. 10 enable the assessment of the cases studied in points 2 and 4, with slabs of 25 cm. The vertical displacement is represented from a few millimetres of camber to a value of 2 cm,

All the cases with the exception of D.2.2. specimen meet the ACI-318 load test for existing structures, which considers immediate deflections. This is in accordance with our extensive experience in the inspection of real cases with variable degree of damage on the joists and few cracking on the constructive elements.

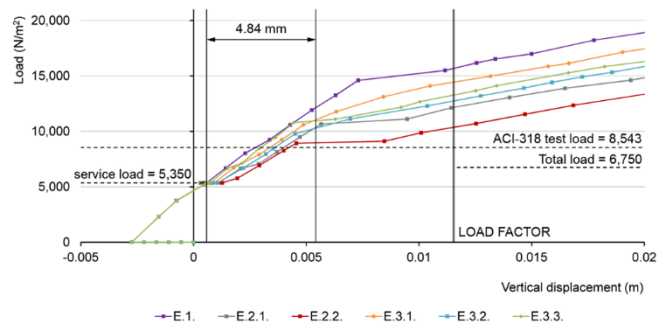
Fig. 10. Load-vertical displacement curves at point 4 for E specimens (25 cm thickness slabs)

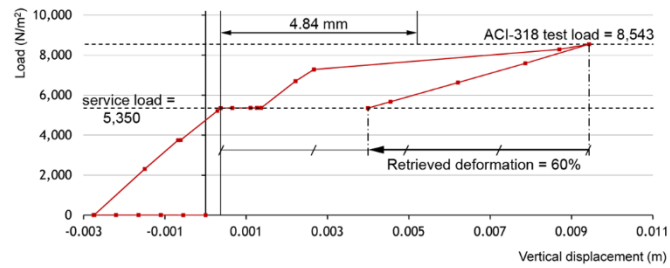
Fig. 11. Unload for D.2.2. specimen according to ACI-318

The ACI-318 unload is also simulated in D.2.2. specimen (Fig. 11). The retrieved deformation is not bigger than 75% of the increased deflection produced by the test, therefore this specimen does not meet ACI-318.

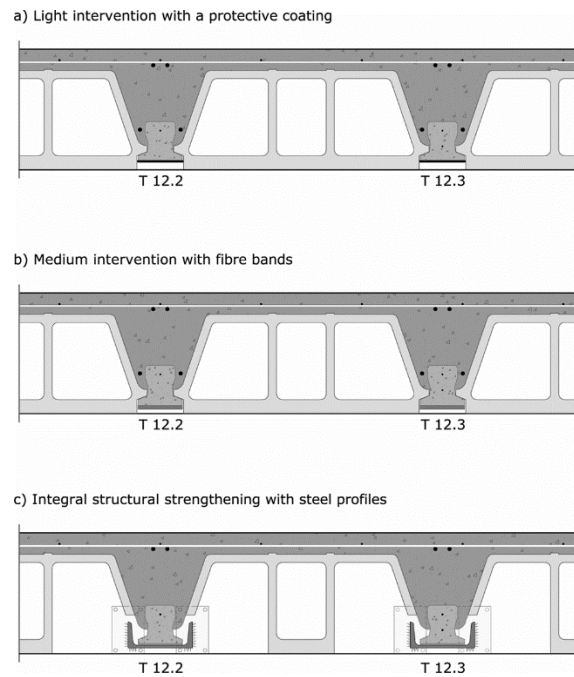
Fig. 12. Constructive details of different degrees of intervention

A light intervention is enough in the cases in which a reasonable safety is observed in ultimate limit states. This intervention can be a protective coating and a consolidation that is realised in the most common cases of corrosion of part of the reinforcement of one of the joists (Fig. 12a).

A medium intervention is necessary in cases of complete corrosion with spalling of up to three adjacent joists. A reinforcement by fibre bands and an external protection are suitable (Fig. 12b).

An integral structural reinforcement is required in cases of complete corrosion at the lower prestressed wires of all joists in a bay. One suitable solution is the joist duplication by steel profiles. A thin layer of grout mortar is applied between the joist and the steel profile. The laying of the profiles in the slabs made with flat beams demands the breakage of the vaults, as shown in Fig. 12c.
