Method for Pedestrian Crossing Risk Assessment and Safety Level Determination: the Case Study of Tallinn

SUMMARY

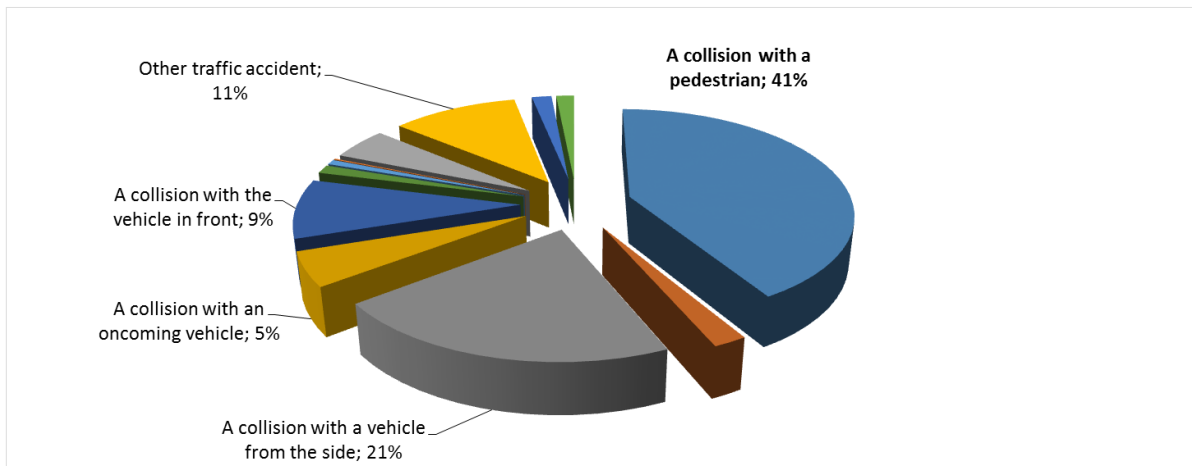
Fig. 1 – Fatal and injury accidents distribution by types

Safety of pedestrians became a very important topic during the last years, especially, in the urban areas. Looking through official statistics, more than 40% of all accidents in Tallinn are accidents with pedestrian. It is clearly presented on the Figure 1: a number of collisions with pedestrians is more than total amount of accidents, where only vehicles participated.

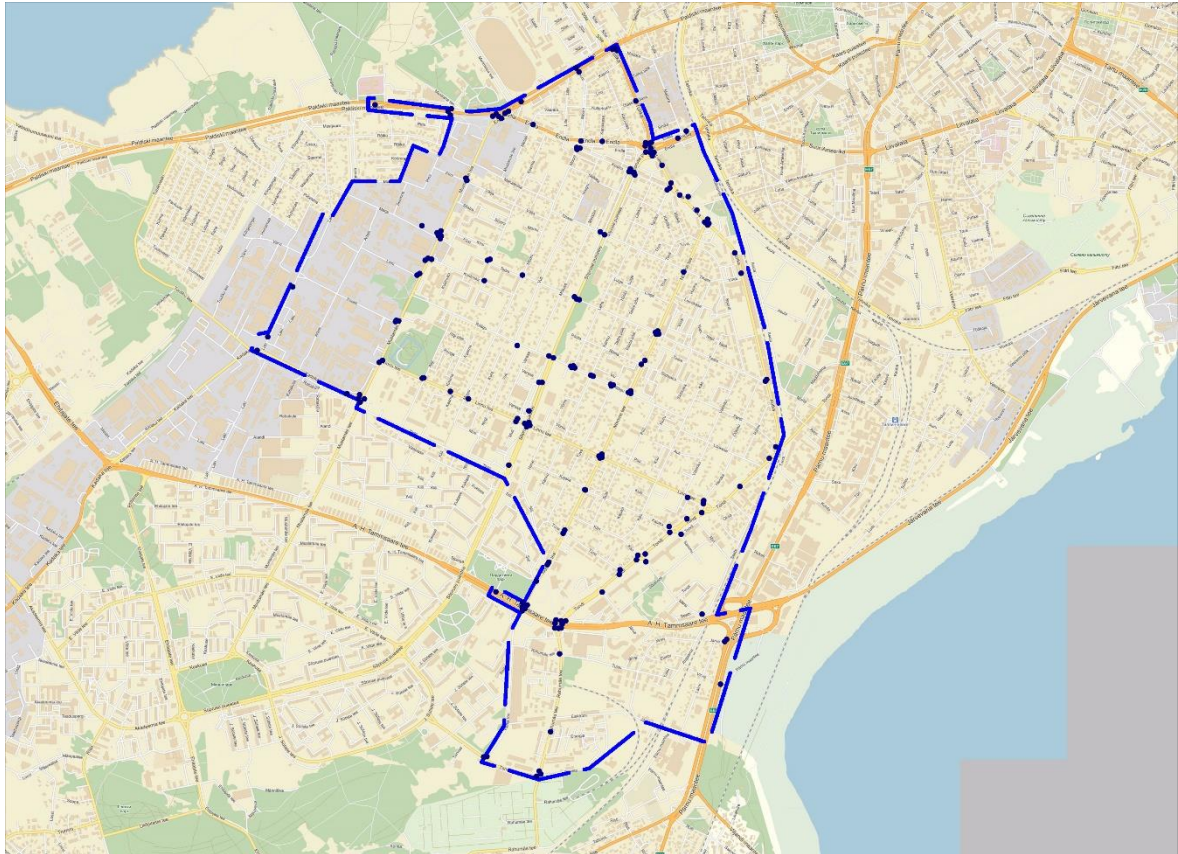
Fig. 5 – Location of all pedestrian crossings in the Kristiine district

Kristiine district was chosen as the most “average” district among existing ones in the perspective of population, area and location. Within the process of research work, information of about 180 pedestrian crossings located in this district was gathered. On the Figure 5 their positions were shown.
