J. Antonino-Daviu; Pons Llinares, J.; Lee, SB. (2016). Advanced Rotor Fault Diagnosis for Medium-Voltage Induction Motors Via Continuous Transforms. IEEE Transactions on Industry Applications. 52(5):4503-4509. doi:10.1109/TIA.2016.2582720

# ADVANCED ROTOR FAULT DIAGNOSIS FOR MEDIUM VOLTAGE INDUCTION MOTORS VIA CONTINUOUS TRANSFORMS

**Abstract** – A number of field case studies for rotor fault diagnosis on medium voltage induction motors operating in a petrochemical plant are presented in this paper. The methodology employed is based on analyzing the induction motor startup current with advanced signal processing tools (Continuous Transforms) that enable a capture of a ‘complete picture’ of the rotor condition. Indeed, unlike the classical tools that often rely on the detection of few fault frequencies, these new tools allow extraction of the evolution of a wide range of fault components during the startup transient and steady-state evolutions, which enables improved reliability. This is crucial in medium-high voltage motors, where a false diagnosis may result in significant expense due to inspection, repair, or forced outage. An additional contribution of the work is its immunity

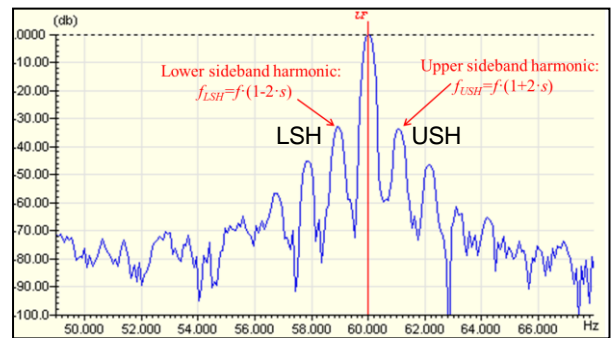
Fig. 1 MCSA results for machine with broken rotor bars

operation by applying the Fast Fourier Transform (FFT) [2-5]. The idea is to evaluate the amplitudes of the frequency components linked with the corresponding failure. In the case of rotor damage, there are two families of frequencies amplified by the fault (see expressions (1) and (2), where  $s$ =slip,  $f$ =supply frequency,  $k$ =integer in (1) and  $k/p=1,3,5\dots$  in (2)). The most relevant components are known as *sideband harmonics* and are obtained from (1) for  $k=1$ . The sidebands (lower and upper) appear around the fundamental frequency, as illustrated in Fig 1.

Evaluation of the amplitude of the lower sideband component, relative to that of the fundamental component, can be used to determine the severity of the rotor failure. Typically, sideband amplitudes between ~55dB and ~45dB are indicative of incipient rotor damage. In case of having values in such range, proper actions should be adopted by the maintenance staff. Note that in most of the cases, damages can be present in the rotor cage for prolonged time intervals (even years) without substantially affecting the machine operation. However, unscheduled outage of the motor and process due to secondary damage caused by protrusion of damaged rotor cage fragments is not uncommon. An example of a 3.3 kV, 450 kW induction motor driving a gasoline transfer pump at an oil refinery is shown in Fig. 2. The motor tripped during operation due to stator winding insulation damage caused by contact between a broken rotor bar and stator endwinding, as can be seen in Figs. 2(a)-(b). Such motor failures not only can cause a forced outage, but also increase the safety risks in the petrochemical industry.

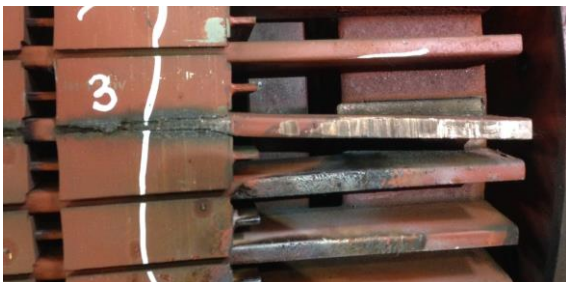
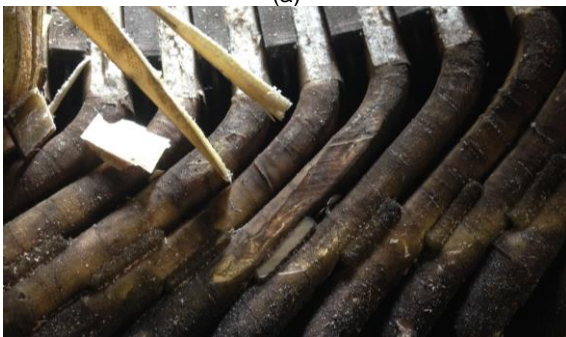
Fig. 2 Forced outage of 3.3 kV, 450 kW gasoline transfer pump induction motor due to rotor bar damage; (a) rotor bar detachment from end ring and damage in rotor core due to arcing; (b) damage in stator endwinding due to protrusion of rotor bar

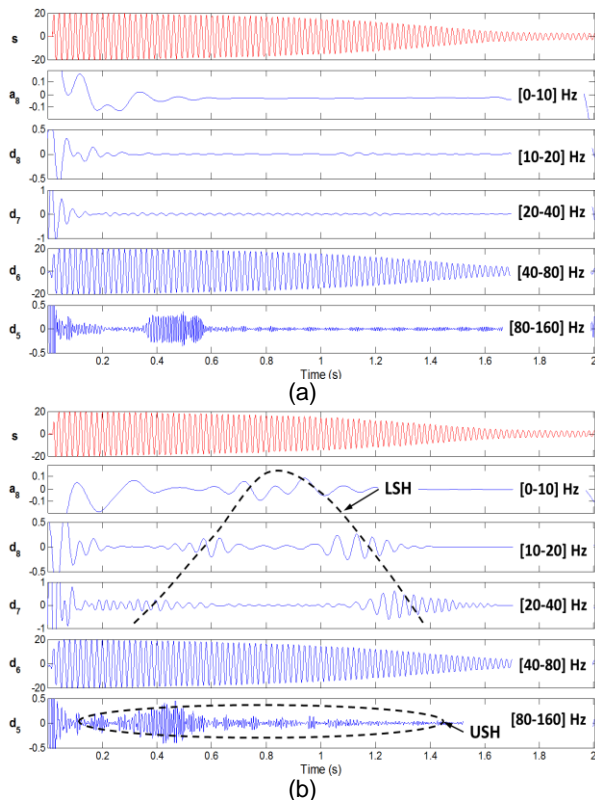
Fig. 3 Discrete Wavelet Transform (DWT) of the startup current for: (a) healthy machine, (b) machine with 1 broken bar

An example of these transforms is the Discrete Wavelet Transform (DWT). Fig. 3 shows the results of applying the DWT to the startup current for a machine with one broken rotor bar [10], where  $s$  is the measured startup current, and  $a_s, d_s, d_7, d_6, d_5$  represent signals associated with a certain frequency range, as shown in the figure. The tool enables detection of the evolutions of some rotor fault related harmonics (in this case the lower and upper sideband harmonics) through the oscillations appearing in the signals resulting from the analysis. The difference between Fig. 3(a) and (b) is clear, where the patterns created by the evolutions of the fault harmonics can be observed in Fig. 3(b). Moreover, since the amplitudes

(and, hence, the energy) of the wavelet signals are higher for severe faults, quantification indicators based on the energy of these signals can be developed. For this particular case, a quantification indicator could be, for instance, based on the energy of  $d_7$  since a substantial portion of the lower sideband harmonic, LSH, evolves in that signal). A possible indicator, proposed in previous works is given by (3) and relates the energy of the signal  $d_7$  (denominator of the quotient in (3)) to the total startup current signal energy (numerator) during the considered interval. In equation (3),  $i_j$  is the value of the  $j$ th sample of the current signal;  $d_7(j)$  is the  $j$ th element of the detail signal  $d_7$ ;  $N_s$  is the number of samples of the signal in the startup transient, and  $N_b$  is the number of samples between the origin of the signals and the extinction of the oscillations due to border effect [10, 14].

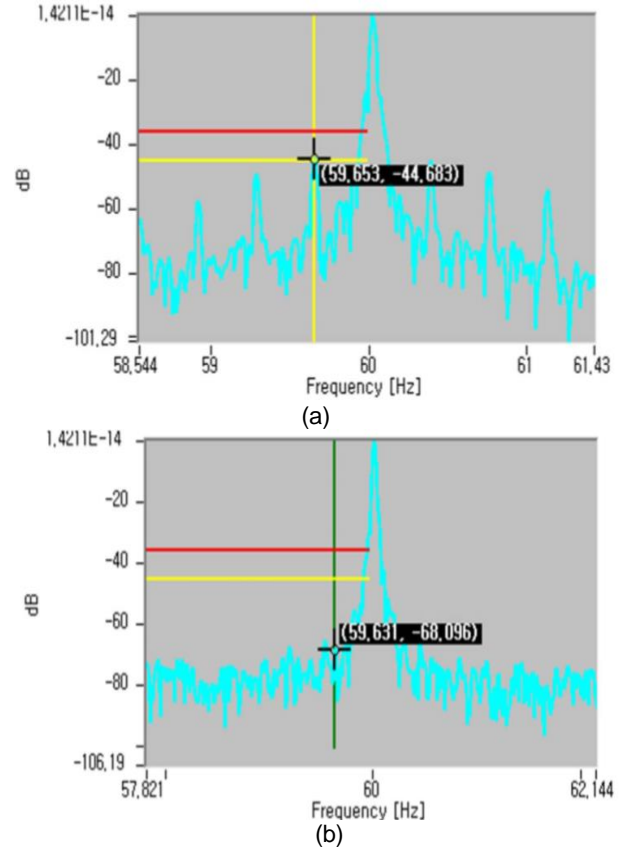
Fig. 5 MCSA application for motor M1: (a) before repair, (b) after repair

The results of MCSA applied for the case of motor M1 before (Fig. 5(a)) and after (Fig. 5(b)) rotor cage repair are shown in Fig. 5. In the former case, the MCSA result reveals a significant amplitude of the LSH (-44.7 dB) that is indicative of rotor failure. However, the chance of the signature being a false positive case must be ruled out. Hence, to ratify the diagnostic, the ATCSA was applied,

The same analyses were repeated after repairing the motor. Fig. 5(b) reveals the low amplitude of the LSH after repair (-68 dB), that is indicative of healthy condition. The patterns given by Figs. 6(b) and 7(b) also confirm this healthy condition of the rotor. Fig. 6(b) shows very weak pattern of the rotor fault wavelet signals and the value of the indicator  $\gamma_{DE}$  was increased to 63.5 dB, which is larger than the 50 dB threshold. Similarly, no significant LSH traces were found in Fig. 7(b).

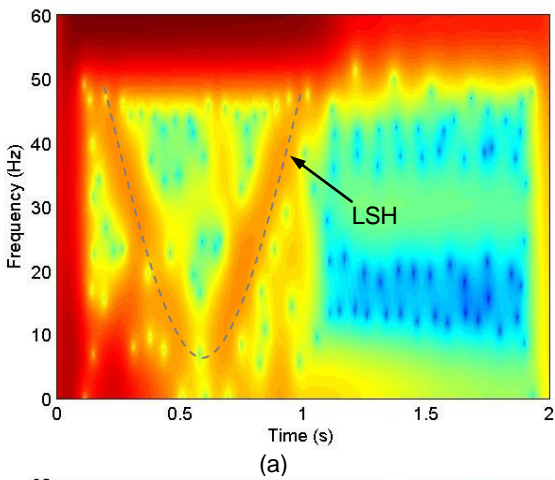
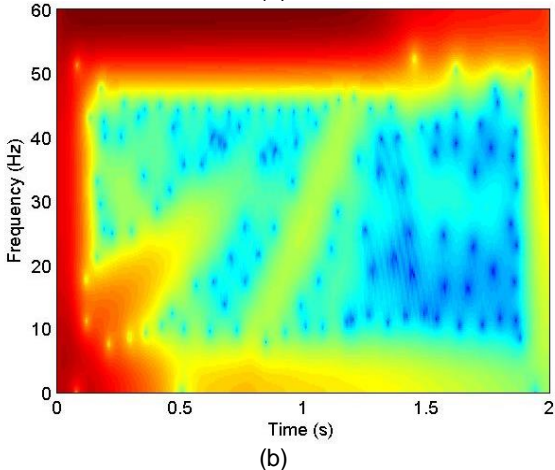
Fig. 7 STFT application for the motor M1: (a) before repair, (b) after repair.

obtained. This is indicative of a clear level of rotor failure since it is smaller than the 50 dB fault threshold. Application of a continuous tool (STFT) results in the same conclusion (Fig. 7(a)) in that a clear V-shaped pattern caused by the LSH evolution can be observed during the startup. This confirms the presence of the rotor fault with a high reliability, avoiding possible false positive indications of the classical tools.

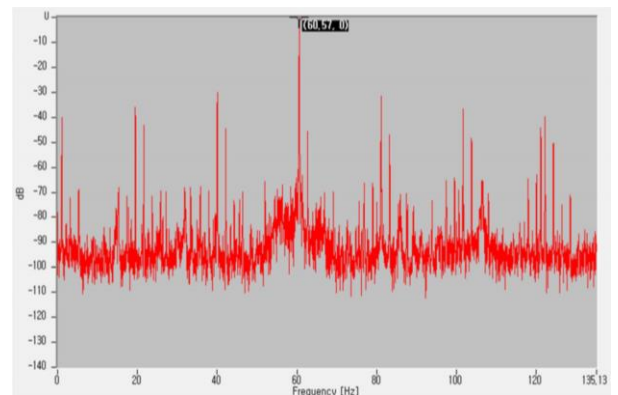
Fig. 8 MCSA application for motor M2.

MCSA of motor M2 led to the spectrum depicted in Fig. 8. The presence of many components with significant amplitudes located near the 20 Hz and 40 Hz and the fundamental frequency were observed, where the source of the interference could not be identified. Diagnosis based on that spectrum is not easy, especially if the speed at which the motor runs is unknown. ATCSA was applied to this case to evaluate its reliability in determining the rotor condition. In the DWT analysis of the startup current, shown in Fig. 9, the LSH pattern is not present, but some oscillations are detected in signal  $d_7$ . They are due to the interference of the unexpected component at 40 Hz. The presence of these components leads to a

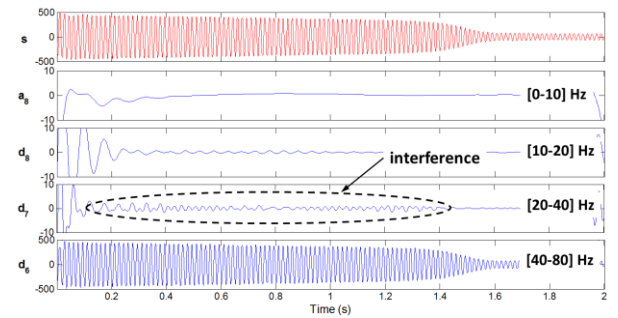
Fig. 9 DWT application for the motor M2.

value of the indicator  $\gamma_{DE}$  close to 50 dB, which can potentially lead to a false indication in the diagnostics.

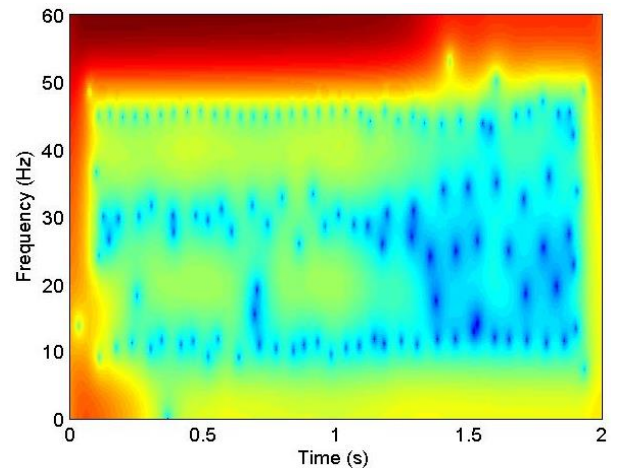
Fig. 10 STFT application for the motor M2.

The application of the STFT shown in Fig. 10 confirms the presence of two constant components at 20 Hz and 40 Hz that are not related to the failure since the LSH pattern is totally absent. Hence, continuous transforms are very useful for ruling out the chance of false fault indication, providing immunity against the external disturbance that introduces components at multiples of 20 Hz.

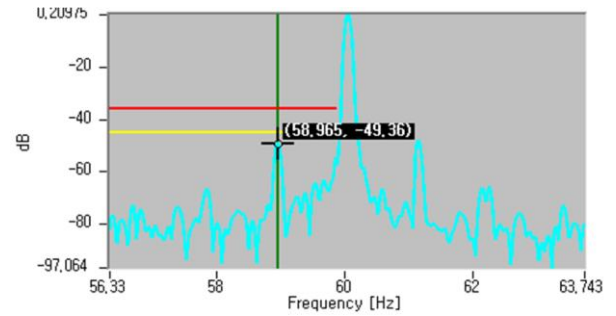
Fig. 11 MCSA application for motor M3.

The MCSA measurements of the rotor fault sidebands,  $f_{bb1}$ , obtained from M3 are shown in Fig. 11. The motor was pulled and inspected since the fault component increased over time to -49.36 dB, as shown in Fig. 11. Visual inspection and a series of off-line tests showed that the rotor was in good condition, and the investigation presented in [15] revealed that the false alarm is produced by rotor core magnetic anisotropy. The 20 and

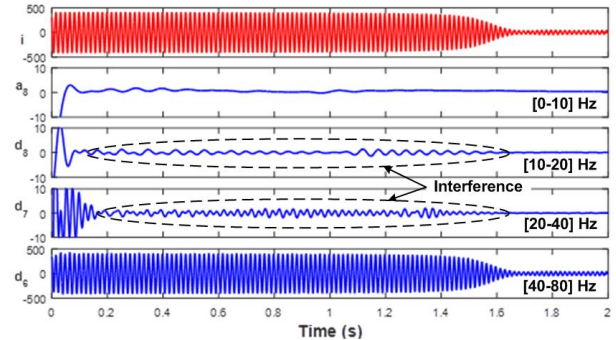
Fig. 12 DWT application for the motor M3.

Although a clear LSH pattern is not present in the DWT analysis of the startup current shown in Fig. 12, noticeable oscillations were observed in  $d_7$  and  $d_8$  due to the interference at 20 and 40 Hz. The oscillations make it difficult for the user to make a judgment on rotor condition with high confidence. The value  $\gamma_{DE}$  was calculated as ???, which is ??? 50 dB, which can lead to a false rotor fault indication. The results of the STFT shown in Fig. 13 confirm that the oscillations observed with DWT were caused by the 20 Hz and 40 Hz components not related to the failure. A weak LSH pattern produced by the inherent asymmetry in the rotor, as in the case of M1 with a healthy rotor (Fig. 6(b)) can be observed in Fig. 13. The results show that the rotor is in good condition since the LSH pattern in Fig. 13 is not strong enough, as in the case of Fig. 6(a), to suspect a broken bar. The reason the startup test method is not influenced by the magnetic anisotropy is because the flux is distributed on the surface of the rotor at startup due to eddy current rejection of the rotor cage [15]. With the flux concentrated at the rotor surface, it is not influenced by the anisotropy of the core. Fig. 13 clearly shows that the potential false alarm produced by magnetic anisotropy and external interference with MCSA or DWT can be avoided with STFT.

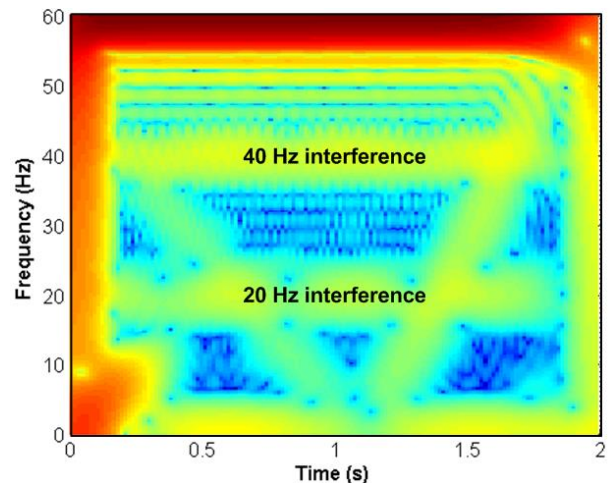
Fig. 13 STFT application for the motor M3.
