Castle of Fossa, Italy

Cultural heritage and earthquakes: a multidisciplinary approach to restoration sites

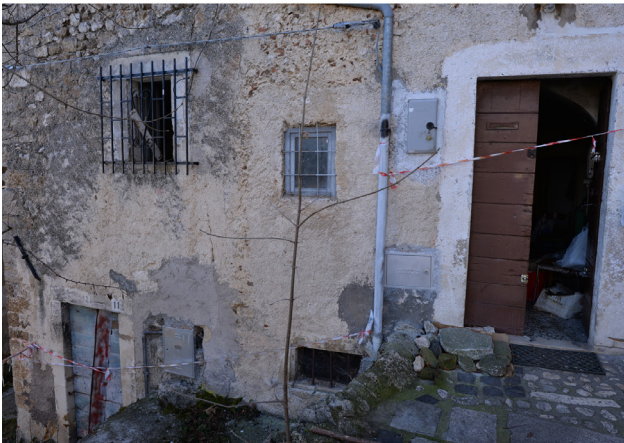
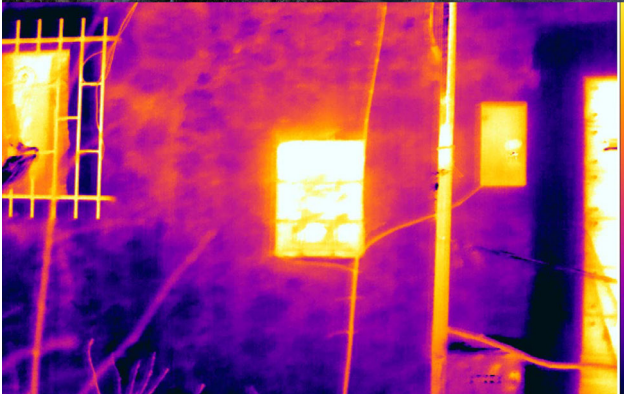
Figure 3.

Architectural Complex 3, Est front: stratigraphical analysis of the masonries and some thermal imaging data

The stratigraphic interpretation of the buildings, carried out both in the field and using a digital photogrammetric model, made use of thermographic images (Ranalli and Boccabella). These images were used to investigate portions of masonry covered by layers of plaster and to shed further light on the relationship between the USMs identified thus providing useful information for structural, architectural and energetic interventions (Fig. 3).

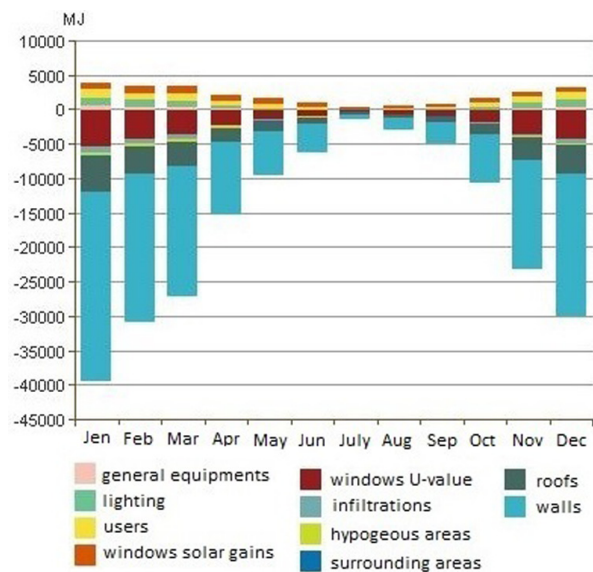
Figure 5.
Actual state. Heating loads from dynamic simulations carried out with Revit Software

The combined interventions (seismic and energetic) on the envelope guarantee a significant improvement in the building's performance in terms of energy saving, as shown in Figures 5 and 6.

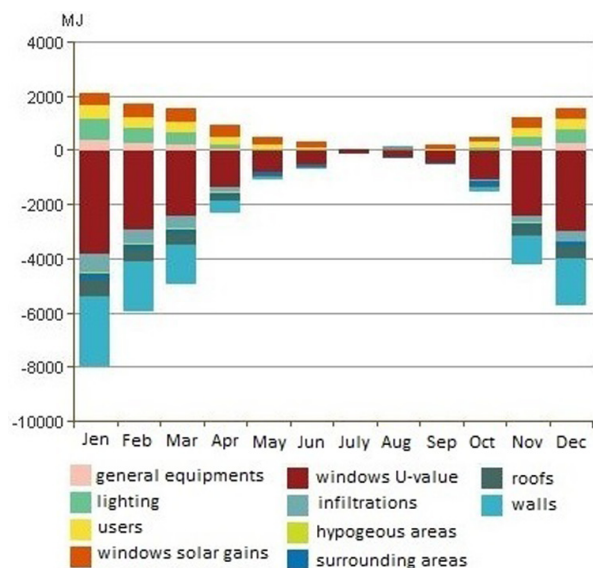
Figure 6.
Project state: combined interventions - seismic and energetic- on the envelope. Heating loads from dynamic simulations carried out with Revit Software.

As a result, we chose to intervene on the envelope in a minimal manner, reducing thermal transmittance by applying thin barriers to the heat flow exclusively on the inner surface of the masonry - using thermal insulation plaster and ultra-thin panels in order to avoid reducing the rooms' volume excessively - and focusing instead on optimizing the installations.
