Sarmiento, PA.; Torres Górriz, B.; Ruiz, DM.; Alvarado Vargas, YA.; Gasch, I.; Machuca, AF. (2019). Cyclic behavior of ultra-high performance fiber reinforced concrete beam-column joint. *Structural Concrete*. 20(1):348-360. <https://doi.org/10.1002/suco.201800025>

Cyclic behavior of UHPFRC beam-column joint.

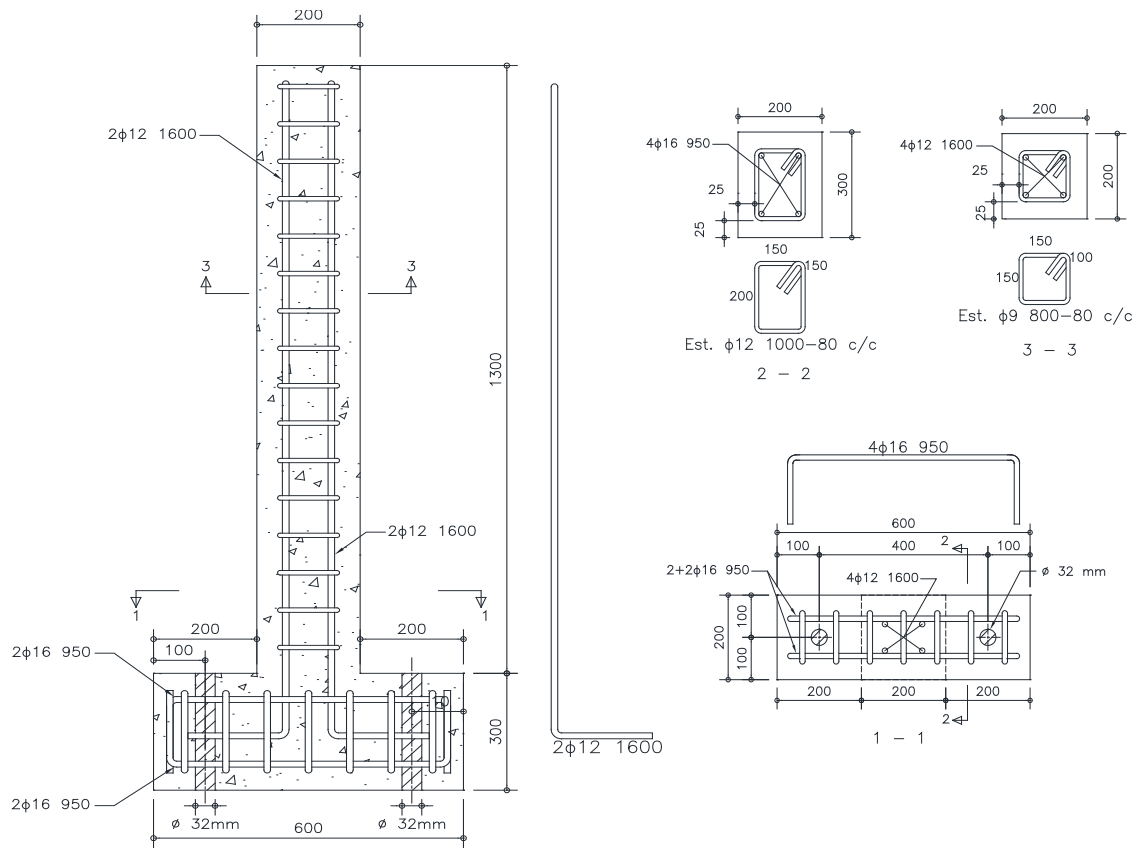
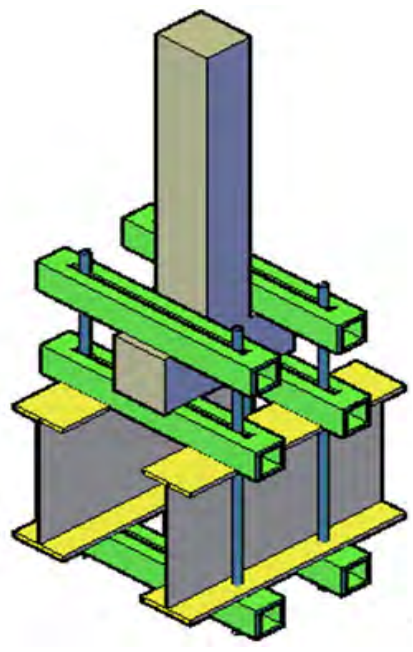
Figura 1. Geometry of the specimens. Dimensions in mm.

In order to characterise its behaviour against cyclic loads, a total of 11 specimens were built with the geometry and characteristics shown in Figure 1a and Table 1. The columns of specimens to be tested were 1.3 m long with a 0.2 m square cross section (minimum dimensions of a structural element with moderate energy dissipation MDO according to NSR-10) [40]. The longitudinal reinforcement was four 12 mm round rebars with 150 x 150 mm stirrups 10 mm in diameter. The concrete cover was 25 mm thick. The compressive strength f'_c of the concrete used in the specimens and the number of specimens tested are given in Table 1. All the specimens had the same geometry and reinforcement, and only differed in the fibers dosage per concrete volume.

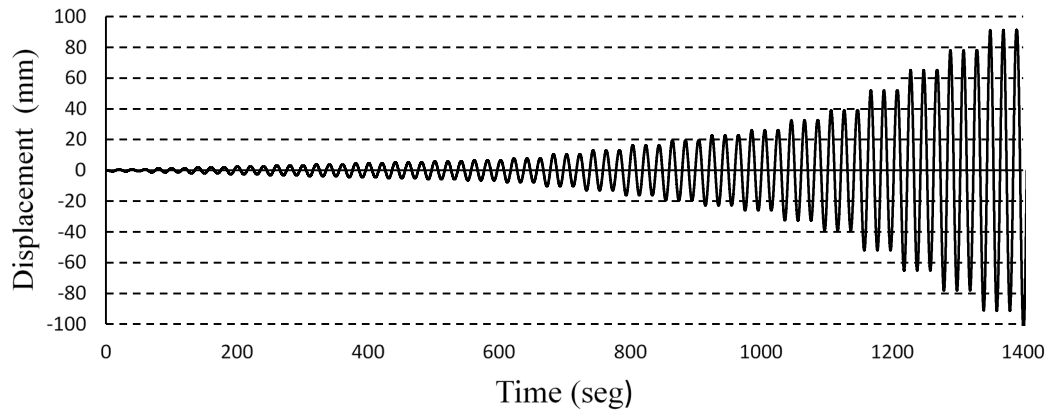
Figure 2. Sinusoidal displacements applied in the upper part of the columns.

Each specimen was subjected to a reverse cyclic lateral load in displacement control. Controlled cyclic (sinusoidal) displacements were applied to the upper part of the columns, as shown in Figure 2. The displacements were small at first, until reaching drift ratio levels close to 6% of the column's length. Three full cycles of reverse lateral loading were applied in each run. Each specimen was loaded until either a load drop of approximately 6% of the drift ratio or irreparable damage occurred.

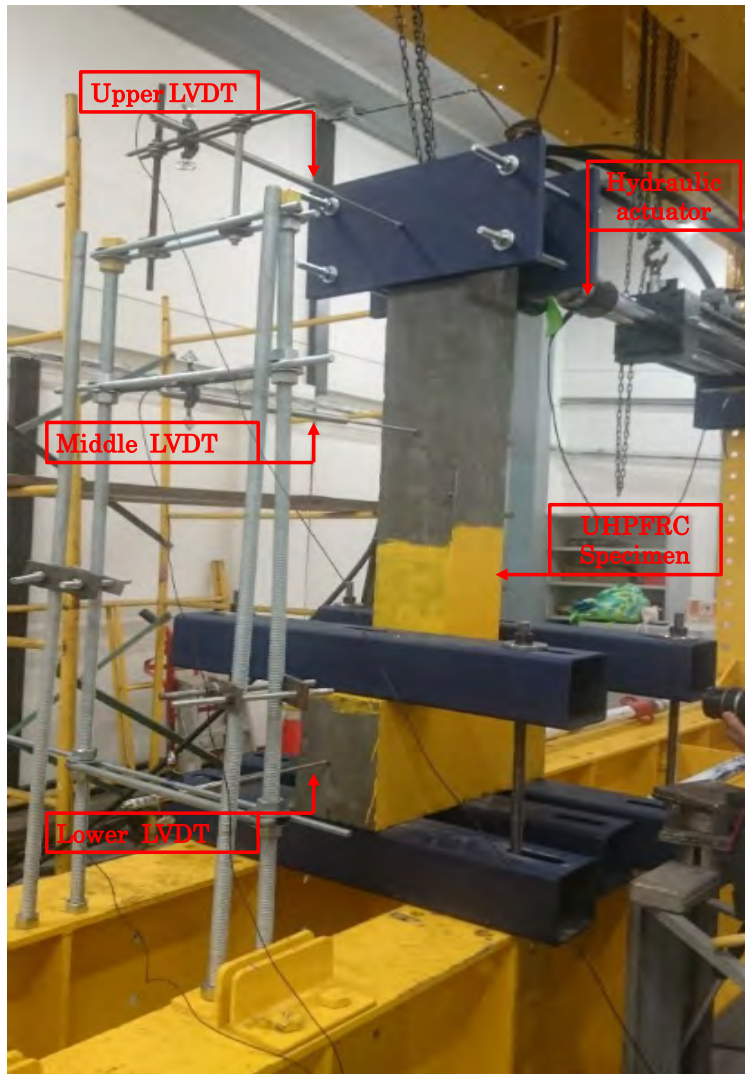
Figure 3. Set-up of the cyclic load test.

Each specimen was tested individually. Figure 3 shows the set-up of the specimens in the laboratory test. The displacement of the footing in the horizontal plane was measured by an LVDT system to guarantee the correct anchorage. To control the stability of the test during the loading cycles three LVDTs were fitted to the column at the base, middle-section and top.

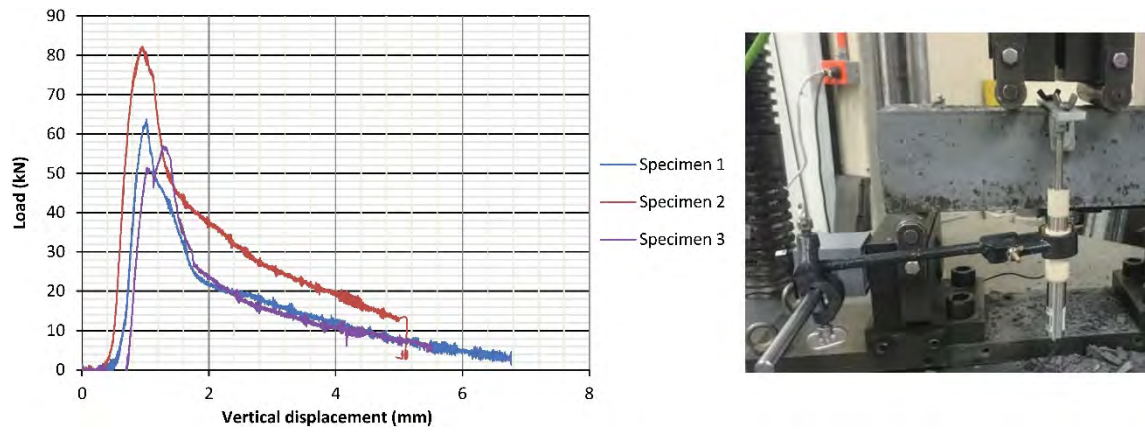
FIGURE 4 Monotonic bending test on UHPFRC specimens

In addition, monotonic test were made on the material. Bending test were made on three specimens according to ASTM C78-10. Figure 4 show the results and the degradation of the mechanical properties for high levels of strain can be seen.

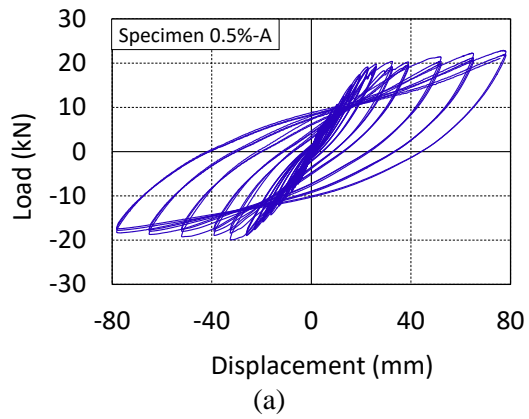
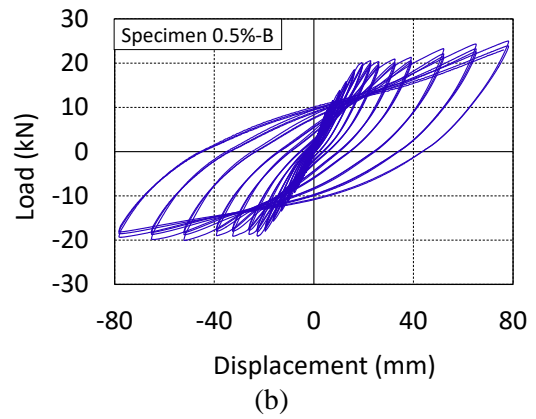
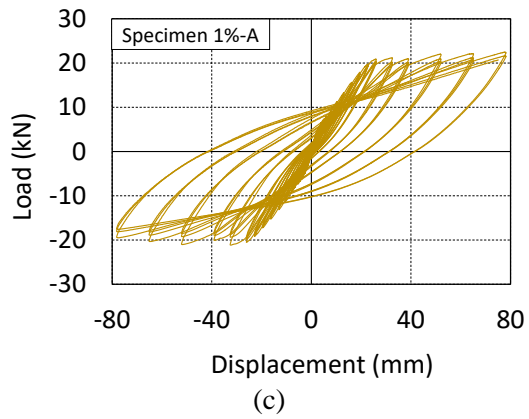
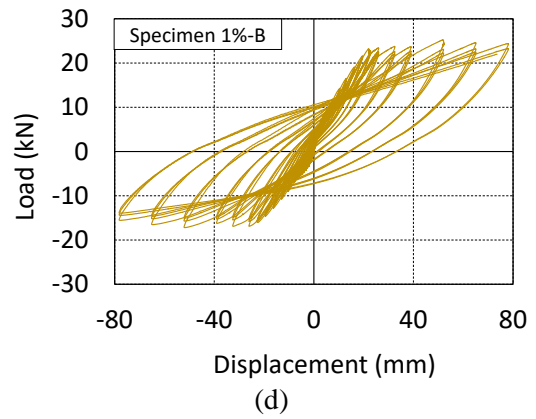
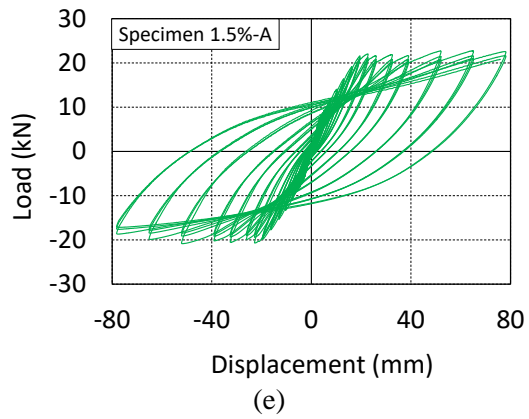
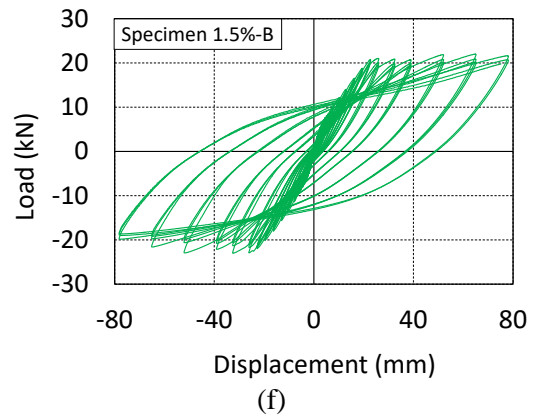
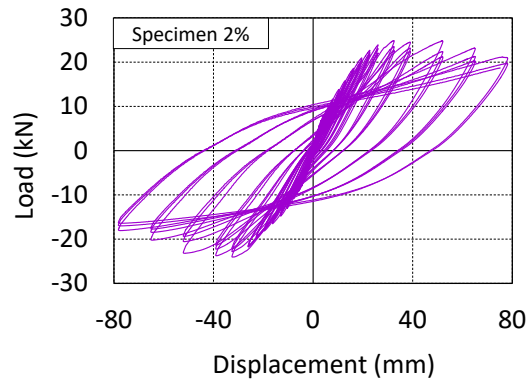
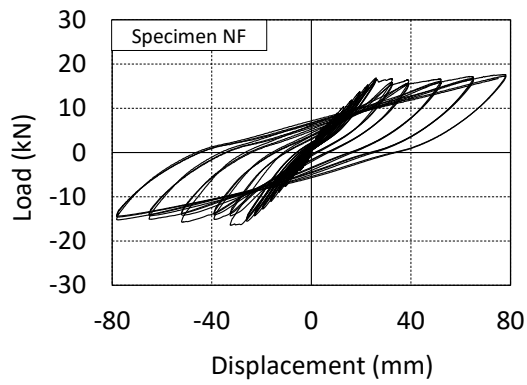
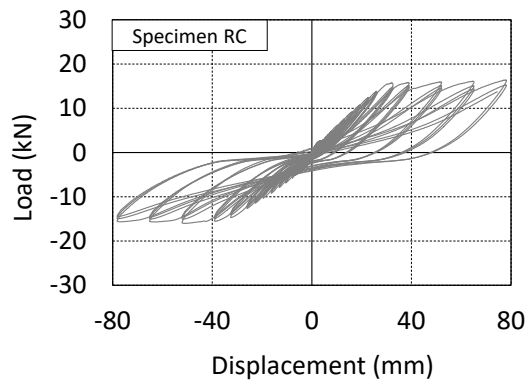
Figure 5. Hysteretic load-displacement response for specimens: (a) 0.5%-A; (b) 0.5%-B; (c) 1%-A; (d) 1%-B; (e) 1.5%-A; (f) 1.5%-B; (g) 1.5%SF-A; (h) 1.5%SF-B; (i) 2%; (j) NF; and (k) RC.

The behaviour of the specimens was evaluated by the relationship between the displacements applied to the upper part of the columns and the loads obtained. The graphs in Figure 5 a-k give the hysteresis cycles for all the specimens up to a drift ratio of 6% (displacement of 78 mm), although some tests reached 8% (displacement of 104 mm).

The similarity of the results obtained for each pair of specimens should be pointed out here (Graphs a-b, c-d, e-f, g-h) as well as the resulting symmetry of both displacement directions.

Figure 5 (j) and (k) show similar maximum load values for the NF and RC specimen, clearly lower than the loads reached by the UHPFRC specimens with fibers. On average, the maximum load reached by the UHPFRC specimens with fiber dosages is 30% higher than that of the NF specimen, and a 47% higher than that of the RC specimen.

From these figures, it can be seen that adding fibers clearly increases the energy dissipation capacity. It can be seen that the UHPFRC specimens have a larger area inside the hysteric cycle than the RC and NF specimens, showing the formers' greater energy dissipation capacity. It should be noted the similarity of the results obtained for each pair of specimens (0.5%-A and 0.5%-B; 1%-A and 1%-B; 1.5%-A and 1.5%-B; 1.5%SF-A and 1.5%SF-B).

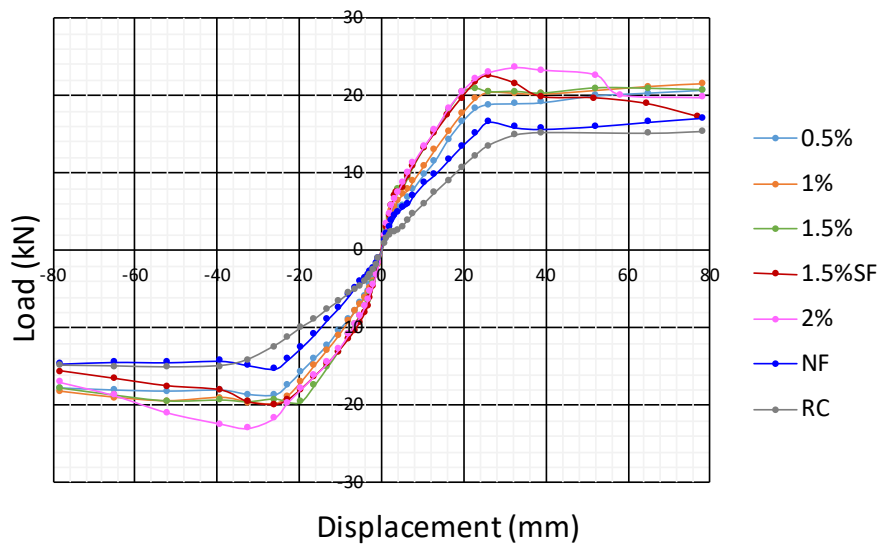
Figure 6. Load-displacement envelope curves.

Figure 6 shows the load-displacement envelope curves of all the specimens. It should be noted that due to the similarity of the results obtained for each pair of specimens (0.5%-A and 0.5%-B; 1%-A and 1%-B; 1.5%-A and 1.5%-B; 1.5%SF-A and 1.5%SF-B), the results shown in Figure 6 shown the average for each pair of specimens. From load-displacement envelope response, the stiffness variations of each specimen can be obtained as the ratio between the load applied and displacement. The load-displacement envelope curves also show the load that cause the failure at the base of the column.

- NF and RC specimens had lower loads than the loads supported by the UHPFRC specimens (0.5%, 1%, 1.5%, 2% and 1.5% SF), due to the lack of fibers. NF and RC specimens reached maximum loads of 17 and 15 kN for a drift ratio of 2% and 3%, respectively (displacements of 26 and 39 mm).

- The 2% specimen reached the greatest load with a value of 24 kN for a drift ratio of 2.5%. This value is 60% higher than the RC specimen and 41% higher than NF specimen.

- The use of fibers increases the maximum horizontal load by an average of 30% more than that of the NF and 48% more than the RC.
- All the specimens presented linear behavior during the first load cycles and up to a drift ratio of approximately 1.5%, which corresponds to a displacement close to 20 mm. From now on, more significant differences are observed depending on the fiber percentage of each specimen.

- The use of SF fibers (1.5% SF specimen) increases the specimens' initial strength but they cannot maintain the load with the same ductility as the others, as their maximum horizontal load degenerates at drift ratios over 2% (displacement of 26 mm). This is due to a greater loss of adherence in SF than in HK, which provide a high anchorage effect.

- 2% specimen suffers a sudden strength loss from a 4% drift ratio (displacement of 52mm). This behavior is observed only for one displacement direction and is due to the sudden cracking of the concrete that has not been properly tied by the fibers. As seen later, the 2% specimen showed deficient workability when being poured. From now on, strength remains constant with a ductile behavior until the end of the test.

- 0.5%, 1% and 1.5% specimens present a very similar behavior. From a 1.5% drift ratio (displacement of 20mm), the strength of the specimens remains constant with a high ductility, until reaching drift ratio of 6% (displacement of 78 mm). This behavior can be observed equally in both directions of displacement.
- The UHPFRC specimens had higher initial stiffness than the RC and NF specimens, as seen in the steeper slope of the initial linear part of the load-displacement envelope curve.

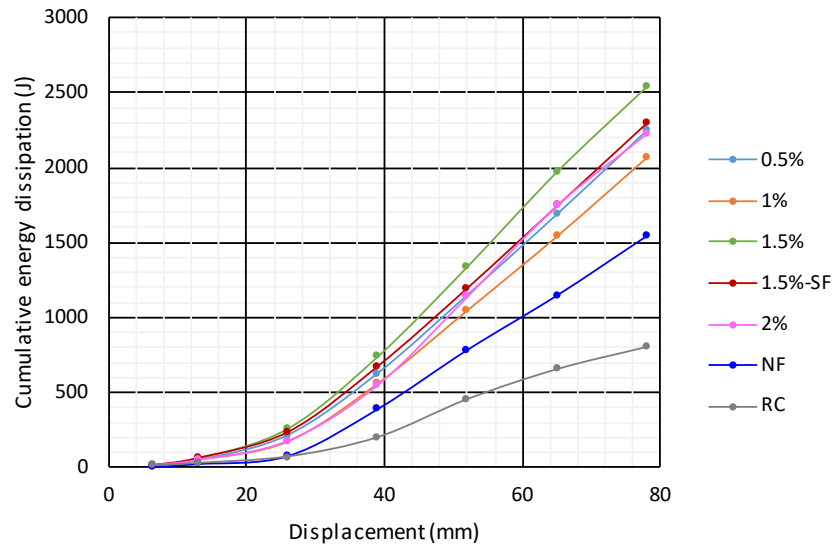
Figure 7. Cumulative energy dissipation - Displacement

The energy dissipated in a single load cycle is obtained by using the trapezoid rule to determine the area within the vertical load versus the displacement of the corresponding drift ratio. The amount of cumulative energy dissipated by the specimens during the test (the average of three load cycles under the same displacement) is shown in Figure 7. It should be noted that due to the similarity of the results obtained for each pair of specimens (0.5%-A and 0.5%-B; 1%-A and 1%-B; 1.5%-A and 1.5%-B; 1.5%SF-A and 1.5%SF-B), Figure 7 shown the average for each pair of specimens.

- The amount of dissipated energy at the start of the test was similar in all the UHPFRC specimens. RC and NF specimens accumulated the least energy due to their not having fibers. Despite this, NF specimen dissipated 92% more energy than the RC specimen.

- After a displacement of approximately 25 mm (drift ratio close to 2%) the amount of energy dissipated by the specimens was seen to change, due to the cracks at the base of the columns and the contribution of the fibers, which helped to dissipate energy. In this way, the UHPFRC specimens showed better behaviour than the RC and NF specimens, since the fibers delayed cracking.

- 1.5% SF specimen dissipated less energy at high displacement values than 1.5% specimen, which was due to a greater loss of adherence in straight fiber (SF) than in hooked fiber (HF), which provide a high anchorage effect.

- 1% specimen dissipated less energy at high displacement values than 0.5% specimen, which can be considered abnormal and was due to a non-homogeneous distribution of the fibers inside the concrete, when it was being poured into the formwork. The authors consider that a problem in

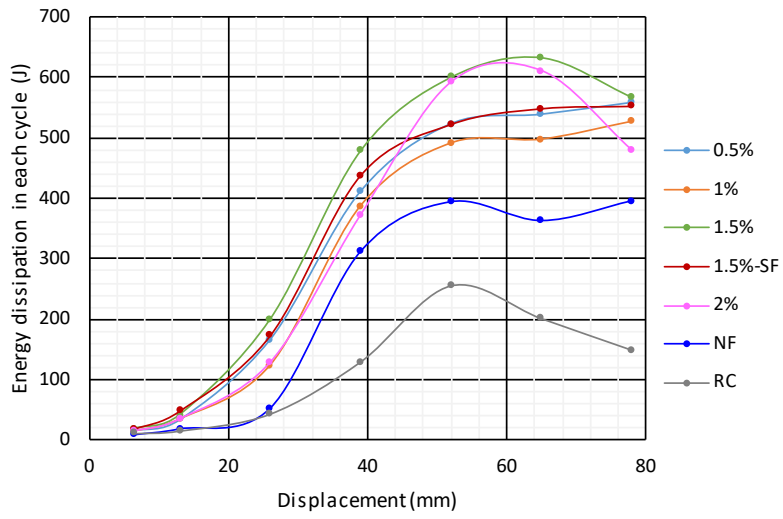
Figure 9. Energy dissipation in each cycle - Displacement

Figure 9 shows the average energy dissipated in each three load cycles under the same displacement. In view of the results, the following can be stated:

- In UHPFRC specimens, the energy dissipated by the cycles increases until a drift ratio of 5% (displacement of 65 mm). From this drift ratio degradation can be considered to start and is reflected because for higher drift ratio, the energy dissipated in each cycle practically does not increase, and even decreases as in the case of 1.5% and 2% specimens.
- The behavior of NF and RC specimens is quite similar, although the NF specimen dissipates a greater amount of energy in each cycle than the RC specimen. For this case, energy dissipated in each cycle increases until reaching a drift ratio of 4% corresponding to a displacement of 52mm. From now on, the energy dissipated by each cycle decreases, which indicates that the NF and RC specimens show greater degradation for lower drift values, with respect to the UHPFRC specimens.

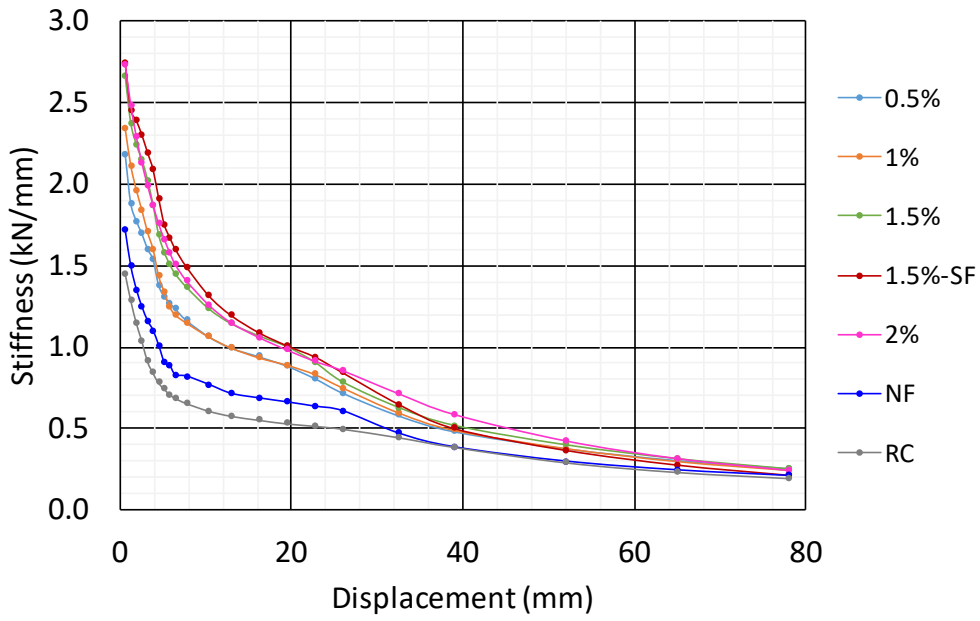
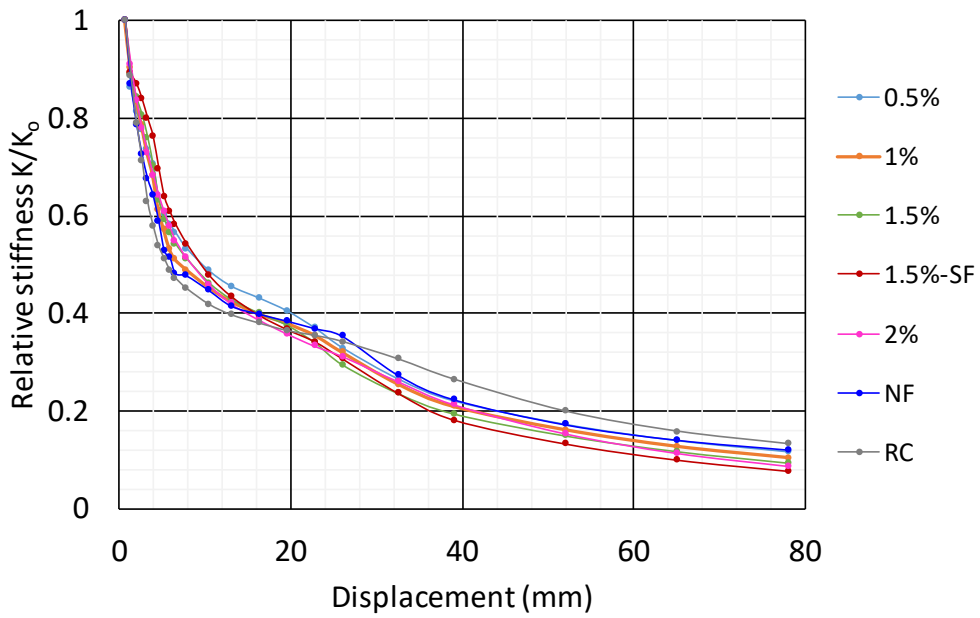
Figure 10. (a)- Stiffness degradation. (b)- Relative stiffness K/K_0

Stiffness was seen to degrade during the test (see Figure 10.a). Using the envelopes, the values of initial stiffness were calculated as the averages of the push and pull directions.

- The stiffness of all the specimens is degraded with time during the tests due to the cracking at the base of the columns.
- Similar results were obtained for each pair of specimens (0.5%-A and 0.5%-B; 1%-A and 1%-B; 1.5%-A and 1.5%-B; 1.5%SF-A and 1.5%SF-B). The differences of stiffness variation between the two specimens of the same mix are negligible. For this reason, Figure 10 shown the average for each pair of specimens.

- The initial stiffness of the specimens varied between approximately 1.4 and 2.8 kN/mm, the stiffest being those with the highest dosage of fibers. The RC specimen was the least stiff. Fibers dosage has a higher influence on stiffness. For example, 1.5% specimen is 72% stiffer on average than the RC specimen.

- After the 3% drift ratio (displacement of 39 mm) the stiffness of all the specimens were quite similar and small, except for RC and NF specimens, which remained below the rest.

- However, it is important to highlight that the relationship between the initial and final stiffness of each specimen is quite similar. This means that the stiffness percentage losses with respect to the initial stiffness k_0 of each specimen is very similar for all the specimens (Figure 10.b). For a drift ratio of 6% (displacement of 78 mm), stiffness of all the specimens varies, on average, between 13% and 7.7% of its initial stiffness. These values correspond to the RC and 1.5%-SF specimens.

- All the specimens suffered the greatest loss of stiffness in the early stages of the test (Figure 10.b), specifically to a displacement of 6 mm (drift ratio of 0.5%). On average, up to a displacement of 6 mm, the UHPFRC specimens lost 45% of their initial stiffness, NF specimen lost 53 % of its initial stiffness and the RC specimen lost 52% of its initial stiffness. Once this drift ratio has been exceeded, the stiffness of all specimens decreases but with a lower slope.

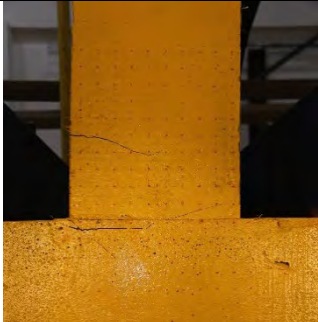
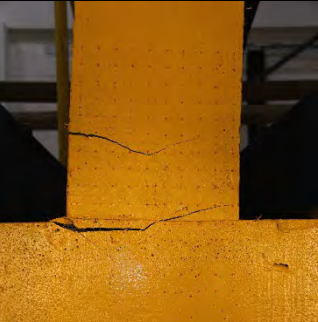
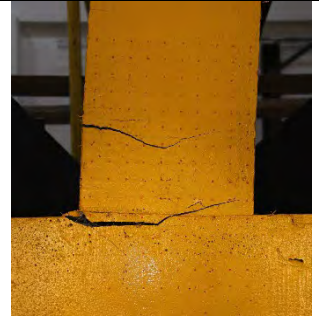
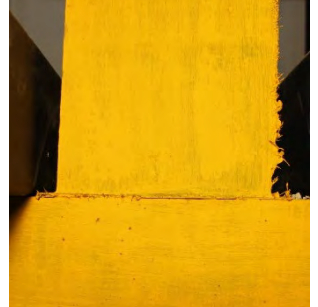
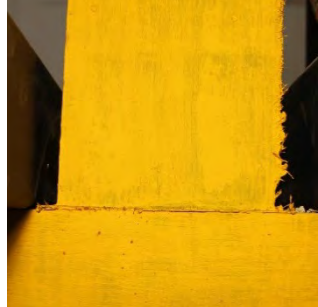
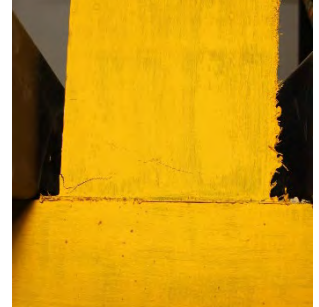
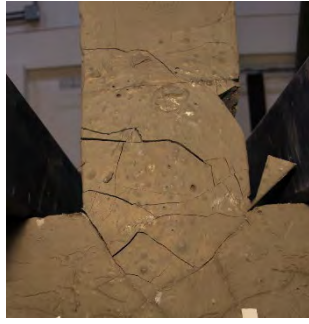
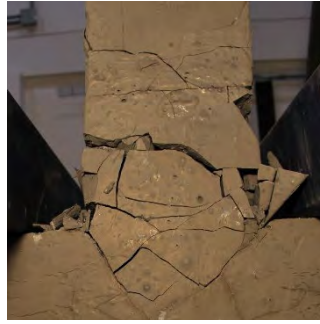
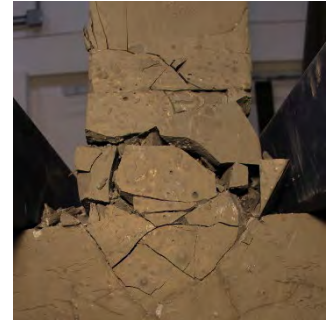
Drift Ratio			
Specimen	1%	2%	3%
0.5%

Figure 11. Evolution of the damage (cracking) in the specimens for different drift ratio.

The cracking patterns were compared using photos of the bottom of the columns and the beam-columns joint of the different specimens. Figure 11 shows the evolution of the cracks in each specimen at different drift ratios of 1%, 2% and 3%. From these results it can be concluded:

- As the cycles progressed, the first bending and horizontal cracks were observed at bottom of the column, close to joint region.
- For UHPFRC, failure was in general due to the bending of the column, with horizontal cracks in the bottom section but with no serious damage at the joint. The even distribution of the fibers within the columns in UHPFRC specimens avoided the propagation of severe cracking. The first bending cracks were observed at the bottom of the column at an imposed displacement of close to 6 mm (drift ratio close to 0.5%). Cracks due to plastic settlement were noted in the 1.5% specimen before the test, which caused the crack to occur away from the joint over one of the stirrups. This effect had greater impact in this specimen due to the atmospheric conditions of the day of the pouring and curing the specimen. Specifically, that day there was a medium-low humidity and high temperatures, which caused more exudation.

- Of all UHPFRC specimens, 2% showed the least damage level at the end of the test. 0.5% specimen was the one that reached the highest damage level.
- However, in RC and NF specimens, the cracks at the bottom of the column caused degradation and loss of material and reduced the element's strength and the adherence of the rebars reinforcement.

- The RC and NF specimens highlighted also a significant vulnerability in the joint region, where there was also a typical shear failure (tilted cracking). The first signs of damage occurred at the column during an imposed displacement of 3.5 mm (close to 0.3% drift ratio). These cracks were small and flexural. For NF specimen, bending cracks were increasing at the bottom of the column until reaching a high level of damage when drift ratio was close to 1% (Figure 10). For RC specimens, these bending cracks did not reach as much spread as in the NF specimen.

- Several cracks then started to develop in the joint region, that affect the strength of the specimen when the cracks along the two diagonals of the joint became dominant (Figure 10). At the end of the test, it could be seen that the failure for NF and RC specimens was characterized by spalling of the concrete and considerable loss of material.

- The use of steel fibers greatly improved the columns' cyclic behaviour and avoided the spalling and loss of material seen in the NF and RC specimens.

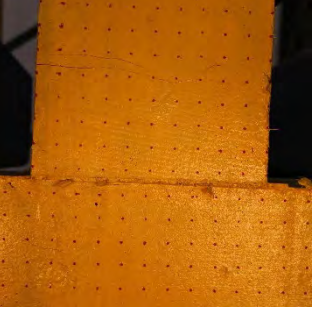
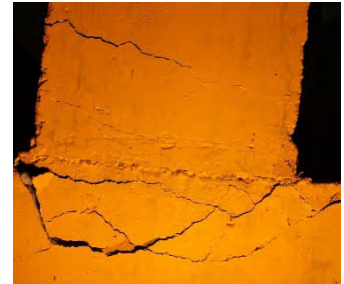
Figure 11. Evolution of the damage (cracking) in the specimens for different drift ratio.

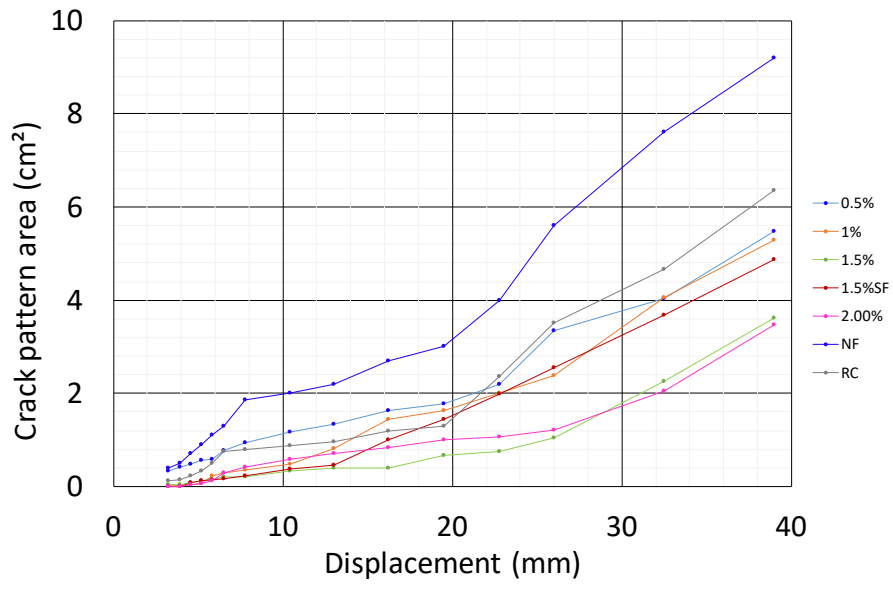
Figure 12. Crack pattern area

The cracking area for each displacements were measured by digital images software taking into account the width and length of the cracks. The photographic acquisition system was configured to take a photograph (of each of the two sides of the beam-column joint) when the last maximum displacement was applied in each of the load cycles, both when the dynamic actuator was in tension and when it was under compression. Figure 12 show the values of the crack pattern area vs displacements applied to the upper part of the column.

It can be seen in Figure 12 that in general the UHPFRC specimens greatly restricted the cracking propagation since they have fewer cracking areas. In the RC and NF specimens the cracking areas tend to grow as the imposed displacement increases.

Here again it can be seen that RC and NF specimens suffer increased degradation as the imposed displacement rises, as they present large cracking areas. On average, for an displacement of 39 mm (3% drift ratio) the fibers have reduced the cracked area by between 40 and 62% compared to the NF specimen and between 15 and 43% compared to RC specimen.
