Failure analysis of a plastic modular belt in-service

In this study, an analysis of the possible causes of the failure in-service of a section of a plastic modular belt was conducted. The study begins with a reproduction of the service conditions in a traction gear. An analysis of the fracture surfaces revealed the existence of defects in the interior of the parts. With the aim of determining the origin of the imperfections and their influence on the failure, an exhaustive mechanical and rheological characterization of the material was carried out. The development of an FE Analysis established that the reduction of the tensile strength of the part due to internal defects was around 70%. Tests also showed that the most stressed area was the area where the most defects appeared. A simulation of the injection process showed that the defects are caused by the geometry of the part, leading to the conclusion that its failure was caused by bad dimensioning of thicknesses.

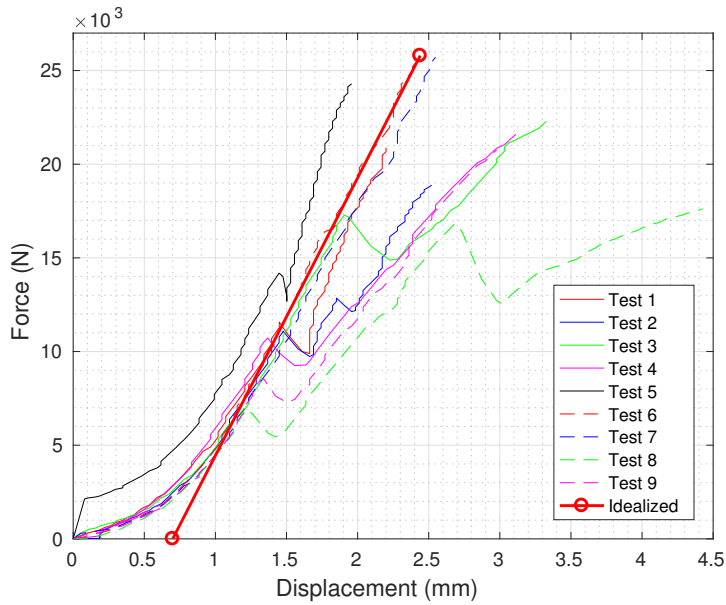
The tensile specimens results were obtained from ten tests, and one of them
 170 was discarded because of the pin premature breakage due to a inner defect.
 While the other specimens were being tested, the pins did not break prior to
 the belt links. Figure 6 and Table 2 show the results obtained in the tensile

tests on the modular belt links. As can be seen, the values obtained are fairly dispersed for tensile strength and the associated displacement. The data also showed that the break began to occur under considerably lighter loads, reaching values as low as 700 N. Finally, the majority of the breaks appeared in the lower part of the pin holes, as previously observed during in-service breakage.

Figure 6: Belt link tensile tests results

Figure 12 shows the relationship between force and displacement obtained
 from the FEA, as well as from the belt link tests (Figure 6). As can be seen, the
 loss of stiffness is significant, reduced up to half the theoretical value. As the
 225 belt link actually works mainly under tensile efforts, this loss of stiffness means a
 useful section reduction of around 50%, according to the results obtained using
 Equation 9.

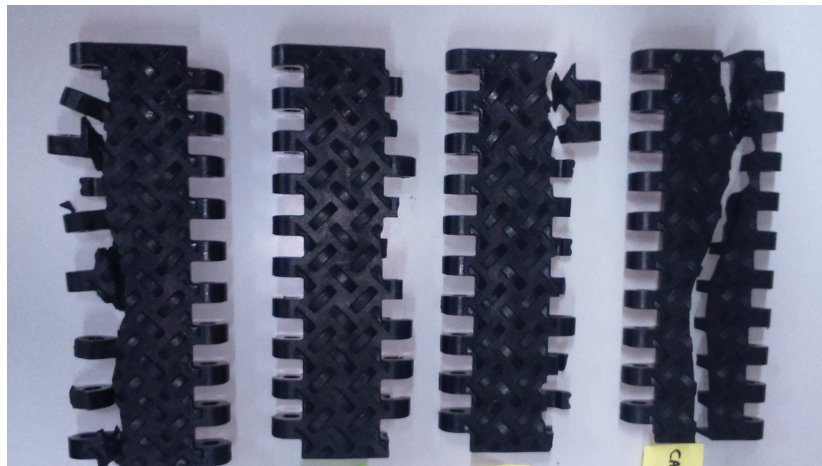
After carrying out the tensile tests on the modular belt, the breakages were analyzed. A simple visual inspection showed the divergence of the fracture shape
185 (Figure 7), as well as the presence of internal imperfections (Figure 8). Figure 9 shows a more detailed analysis obtained under magnification. In all cases, there were imperfections in the fracture surface.

Figure 7: Comparative of different types of fracture.

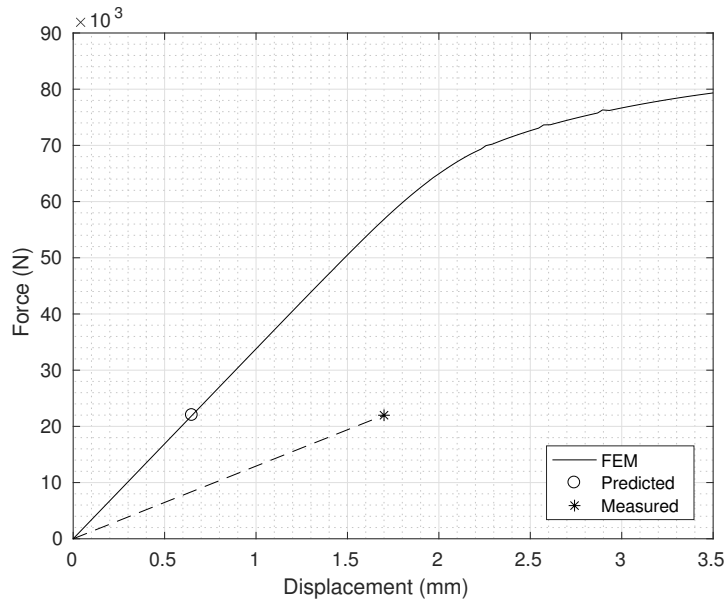
Figure 12: Force vs displacement
