Characterization of historical coating mortars of La Ceramo factory in Valencia

Marcela Luana Sutti¹, Maiara Oliveira Silva de Aguiar¹,
Cesar Fabiano Fioriti¹, Maria Paula Hêngling Christófani¹

¹ Department of Planning, Urbanism and Environment, Universidade Estadual Paulista (UNESP)

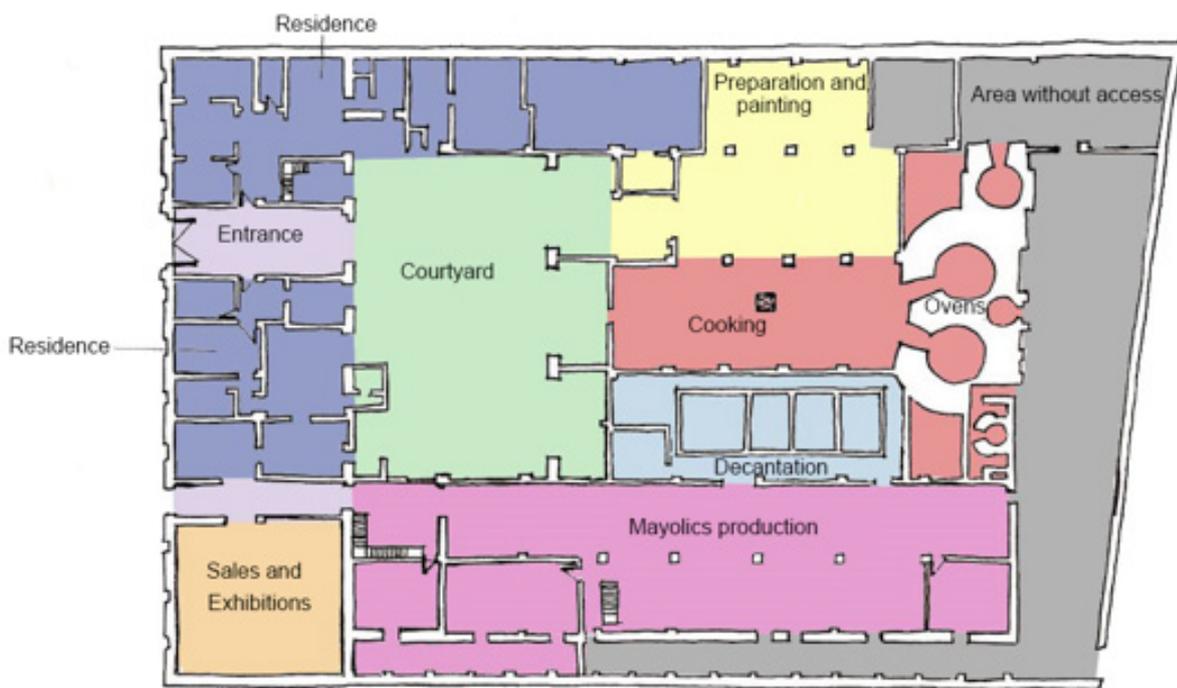
Figure 1.
Sketch of the Location for the built blocks and the open courtyards of La Ceramo

The La Ceramo factory is basically formed by four built blocks and open courtyards. The building main entrance gives direct access to the activity courtyard and the owning family residence block. From this central patio it is possible to access the first factory

built block, the ovens and the cooking place; the second open patio, the decantation one; the block of ceramic production workshops; and the block connected to the ovens; preparation and painting processes, all presented in the sketch of figure 1.

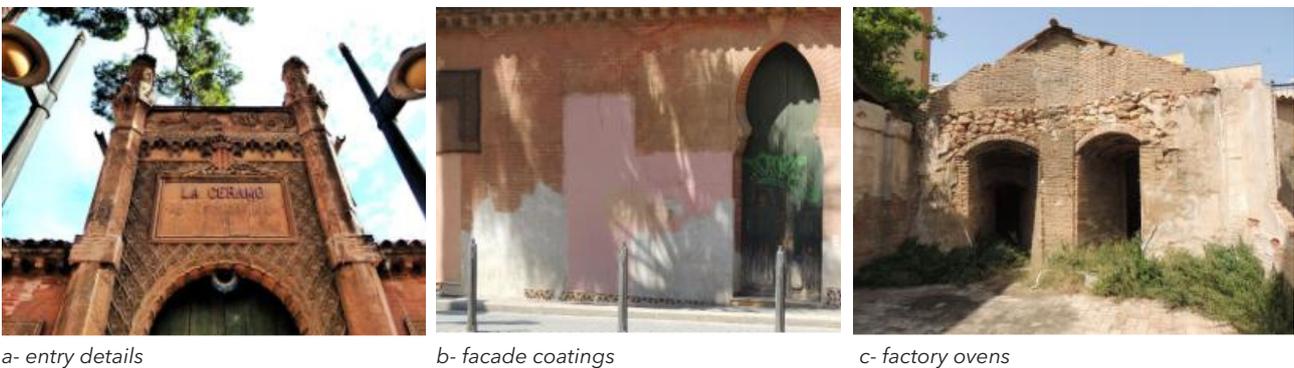
Figure 2.
Images of the La Ceramo factory

The first block main facade consists of an entrance with an arc of evident arab influence, supported by two columns which the right-hand column was lost over time and the column on the left is all smooth containing capital, while the upper part consists of an abacus with interlaced decorations. The arc is also included within a large rectangular decorated frame, consisting an iconic rhombic pattern, also with

obvious arab origin. Finally an effigy above the arch, which also shows the city of Valencia's shield and the name of the factory, as shown in figure 2 [a]. The main access door is run down, made of wood and painted in green color, leads to the main patio of the factory. To the right of the entrance door there is another side entrance leading directly to the building where the ceramic production processes were present. Other openings, containing Arabic-style frames, are also present on the facade, now protected by safety nets (Pagliuca, 2017).

The facade observed in figure 2 [b] does not contain many of the original coatings, existing vestiges of an older mortar in the walls, but what prevails is a coating of ordinary mortar, regularizing what was before collapsing.

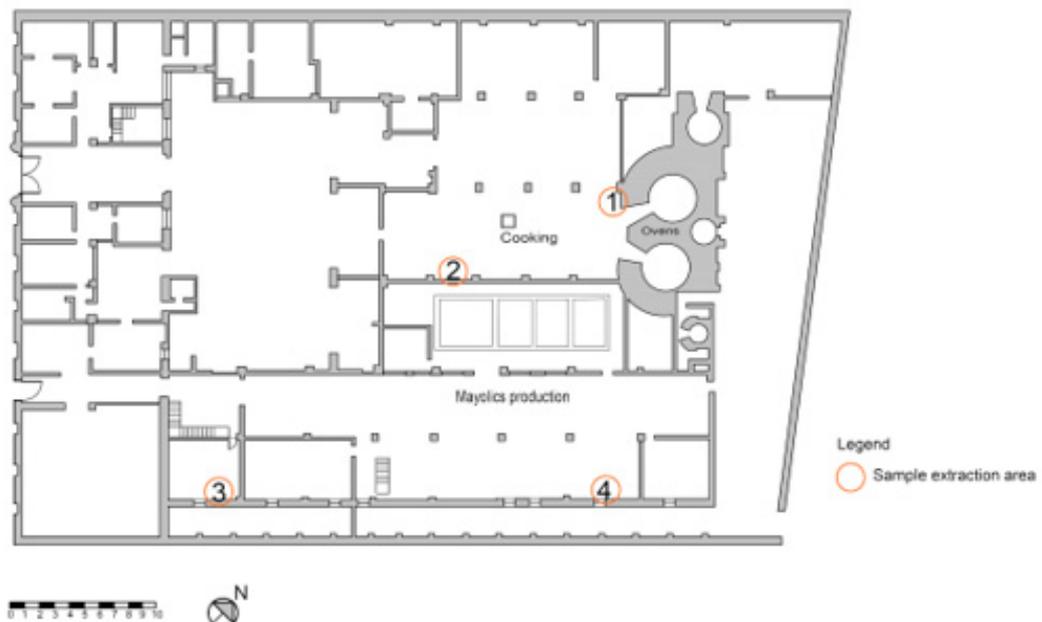
Figure 3.
Sample extraction areas

The removal of mortar coatings samples for study in this work was carried out inside the La Ceramo factory. All the pieces were taken from inside the factory masonry, because, as the building description shows, the outside part was not able to remove the cover layer, while inside the building, the chosen areas presented better conditions for this practice. Sample removal areas are marked in figure 3 and numbered from 1 to 4, as they will be displayed from this point of work.

There are two study areas in each of the blocks chosen, the samples of areas 1 and 2 were in the oven block, and 3 and 4 in the production block.

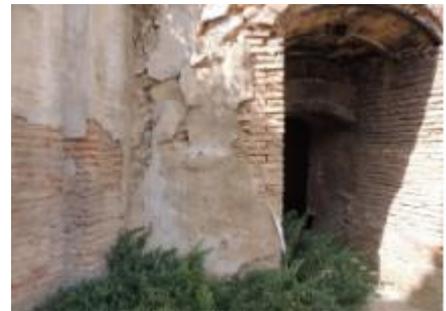
a- area 1

Samples from area 1 were removed from a wall of the oven itself (figure 4 [a]), which has a sacco-type masonry structure. The coating was already very aggravated and compromised, with a large area with erosion, detachment and disintegration of the mortar, and there were practically no significant cracks amid lack of coating in the area. Dirt has also been

observed, but there are no manifestations of moisture spots, efflorescences or biological colonization.

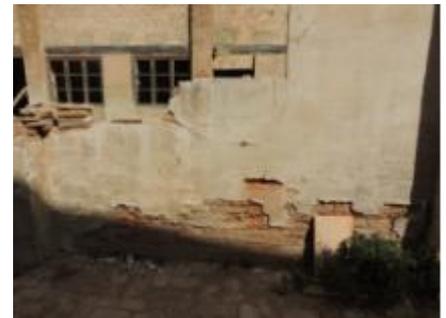
b- area 2

Samples from area 2 were removed from what in their original state was an entire wall (unlike figure 4 [b], which shows the state in which it was found in situ surveys), the region was also originally covered. The area shows loss of mortar at the lower part of the wall, being possible the visualization of different layers of mortar, the external one already totally unobstructed, and the second with some remaining parts. There are few cracks, some dirt and a large region where there was loss of coating adhesion.

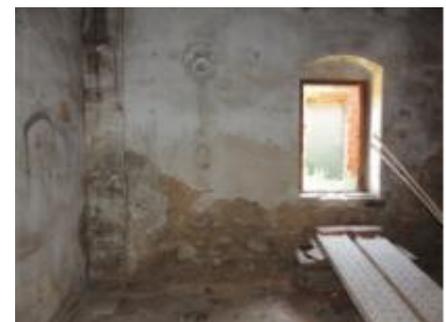
c- area 3

Samples from area 3 were removed from a fully covered room with few openings, only the window can be seen in figure 4 [c] and a door that leads to a room also covered, meaning that the wall did not receive direct sunlight. The wall, one of the exteriors of the building, is built of stone. The coating of the area is in serious condition, with the lower part fully compromised as the coating does not exist in this room anymore. It is possible to differentiate three different layers of coating in this area: the upper, still preserved, one in the middle, approximately 1.20 m from the ground, which presented some desolate areas on the surface, observed to the hollow sound resulting from a inspection with rubber hammer in the coating, and a third layer almost nonexistent, further down the wall. The removal sample has only two of the three layers observed. Samples from area 4 (figure 4 [d]) were removed from a wall which, even in a covered environment, had large openings. The remaining coating of this area showed some cracks, dirt and moisture spots, there were large areas with loss of adhesion and erosion of the coating.

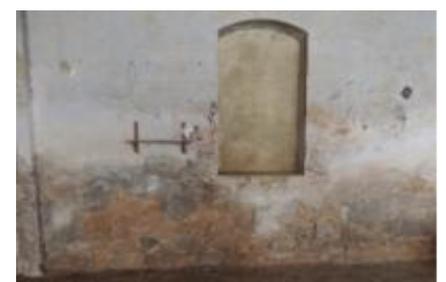
d- area 4

Figure 4.
Areas where samples were taken from the
La Ceramo factory

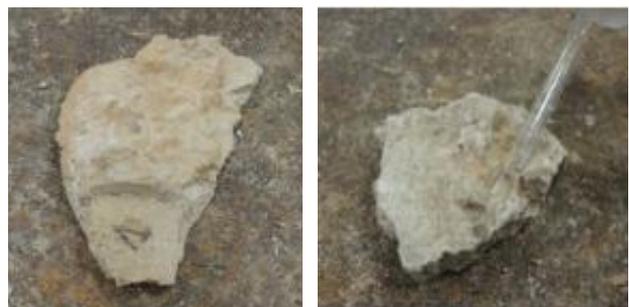
Figure 5.
Test with application of hydrochloric acid in some of the samples

Therefore, when hydrochloric acid was applied to samples from group B (figure 5), it was possible to identify whether or not there is cement in its

composition. The data found are shown in table 3. It can be observed from the results obtained in figure 5 that only the sample from area 1 presents cement in its composition, the other mortars were constituted without this component, probably containing only limestone, mineral aggregates and water.

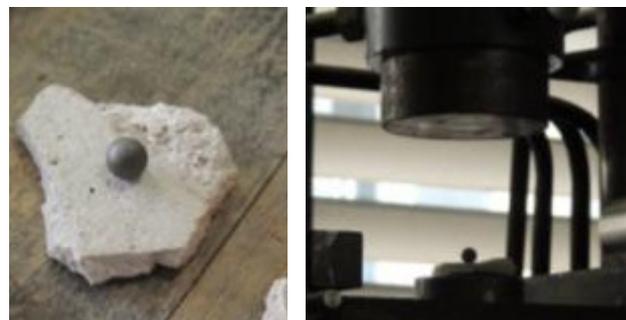
Figure 6.
Hardness test in laboratory

Then, the samples whose composition did not contain cement, that is, lime mortars, passed the UNE EN 13279-2 (2014) hardness test. In them, a steel sphere of diameter equal to 10 mm was placed at a fixed point on the surface, and a force of 200 N was applied, as shown in figure 6.

The hardness formula: $H = F / (\pi \cdot D \cdot t)$ was applied, where t refers to the depth of the mark that the sphere leaves on the surface after the test. Therefore, the hardness found in lime mortars is shown in table 7.

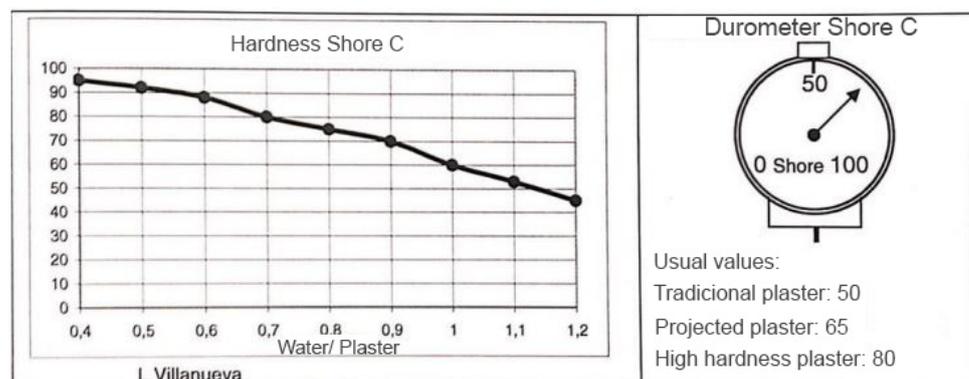
Figure 7.
Shore C hardness graph.
Source: Pastor e Agórriz (2009)

According to the graph of figure 7, the results point to hardness values between 70 and 85 Shore C, so its water to gypsum ratio is approximately 0,7.

According to the measurement conversions data of the used durometers, the measurements made with Shore C between 70 and 77 correspond to measurements performed with Shore D between 46 and 58, so measurements taken in situ and in the laboratory coincide.

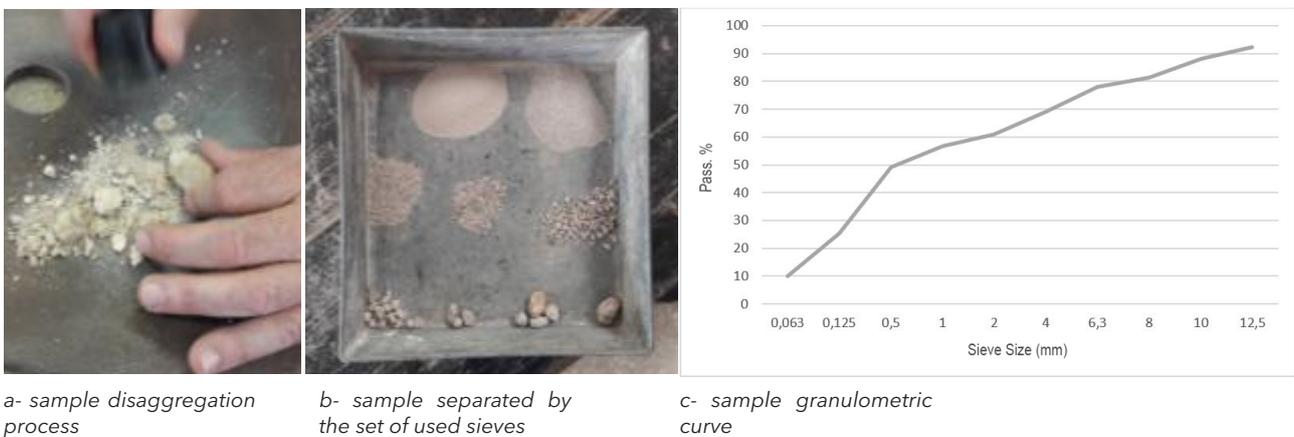
Figure 8.
Realization process of
granulometry test.

The aggregates granulometry directly influences the composition of the new mortar, in the texture, color, compactness and in the main properties of the mechanical resistances, besides the workability and water retention. The granulometry test was performed only on a sample of area 1 (cement and lime mortar), that mass was 45.2 g. The sample went through the disaggregation process with the rubber stopper (figure 8 [a]), to be able to pass the grains through the sieves, as shown in figure 8 [b].

The sieves used have their retention in mm of 12.5; 10; 8; 6.3; 4; 2; 1; 0.5; 0.125; 0.063. In each sieve, the retained material was weighed. The result of the process can be seen in the graph of figure 8 [c] which the different types of dimensions obtained in the sieving can be observed.

The granulometry presented boulders larger than 8 mm, which could already be considered too large for the composition of the mortar, and are not currently used. The aggregate used is considered well graded, with varying dimensions.

When analyzing the Coefficient of Uniformity $C_u = d_{60}/d_{10}$, it was obtained the value 31.7, greater than 15, referring to a non-uniform material. The Coefficient of Curvature obtained by the formula $C_c = (d_{30})^2/d_{60} \times d_{10}$ was 0.12; being fewer than 1, and refers to an open degree.

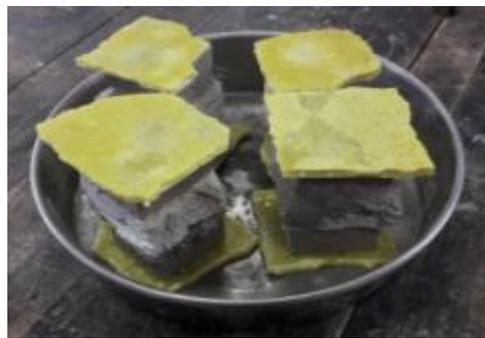
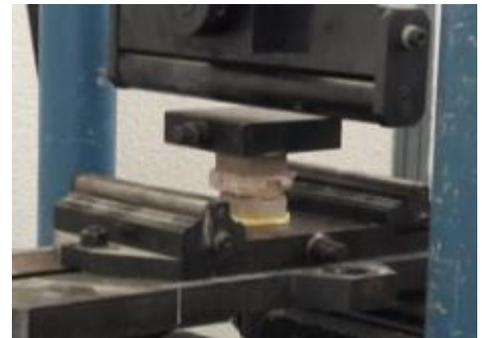
Figure 9.
*Test bodies and positioning
 in the compression test
 press*

It was made wood molds of 4x4 cm to the confection of the confining mortar (composition of cement and sand in the 1:3 dash by mass) more resistant than the mortars studied, in order to regularize the surfaces of the samples and make it possible to carry out the compression test on a homogeneous basis, there are no specific accusations that will disqualify the judgment. To obtain a smooth surface, after 15 days drying of the confinement mortar, plates of sulfur were molded on them, as shown in figure 9.

Then the compression tests were performed on the four samples (1B, 2B, 3B and 4B), which had their lateral dimensions decreased, as shown in the figures in figure 9 [a]. The results are shown in the graphs in figure 10.

a- final appearance of the tests bodies

b- test body positioned in the press

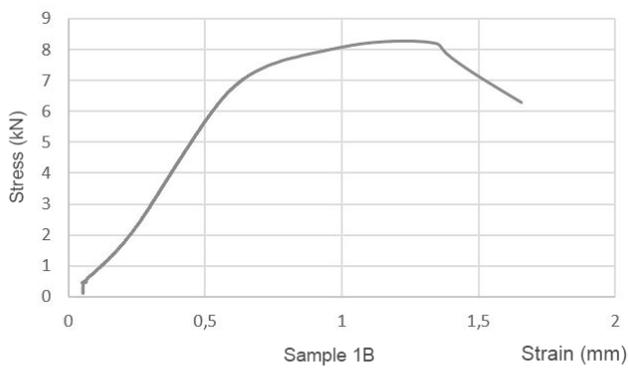
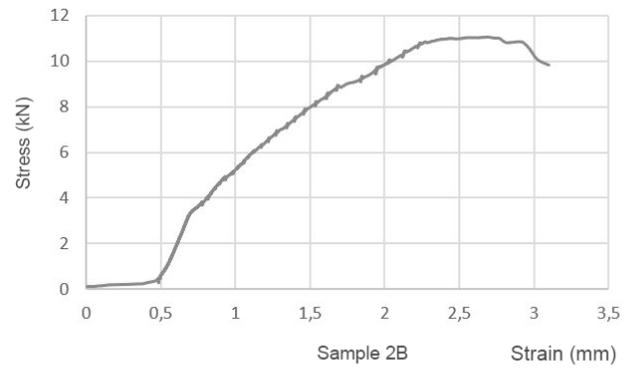
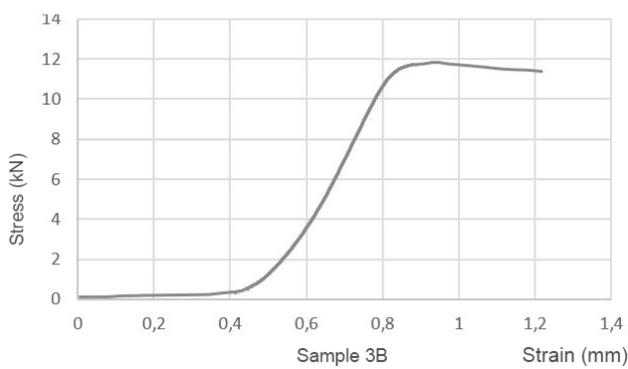
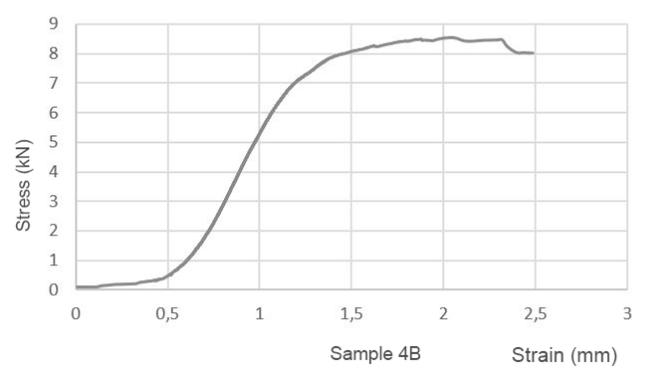
Figure 10.
*Individual results of the compressive
 strength tests of the samples*

The speed of application charging with sample 1B (0.2 kN/s) was higher than the others (0.1 kN/s), because it is a mortar constituted with cement. The curvature of the graphs showed that the first two samples (1B

and 2B) are composed with more aggregates than the others (3B and 4B), because they presented a more curved graph, while the last ones, especially sample 3B, have the line formed by the graph more straight than the others, meaning a reduced amount of aggregates in their composition.

It was observed, through the values obtained in the tests, that sample 1B (cement mortar) did not present resistance to high compression, losing in mechanical resistance even for the other samples (composed only with lime), since the composite samples of lime (2B, 3B and 4B) presented slightly higher values of compressive strength.

It should be mentioned that sample 2B could lead to a positive result in terms of compressive strength, due to the very reduced thickness of the samples in this area of study when compared to the others, but this fact cannot be considered conclusive, since the amount of regularization mortar that needed to be used was higher than the other samples, which may have influenced its final result. The high compression result of the sample 3B, however, can be taken into account, since the sample had enough thickness for a more conclusive test.

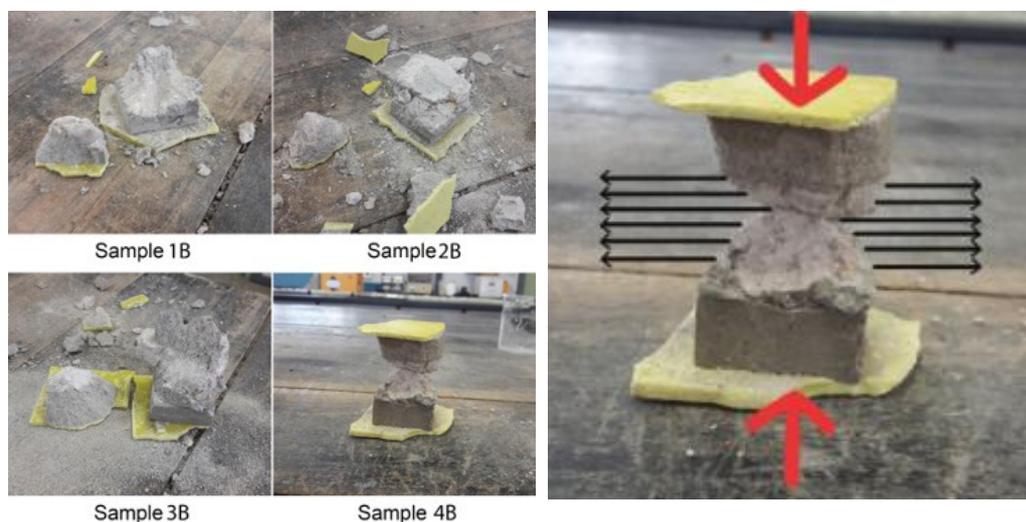
Figure 11.
Mortar samples after the compressive strength test

Figure 11 shows the final appearance of the samples after the compressive strength tests, and as an example, one of the samples was used to show the

vectors of forces acting on the test body during the test. The red vectors represent the compression suffered and the black ones the reaction of the part. In this way, as the upper ends were connected to another containment surface, tend to have vectors smaller than the center of the sample.
