Cartography of profiles of sociospatial vulnerability in four neighbourhoods of the City of Barcelona

Socio-spatial analysis of the vulnerable urban fabric in the city of Barcelona

Sara Vima-Grau¹, Còssima Cornadó¹, Pilar Garcia-Almirall¹

¹Department of Technology in Architecture, Universitat Politècnica de Catalunya (UPC)

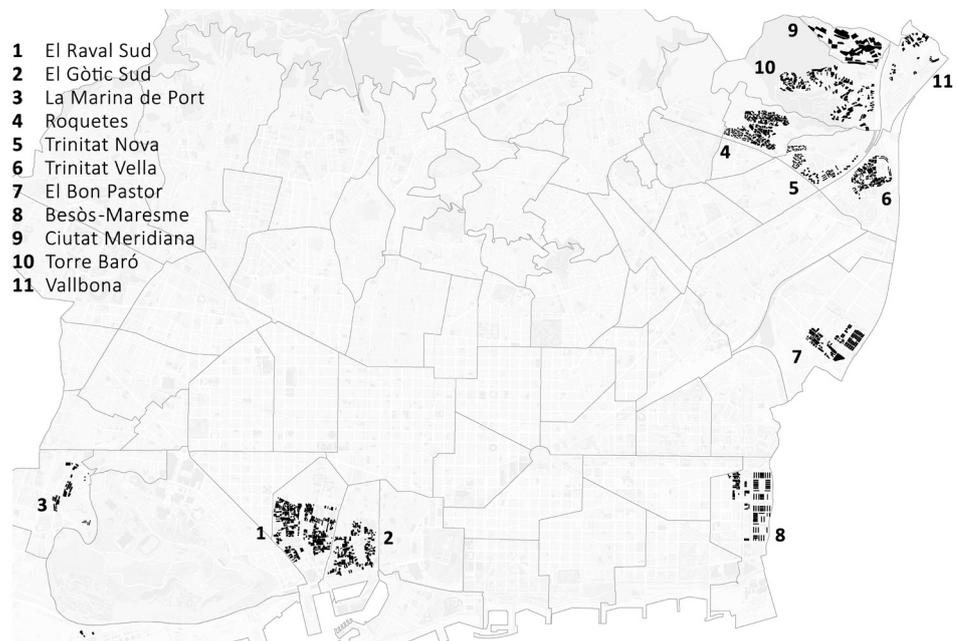
Figure 1.
List and geographic location of the areas of the eleven neighbourhoods included in this study.

The main sources for this paper are both the previous study on the detection of the most vulnerable areas of the city of Barcelona according to sociodemographic, socioeconomic, socio urban and socio spatial indicators (Cornadó et al., 2018), and the further study on the prediagnosis of the state of conservation of the building stock in the 16 most vulnerable neighbourhoods (Cornadó et al., 2019). The present paper provides the results of a further research carried out in the master thesis Characterization and prediagnosis of the socioresidential vulnerable tissue in the city of Barcelona (Vima, 2018). It consists of an analysis of 11 neighbourhoods included in the previous studies, in which the number of studied buildings with available data is statistically representative of the full neighbourhood (Fig. 1, Tab.1, Tab.2).

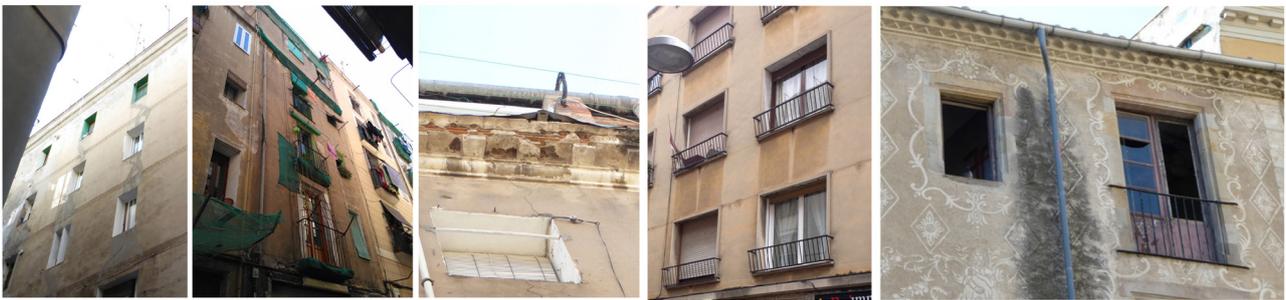
Figure 2.
From left to right, indicators D1, D2, D2, D3, and D4 observed during the fieldwork.

Physical indicator	Source (Garcia-Almirall, 2017) Statistical Data	Source (Cornadó, 2017) Fieldwork
Damages of mechanic structural origin (D1)		<ul style="list-style-type: none"> Cracks in bearing walls Façade buckling
Risk of material detachment (D2)		<ul style="list-style-type: none"> Unstable elements in façades or roofs Nets and other precautionary elements
Dampness (D3)		<ul style="list-style-type: none"> Rising damp Moisture Rainwater leaks
Damages in windows woodwork and carpentries (D4)		<ul style="list-style-type: none"> Broken window glasses Degraded carpentries and woodwork
Lack of accessibility (D5)	<ul style="list-style-type: none"> More than four storey buildings without elevator installation

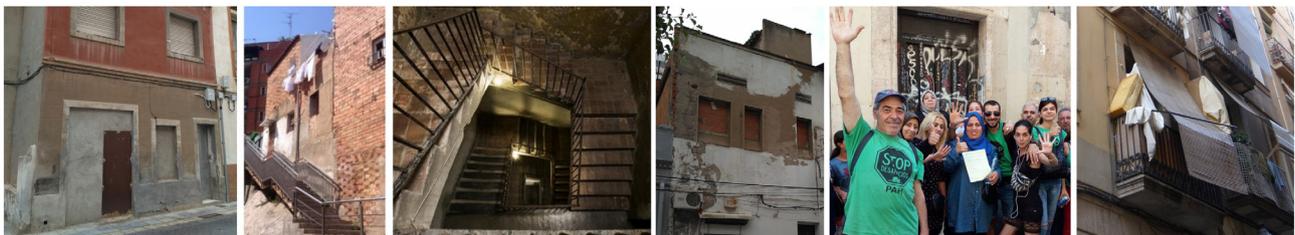
Figure 3.
From left to right, S1, D5, D5, S2, S2, and S3 observed during the fieldwork.

Social indicator	Source (Garcia-Almirall, 2017) Statistical Data	Source (Cornadó, 2017) Fieldwork
Lack of activity (S1)	<ul style="list-style-type: none"> Empty premises on the ground floors 	<ul style="list-style-type: none"> Empty premises on the ground floors Private activities in ground floors
Residential exclusion (S2)	<ul style="list-style-type: none"> Irregular occupancy Eviction 	<ul style="list-style-type: none"> Irregular occupancy
Risk of over-occupancy (S3)	<ul style="list-style-type: none"> Surfaces under 45 m² Less than 14 m²/inhabitant 	<ul style="list-style-type: none"> Signs of over-occupancy
Residential mobility (S4)	<ul style="list-style-type: none"> Immigration 	
Tenure difficulties (S5)	<ul style="list-style-type: none"> Horizontal structure of property Rental tenure 	
Economic difficulties (S6)	<ul style="list-style-type: none"> Rental social aid Punctual social aid Non-contributory and disability pensions

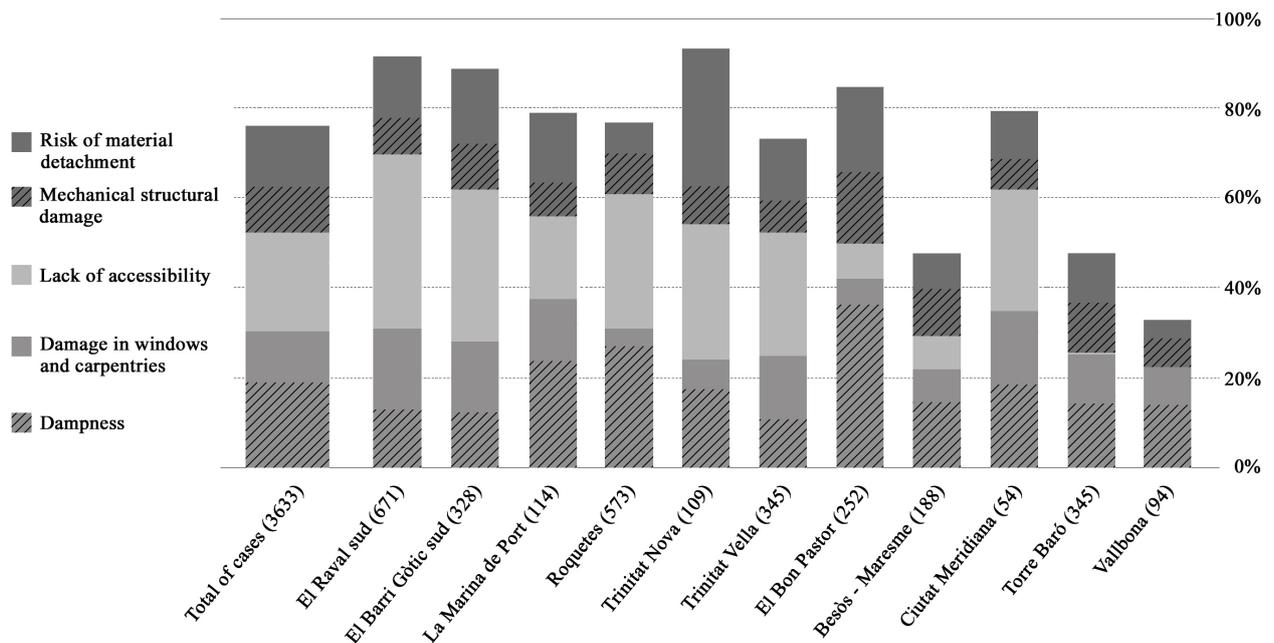
Figure 4.
Percentage of buildings with physical damages and relevance of indicators per neighbourhood
Regarding those aspects that refer to the resident.

First, the graphic in Figure 4 presents a comparative measure of the percentage of buildings presenting some indicators of physical damage showing the proportion of each indicator per neighbourhood.

Remarkably, there is an important variation of results among different neighbourhoods. The two neighbourhoods in the historic centre (El Raval sud and El Barri Gòtic sud) together with Trinitat Nova and El Bon Pastor, present the highest percentages of buildings with observed physical damages (over 90%). While some peripheric neighbourhoods, especially Besòs-Maresme, Torre Baró and Vallbona, present lower percentages (under 50%).

Regarding the type of observed damages, the highest variation among neighbourhoods is the significance of accessibility deficits, which are especially relevant in the historic central neighbourhoods. The observation of dampness also varies significantly, yet it is present in all studied areas, particularly in El Bon Pastor. Degradation of carpentries and woodwork is quite relevant in all studied areas, with the exceptions of Roquetes, Trinitat Nova, El Bon Pastor and Besòs-Maresme, where other aspects are a lot more important. Being a more severe damage, the risk

of material detachment on the street is extremely important in Trinitat Nova and considerable in El Bon Pastor, La Marina de Port and El Barri Gòtic sud, and it is still important in the rest of neighbourhoods. Nevertheless, damages of mechanical structural origin (cracks and facade buckling) are found homogeneously in all studied neighbourhoods in rather low percentages.

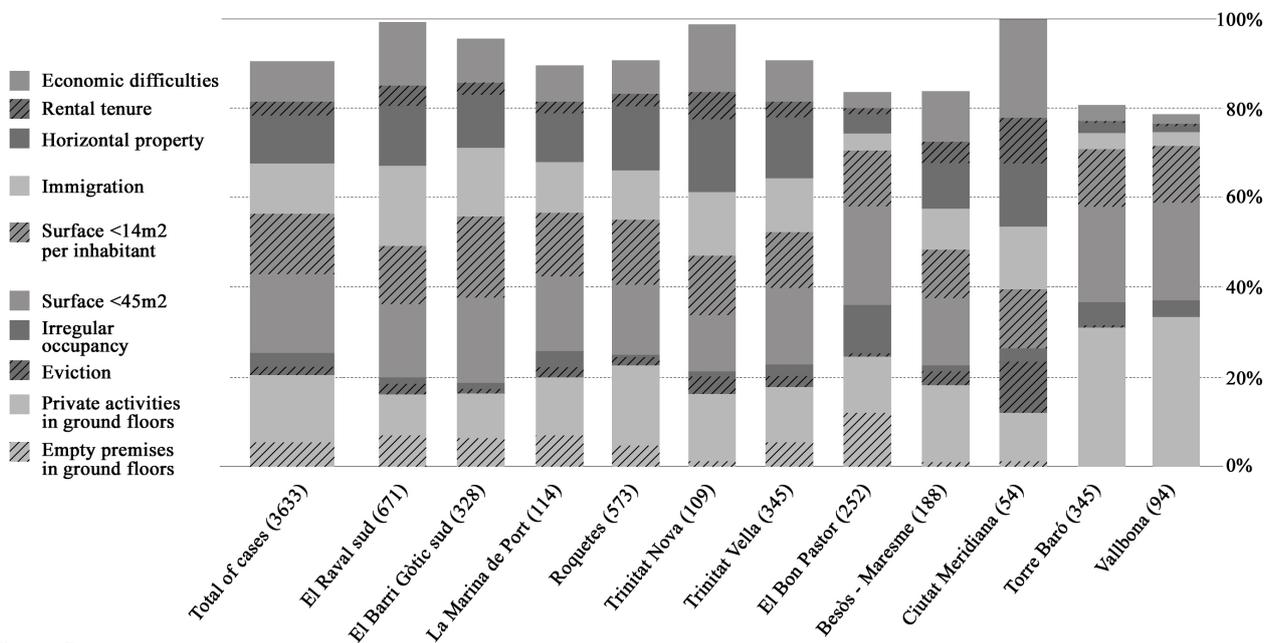
Figure 5.
Percentage of communities with social indicators and relevance of indicators per neighbourhood.

The most abundant problematic is the risk of over occupancy as a result of insufficient housing surfaces. The lack of activity in ground floors is proportionally more relevant in monofunctional residential neighbourhoods like Torre Baró and Vallbona, even though empty premises in ground floors are mostly found in areas where the ground

floor is not residential, such as the historic central neighbourhoods. Indicators that relate to a risk of residential exclusion are also important and more variable among neighbourhoods: eviction, irregular occupancy and demand for rental social aid are extremely relevant in Ciutat Meridiana, and exceed the average in Trinitat Nova, Besòs-Maresme, El Bon Pastor and El Raval sud. Most neighbourhoods have high proportions of horizontal property, with the exception of El Bon Pastor, Torre Baró and Vallbona where, additionally, the proportion of immigration is lower. Finally, indicators of economic difficulties are extremely high in Ciutat Meridiana, and still very relevant in Trinitat Nova and El Raval sud, while they are less important in Vallbona, Torre Baró and El Bon Pastor.

In the case of social indicators, most of the problematics relate to the risk of residential exclusion, such as evictions and demand for social rental aid, which clearly correspond with the concentration of residents facing higher economic difficulties. Other relevant problematics have a direct relation with spatial aspects, as it is clearly the case of the risk of over-occupancy. The morphologic and typological conditions of the existing urban fabric result into housing units with insufficient surfaces in relation to the number of occupants.

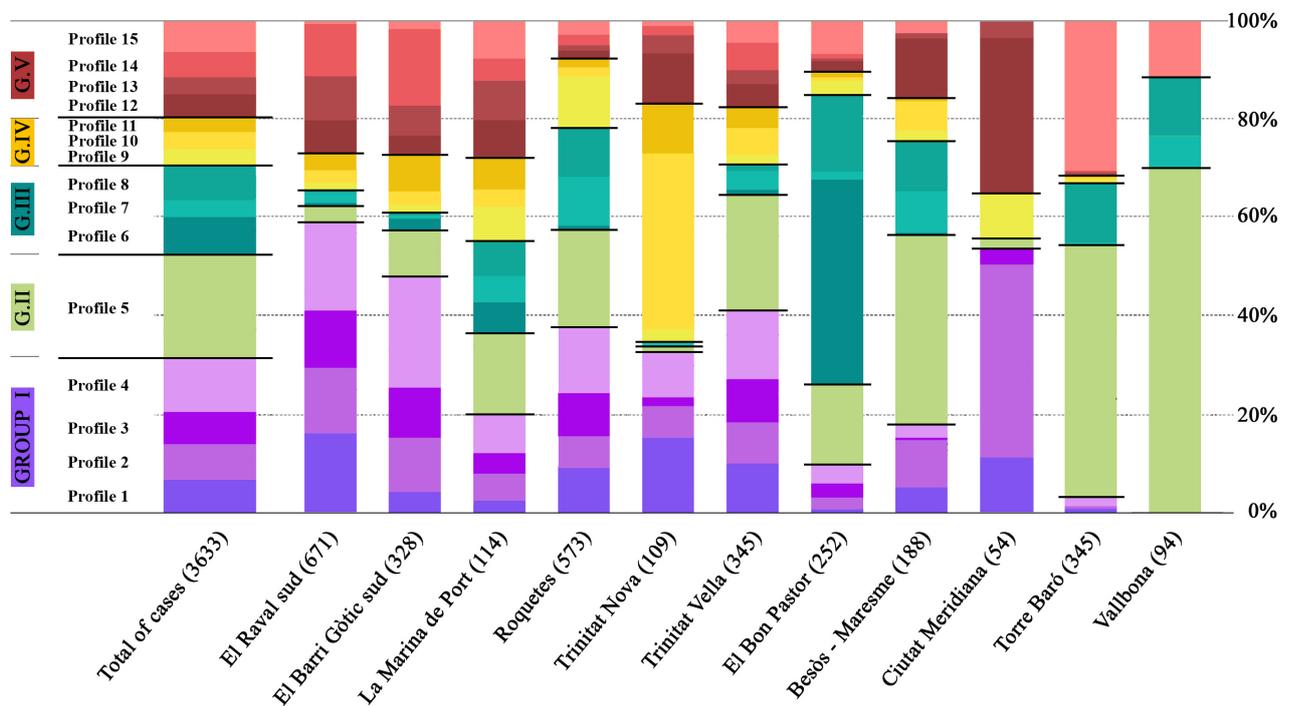
Figure 7.
Relevance of each profile and group of profiles according to the neighbourhoods.

The obtained profiles of vulnerability are presented according to neighbourhood in Figure 6, where an enormous diversity within the total sample of analysed buildings in the vulnerable areas of the city can be observed. The relevance of each group of profiles according to the number of cases is quite balanced. If profiles in Groups III and IV are considered together, they have a similar relevance as profiles in Group I, while profiles in Groups II and IV appear in relatively lower percentages.

However, this balanced proportion on the total sample manifests very important variations according to each neighbourhood. The two historic central neighbourhoods present similar distributions, and they differ from the rest of studied areas and particularly to Trinitat Nova, el Bon Pastor and Ciutat Meridiana, which present similar results according to the percentages and type of problematics that have been previously stated in this paper. According to the profiles, Trinitat Vella is the neighbourhood that has higher similarities with the central neighbourhoods, although it happens to be very different in geographical and urban morphological terms.

The areas included in El Raval and El Barri Gòtic are clearly integrated mostly by profiles of Group I, in which accessibility deficits are combined with many other socioeconomic weaknesses. Group II, including buildings with barely no significant deficiency, has the smallest proportions observed among all analysed neighbourhoods. Group III, including profiles with dampness in combination with different social weaknesses is also not relevant in comparison with other areas. Moreover, the proportion of Group V and particularly of profiles 12, 13 and 14 exceeds significantly the average among all vulnerable areas. This group include profiles in which there is high percentages of physical deficiencies combined with also high percentages of social shortcomings. Particularly, profiles 12, 13 and 14 present the highest combination of weaknesses simultaneously in one single building.

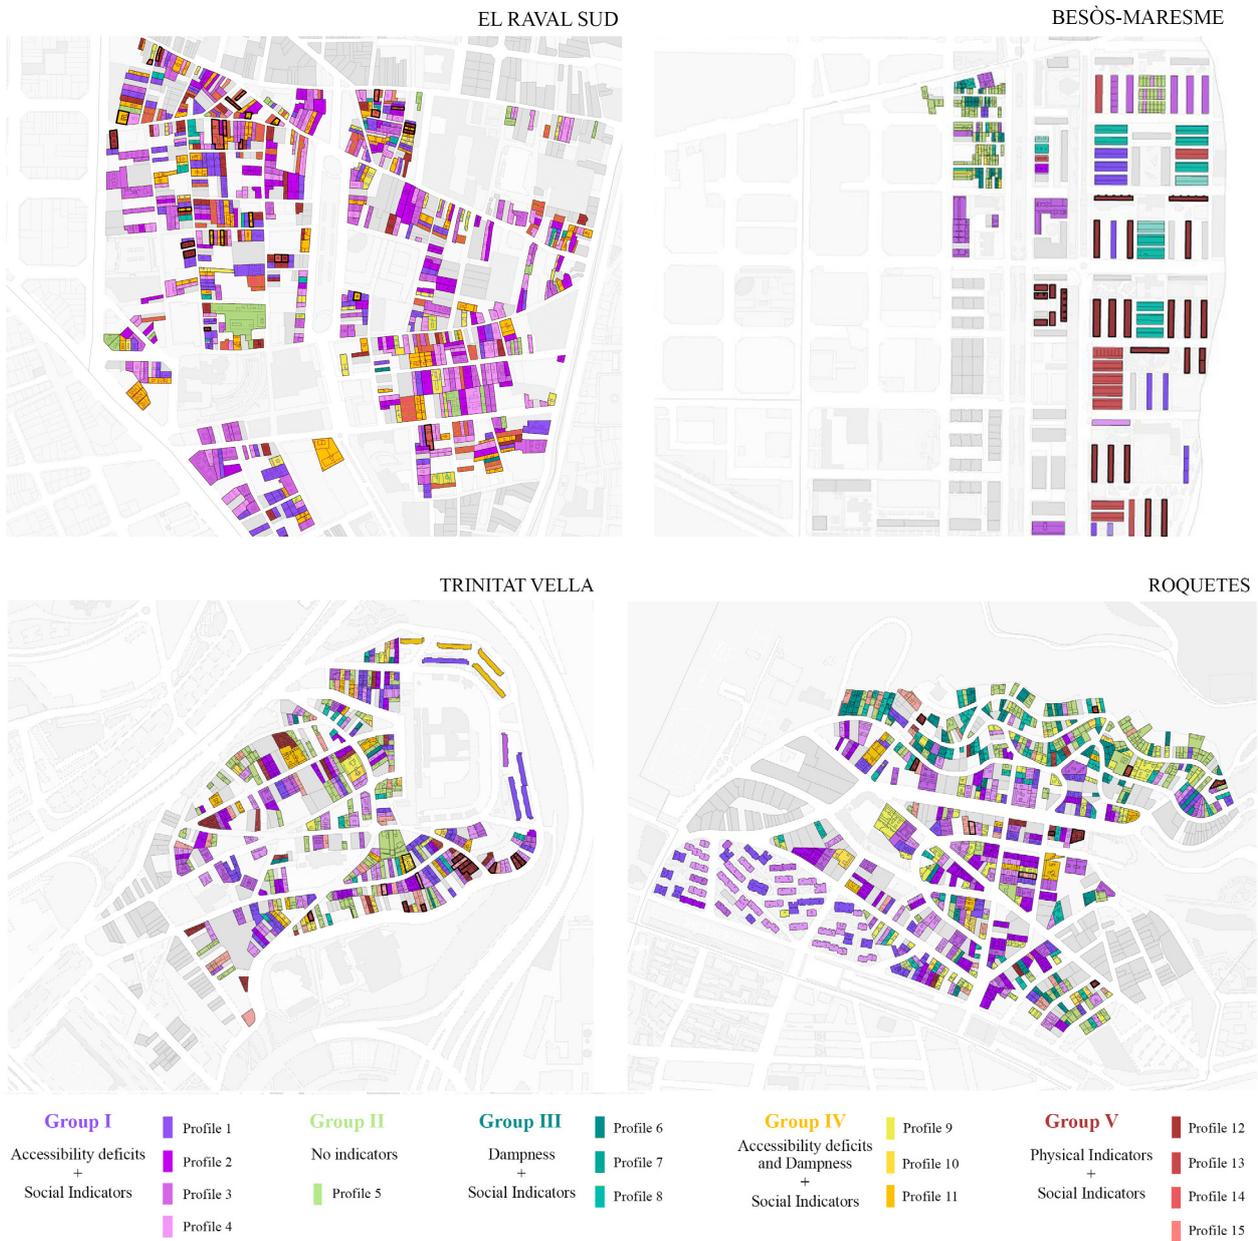
Figure 8.
Cartographies of resulting Profiles of vulnerability in El Raval sud, Besòs-Maresme, Trinitat Vella and Roquetes.

The previously described diversity materializes into a high complexity within the urban fabric even at very small scale and considering quite homogeneous urban fabrics such as the cases of Besòs-Maresme and El Raval sud, as well as more variable urban fabrics like Trinitat Vella and Roquetes (Fig.8).

Generally, it is possible to distinguish different patterns of profiles in zones of a certain scale that are typologically different, such as the northern area of Roquetes, the western side of Besòs-Maresme, or even the typologies of low attached houses in Besòs-Maresme. A certain convergence of profile groups tend to appear within similar building types in each neighbourhood. Rather

homogeneous neighbourhoods like El Raval sud and the largest southern part of Roquetes present more homogeneous cartographies than neighbourhoods with higher typological variety such as Besòs-Maresme and Trinitat Vella.

Nevertheless, the diverse qualities of each profile within one same group maintain a certain diversity that can be observed in the cartographies. Moreover, the localisation of profiles in Groups IV and V result into a high dispersion within each neighbourhood and even within very similar or identical typologies. Although it is possible to detect patterns and aggregations, these profiles appear scattered in small concentrations of usually not more than 3 buildings. Their dispersed location with similar proportions in each different neighbourhood is key to configurate a patchwork of high complexity that does not allow for a simplistic delimitation of homogeneous zones or building types.
