## Venetian Walls of Nicosia: Between Kyrenia Gate - Barbaro Bastion

Zehra Öngül

Faculty of Architecture - Eastern Mediterranean University, Famagusta, North Cyprus, zehra.ongul@emu.edu.tr

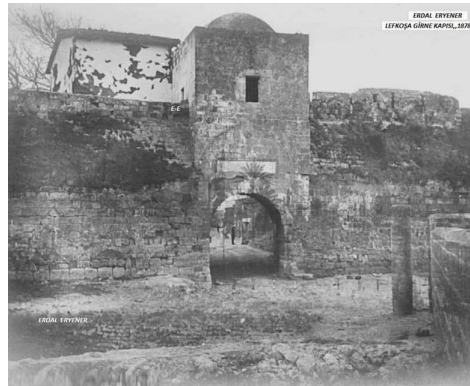
at the island (Fig. 2). The rectangular marble slab with the Sultan's *tughra* depicts the repair performed on the gate during the Ottoman period in 1821. During the reign of Sultan Mahmud II the structure underwent a restoration and a domed, four-corner room was built on the door (Gürkan, 1996). In addition to the east corner of the domed room viewing west, another room with a double-gabled roof was built on the fortification wall with a connection almost adjacent to the eastern corner of the domed room. To the west of this domed space, a stone wall was constructed with holes or openings for cannons.

Fig. 2. Kyrenia Gate (Erdal Erşener Archive).

**Kyrenia Gate:** Ottomans made some changes on the gates of the walls of Nicosia. A photograph from the Erşener archives taken outside the city walls shows the changes made during the Ottoman period in 1878, the year the British arrived

The arched door opens to the view of stone buildings inside the city walls. Another name of the Kyrenia Gate is *Kızılküle*, the “Red Tower” and it is alleged to be given due to the blood shed in the violent battles during the Venetian-Ottoman War. However, there is no mention of a violent conflict in this spot in the written accounts of this war (Gürkan, 1996; Kaba, 2018). Horoz Ali served as the guard at the Kyrenia Gate for many years during the Ottoman period and according to historical records he was the one to hand over the key of the gate to the British in 1878 before finally leaving his post (Kaba, 2018). It is reported that the gate was also called the *Edirne [Adrianople] Gate* in this period (<http://www.evka.org/site/sayfa.aspx?pkey=471>). **Barbaro Bastion:** The tombs of the three martyrs believed to fall in the Ottoman-Venetian wars are found in this bastion. In later years this space served as a cemetery. The Turkish name of the bastion, “Musalla” comes from the marble

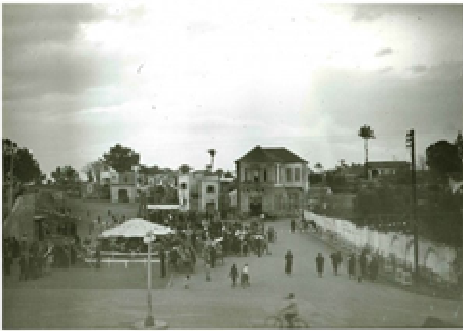
Fig. 4. İnönü Square festivities (Tuncer Bağışkan, 2011).

January 1<sup>st</sup>, 2011 stated that the first location used for holiday celebrations was the Sarayönü Square, but it was later moved to the İnönü Square and this area was used as a second center of festivities in Nicosia between 1945-1956 (Bağışkan, 2011). In Gürkan's account the place for celebrations was Sarayönü until 1940 and was transferred to the Kyrenia Gate (İnönü Square) in 1940 to remain there until 1955 (Gürkan, 1996). Bağışkan provided information about the square for festivities and its surroundings, especially the section to the south of the square, as well as a photograph (Bağışkan, 2011) taken before the Ford Garage was built in 1947 or 1949 (Fig. 4).

We learn from Gürkan's account that there was a large orchard in the area where the garage was to be built and it was destroyed in 1946 for the construction (Gürkan, 1996). Accordingly, in these years an approximately 3-4 m extent of the city walls, close to the Kyrenia Gate was covered with stonework and the remaining part continued as an elevated earth structure. The section closer to the road was gradually elevated until it reached at the height of fortification and at that point it ended with a horizontal line of approximately 2 m width. Sevgi Atai, a resident of the Reşadiye Street close to the square wrote in her memoirs of those years that those "living on the side of the cut wall adjacent to the road would climb the wall with the help of a ladder with portable chairs they brought along to watch the festivities." This area unfortunately did not enter the frame in the existing photograph. In the pho-

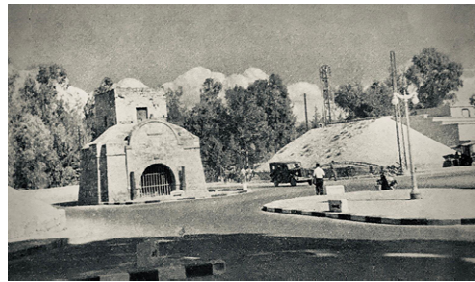
Fig. 5. Kyrenia Gate and city walls (Kemal Rüstem, 1961).

This is a very important source on the change that took place from the year 1950 to 1961. It shows that some work was made on 5 different levels of city walls, each at different heights and widths and facing the direction of the İsmet İnönü Square in the form of an amphitheater. Furthermore, the section facing the road and the square were completely paved as a smooth stone surface to form a slope towards the middle of the wall and the surrounding area was arranged as pedestrian walk. In the same photograph, a rec-

tangular chamber is observed on the wall façade with an opening facing the square.

As it is understood from the existing photograph, only a 3-4 m long part of the city walls passing through the middle part of the square was built by the British to reshape the earth structure using cut stones. This modification on the city walls probably took place between 1950 and 1956 and led to other restructuring or renovation activities in the surrounding environment. In the 1961 book *Kıbrıs (Cyprus)*, a collection of photographs by Kemal Rüstem from different parts of the island, there is only one photograph of the city walls, showing a small section between the Kyrenia Gate and Barbaro Bastion (Rüstem, 1961) (Fig. 5).

Kyrenia Gate: On October 29<sup>th</sup>, 1963, a statue of Mustafa Kemal Atatürk was erected on the north side of the Kyrenia Gate and this area was reserved for state ceremonies. Between the gate structure and the statue, two English-style cannons were placed alongside flag poles. According to Bozkurt, the chamber on the Kyrenia Gate was used as a post in the war between 1963-1974 and soldiers used it to watch the surrounding (Bozkurt, 2011). Barbaro Bastion: The Bastion was in use as the the 1st Infantry Regiment Command Headquarters when the military started to construct the Mücahitler Sitesi (Veterans Lodge) in March 1967 (<http://www.tbgocturk.com>). On October 29<sup>th</sup> 1973, the building was inaugurated as the Nicosia Sancak Headquarters. City wall: A photograph from 1961 taken by Kemal Rüstem shows that seating areas were arranged on the city walls at different levels.
