Study of nuisance tripping of residual current circuit breakers with electronic loads

Guillermo Escrivá-Escrivá ^(a) ⁽¹⁾

Abstract

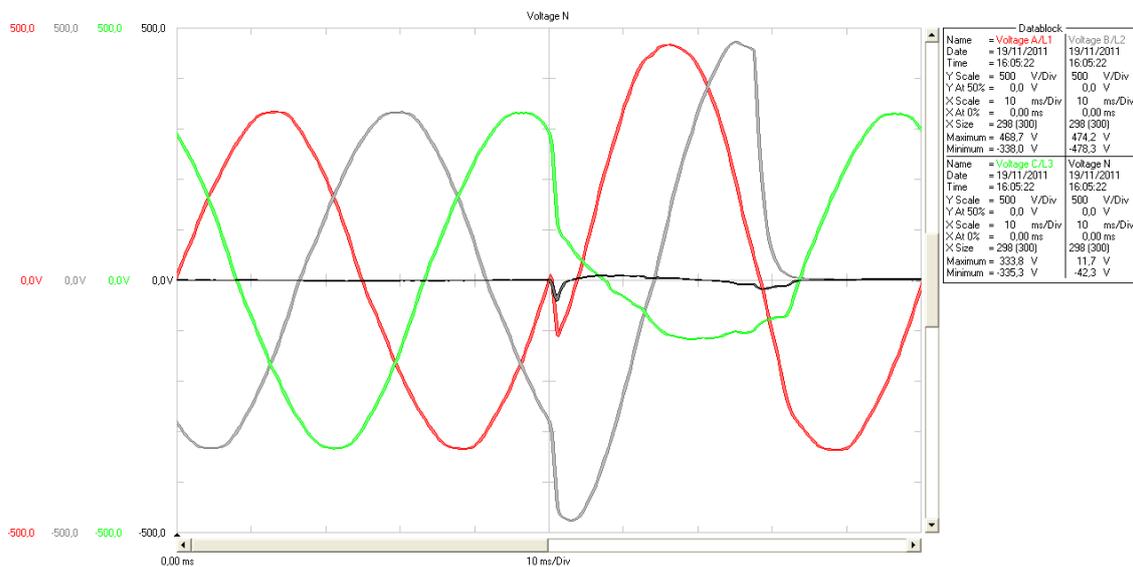
Fig. 1 shows voltage waveforms and Fig. 2 shows currents obtained during an RCCB tripping event using the PQA in circuit A. When the trip occurs the voltage of phase B falls to zero due to the measuring circuit used on the site [1]. The fault caused a peak in the currents (Fig. 2).

Fig. 1. Disturbance in the voltages produced during an RCCB tripping event on the 19/11/2011 at 4.05 pm in circuit A.

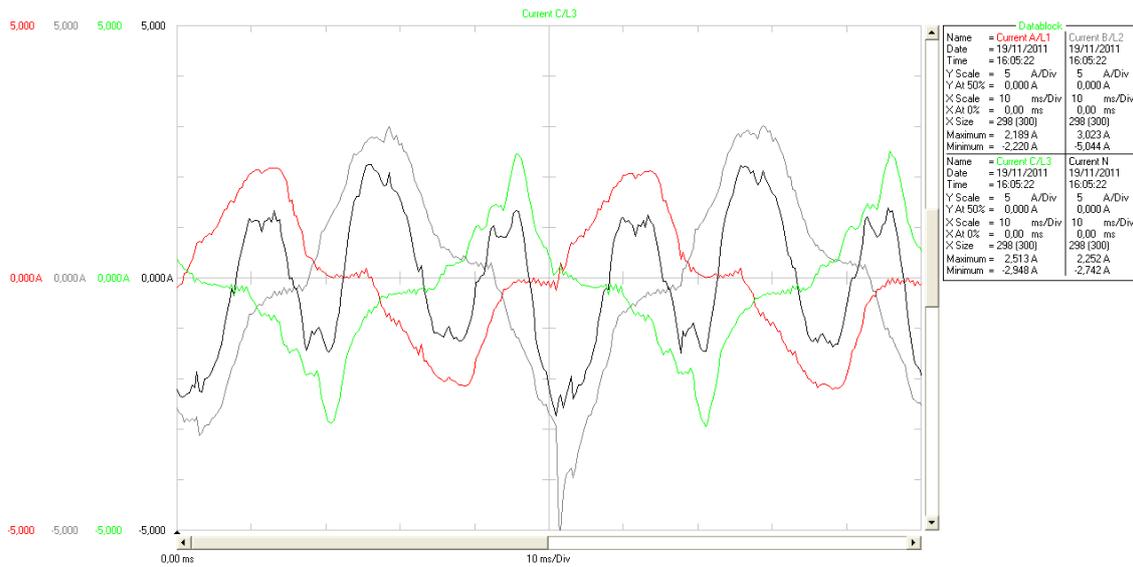
Fig. 2. Disturbance in the currents produced during an RCCB tripping event on the 19/11/2011 at 4.05 pm in circuit A.

Table 3 presents the values of the currents obtained solving the circuit during the event. Currents obtained in the theoretical circuit are similar to those obtained in the experimental measurements (Fig. 2).

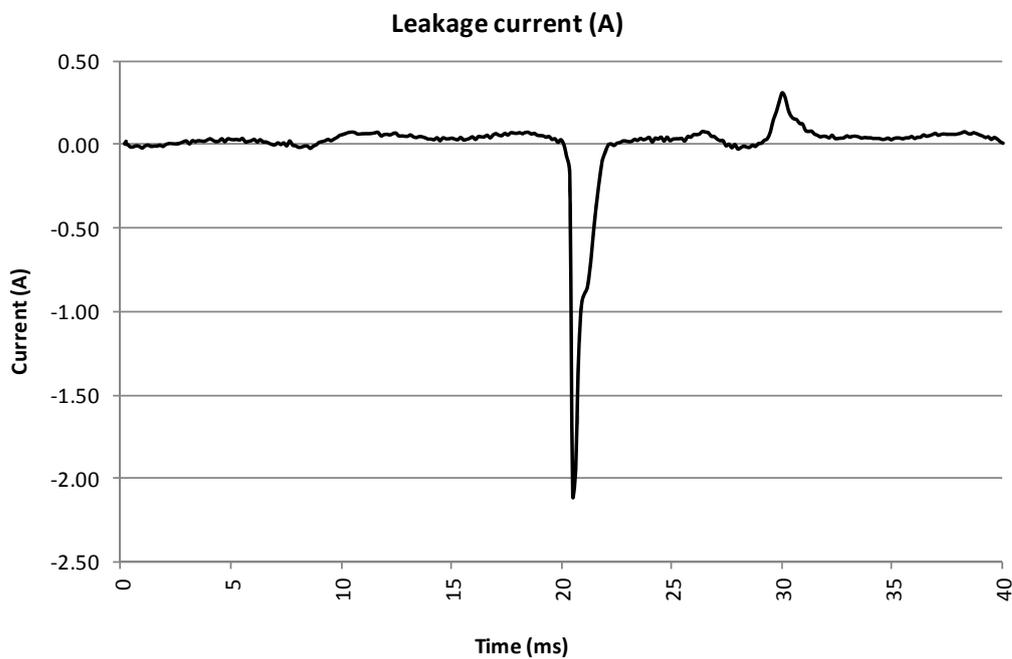
Fig. 3 shows the leakage current calculated using the values of currents in the event shown in Fig. 2. Values of the leakage current are higher than 2 A and this clearly explains why a 30 mA AC RCCB tripped.

Fig. 3. Leakage current during an RCCB tripping event on the 19/11/2011 at 4.05 pm in circuit A.

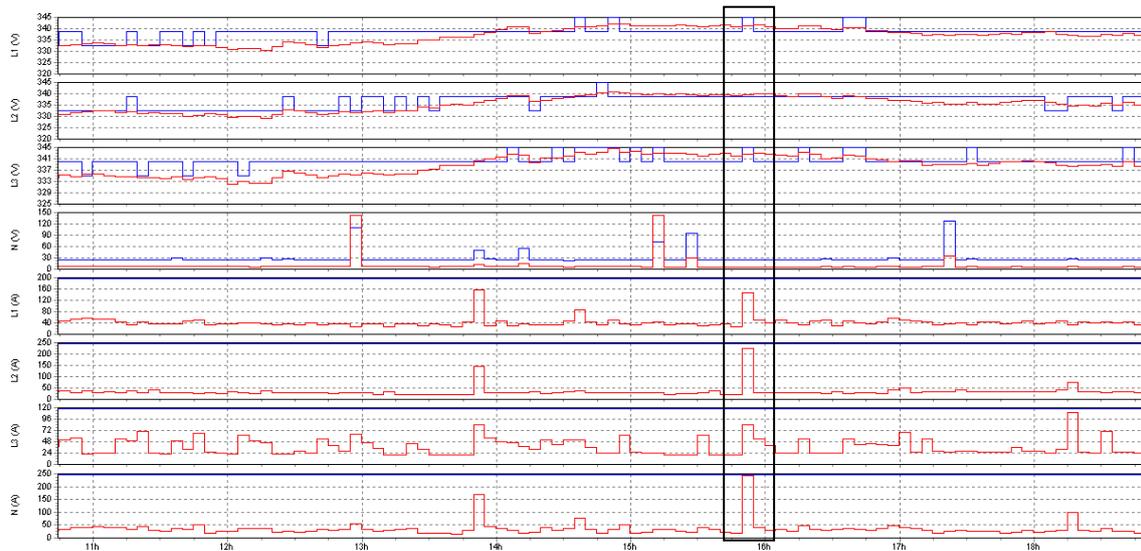
Similar behaviour was recorded in circuit B. Voltage and current recorded measurements during a trip were obtained at 3.54 pm on the 24/03 (Fig. 4).

Fig. 4. Voltage and current recording for 24/03 at 3.54 pm on the RCCB tripped in circuit B.

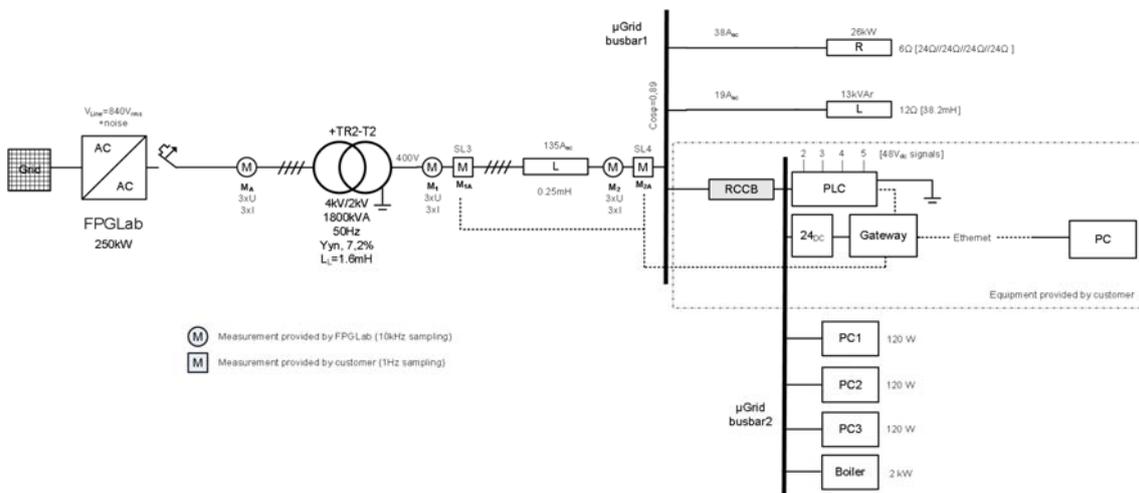
Many tests were performed and the specific single-line set-up diagram used for the tests is shown in Fig. 5.

Fig. 5. Test layout for transient analysis in RCCB tripping.

The set-up of the test is prepared from the grid connection to a diverse range of loads. The transformer is earthed. A 250kW AC to AC voltage source (FPGLab) is used to generate the desired voltage waveforms (containing transients). 840 V_{rms} at the output of the AC voltage source (electrical point M_A) are required to obtain 400 V_{rms} at the electrical point M₁. Voltage ratio of the transformer TR2-T2 in the test is not identical to his nominal turn ratio (4kV/2kV) because of the voltage drop due to his short-circuit impedance (7.2%) and the tap transformer setting (usually ±2.5% or ±5%). Power meters at different voltage points were installed to record the different waveforms. Three non-linear loads (computers) were connected downstream of an RCCB 20A 30 mA. Table 1 describes the tests performed.

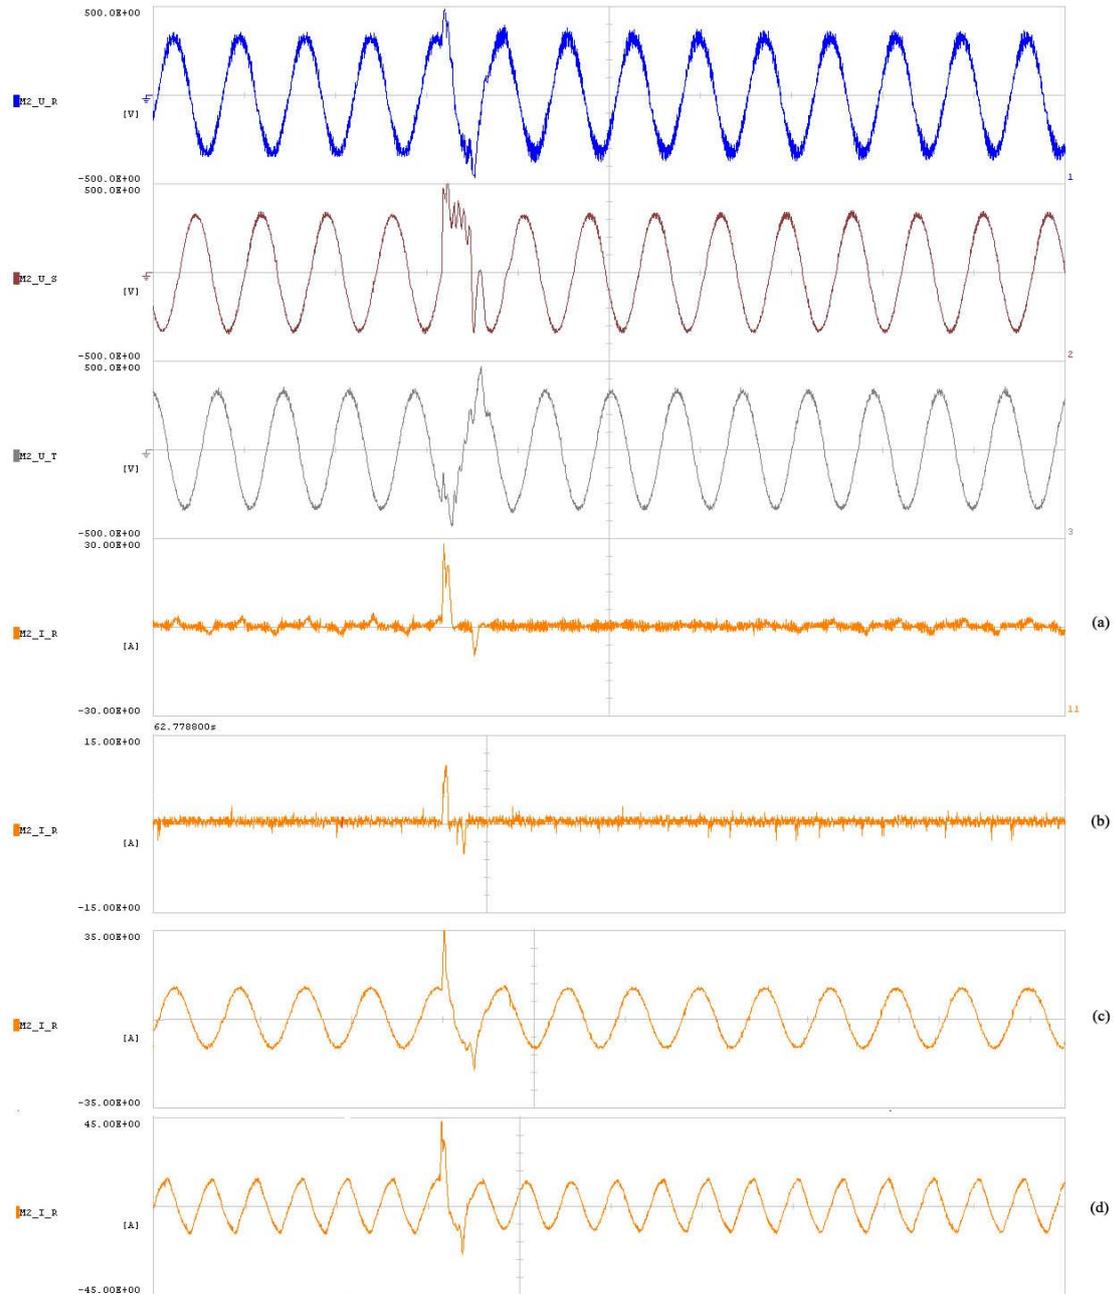
The voltages waveforms were the same in all the tests – as shown in the Fig 6.

Fig. 6. Waveforms as a response of a perturbation in the voltage supply (x axis: time, y axis: voltages (V) or currents (A)). (a) 3 computers as load (Test 1). (b) 3 unplugged PCs as load (Test 2). (c) Boiler as load (Test 3). (d) Boiler and PC as load (Test 4).

Test 1 was performed with three computers ON in phase R. Fig. 6 (a) shows that an increase of approximately 1000% with respect to the nominal current (a value of the amplitude of 2.7 A changed to 28 A during the event) is observed in the computer load current (phase R connection). A similar result is observed when the earth connection is removed from the set-up.

Test 2 was performed connecting three unplugged computers in phase R. Fig. 6 (b) shows that an increase of the current is observed even with the computers are turned off (a value of the amplitude of 0.7 A changed to 9.8 A during the event). This may explain why in rooms with many computers, nuisance trips sometimes occur even when the computers are turned off.

In Test 3, a resistive load (a boiler) is connected in phase R. Fig. 6 (c) shows voltage disturbances in circuits feeding resistive loads with current increases of 100% of the nominal current (a value of the amplitude of 14.2 A changed to 35 A during the event).

In Test 4, a computer and a resistive load is connected in phase R. Fig. 6 (d) shows that voltage disturbances in circuits feeding resistive loads with electronic loads have current increases greater than those without those electronic loads (a value of the amplitude of 14.7 A changed to 45 A during the event).

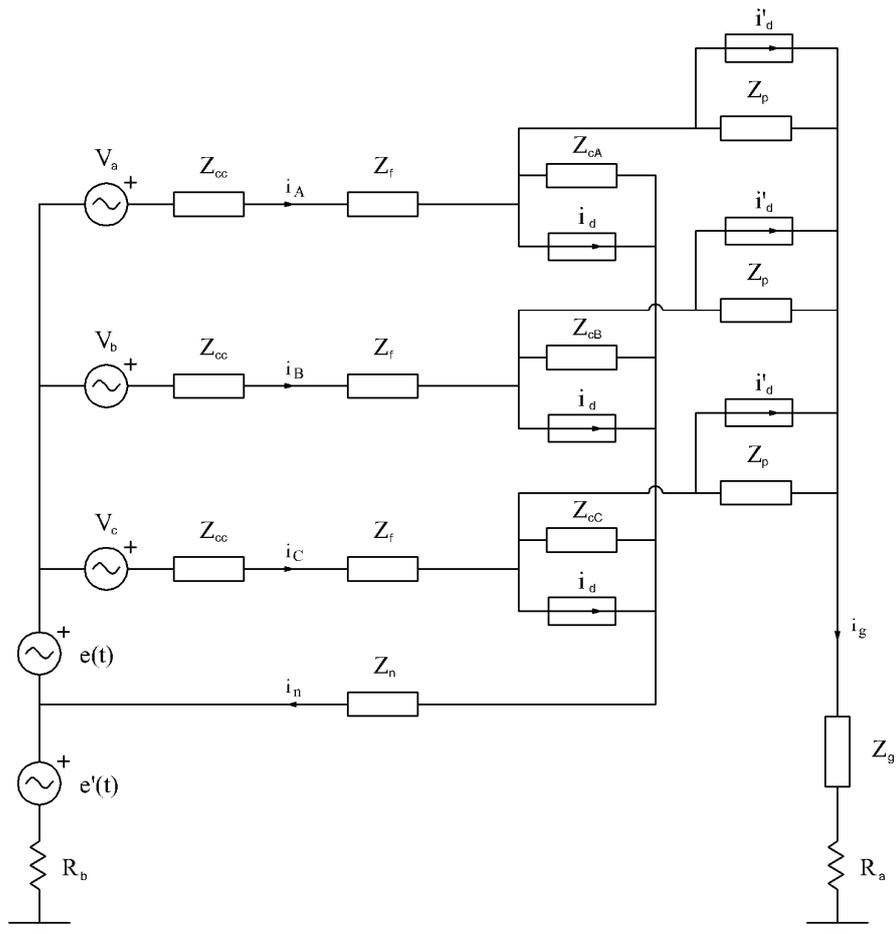
In this section, a simplified equivalent electrical circuit of the data measured in the hospital (Section 2) is presented (Fig. 7) to obtain just the main data related to the phenomenon. The circuit is obtained as an equivalent circuit of a T-T three phase system and uses a Norton equivalent model to represent the nonlinear behaviour of the loads. This circuit enables the authors to further analyse the results and theoretically explain the phenomena.

Fig. 7. Equivalent circuit for circuit A.

- $e'(t)$: disturbance voltage between neutral to earth.
- $e(t)$: disturbance voltage between phases to neutral.
- Z_{cc} : transformer short circuit impedance.
- Z_f : phase cable impedance.
- Z_n : neutral cable impedance.
- Z_{cl} : load impedance in phase I.
- Z_p : impedance between phases and earth.
- Z_g : cable impedance to ground protection.
- R_a : grounding resistance of the mass loads.
- R_b : grounding resistance of neutral to earth transformer connection.

- $i_d(t)$: current source in the nonlinear loads as a result of a disturbance of the voltage and showing an increase in consumption of the load in response to a disturbance. A Norton equivalent model is used to represent the nonlinear behaviour of the loads.

- $i'_d(t)$: current source that represents the capacitive effect and varistors present in the nonlinear loads that forces a discharge current in reaction to a voltage surge using the Norton model. The value is modelled as the expression $i'_d(t) = \alpha \cdot |e(t)| \cdot [v(t) + e(t)]$, for each phase. Values of the parameters used in the model for circuit A are shown in Table 2. Real values are used for the three-phase system and tuned values for the Norton equivalents to obtain results consistent with the measurements presented in Section 2.

On the one hand, the authors propose, in real facilities in use suffering nuisance tripping of RCCBs, to request the utility to improve the power quality of the supply voltage, to install uninterruptible power suppliers (UPS), or to use SI RCCBs in sensitive circuits. On the other hand, the authors propose, in the design stage of facilities with electronic loads, to use a T-N earthing system to avoid installing RCCBs or to use a dedicated line from the transformer centre to supply the sensitive loads.

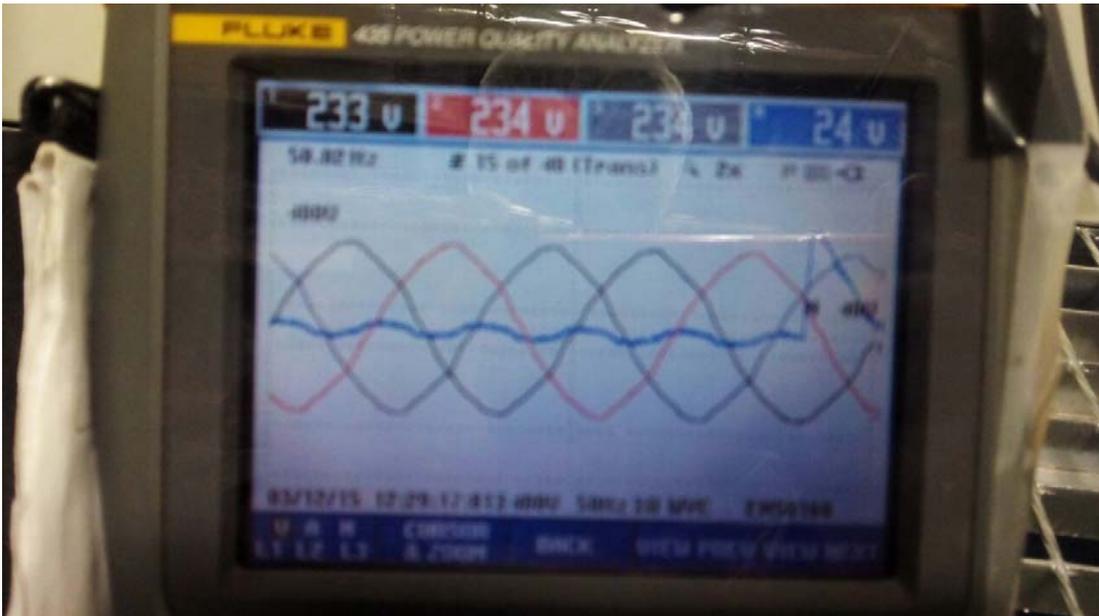
Fig. 8 shows voltage waveforms and Fig. 9 shows the leakage current obtained during an RCCB tripping event.

Fig. 8. Disturbance in the voltages produced during an RCCB tripping event on the 12/3/2015 at 12.29 pm in a circuit in the food manufacturing factory.

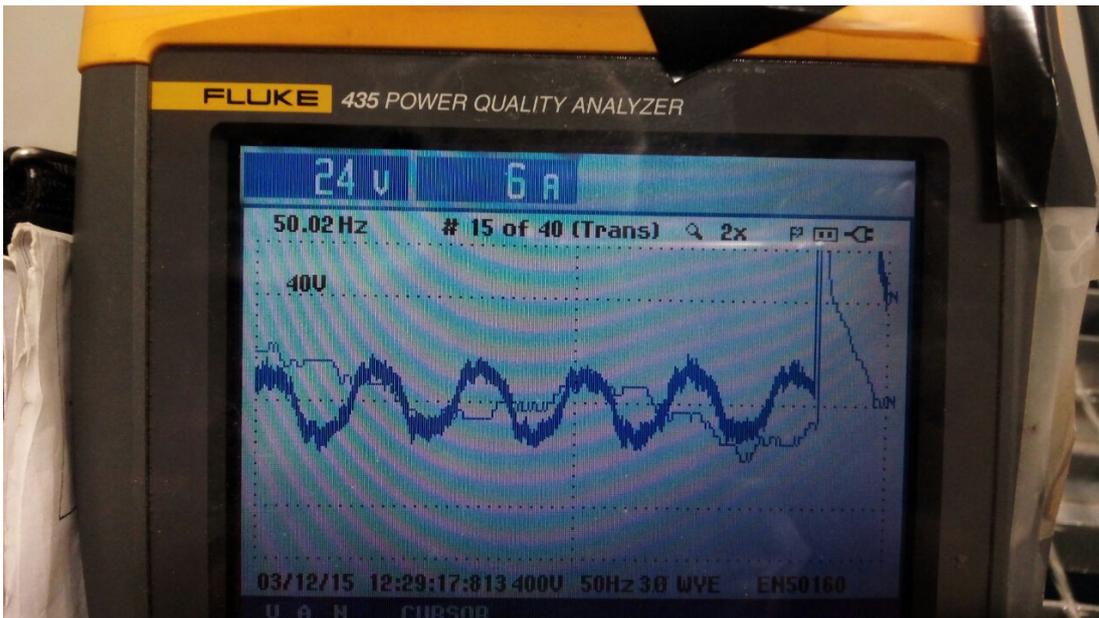
Fig. 9. Leakage current produced during an RCCB tripping event on the 12/3/2015 at 12.29 pm in a circuit in the food manufacturing factory.

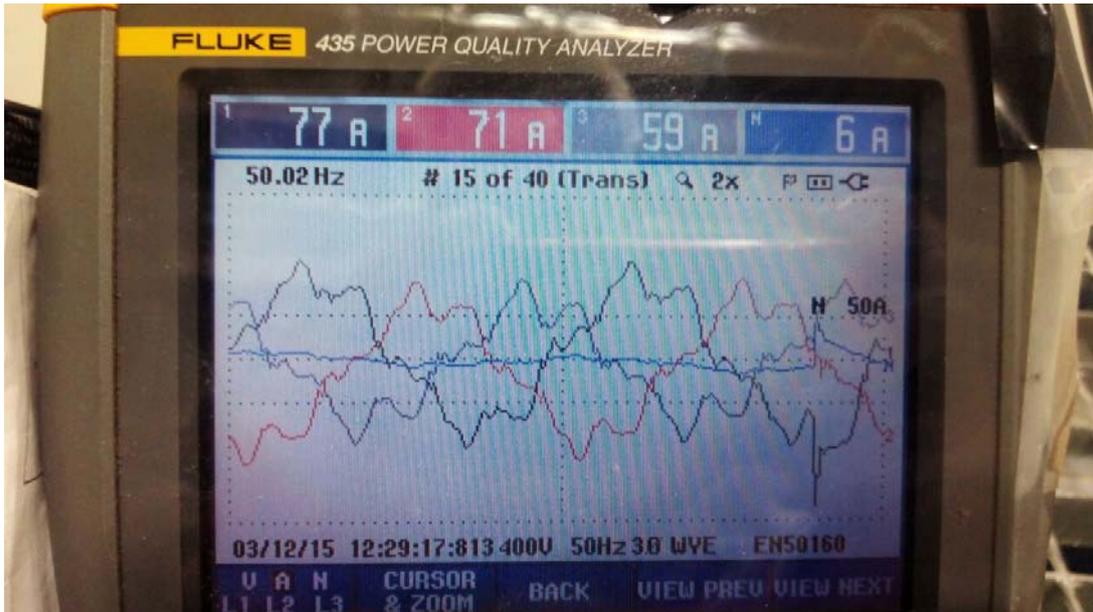
The fault also caused a peak in the currents (Fig. 10).

Fig. 10. Disturbance in the currents produced during an RCCB tripping event on the 12/3/2015 at 12.29 pm in a circuit in the food manufacturing factory.

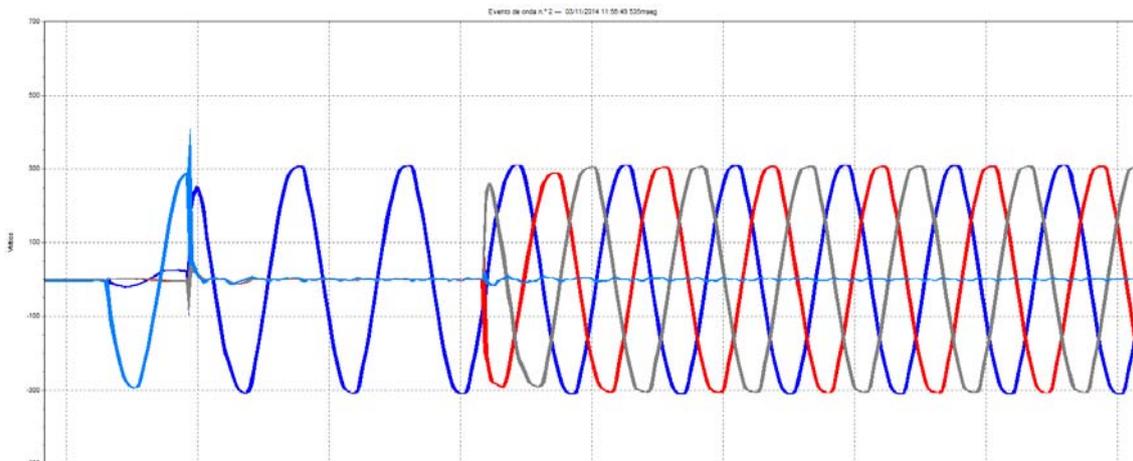
Fig. 11 shows voltage waveforms and Fig. 12 shows the leakage current obtained during the RCCB tripping event.

Fig. 11. Voltages recorded during the energization of the laboratory and the RCCB tripping event on the 18/8/2015 at 8.41 am in a circuit in the computer laboratory.

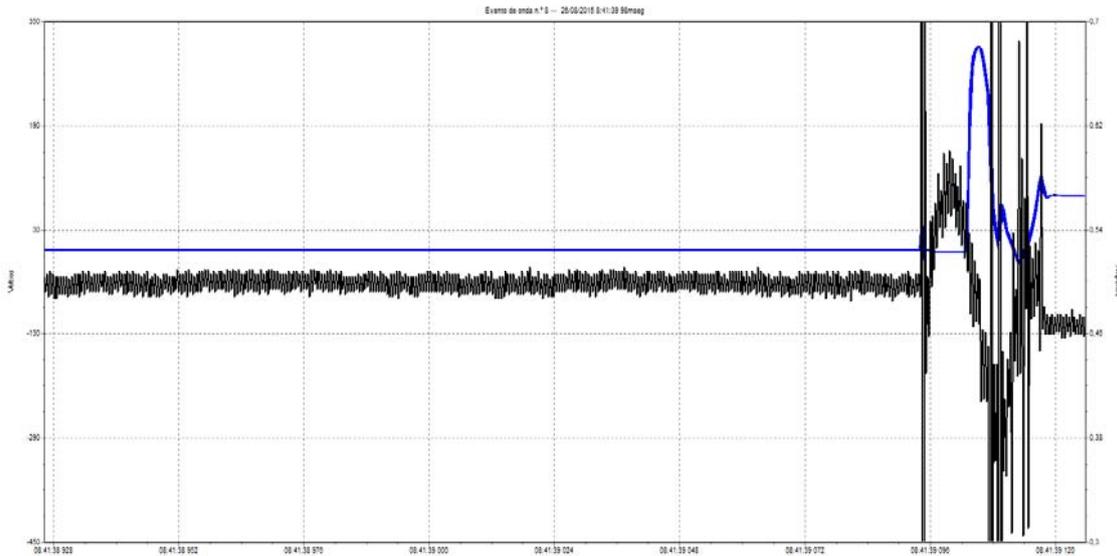
Fig. 12. Leakage current produced during an RCCB tripping event on the 18/8/2015 at 8.41 am in a circuit in the computer laboratory.
