Adam, JM.; Buitrago, M.; Bertolesi, E.; Sagaseta, J.; Moragues, JJ. (2020). Dynamic performance of a real-scale reinforced concrete building test under a corner-column failure scenario. *Engineering Structures*. 210:1-14. <https://doi.org/10.1016/j.engstruct.2020.110414>

Dynamic performance of a real-scale reinforced concrete building test under a corner-column failure scenario

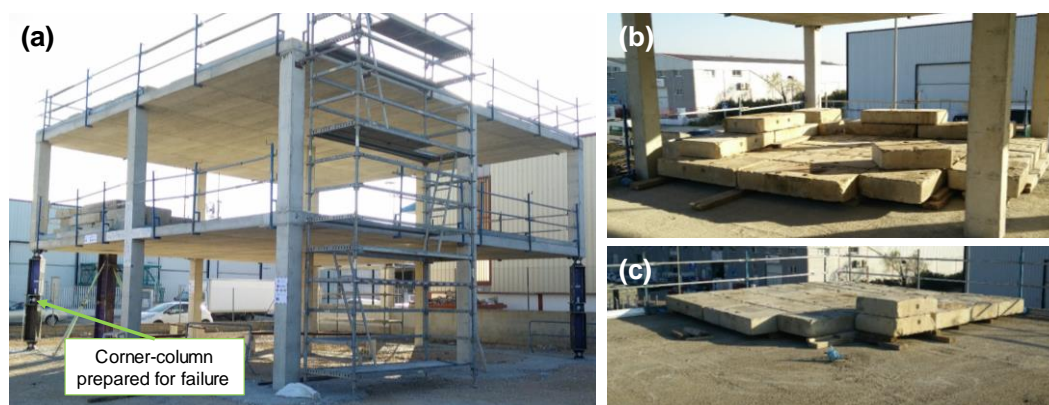
150 (the remaining bays had no superimposed loads). The blocks used for the superimposed load were
151 heavier than initially intended leading to a final load of 5.3 kN/m^2 . On the first floor, the weight
152 of a hypothetical outside wall was also considered by adding blocks at the edges; this was roughly
153 equivalent to a line load of 0.56 kN/m . Fig. 4 shows a photo of the finished building ready for
154 testing, with two views of the superimposed loads placed on each floor.

156 **Fig. 4. Details of the building (a) and the superimposed loads for the accidental situation on Floors**
157 **1 (b) and 2 (c).**

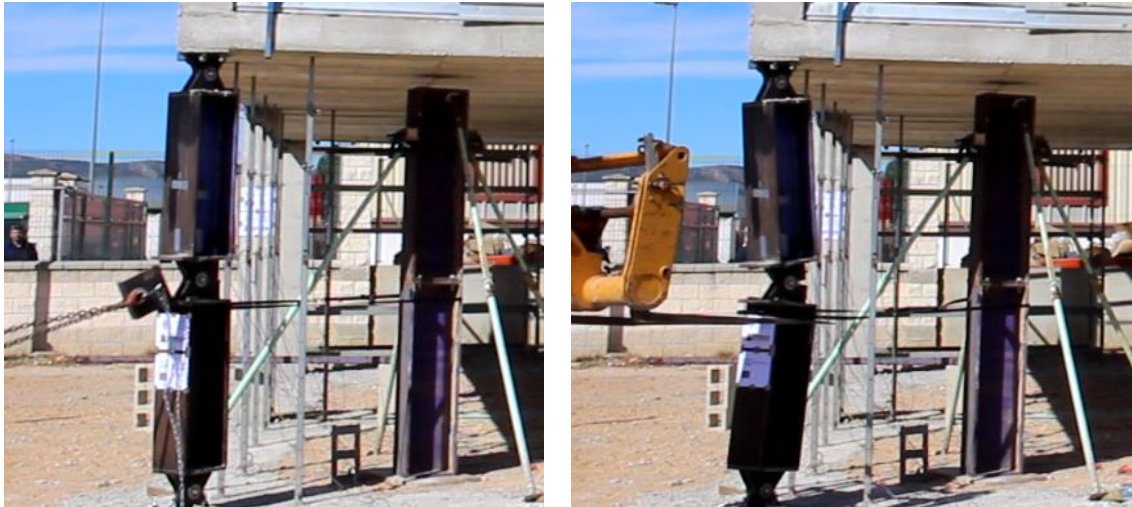
172 The sudden column removal was achieved firstly by extracting the UPN girder (unblocking
173 the intermediate hinge) which was followed by a slight destabilisation of the column using a
174 forklift. Fig. 6 shows the moment just before the column was destabilised. For safety reasons an
175 additional column (unattached to the building structure as shown in Fig. 6) was placed next to the
176 removed column to prevent the total collapse of the structure.

Fig. 6. Reproduction of the sudden failure of the column.

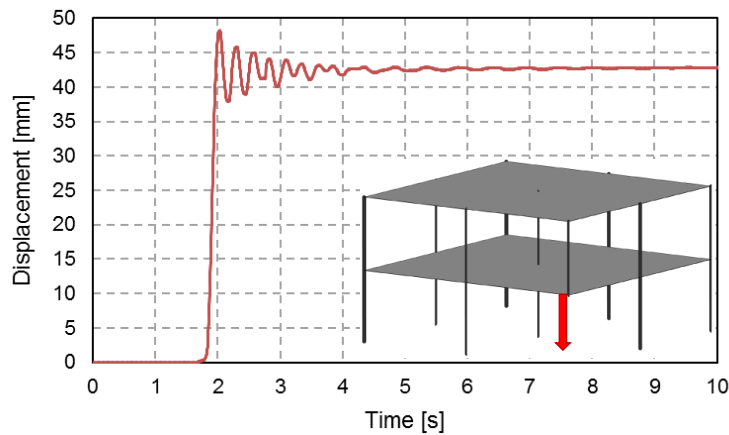
219 Fig. 9 shows the time-history of the vertical displacement of one of two LVDTs close to the
220 failed column P3. Both sensors (P3_11V and P3_12V) showed similar values, with a maximum
221 descent of 48.1mm and stabilised at 42.8mm two seconds after the sudden column removal.

223 **Fig. 9. Vertical displacement in the position of the failed column.**

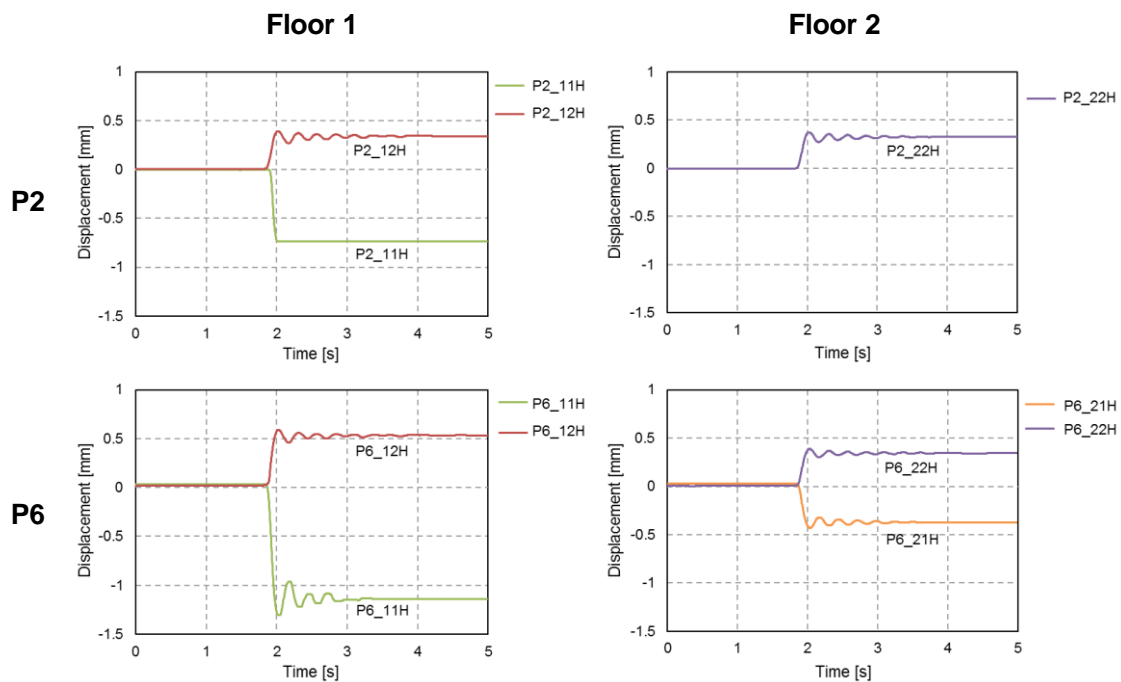
237 Fig. 11 shows the relative horizontal displacement time-history results for the seven LVDTs
238 on column-slab joints around columns P2 and P6 on the first and second floors (P2_11H, P2_12H,
239 P2_22H, P6_11H, P6_12H, P6_21H and P6_22H, see positions in Fig. 7). The data from sensor
240 P2_21H is not shown as the sensor was faulty during the test. The results show that the upper face
241 of the slab is in tension while the lower is under compression, with tensile deformation higher
242 than compression deformation due to localised slab cracking. Slightly asymmetric behaviour can
243 also be seen in the first-floor structure, where the sensors close to P6 recorded larger
244 displacements than those around P2, although those on the second floor all gave similar values.

246 **Fig. 11. Horizontal displacements on slabs near columns P2 and P6 on first and second floors.**
 247 **Positive values represent compression displacements.**

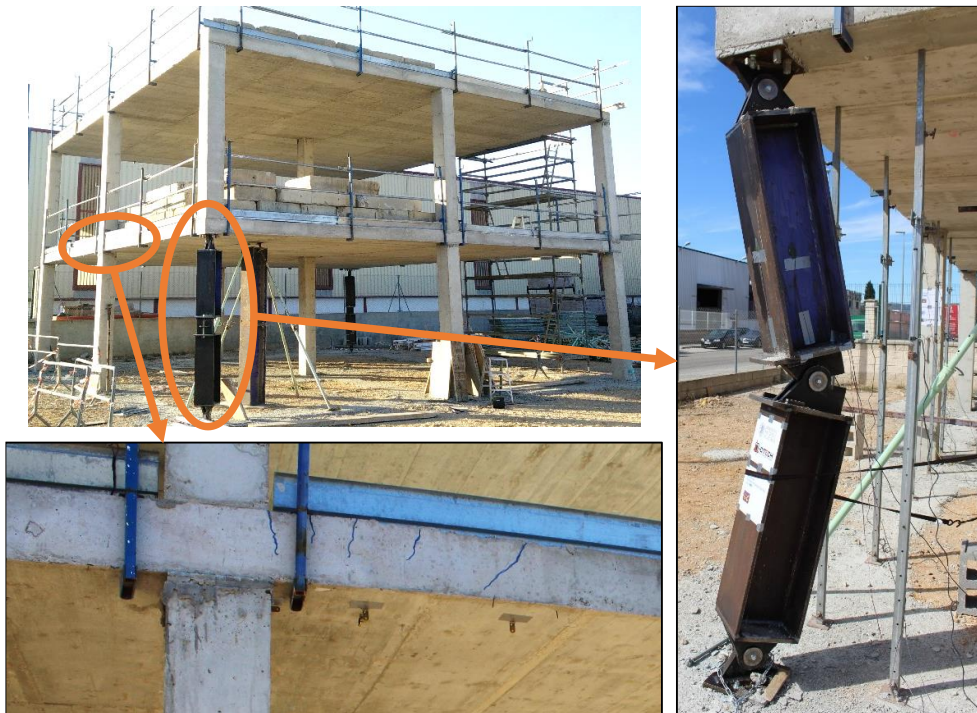
308 There was no extensive cracking in the structure before and after removing the column; only
309 the upper slab surface around P2 and P6 were affected, as confirmed by the results given in Fig. 11.
310 Flexural cracks in the slab were visible near the column-slab connection as shown in Fig. 16. At
311 the end of the test, for safety reasons, P3 was pulled back into its original position by a cable until
312 the central hinge re-blocked; flexural cracks closed consequently.

314 **Fig. 16. Final state of the removed column and detail of cracking on P2 slab-column joint (1st floor).**

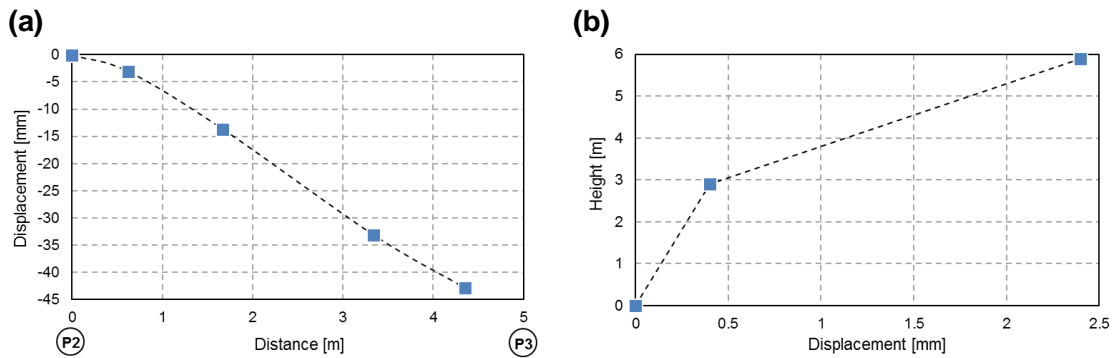
374 curvature deformation as shown in Fig. 18). Fig. 18a shows the vertical deformed shape of the
 375 first-floor slab between P2 and P3. The results show that deformation is not only due to flexural
 376 or cantilever action, but that the Vierendeel beam effect is also significantly present.

377 Fig. 18b shows the horizontal deformation of P9 as representative of the drift of the structure.
 378 The deformation is not uniform, but is approximately five times greater on the second than the
 379 first floor, and also indicates the existence of the Vierendeel beam mechanism, which reduced the
 380 horizontal deformation on the first floor. It should be noted that this mechanism also requires the
 381 bending capacity of the slab-column joints which is limited due to punching and moment transfer.

383 **Fig. 18. Vertical residual displacement of the first floor between columns P2 and P3 (a) and**
 384 **horizontal residual displacement of column P9 (b).**

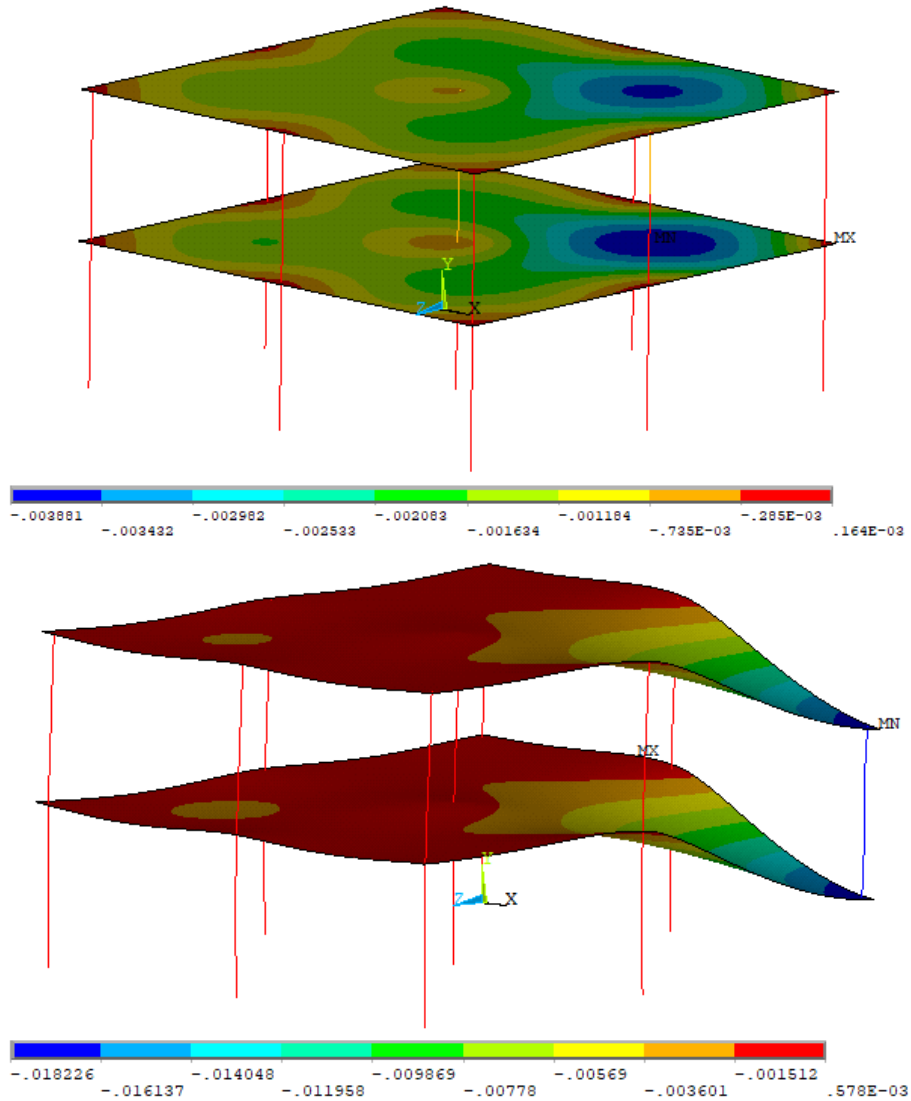
406 The use of a linear static approach in the DoD guidelines is restricted to structures without
407 “structural irregularities” as well as irregular structures in which the estimated demand-capacity
408 ratio from the linear analysis is less or equal than 2.0. Therefore this approach seems suitable for
409 the structure tested in this work. In the present study a linear static analysis was performed using
410 ANSYS software [55] to compare the experimental and numerical results in order to evaluate the
411 DAFs, as has been done in previous studies (e.g. Xiao et al. [42]). Beam elements (BEAM188
412 [55]) were adopted to simulate columns and shell elements (SHELL181 [55]) were considered
413 for slabs. The finite element model considered those mechanical and geometrical parameters of
414 the experimental test (See Section 2). A linear static analysis was carried out, without considering
415 dynamic amplification (DAF = 1.0). Fig. 19 shows the deformed shape (UY) of the finite element

417
418 **Fig. 19. UY deformed shape of the structure. Units in m.**
