Sangiorgio, V.; Uva, G.; Adam, JM.; Scarcelli, L. (2020). Failure analysis of reinforced concrete elevated storage tanks. *Engineering Failure Analysis*. 115:1-16.  
<https://doi.org/10.1016/j.engfailanal.2020.104637>

# Failure analysis of reinforced concrete elevated storage tanks

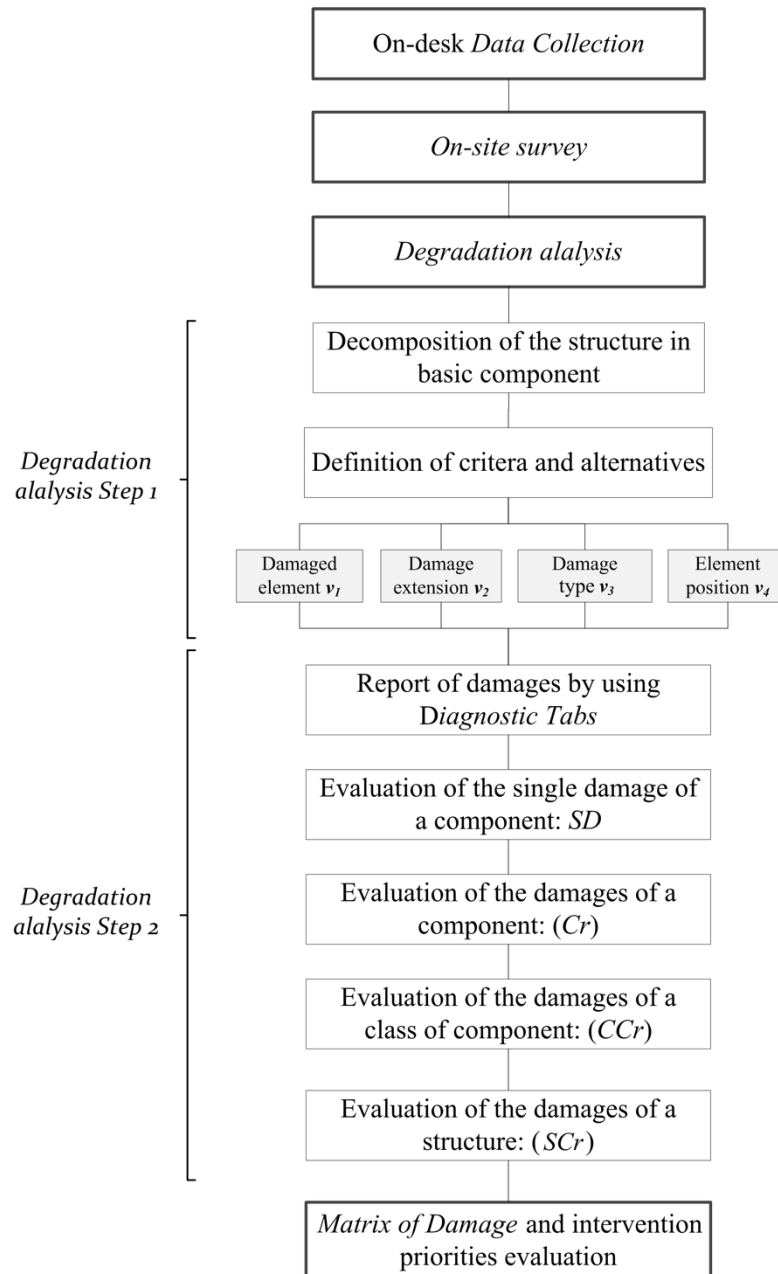
**Fig. 1** Flow chart of the Alert-DT damage evaluation method.

This novel approach is based on four main phases: a) *Data Collection*; b) *On-site Survey*; c) *Degradation Analysis*; d) *Intervention priority*. In the first phase, *Data Collection* aims at acquiring the main information on the water towers regarding: age of the structure, existing original project, location and any other useful information, such as the code in force when the structure was built. The second phase, the *On-site Survey* consists of a visual inspection. During this phase, a rapid survey is carried out to obtain geometrical data through direct measurements. In the third phase, the *Degradation Analysis* is conducted by adapting the existing *diagnostic tab*, *condition ratings* and multicriteria approach proposed by Sangiorgio et al. [19,20] to study the components of the storage tanks. In this phase the structure is broken down into its basic components and damage is evaluated by defining a set of criteria and alternatives. For each component the *condition ratings* are computed. The three *condition ratings* assume real values in the interval between (0 – 10) and are defined as follows: i) the *criticality condition rating* ( $Cr$ ) is a numerical value to qualify the damage in a single component; ii) the *component condition rating* ( $CCr$ ) is a numerical value to quantify the critical condition of a class of components (for instance beams or columns); and iii) the *structure condition rating* ( $SCr$ ) is a numerical value that quantifies global damage in the structure. These three condition ratings synergistically provide a complete overview of the storage tank's condition.

Finally, the *matrix of damages* is derived by following the standard procedure and the *intervention priority* can be deduced from the condition ratings. Figure 1 shows the flow chart of the evaluation phases.

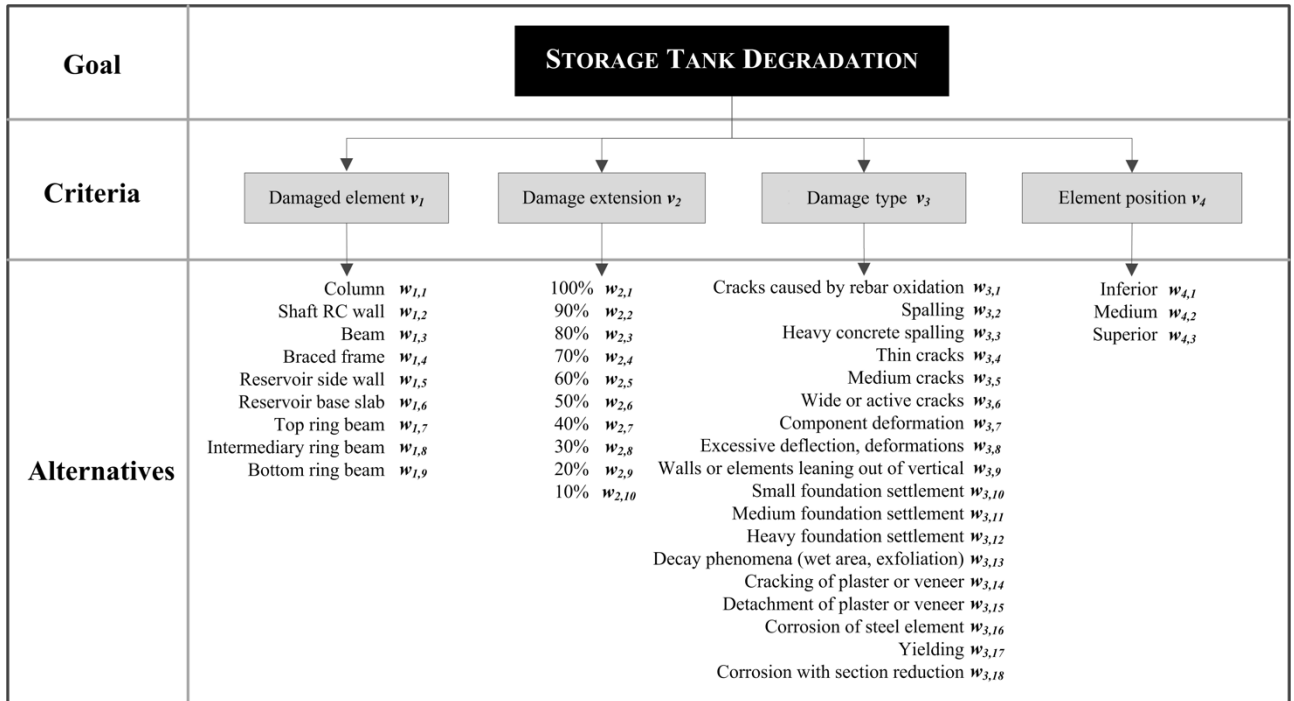
**Fig. 3** Storage tank damage evaluation: alternative criteria and associated weight.

In addition to performing diagnostics, suitable criteria and alternatives are defined and selected by the standard approach (Sangiorgio et al 2019). The original method considers many component and damage types, since it was designed for a generic structure. In this work, only components and damage compatible with water towers are considered. Figure 3 shows the selected criteria, alternatives and associated weights.

The problem is structured into  $m=4$  criteria: *damage type*, *damage extension*, *damaged element* and *element position*. The weights are defined as follows:

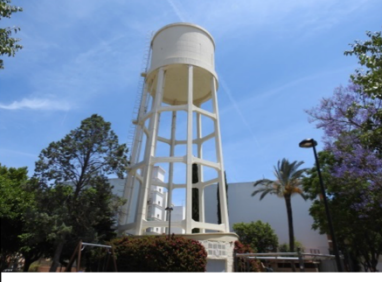
Fig. 11 Matrix of damage of the tank ST3.

By inspecting the values of the condition ratings reported in the *Matrix of damage* (Figure 10) and using the threshold values in Sangiorgio [20] (Figure 5), some preliminary concise observations can be made. For example, in tank ST16: (1) the maximum criticality condition rating 7.7 exceeds the threshold for serious danger, i.e. it can severely affect the performance of the structure; (2) the maximum *component condition ratings* suggests that all the beams of the tank are in a critical condition and the columns are in a medium-serious status. This situation can compromise the overall component effectiveness; (3) the structure condition rating also exceeds the threshold values in Sangiorgio et al. [20] i.e. the tank is in a critical state of conservation. In addition, in order to shows the difference of the condition ratings evaluation for structures in good condition Figure 11 shows the resulting *Matrix of damage* for the storage tank ST3. This is the structure in the best conditions among those investigated. The last damage surveyed regard a small exfoliation of the plaster  $Ccr=1.5$ . and the structure condition rating is  $Scr = 0.3$ .
