# Sustainable and traditional technologies in Kutahya historic houses and their contribution to circularity: the case of Lajos Kossuth house

Betül Ankaraligil<sup>1</sup>, Gülşen Dişli<sup>2</sup>

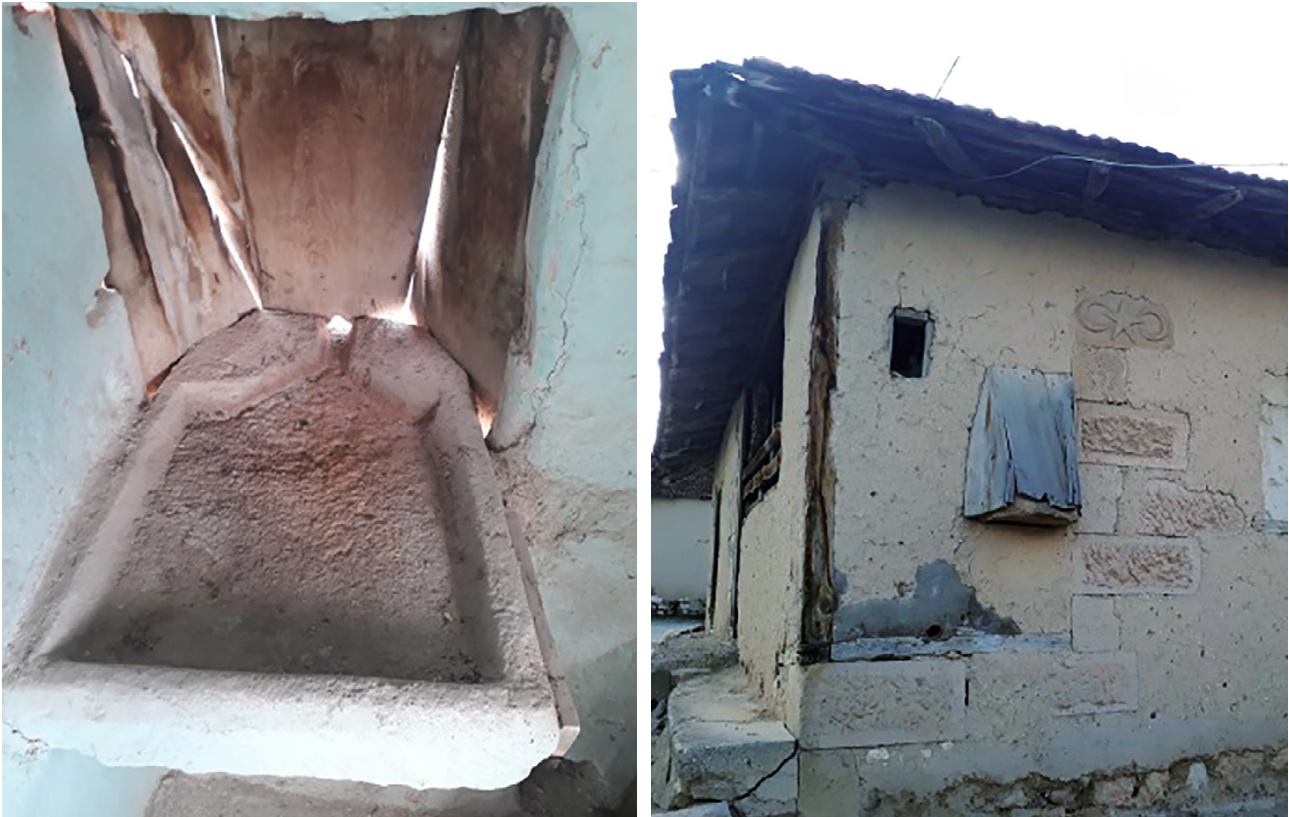
Figure 1 | Interior (left) and exterior (right) views of an original ablution space protruded from the facade (a guesthouse in Siner Village, Kutahya).

Because of religious necessities, in traditional Kutahya houses, spaces related to clean and wastewater systems, such as toilets and ablution spaces, were generally located in the courtyard or outer sofa, rather than inside the building, and originally made of either timber or mud-brick material. Toilets were mostly lined up to one of the walls of the courtyard or built as a separate unit. The ones located inside the house were either later additions or in the form of projecting spaces. For instance in Ali Pasha House, the toilet was made of timber construction walls and located in the courtyard, and similarly, in Bandımzade House, the toilet was disguised inside the thick stone courtyard wall. In Hacı Efendi House, the toilet was located in the courtyard, as well. Thus, they were easily connected to the city sewage, or in the form of cesspools that could easily be cleaned. There were also some projecting balcony-like semi-open spaces in the first or second floors of the houses, located on the outer sofa, mostly close to the sitting area/kiosk (*taht/köşk*) for the ablution or handwashing purposes via portable water carried with ewers. Wastewater was discharged in those spaces through wooden waterspouts connected to the floor drains, and then to the courtyard. Thus, it was possible to water the greenery in the garden with this recycled water. Deferdar Mansion, Hacı Efendi House, İsmail Hacı Çakır House, and Halit Yargılayan House were some examples of traditional Kutahya House, which had original ablution spaces (Eser, 1955) (Fig.1). In some other cases, there was a fountain in the courtyard (Eser, 1955). Water ditches (Kahraman, 2011) and pools were also observable for both the provision and collection of water and for cooling purposes on hot summer days. Bathing cubicles located inside the wooden cupboards in each room and public baths in the vicinity were the primary spaces for cleaning the body. The bathing cubicles were in the form of projecting spaces on the façades, and their floors were originally covered with zinc. The wastewater was drained with free-fall from the floor drains on the projecting walls, and directed to the city sewage with the inclined ground surfaces (Eser, 1955). Clean water for bathing in houses was provided from either public fountains or wells, private fountains, and water ditches in the courtyard. Ewers, water jugs, and buckets were the main portable devices to carry the water. Thus, especially in waste and clean water systems, as part of circular design strategies, design for multiple cycles are observable

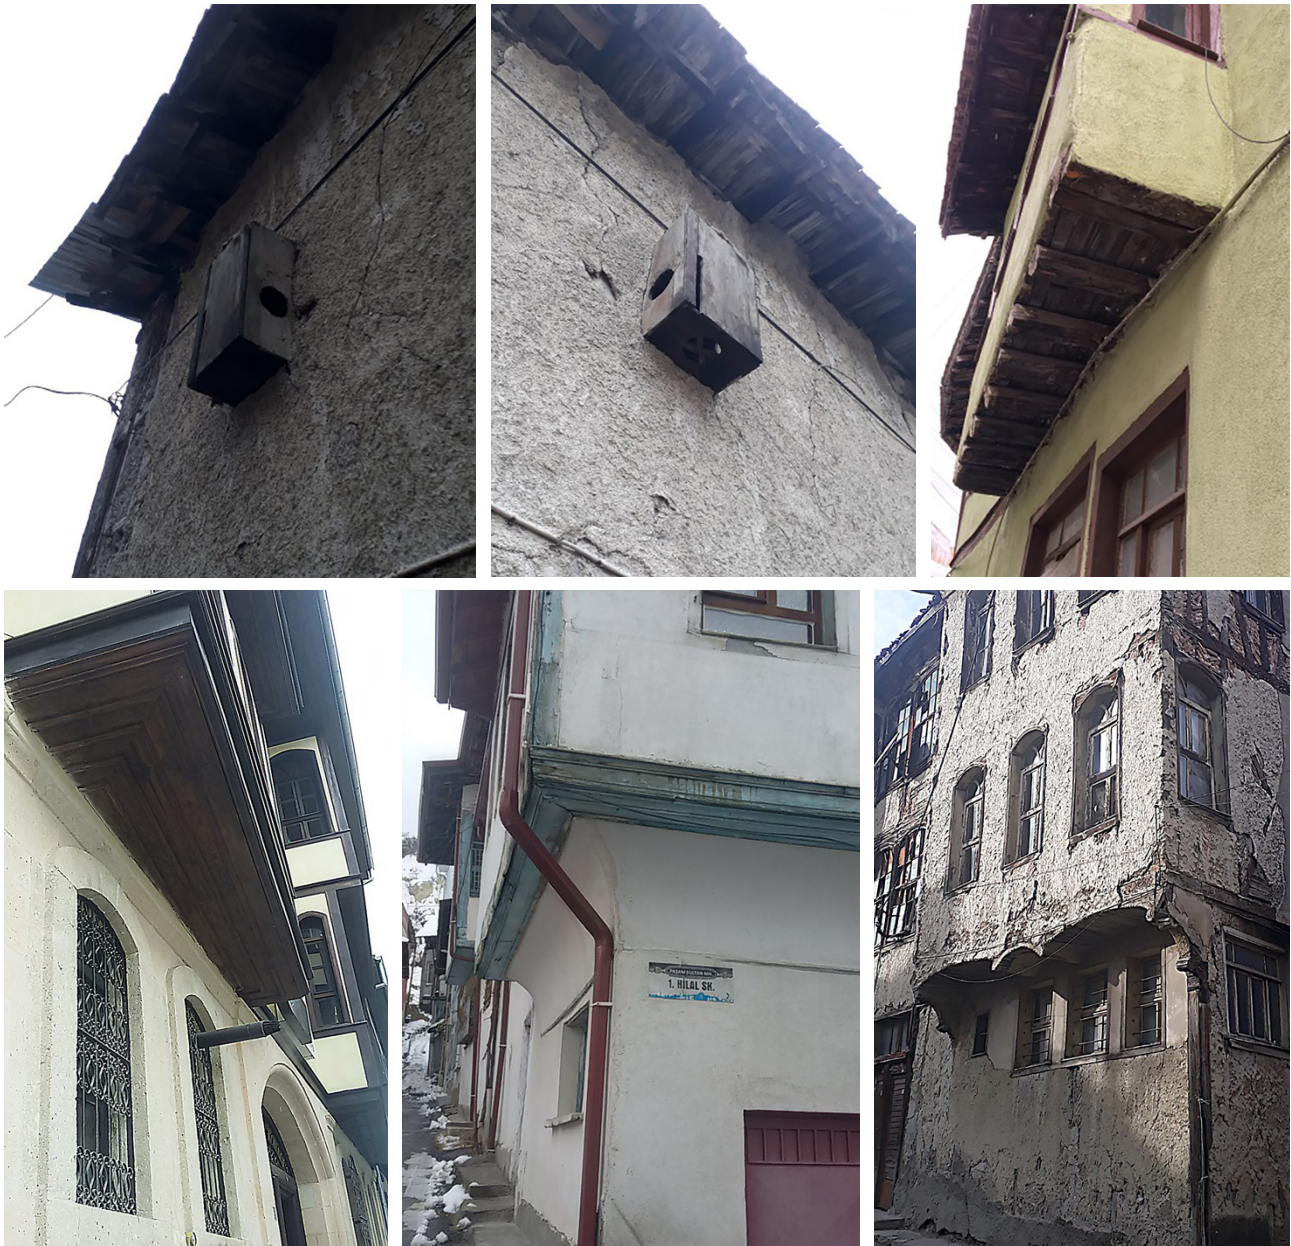
Figure 2 | Views from “süt dolabı” in a traditional Kutahya house (top), and types of protrusion areas in living spaces; carried on floor beams (top-right), with flat coated (bottom-left and center) and coated with curved ornaments (bottom-right)

of a projecting wooden window called “süt dolabı” in the local language, perforated on three sides, mostly located on the northern facades of the houses (Fig.2). Thanks to the fast and intense airflow on three sides, the food is kept cold and fresh for long hours in those projecting cubicles. This protrusion can also be in the form of a wire mesh cover on three sides, and called “sütlük” in the local language (Davulcu, 2010). A similar detail is observable in the form of projecting facades in living spaces. In some of the rooms, there are approximately one-meter protrusions mostly facing towards the street and to the north direction, with window openings on the front and two sidewalls (Fig. 2). Diwan (wooden sitting benches with cushions on) surrounds the periphery of protruding walls at the interior. This special sitting arrangement in the room is preferred especially for its highly ventilated and cooling effect.

Beneath the wooden eaves and protrusion areas in living spaces are covered either with straight timber, left bare, or with curved timber (Koçlardan, 2019) (see Fig. 2).

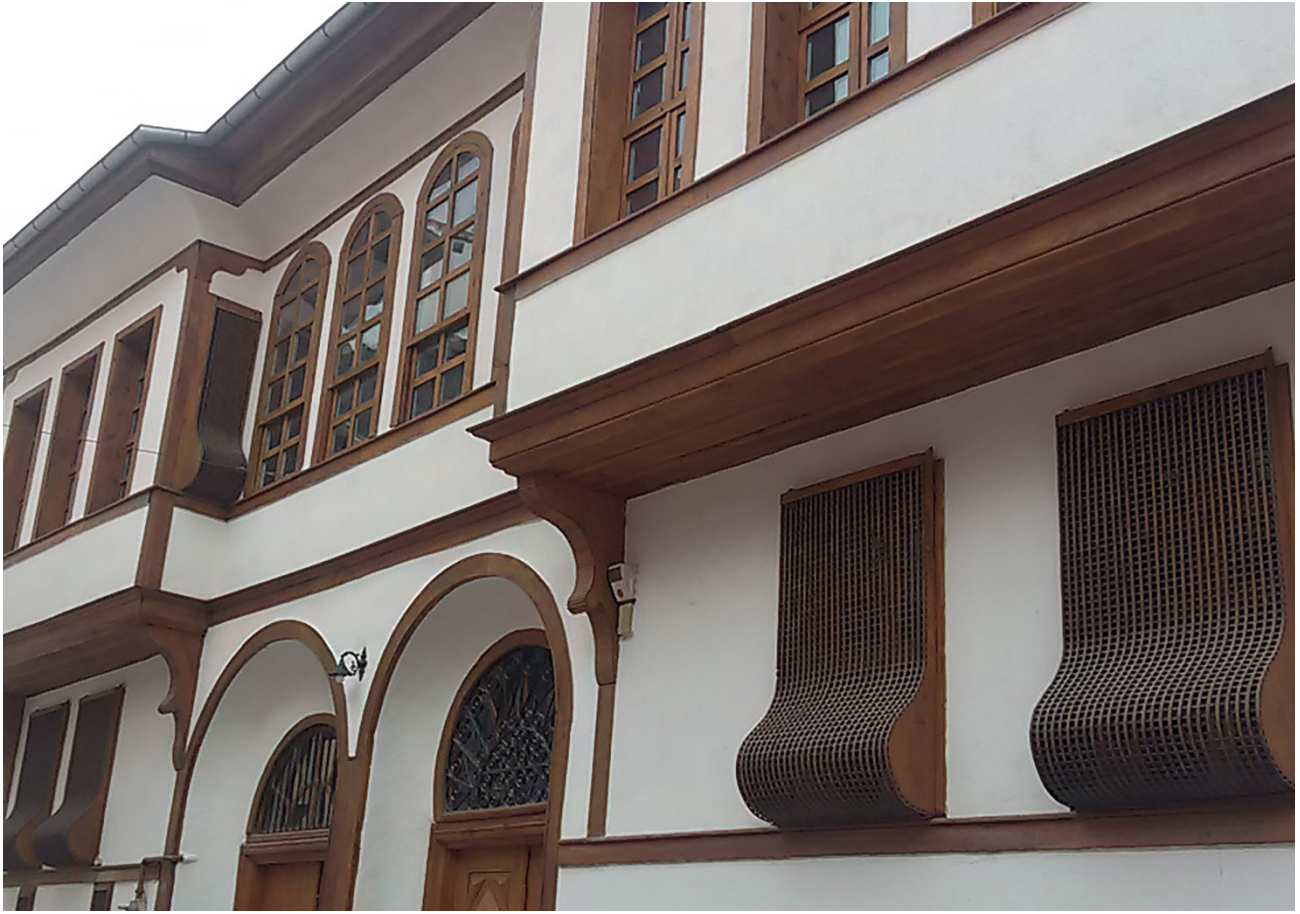
Figure 3 | Wooden shutters for shading for privacy purposes in traditional Kutahya houses.

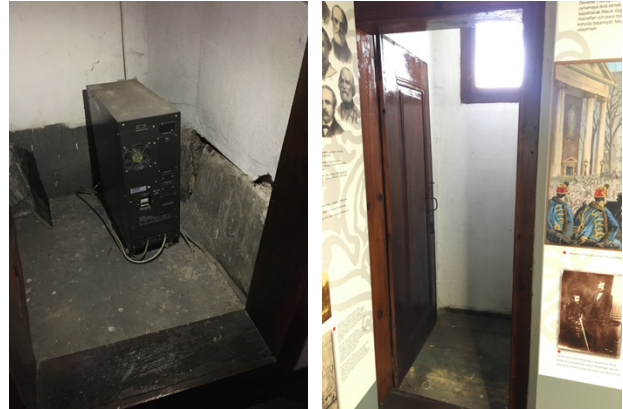
Figure 4 | Bathing cubicles in rooms 101 (top-left) and 103 (top-right) on the winter floor with lead covering on the ground and on the wall up to ≈20 cm height to prevent the splash of water to the wall surfaces during the bathing and their location on plan drawing (bottom).

In Lajos Kossuth House, the toilets are later additions, located on the southeast corner of the building on top of each other, and at present can be reached from the outer courtyard or stairway. During the refurbishment process, instead of complete demolition of those unoriginal parts, they were adapted to be used as either a depot or toilet again. Originally, it was probably in the courtyard connected to the sewer pipes carrying wastewater mostly made of terracotta, sealed with a special mortar. Since, originally, there were no taps; people probably flushed the toilets with pitchers of water after each use and cleaned themselves with the water carried with portable devices. Yet, at present, neither the original sewer system nor the terracotta pipes are observable. There are also bathing cubicles as protruding spaces on the east and west sides of the north wall and inside the wooden cupboards of the rooms (Fig. 4). In Lajos Kossuth House, the bathing cubicles are located in rooms 101, 102, and 203, and in room 201, there was also a bathing cubicle inside the wooden cupboard, which is not existent at present. Those cubicles, most of which were closed during

the refurbishment works, were used as bathing spaces, with wooden seats, small lighting windows, and floor drains for the discharge of wastewater. Clearwater, on the other hand, was provided with portable devices such as water jugs and ewers heated on the furnaces. Though the bathing cubicles are out of use at present because of the new function of the building, they still exhibit and retrieve the traditional bathing culture of the region in history, to the visitors of the museum, thus promote circularity in the social aspect. In addition to bathing cubicles, nearby public bathhouses were so often used to clean the body. Since there is no room to be a kitchen and for washing the dishes or clothes, the courtyard might have been used for those activities. Besides, there might have been a well inside the courtyard to provide water for those cleaning activities. There are no taps inside the house, but the fountain on the entrance courtyard wall must have served for the provision of drinking water. At present, there is an ornamental marble pool in the courtyard that might have been used for the collection of rainwater directed from the roof and ground surfaces and for cooling purposes on hot summer days, but not in its original location. Thus, originally, it served for water reuse and different purposes thus foster R1-rethink and R3-reuse strategy in the circular economy (Potting et al., 2017). Barn, warehouse, hayloft, and depots are located on the basement floor entered via a sloped floor surface from the sunken courtyard, and a drain is located on it to prevent ponding of water. Since

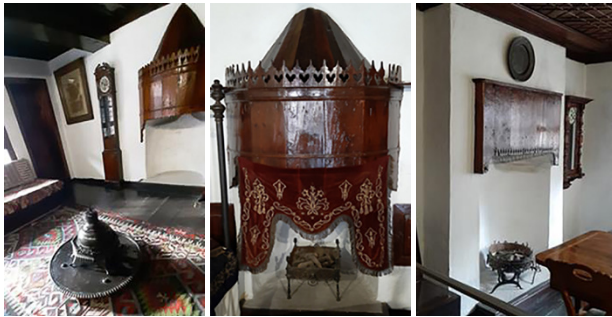
Figure 5 | Furnaces and braziers in rooms 101, 103, and 104 on the winter floor (top-from left to right) and plan drawing showing their location in the building (bottom).

In Lajos Kossuth House, built-in wall furnaces and braziers were used for space heating (Fig. 5, Fig. 6). There are furnaces and braziers, still observable, in all living spaces. The furnaces are located on the outer and thicker walls of the rooms, so they do not form any projections on the facades. Their inner surfaces are generally covered with large wooden hats or sliding metal covers to prevent the cold when they are not in use. Stoves and Dutch ovens, on the other hand, started to be used in Kutahya only after the second half of the 19<sup>th</sup> century with the arrival of Hungarian refugees (Özdemir, 2018). In addition to those direct heating elements, there are also some indirect applications serving for the warmth of the spaces and the users, as well. Among them, the proper direction of living spaces plays an important role, such that the longer façade of the house lies along the southwest-northeast direction, and the north façade was built thicker without any openings to prevent the effects of strong cold winds

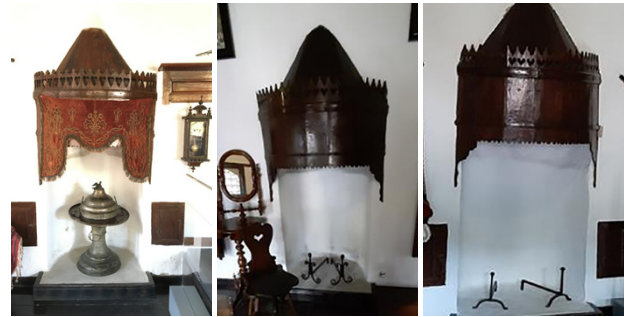
Figure 6 | Furnaces and braziers in rooms 201, 202, and 203 on the summer floor (top- from left to right) and plan drawing showing their location in the building (bottom)

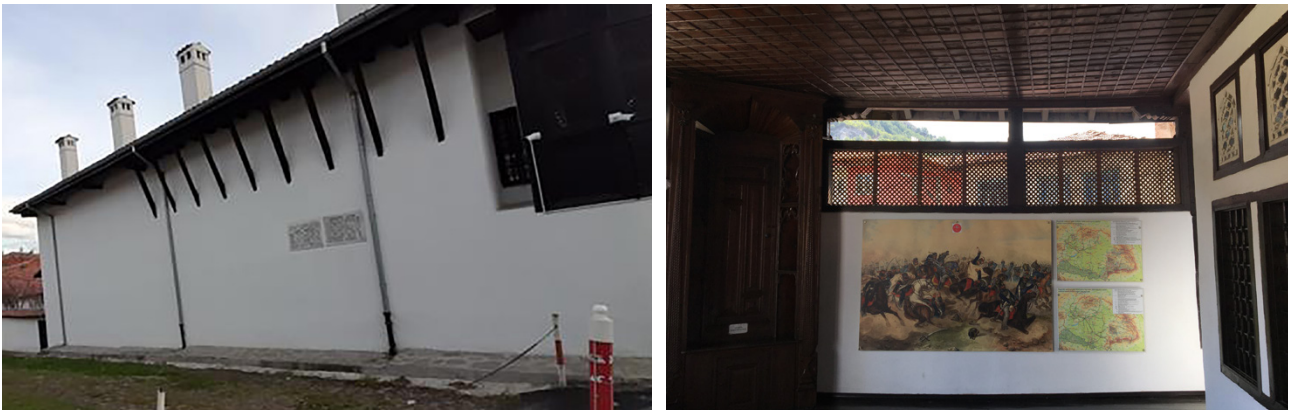
Figure 7 | North (left) façade of the building without any window openings and raised wall of outer sofa (right).

blowing from the north, thus increasing environmental resilience (Fig. 7). Privacy was the other reason, such that because of religious considerations, this facade facing the street was left bare without any openings (Eser, 1955). Most of the windows and doors of the building are directed towards the south to benefit from the sunlight at an optimum level, but not let the cold northern winds. Besides, floor heights show variations to allow winter and summer usages. On the winter floor, to prevent the heat flow, the height of the living spaces is built lower (2.60 m.) than the summer floor (3.20 m.) (Fig. 8). Wooden railings at the floor level and coatings at the ceiling level on the outer sofa of the winter floor were kept higher than the summer floor to keep the heat inside. Thick mat coverings, rugs, and diwans also contributed to the warmth of the users (Eser, 1955). Akok also mentions the existence of separate space in the courtyard with an oven in it, used both for cooking and for cleaning (Akok, 1963), but today it is not observable. Thus, the use of such simple, flexible, durable, and low-maintenance systems and architectural solutions (proper direction, winter-summer rooms with varying heights, furnaces with wooden hats/sliding metal covers, thick walls, no window openings on the north side) for the heating of spaces contributes to resilience benefits of DfA strategy by withstanding the natural forces and climate change.

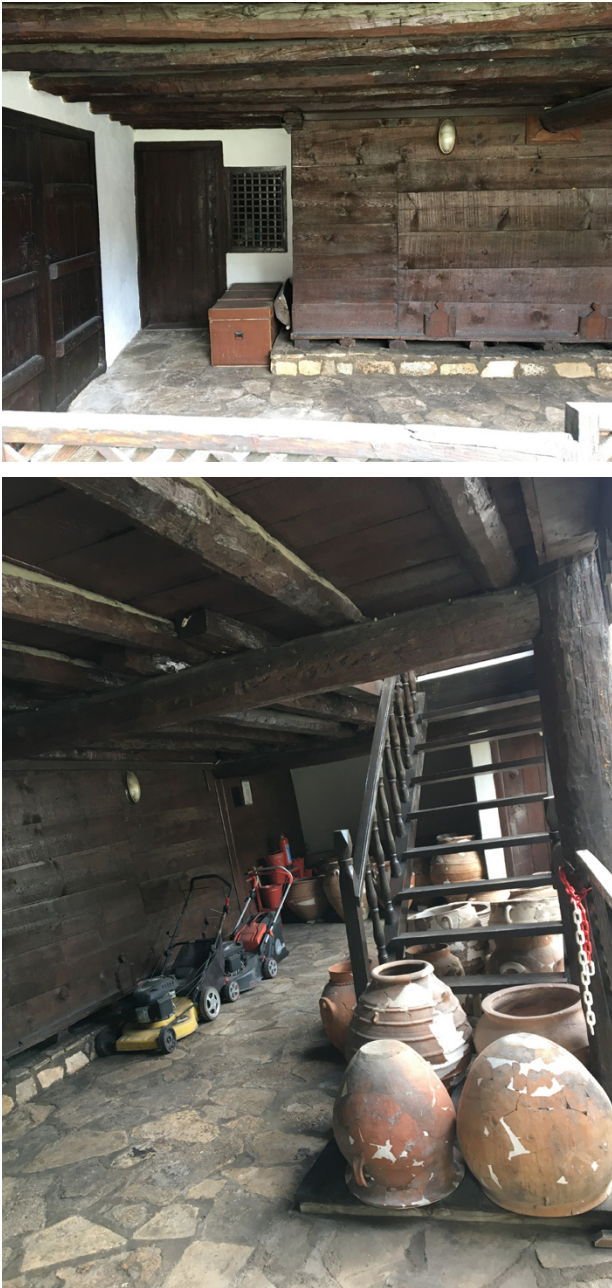
Figure 9 | Depots, and wooden wheat storage room (above), terracotta jars for food storage (below).

lattice windows for ventilation purposes. The food inside was kept in pottery vessels (Fig. 9). Today, barn, warehouses, hayloft, and depots are used as inventory/storage rooms where museum collections are stored and the objects in the exhibition are changed at certain intervals. Thus, those discarded spaces have been re-functionalized suitable to the “R7-repurpose” circularity strategy (Potting et al., 2017). There are also some special solutions for cooling purposes on the summer floor in Lajos Kossuth House. On this floor, there is a semi-open kiosk (*köşk*) on the Northwest corner of the outer sofa, elevated with two stairs ( $\approx 0.50$  m). It has wooden lattice windows on the west and north sides, thus speeding up the airflow and cooling the space, even on hot summer days. The wooden lattice windows were also used for privacy considerations and to determine the guests without opening the door. Increased floor height (3.20 m) and lower wooden railings on the outer sofa, provided the fresh air to reach that floor easily, and thus keep the space cooler (Fig. 10).

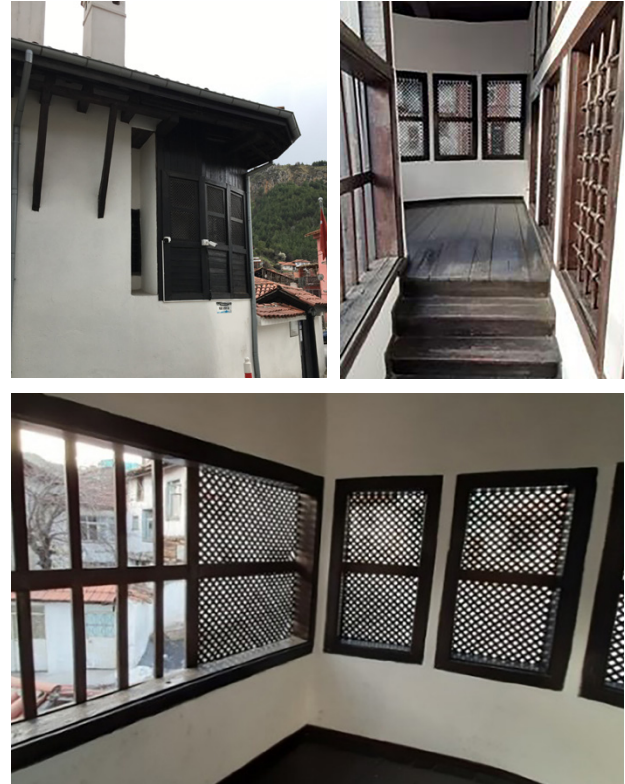
Figure 10 | Exterior (top left) and interior (top right) views from the semi-open kiosk (*köşk*) on the northwest corner or the outer sofa on summer floor.

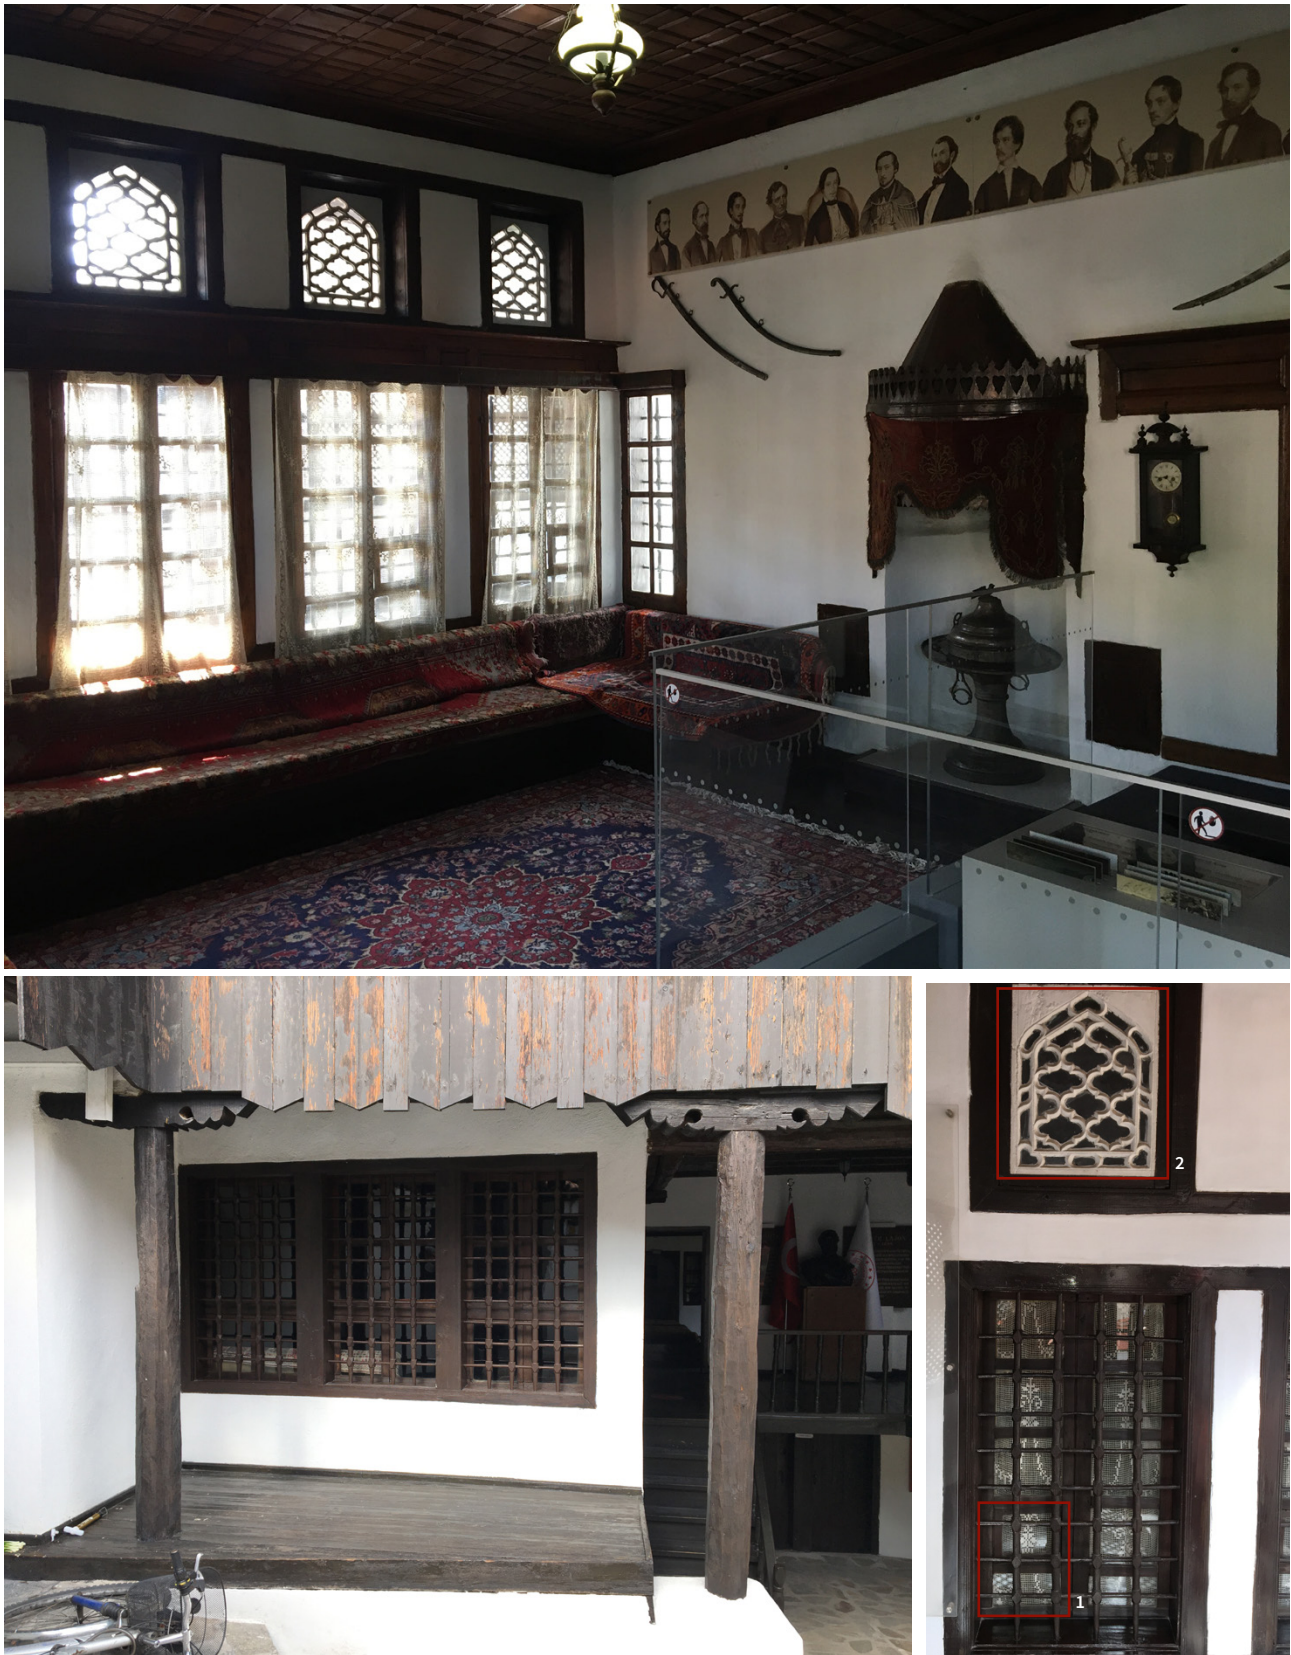
Figure 11 | Exterior and interior views of windows on the winter floor (bottom-left) and summer floor (top and bottom-right) 1: small special opening arrangement used for the ventilation of the room quickly, 2: decorated plaster window at the second row.

For lighting the rooms, similarly, there are one or two rows of windows at different levels. They have various opening arrangements depending on their location. On the winter floor, the rooms have only one row of windows, located just above the diwan (seating units), and have two levels of casements opened on two sides. When the room is needed to be ventilated easily and rapidly, the bottom casement openings are preferred (Fig. 11). However, on the summer floor, the living spaces have two rows of larger windows, compared to the ones on the winter floor. The first level windows are rectangular and their casements are opened as a whole on two sides. The top-level of windows is made of decorative plaster with glass infill (Fig. 11). On the summer floor, the outer sofa is ventilated on the west side through a straight opening at the top level of the wall, and there is a row of lattice windows just beneath that opening. Thus, the outer sofa is well ventilated both on the south and west sides. Ventilating diwans are also observable on this floor (Fig. 12). In room 201, the wall, through which the wooden seating (diwan) lies, does not sit directly on the wall of the bottom floor (room 101) instead, it was constructed overflowing just as the width of the diwan in front of it with additional wooden beams supporting this wall. Thus, 3-4 cm air openings are created beneath the wooden seating in room 201, providing ventilation in this summer room. Ventilating diwans, winter and summer room applications, and various window arrangements might be considered as C2C innovations in the ventilation systems. Similarly, the chimney extensions of furnaces, observable in all living spaces, both provide smoke evacuation when they burn

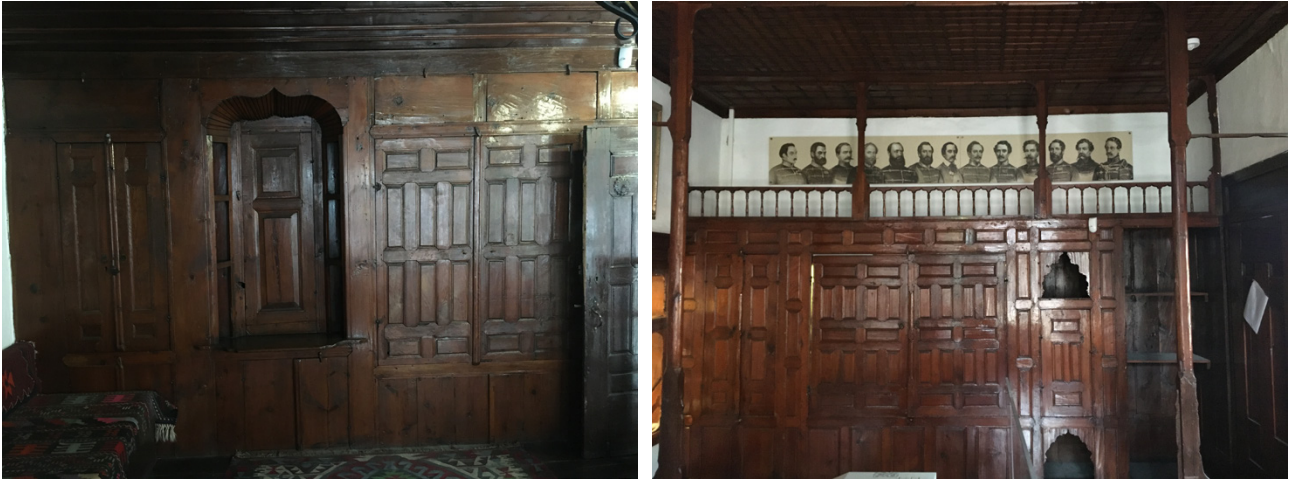
Figure 13 | Niches on wooden cupboards used for holding candle/candlesticks/oil lamps in room 101 (left) and 201 (right).

and are useful construction details for the natural ventilation of spaces for part of the year, thus support intentional multiple uses and contribute to environmental benefits of DfA strategy. All the rooms are opened to a semi-open outer sofa, thus constant air circulation is provided when the doors and windows are open. On the basement floor, the depots are ventilated and illuminated via small lattice wooden window openings. There is a granary raised on wooden feet just in front of the depot on this floor. This raised platform of wooden feet both keep the grain well ventilated and protect the grain from moisture and water during rainy days. In addition to natural lighting, there are also devices for artificial lighting in Lajos Kossuth House. In the house, there are some wall niches or decorative elements in wooden cupboards to locate the oil lamps or candles, some of which are still observable (Fig. 13). They are either in the form of wall niches called “şerbetlik” or projecting surfaces called “lambalık/kandillik”. Decorated wooden cores of living spaces were also used for hanging oil lamps at the centre of the room to provide lighting during the night. The small niches called “tembel gözü” located on two sides of furnaces, were used for storing some small equipment such as kindling and match to ignite the wood and candle (Fig. 13).

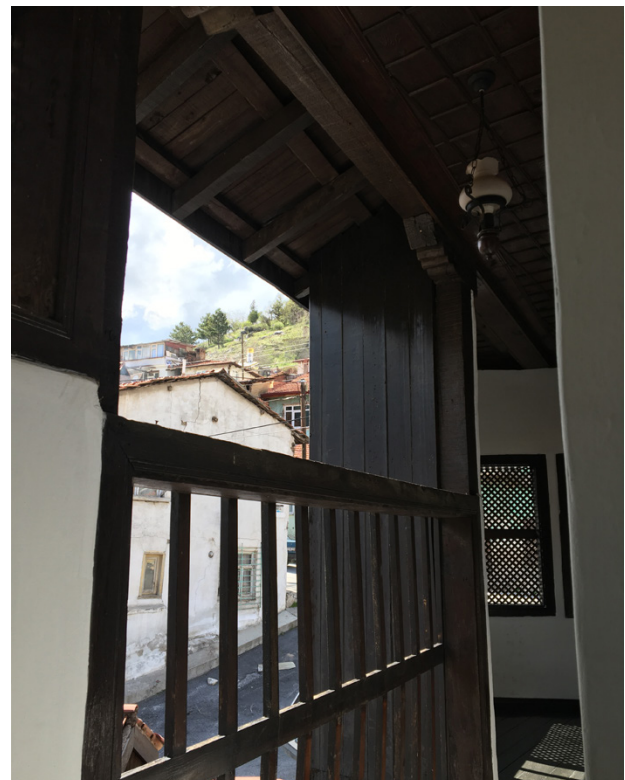
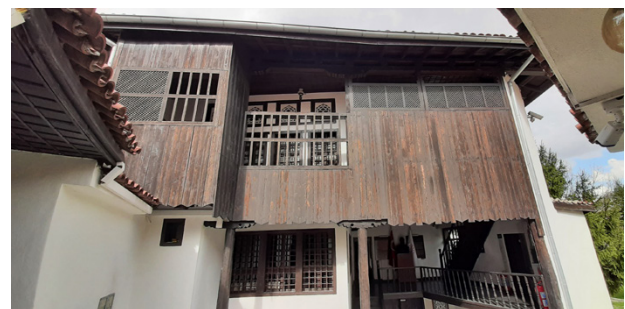
Figure 14 | Views from the large wooden eaves, downspouts, downpipes, and tile covering (top and bottom).

Large wooden eaves ( $\approx 1.30$  m) and hipped roof covered with clay roofing tiles are the main roof drainage elements in Lajos Kossuth House. At present, drainage is supported with metal downpipes and downspouts (Fig. 14).
