## WHEN THE RISK IS URBAN PLANNING. A CASE STUDY IN EL CABANYAL (SPAIN)

This paper presents the vicissitudes of a residential dwelling built in El Cabanyal in 1923 and how poor urban planning can be a risk. The building corresponds to one of the most common traditional typologies: a terraced house with masonry load bearing brick walls and timber floors, three storeys, a linear staircase attached to the party walls, a courtyard at the rear and a gable roof. In the past, this building, proved to be resilient, overcoming the risk of collapse in some important episodes which affected directly El Cabanyal: the air raid attacks of the Valencian coastline settlements during the Spanish Civil War and the floods occurred in 1949 and in 1957. In 1988, the building was listed in the catalogue of the General Plan with a protection grade 3. The special protection plan (PEPRI 2001) which was supposed to protect and rehabilitate El Cabanyal, projected the extension of Blasco Ibañez Avenue to the sea and consequently, the division of the neighbourhood in two halves, tearing down an important number of houses. Subsequently, the City council began to expropriate buildings facilitating their occupat

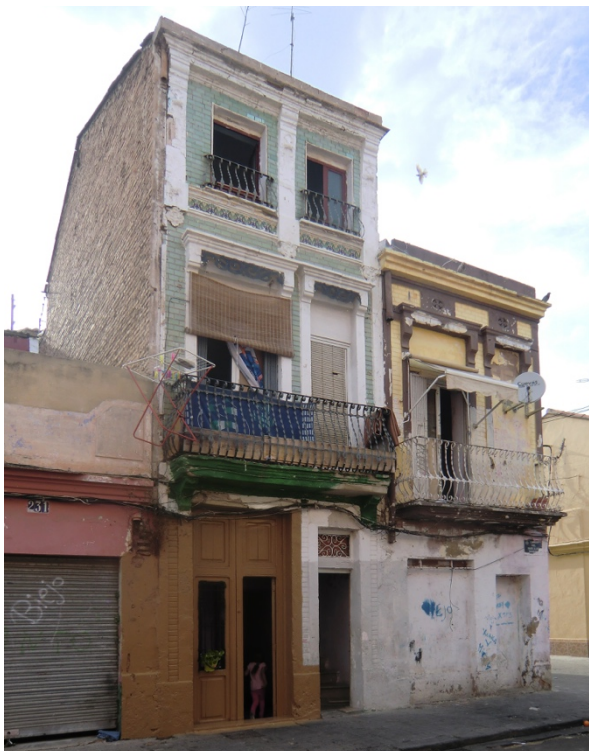
Figure 19. Padre Luis Navarro Street no 233. Credits: The authors, 2019.

The main façade follows the openings layout guidelines pointed out by Pastor (2012) for Type B typologies. The ground floor is organised with two independent entrances with different dimensions: on the right, the small door opens to the stairs leading to the first floor while the double door on the left opens to the ground floor household.

The same layout is repeated in the first floor, with a balcony connecting both openings. Finally, the windows on the second floor were designed with the same dimensions (Figure 19).

Finally, it must be pointed out that at the moment of writing this paper, the house seemed to be inhabited by squatters with an appalling state of maintenance (Figure 19 and Figure 22), being this condition similar to the adjacent houses which don't seem to be in a better state (Figure 23).

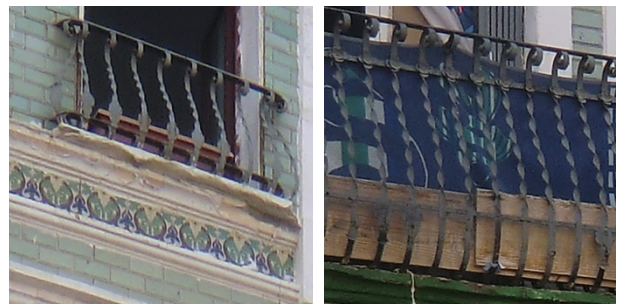
Figure 20. Tiles and ironworks. Credits: The authors.

1. The ceramic decorative frieze between the first and the second floor together with the green<sup>1</sup> tiles and their bonding style (figure 20). These tiles and pattern can be seen in many buildings along the quarter (e.g. in the same block at 209 and 219 Luis Navarro st and 196 Progreso st).
2. The ironwork of the balcony and windows. This design (figure 20) is repeated along the balconies and windows of the quarter.
3. First floor blind protections. Being Valencia a Mediterranean city, it was common practice to install outdoor wood chick blinds for blocking the summer sunlight heat. The houses of El Cabanyal used to protect these blinds with wrought iron elements like those in figure 21.

To guarantee the conservation and enhancement of El Cabanyal, preserving the traditional art and crafts skills, the opening on the right side of the first floor should recover its original dimensions. Additionally, the following elements of the façade should be preserved:
