Hydrogeomorphological analysis and modelling for a comprehensive understanding of flash-flood damage processes: the 9 October 2018 event in northeastern Mallorca

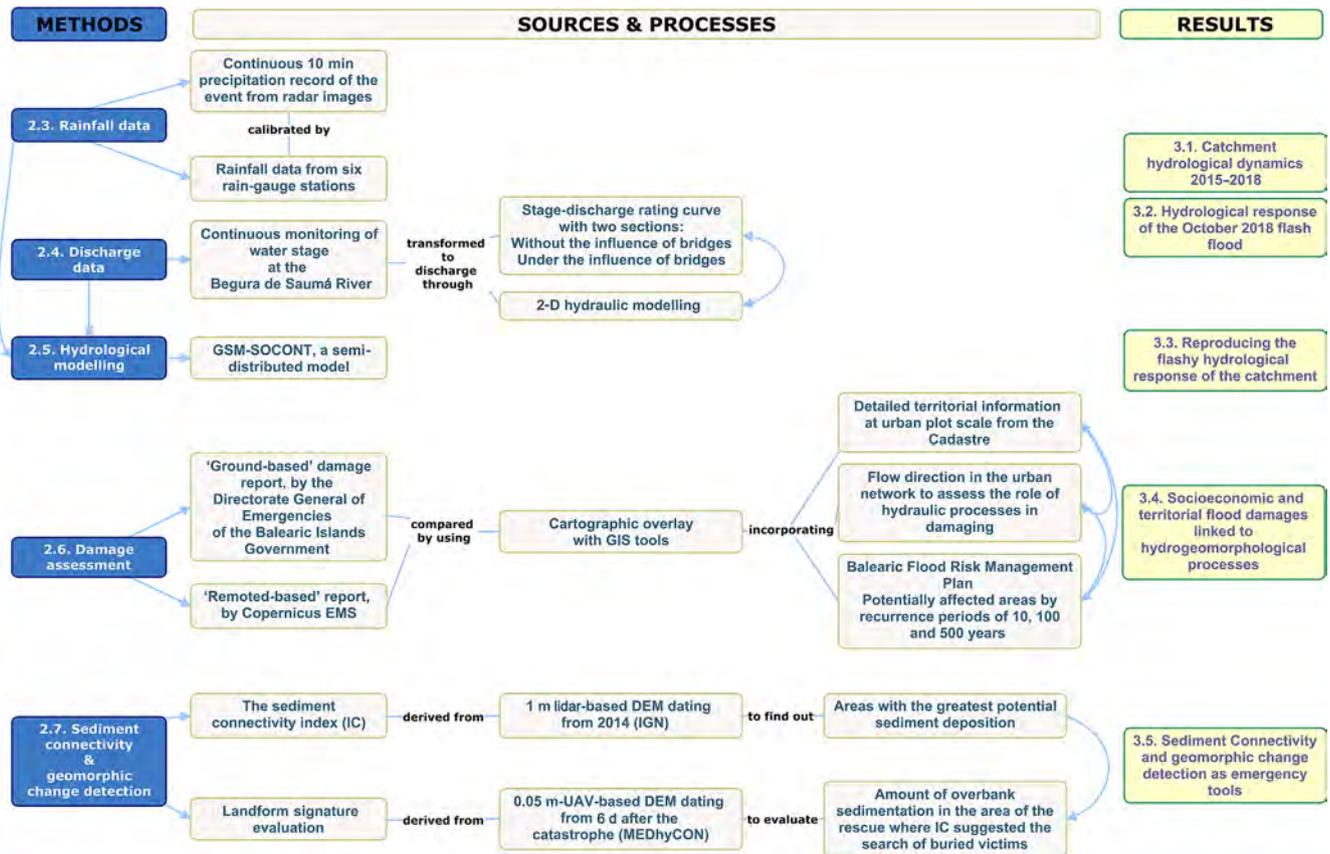
Figure 1. Workflow of the experimental design.

charge was developed through the analysis of the rainfall-runoff processes at a small spatial scale during this extreme event. Likewise, this analysis was linked to hydrological modelling to check the internal consistency of the information gathered by instruments and to flood damage and losses at the village of Sant Llorenç des Cardassar. Finally, HR-DTMs were generated by lidar 2014 data from the Spanish National Geographic Institute and by imagery captured through a low-cost UAV just 6 d after the catastrophe, to calculate a sediment connectivity index (IC) and measure geomorphic changes (Fig. 1).

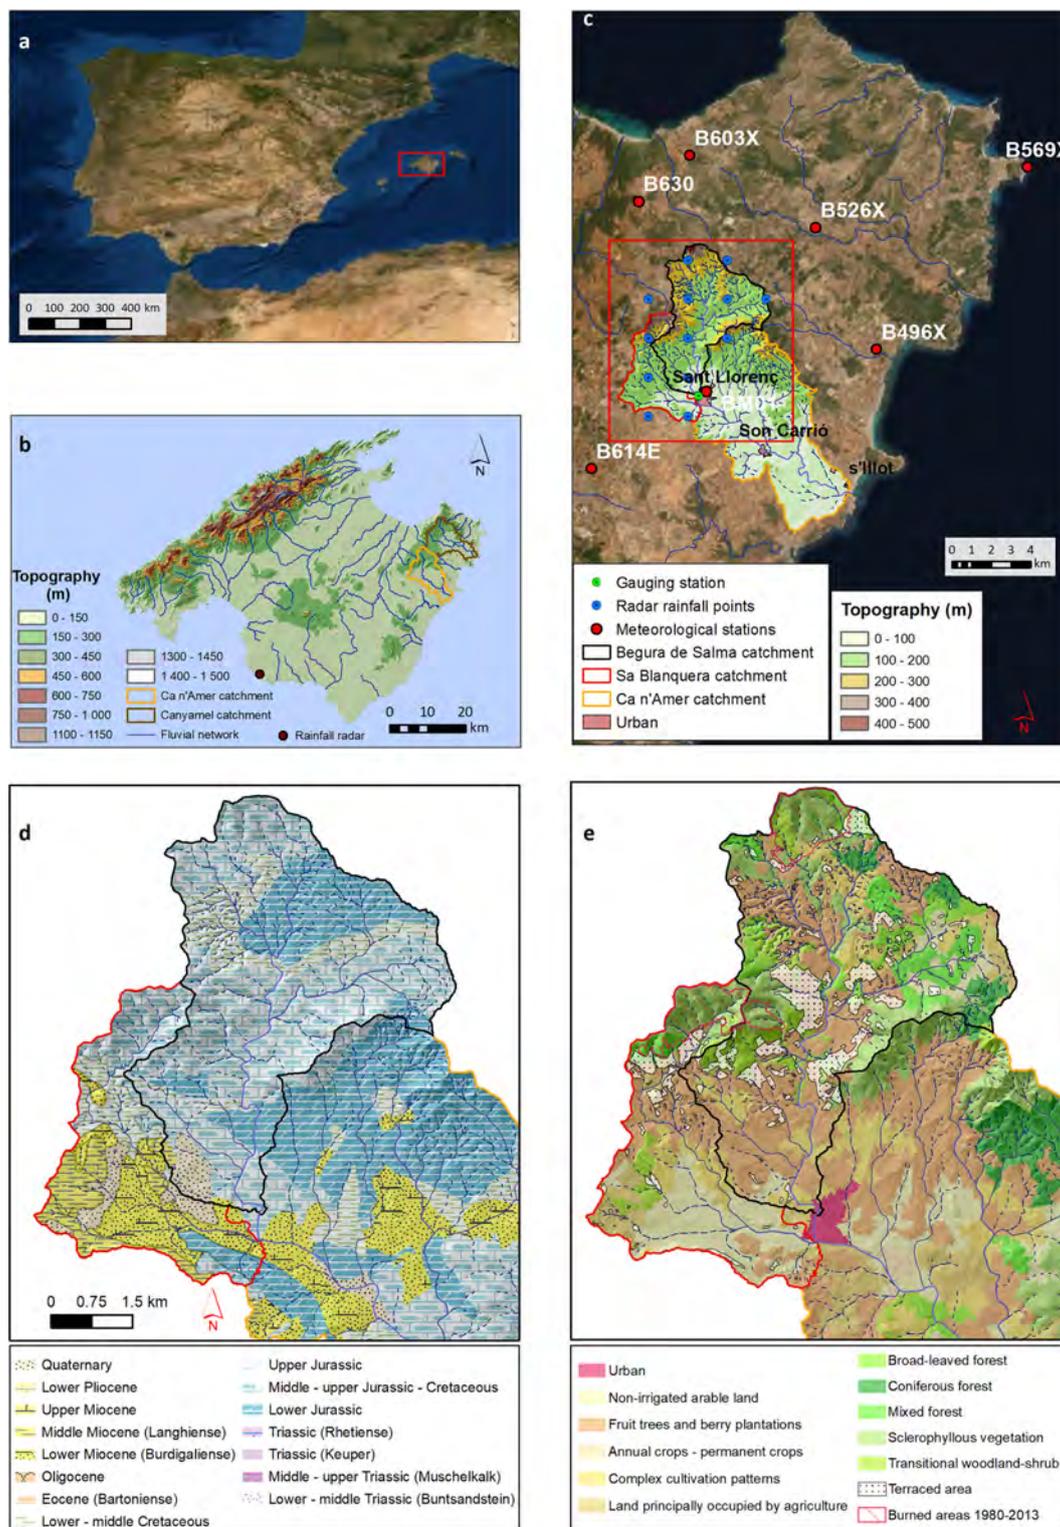
Figure 2. Main characteristics of affected basins during the 9 October 2018 flash flood. **(a)** Location of Mallorca in the western Mediterranean. **(b)** Topography and fluvial network of Mallorca with the location of the main basins affected: Canyamel and Ca n'Amer rivers. **(c)** Sa Blanquera and Begura de Salma headwater river catchments within the Ca n'Amer River, with locations of rainfall and hydrometric stations; and radar rainfall points derived from a regular mesh of 1×1 km. Source: <https://opendata.aemet.es> (last access: 15 May 2020). Background: aerial photography and DTM data (PNOA, 2015). **(d)** Lithology of both the Sa Blanquera and Begura de Salma catchments. **(e)** Land use and terraced areas for the same headwater catchments. Source: Corine Land Cover (2018).

mostly located in lowland areas. Forest (26 %) and scrubland (17 %) were predominant at headwaters. Terraced fields still occupied 10 % of the catchment, although most of them were abandoned (Fig. 2e). In 1956, natural vegetation covered 21 % of the catchment. This rose to 42 % in 2012 due to an afforestation process of former agricultural land in the second half of the 20th century. In combination with other factors, afforestation triggered a higher fire risk: two wildfires burned an area of 1.7 km²: 17 % in 1983 and 83 % in 2011 (Balearic Forestry and Soil Conservation Service; <http://xarxaforestal.caib.es>, last access: 15 May 2020; Fig. 2e). The climate of the area is classified as Mediterranean temperate sub-humid on the Emberger scale (Guijarro, 1986). Mean annual rainfall (1968–2018, B630 Spanish Meteorological Agency (AEMET) station; see Fig. 2c) is 652 mm yr⁻¹. A rainfall amount of 140 mm in 24 h was estimated to have a recurrence period of 25 years (YACU, 2003).

The 9 October storm affected the two northernmost catchments of Llevant county, i.e. the Ca n'Amer and Canyamel rivers (Fig. 2) with nine and four casualties, respectively, and significant damage. The synoptic situation was characteristic

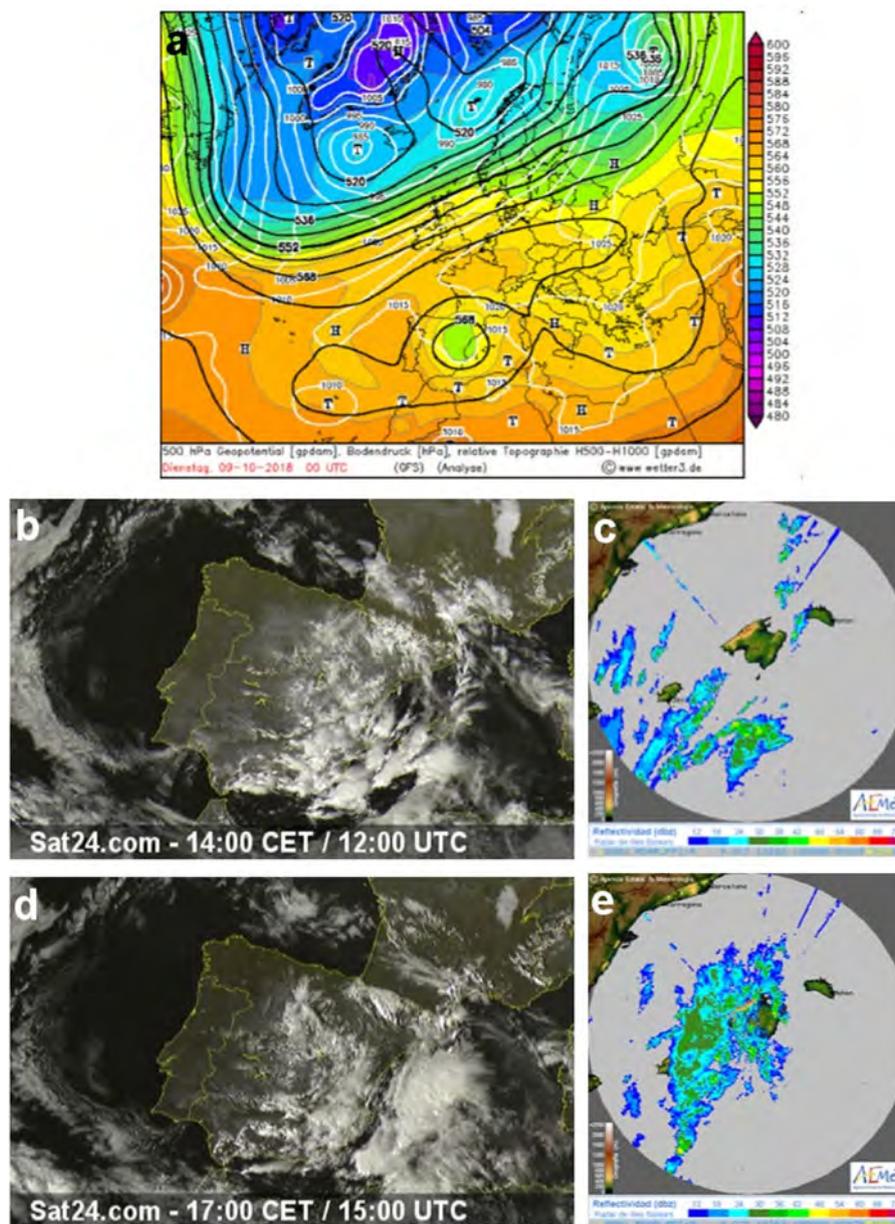
Figure 3. (a) Surface pressure and 500 hPa height analyses at 12:00 UTC on 9 October 2018 (source: <http://wetter3.de> (last access: 15 May 2020), i.e. at the beginning of the precipitation event. Satellite image at (b) 12:00 UTC and (d) 15:00 UTC (source: <http://www.sat24.com>, last access: 15 May 2020). EUMETSAT and radar images are shown for the same hours (c, e) (source: <http://www.aemet.es>, last access: 15 May 2020).

of flash-flood events in the Western Mediterranean (Fig. 3a). A cut-off low at midlevel was located in the eastern part of the Iberian Peninsula and shallow low-level pressure affected the same region, driving warm and wet air from the Mediterranean Sea to the Balearic Islands and the eastern part of the Iberian Peninsula. This occurred in early October, when the sea surface temperature is close to its annual maximum in the Western Mediterranean, providing high quantities of moisture. Moreover, the cut-off low showed a typical divergence at midlevel on its eastern flank, affecting the Balearic Islands and favouring the development of deep convection. Convection started on the sea between the Balearics and the Iberian Peninsula (Fig. 3b and c) and, due to SW winds at mid-tropospheric levels, the convective cells started to move towards the Balearics, where heavy rainfall triggered the flash-flood event (Fig. 3d and e).

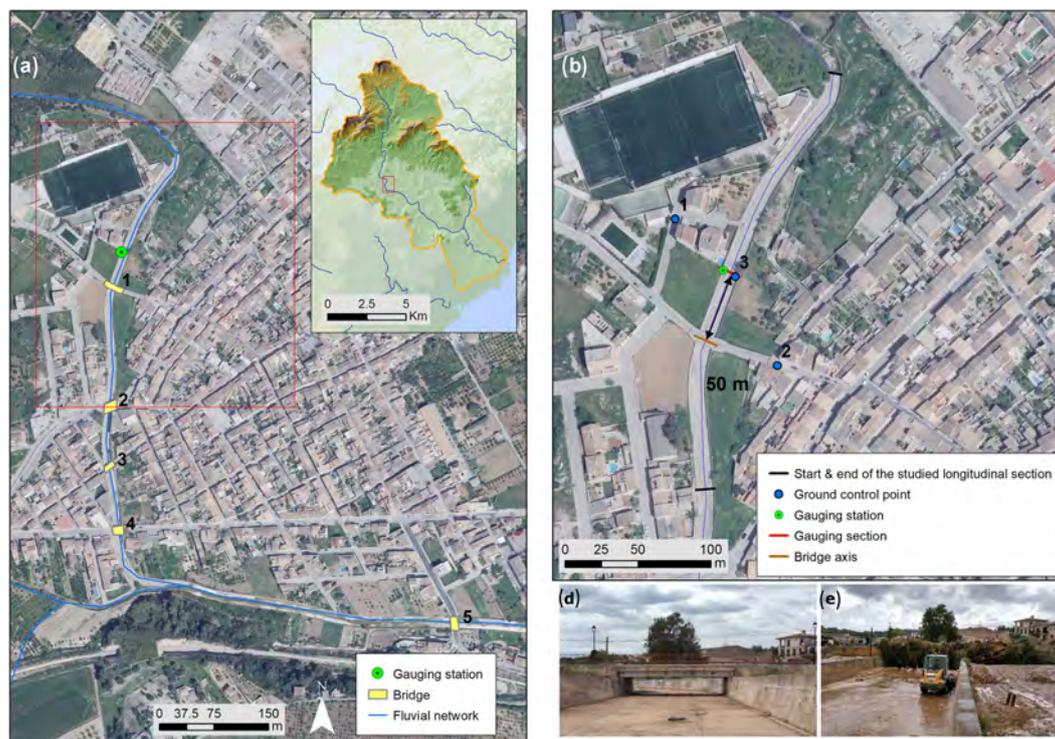
Figure 4. (a) Aerial view of the concrete channel of the Begura de Salma River that crosses the village of Sant Llorenç des Cardassar and the location of bridges. (b) Detailed aerial view of the very beginning of this concrete channel, where the hydrometric station is located. The photographs show a view of bridge 1 from the hydrometric station when (d) the digital equipment was installed on 10 June 2015 and (e) a few hours after the flash flood, on 10 October 2018. Background: aerial photography and DTM data (PNOA, 2015).

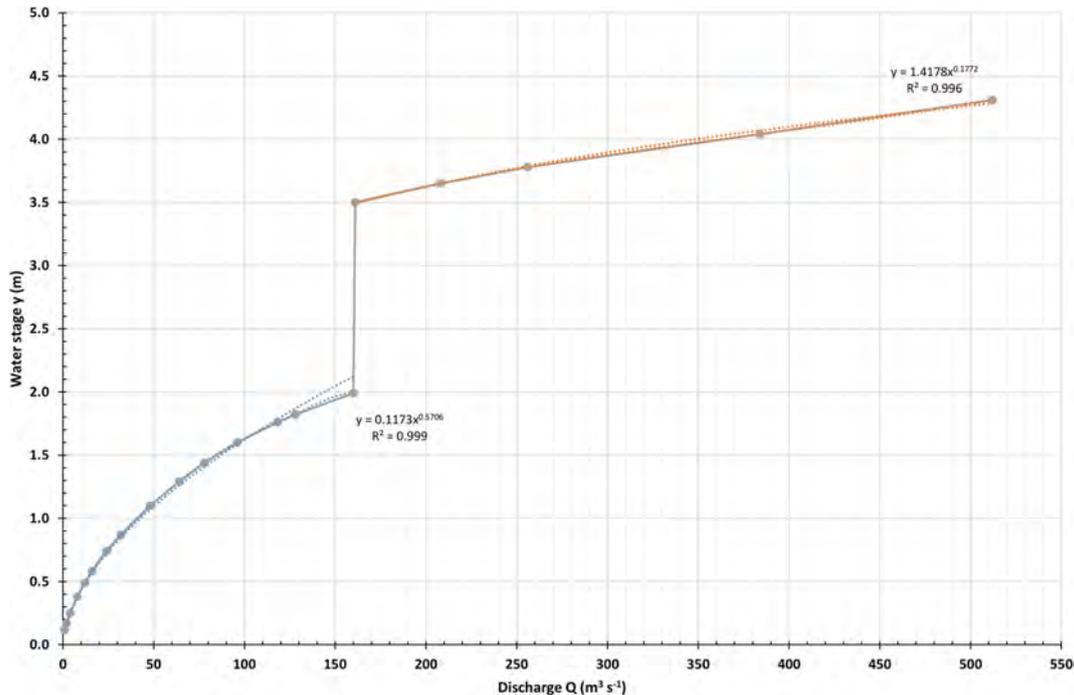
Figure 5. Stage–discharge rating curve performed by means of two-dimensional hydraulic modelling with two differentiated sections in accord with the influence of bridge 1 (see Fig. 3a) and its potential obstruction.

The SDRC was finally designed (see Fig. 5), showing clearly the two differentiated sections with a gap between them in WS of approximately 1.5 m because 1.4 m is the edge of road bridge 1 located just 50 m downstream from the hydrometric station. The SDRC is fitted to a power equation for both sections, obtaining high values of significance ($R^2 > 0.990$). Thus, in the case of the first section of the SDRC, the adjustment was R^2 of 0.999, operating in open-channel flows up to $160 \text{ m}^3 \text{ s}^{-1}$ in bankfull conditions or even overbanking the channel but always without the bridges' influence. The second section, with a R^2 of 0.996, defined for $Q > 160 \text{ m}^3 \text{ s}^{-1}$, was already influenced by the presence of the bridges, i.e. in open-channel flows but conditioned by the backwater generated in the flow under pressure inside the span of bridge 1 as well as over its concrete decks.

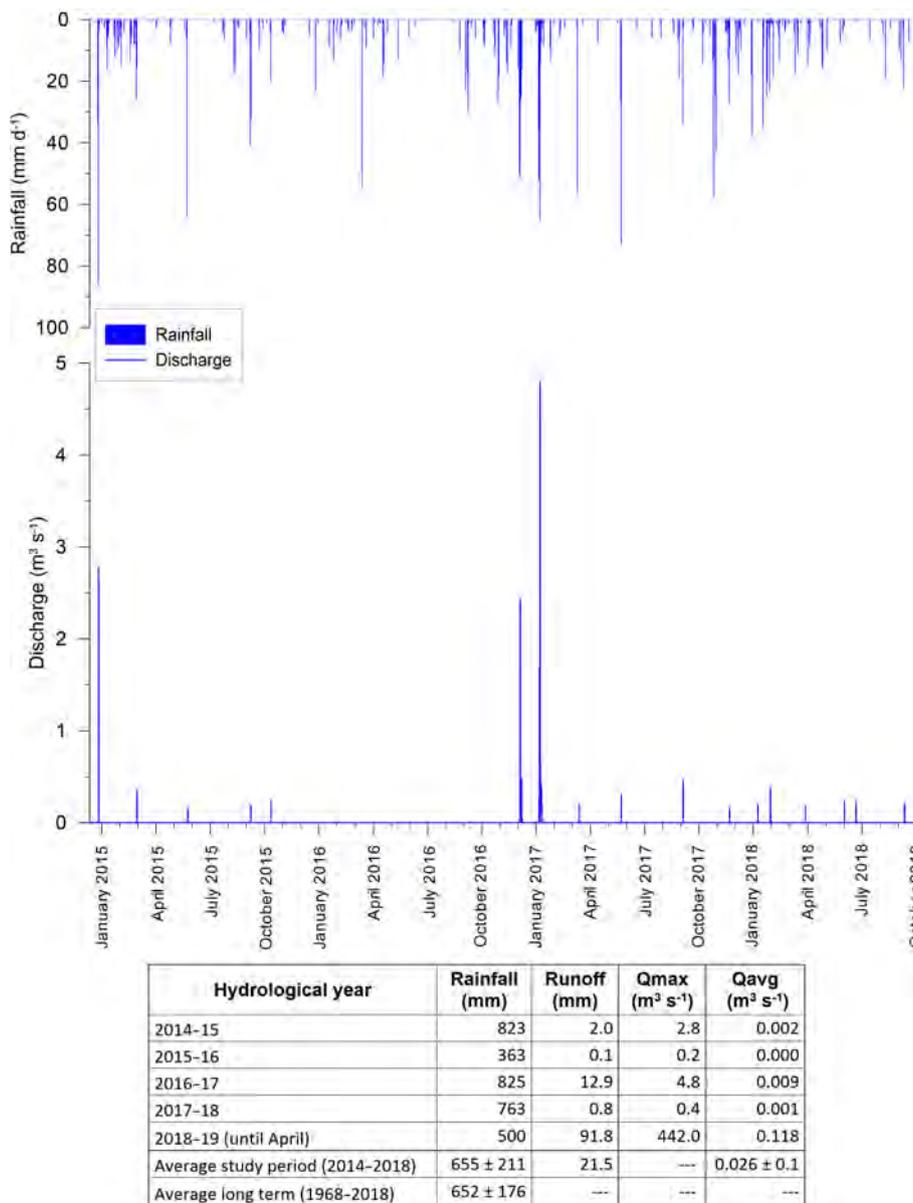
Figure 6. Discharge at 15 min intervals measured at the MEDhyCON hydrometric station located at the beginning of the concrete channel of the Begura de Salma River in Sant Llorenç des Cardassar. Likewise, the daily rainfall measured at the AEMET-B630 Ses Pastores during the monitored period (10 January 2015–30 September 2018), prior to the catastrophic flash flood of 9 October 2018, is shown. The bottom table displays the rainfall, runoff and peak discharge for hydrological years during study period. Rainfall data are from AEMET-B630 Ses Pastores, located 10.5 km from the Begura de Salma River catchment outlet and representative of the rainfall dynamics of the Llevant range’s headwaters.

The hydrological monitoring period assessed in this paper by using data from the hydrometric station was from 10 January 2015 to 30 September 2018 (Fig. 6). The month of October 2018 was reserved for a singular and deeper study that could describe the catastrophic flash-flood event better (see results, Sect. 3.2). This gives a series of almost 4 hydrological years under hydrometeorological conditions illustrating ephemeral behaviour of the Begura de Salma River that was average in terms of precipitation (see the inset table, Fig. 6). In terms of Q , this inset table also shows the behaviour during the study period of several hydrological parameters. However, these values cannot be compared in the long term due to errors of up to 2 orders of magnitude in Q values measured by the hydrometric network managed by the Balearic Islands Government (see Fortesa et al., 2019). Events of different magnitudes occurred during this study period, some of them representative of recurrence ≈ 5 years in terms of rainfall. However, only two events recorded peak Q (hereafter Q_{peak}) values $> 1 \text{ m}^3 \text{ s}^{-1}$, both occurring in January, when the hydrological pathways were fully active due to saturation processes. In January 2015, 120 mm of rainfall in 48 h at the AEMET-B630 Ses Pastores rainfall station (see location in Fig. 2) created a flow response with a Q_{peak} of $2.8 \text{ m}^3 \text{ s}^{-1}$. Finally, in January 2017, 153 mm of rain fell in 72 h with a Q_{peak} of $4.8 \text{ m}^3 \text{ s}^{-1}$, the maximum recorded at the hydrometric station during the study period before the catastrophic flash flood.

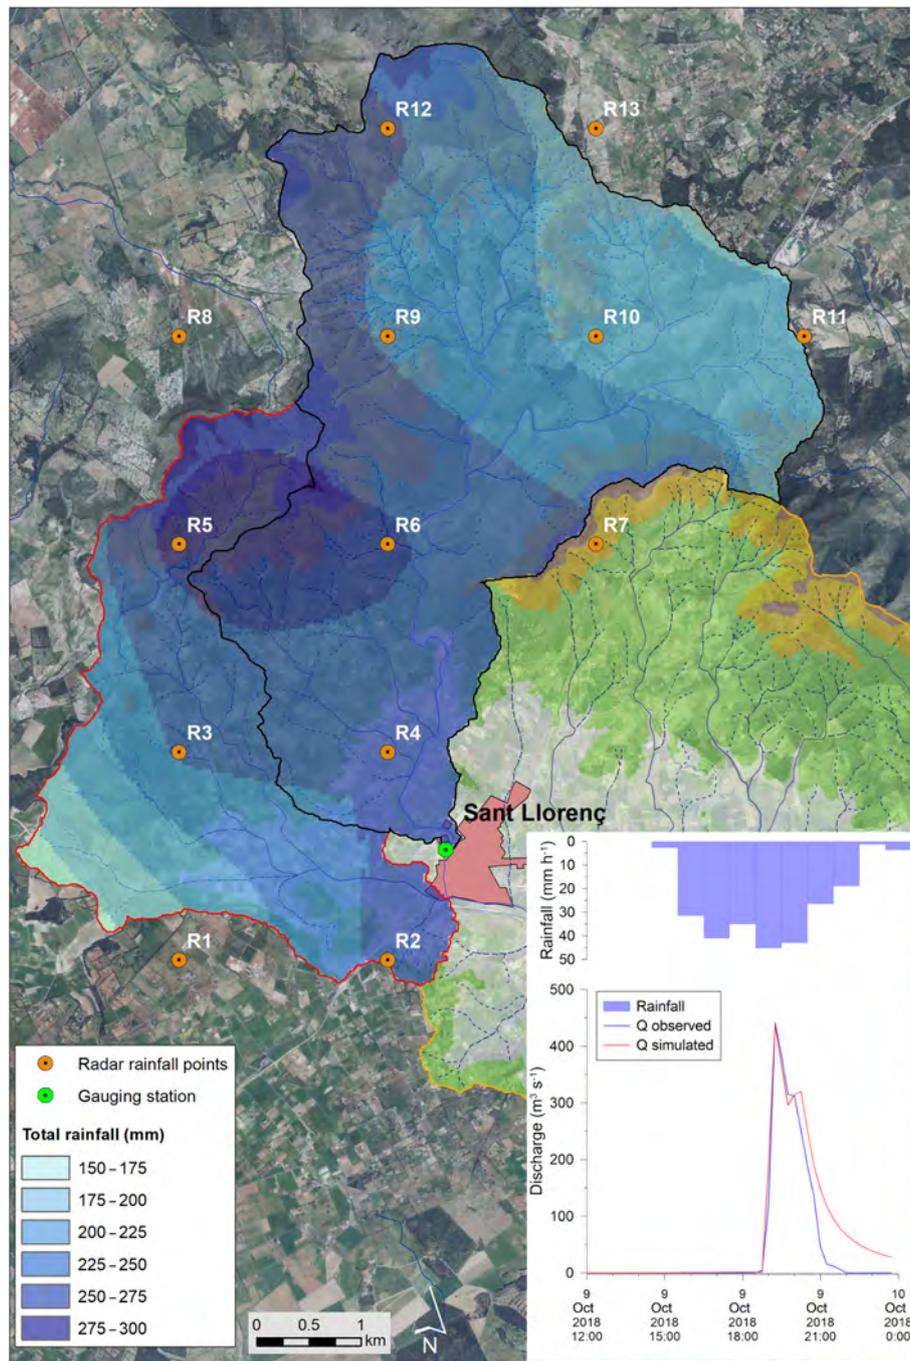
Figure 7. Map of isohyets of the rain storm of 9 October 2018 in the two headwater catchments of the Ca n' Amer River, i.e. the Sa Blanquera River and Begura de Salma River. Source: 10 min radar images obtained from the web <https://opendata.aemet.es/> (last access: 15 May 2020). The inset figure shows the discharge measured at the MEDhyCON hydrometric station, as well as the result of the rainfall–runoff simulation using a modified version of the GR3 model. Background: aerial photography and DTM data (PNOA, 2015).

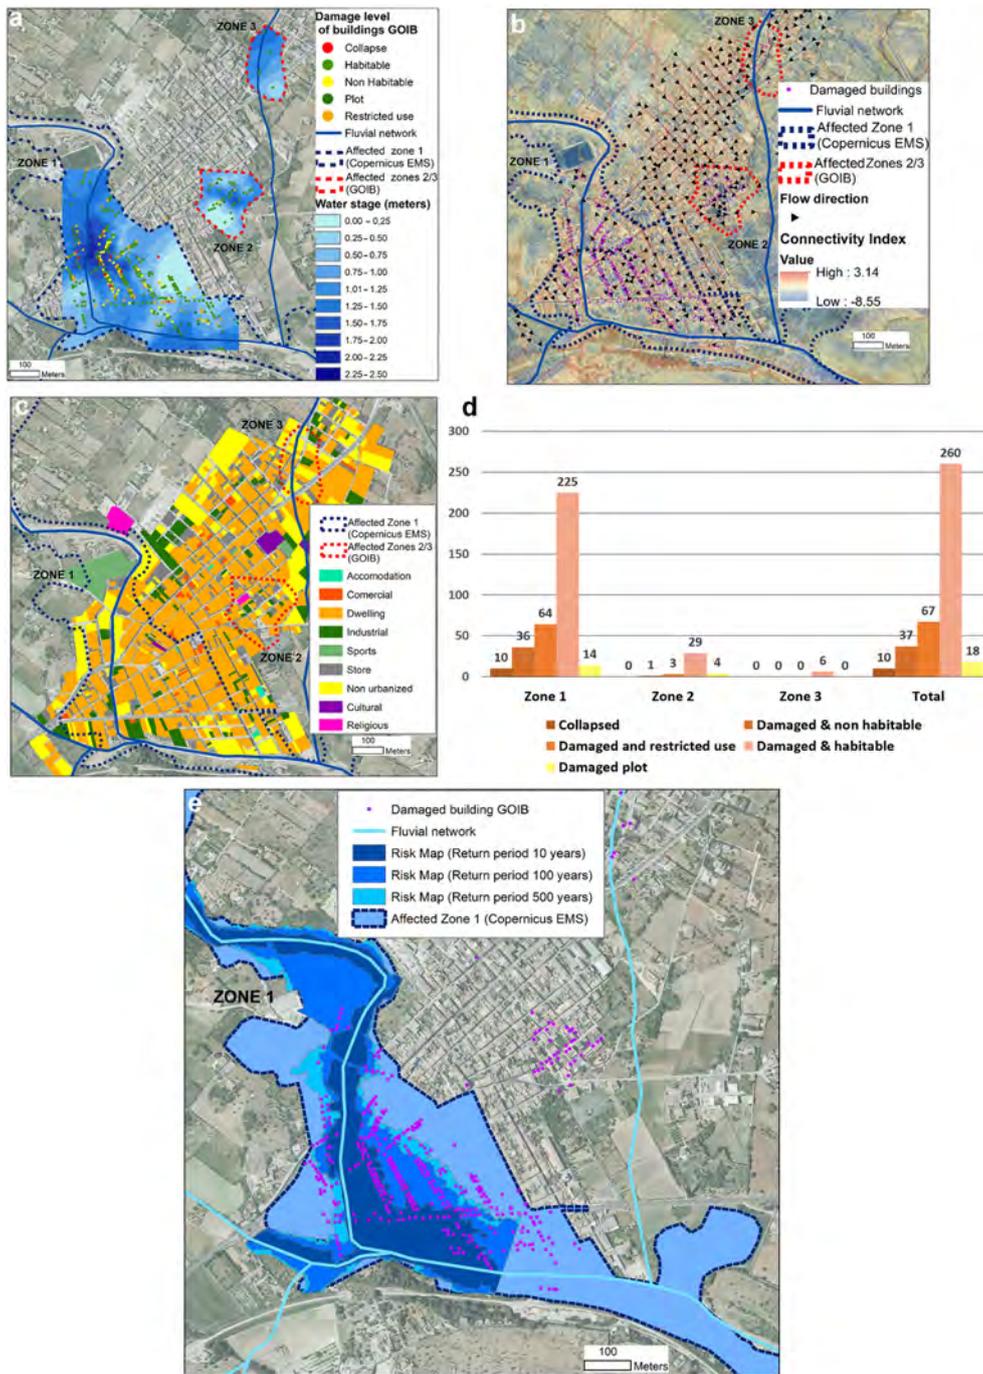
Figure 8. (a) Map of the damage level classification of buildings and water stage reached in the different affected zones at Sant Llorenç des Cardassar according to the Balearic Islands Autonomous Government, in comparison to the flood delimitation by Copernicus EMS. Flow direction and hydrological connectivity in the affected zones (b) (1, 2 and 3) in the Sant Llorenç des Cardassar urban network. (c) Economic activities by building in the urban area of Sant Llorenç des Cardassar and the delimitation of affected zones by the flash flood. (d) Damage level classification of buildings in the different affected zones in Sant Llorenç des Cardassar. (e) Official flood risk maps and flood delimitation by Copernicus EMS in the village of Sant Llorenç des Cardassar with the location of buildings affected by the flash flood of 9 October 2018. Background: aerial photography (PNOA, 2015). In Fig. 7d, the source of land use at the urban plot scale is the General Directorate for the Cadastre (<http://www.sedecatastro.gob.es/>, last access: 15 May 2020).

A territorial and hydrological analysis of the damage assessment is developed here. The location of the affected buildings and the WS reached in the streets and buildings provided by the emergencies department of the Balearic Islands Government and by the Copernicus EMS enabled three affected zones within the urban area of Sant Llorenç des Cardassar to be mapped (Fig. 8a). Zone 1 was due to the overbank flow of the Begura de Salma River and corresponded mostly to the affected areas defined by the Copernicus EMS. In this zone (1), the highest WS in the streets was reached, exceeding 3.3 m. Zones 2 and 3 were those urban areas affected by the overbank flow of the Sa Muntanyeta creek, located in the northernmost area of the village. The streets of Sant Llorenç des Cardassar rerouted the overbank flow from both the Begura de Salma River and the Sa Muntanyeta creek (Fig. 8b), causing significant damages to vehicles and movable public property. In addition, as most of the buildings in Sant Llorenç des Cardassar use the ground floor as a home or business, the event caused major flooding by water and mud that made their use impossible and required cleaning and restoration. According to the Balearic Islands Government, 392 damaged buildings and plots were inventoried in the urban area of Sant Llorenç des Cardassar, most of them in zone 1 (Fig. 8c and 8d). The flow direction illustrated how the north-to-south direction, parallel to the Begura de Salma River, caused most damage in zone 1, with 349 affected buildings and a WS average of approximately 1.03 m. Zones 2 and 3 had lower-intensity damage, with 37 and 6 affected buildings and a maximum WS of 1.80 m and 1.60 m, respectively. In these zones (2 and 3), the flow direction had no clear pattern because the Sa Muntanyeta creek has a small catchment (2.2 km²) and the urban street network and plots are not parallel to its natural flow direction.

aged buildings were found (Fig. 7f) in zones 2 and 3. It is worth noting that the post-event definition of the Copernicus EMS (Copernicus Emergency Management Service, 2018) covered approximately 90 % of the real damage.

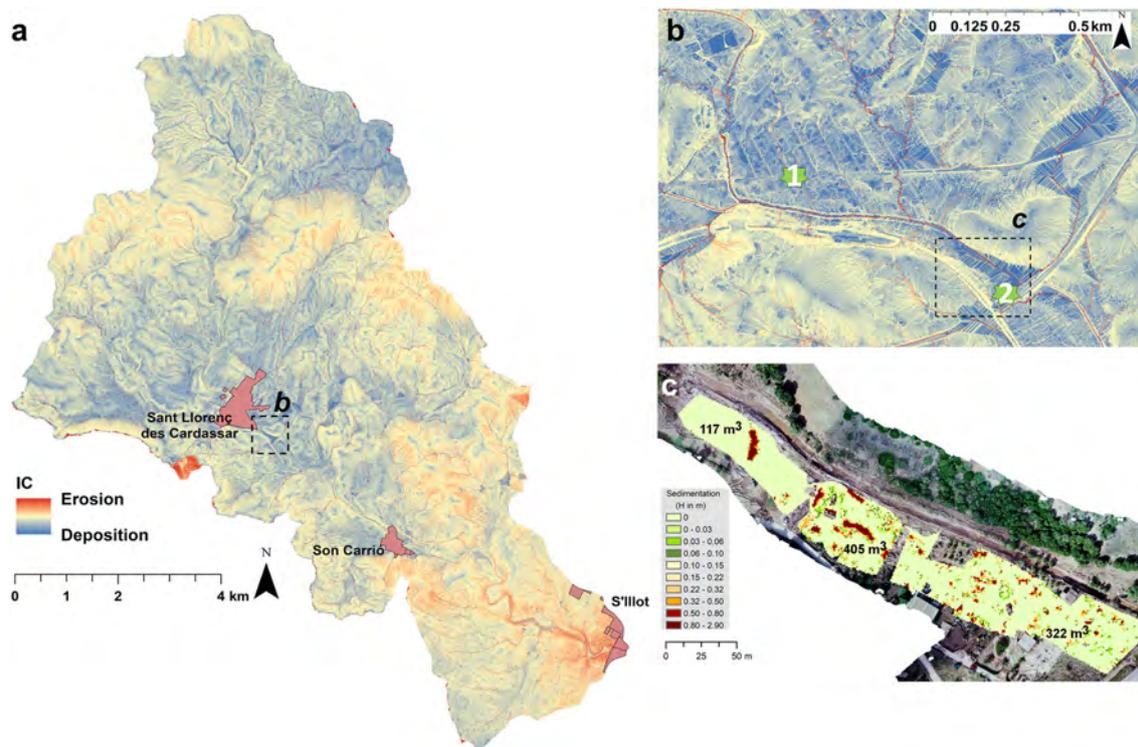
Figure 9. Spatial patterns of hydrological and sediment connectivity (deposition zones in blue colours) (a) in the Ca n' Amer River basin, (b) in the southeastern part of Sant Llorenç des Cardassar with numbers indicating (1) the point where the missing person was last seen and (2) where this person was found by using this connectivity index from a 2 m resolution digital terrain model (DTM) (Instituto Geográfico Nacional, 2014). (c) Overbank sedimentation estimated after the flash flood from a DTM performed with SfM from a UAV flight (15 October 2018) in relation to the ground points of the 2014 lidar data. Background aerial orthophotography of approximately 2 cm resolution also obtained from the drone images. Numbers indicate the total volume of deposited sediments in the three areas measured.
