1 RC columns strengthened by steel caging: cyclic 2 loading tests on beam-column joints with non-ductile 3 details

11 **Abstract**

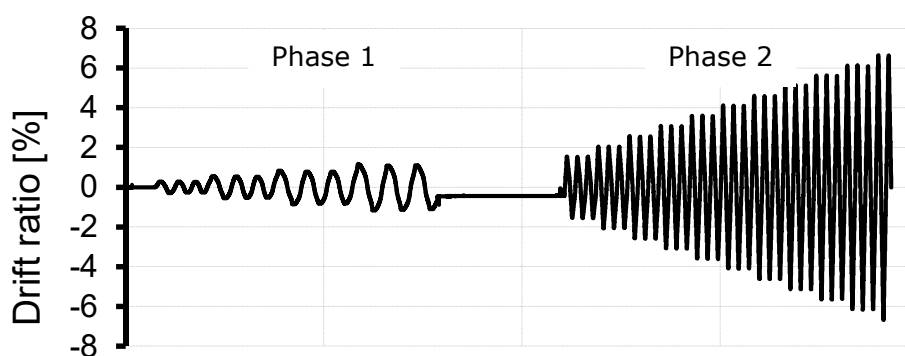
218 Each cycle was repeated 3 times to detect whether or not degradation
219 increased with each repetition, as in [56,57]. In the first phase, the loading
220 rate was 0.33 kN/s at opposite beam ends until drift ratio values of 0.25%,
221 0.50% 0.75% and 1.00% were obtained. In the second phase, control was
222 achieved by imposing displacement with a 120-second period per cycle and
223 with a raising drift ratio of 0.50% until specimen failure occurred (Figure 6).

Figure 6. Load cycles (drift ratio & time).

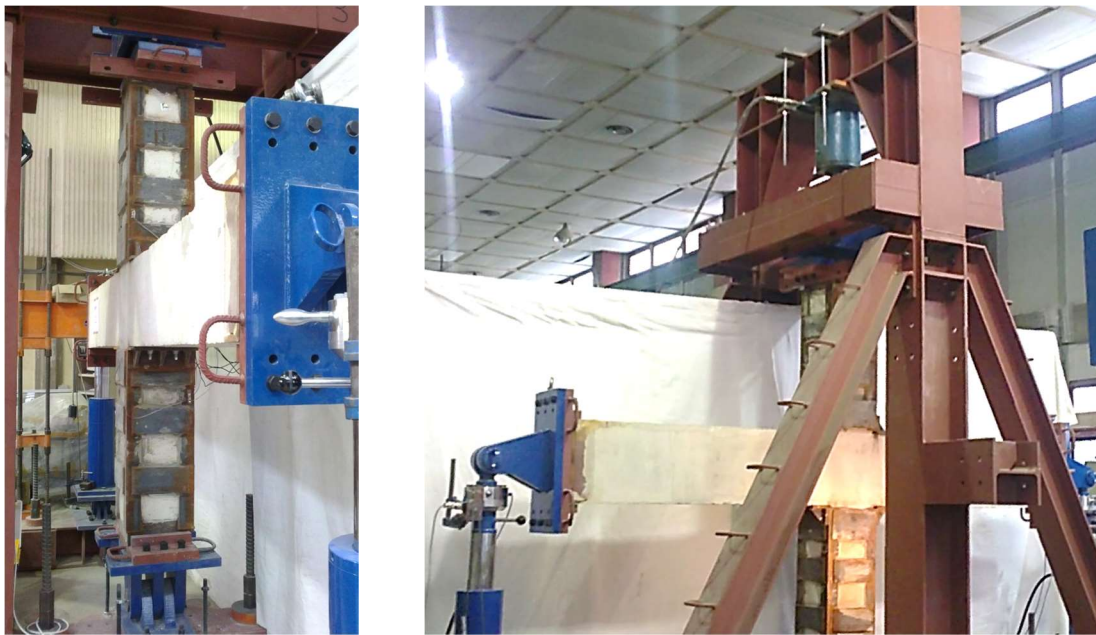
224 All the test frame/specimen connections were hinged to rotate freely on the
225 test plane. Figure 7 depicts a specimen ready for testing. Axial load was
226 applied to the column by a 1000 kN hydraulic actuator. As the specimen
227 was connected to the test frame at the point where the axial load was

231 *Figure 7. Specimen in the test frame ready for testing.*

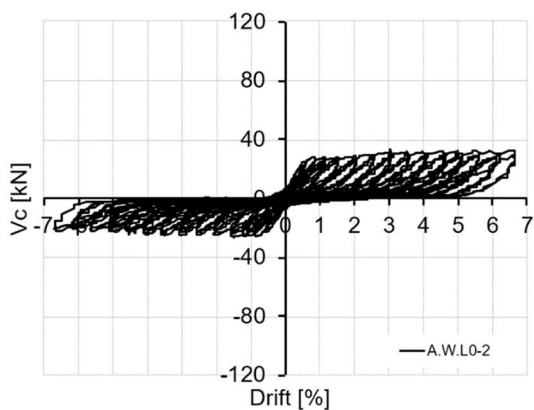
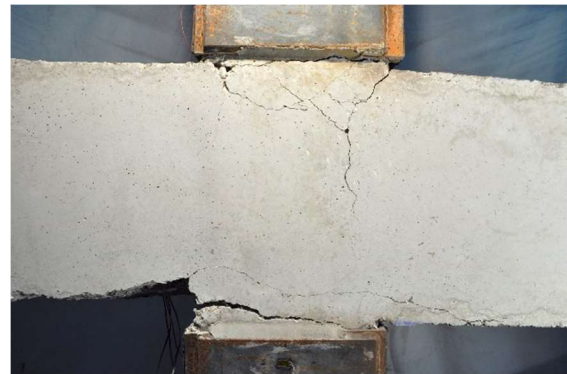
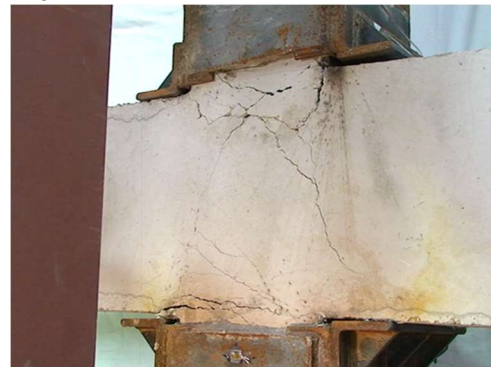
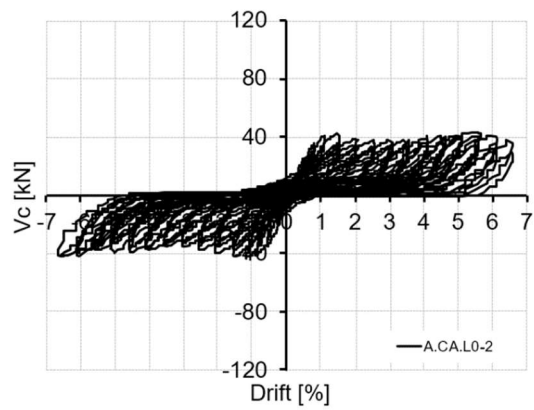
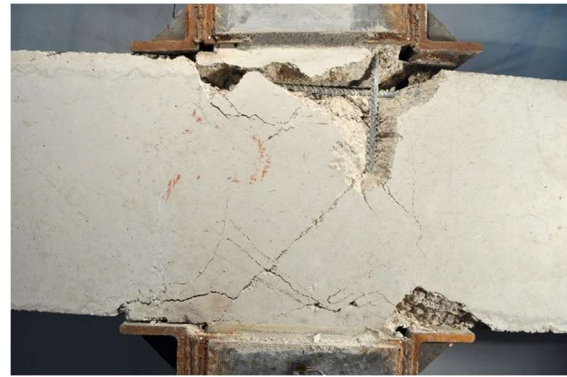
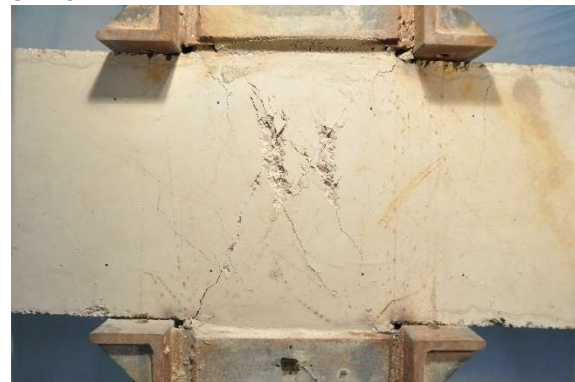
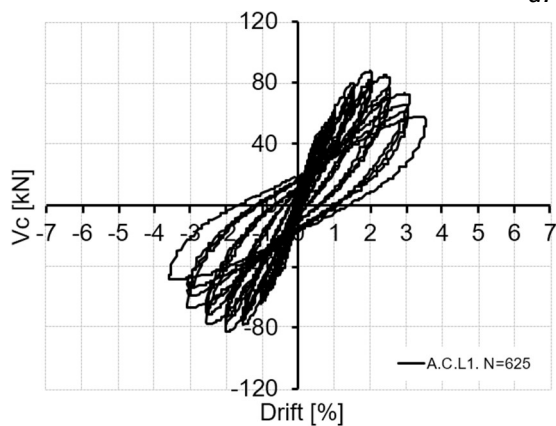
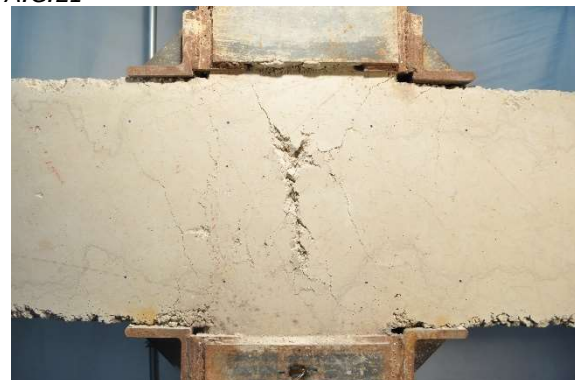
270 Figure 10 shows two different types of cracking: bending cracks where the
271 column meets the joint, negative (hogging) bending moment cracks in
272 beams, positive (sagging) bending moment cracks in beams, and shear and
273 compression cracks in the joint.

274 The effects of axial loads on columns can be seen in the graphs in the form
275 of hysteresis loops. With no gravity loads on the column, marked pinching
276 appeared (Figure 10a, Figure 10b and Figure 10c). Degradation occurred
277 when the concrete lost part of its compressive strength in the beam and
278 column segments due to joint shear deformation [59], plus loss of
279 reinforcement adherence. The hysteresis loops obtained in the tests with
280 the applied axial loads to columns clearly differed (Figure 10d and 10e).

Figure 10. Left: column shear load vs. drift ratio. Right: joint view at the 3.5% drift ratio in the specimens with no axial loads on the column (L0), and a 2.5% drift ratio in those with axial load (L1).

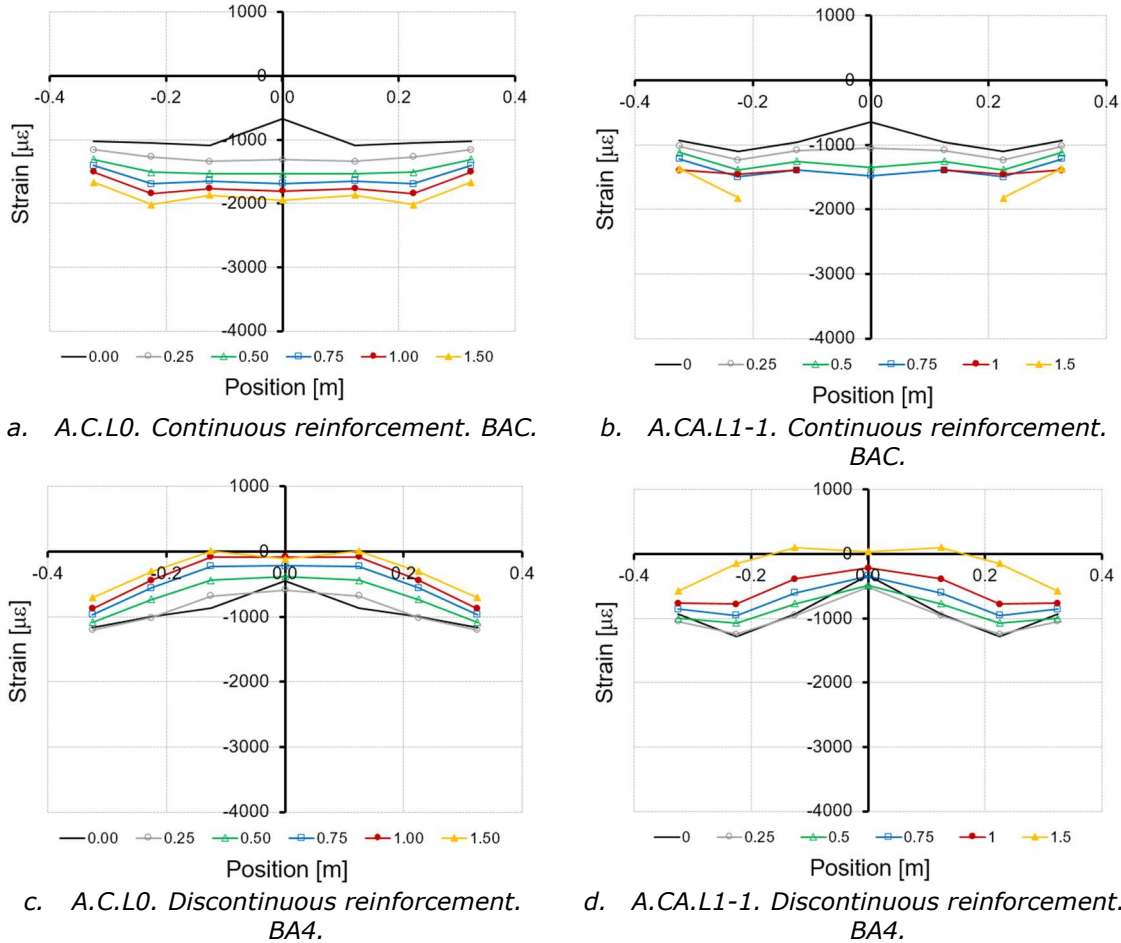
369 Figure 15 illustrates the upper strain in *BAC* and *BA4* in tests *A.C.L0* and
 370 *A.CA.L1-1*. The X-axis represents the distance in metres from the
 371 measurement point to the column axis (Figure 8); the Y-axis represents the
 372 strain recorded by the strain gauge under gravity loads only (Figure 5a), i.e.
 373 after three load cycles at each drift ratio (Figure 5b, Figure 6). The following
 374 reinforcement behaviour patterns were noted:

- 375 - When gravity load was applied to beams, the reinforcement strain at
 376 the mid-point of the joint was less than at the points where the beam
 377 entered the joint.
- 378 - After the first three cycles at the 0.25% drift ratio, the strains at all
 379 points into the joint (*Pos -1*, *Pos 0* and *Pos 1*) in the *BAC*
 380 reinforcement were equal, which indicates loss of adherence to the
 381 joint concrete and that reinforcement acted as a tie.

- 382 - Strain in the BA4 reinforcements gradually decreased after each cycle
 383 until a zero strain, which indicates complete loss of overlap.
 384 - [Figure 15d](#) shows that the axial load on the column favoured the
 385 overlap effectiveness of discontinuous reinforcements.

Figure 15. Strain of all the drift ratio values of the upper reinforcement in the beams of specimens A.C.L0 (left) and A.CA.L1-1 (right). Gravity load.

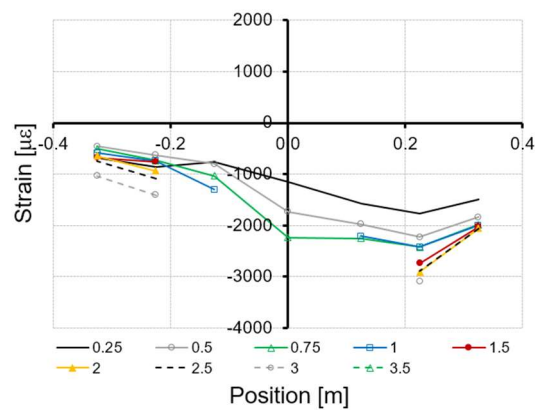
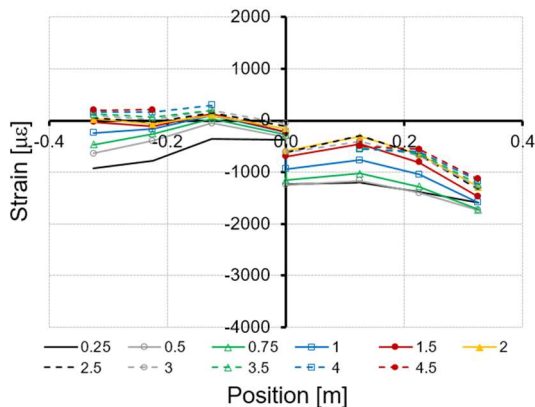
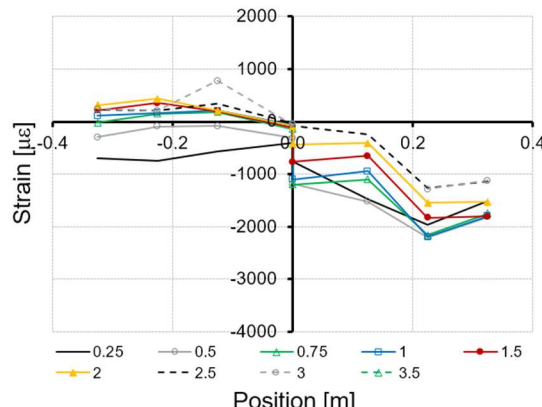
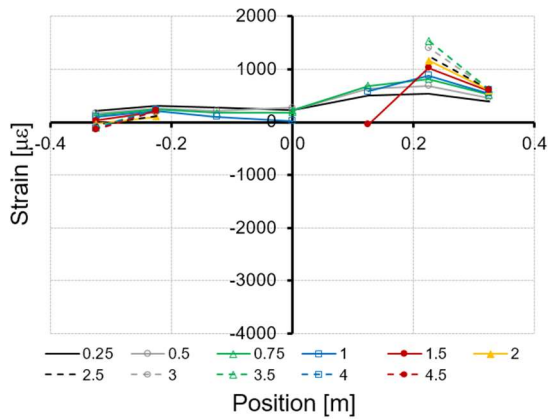
- 391 - In [Figure 16a](#), the tensile strain in the BAC upper reinforcement was
 392 constant up to approximately the column axis, after which it
 393 gradually declined due to adherence. It should be noted that this
 394 reinforcement was anchored to the other side of the joint, where
 395 concrete was compressed due to inverse beam moments ([Figure](#)
 396 [12b](#)). In the specimen with the axial load (A.CA.L1-1), the BAC

- reinforcement anchorage was seen to start at the point where it entered the joint zone (Figure 16b).
- Although the continuity of tensile loads was not possible in discontinuous reinforcements BA4 (Figure 15c and Figure 15d), certain reinforcement anchorage capacity was noted when the horizontal loads were applied (Figure 16c). The transmission of tangential stress between reinforcement and concrete in the joint was once again favoured by applying the axial load to the column (Figure 16d).

- Lower beam reinforcement BA1 remained under compression strain at all the recording points in specimen A.C.L0 (Figure 16e). The reinforcement compression strain can be seen on the right of the graph due to the negative bending moment, while there is no tensile strain on the left in spite of the reversed direction of loads. However, the lower reinforcement had greater anchorage capacity in the specimen with an axial load on the column (Figure 16f), thanks to which beams were able to reverse bending moments (Figure 12b).

Figure 16. Strain for all the drift ratio values in the beam reinforcement of specimens A.C.L0 (left) and A.CA.L1-1 (right). Gravity plus horizontal loads.

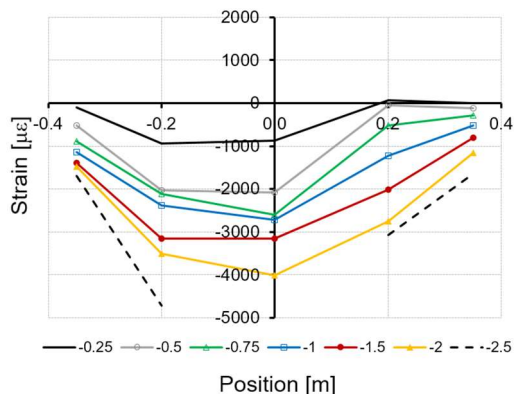
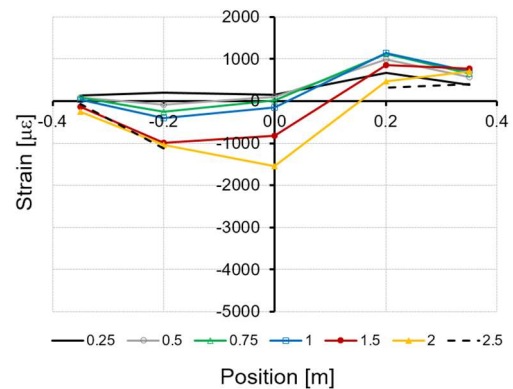
414 Figure 17 gives the unitary column reinforcement strain of specimens
 415 A.C.L0 (without axial load) and A.C.L1 (with axial load). The X-axis
 416 represents the distance in metres between the strain gauge and the beam
 417 axis. Column reinforcements behaved similarly to the continuous beam
 418 reinforcements (Figure 16a), but with some considerable differences:

- 419 - Max reinforcement strain took place in the column/beam intersection
 420 and continued as far as the beam axis, the point at which tensile
 421 strain declined.
- 422 - The tensile strain of reinforcement considerably reduced in the
 423 sections where column reinforcement was confined by external
 424 strengthening.
- 425 - The column reinforcement strain substantially reduced when the
 426 column was subject to an axial load. The tensile strains at the 1.5%
 427 drift ratio were 3,000 $\mu\epsilon$ and 900 $\mu\epsilon$ for tests A.C.L0 and A.C.L1,
 428 respectively.

Figure 17. Strain for the drift ratio values in the column reinforcement of specimens A.C.L0 (left) and A.C.L1 (right). Gravity plus horizontal loads.

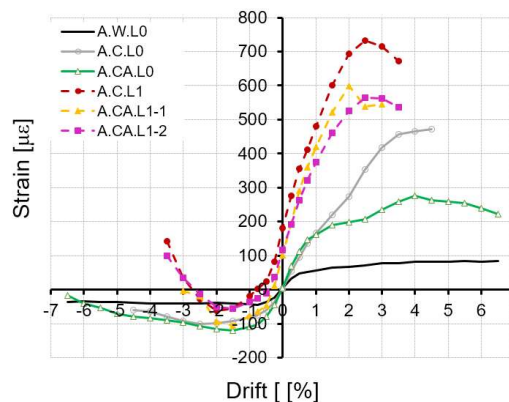
- 433 - The angles on the control specimen (*A.W.L0*) were required to work
434 the least for not having capitals. So the tensile and compression
435 loads that they received were due to friction with the column.
- 436 - Capitals allowed compression loads to be transmitted directly
437 between the beam and strengthening (*A.C.L0*).
- 438 - The compression strain of angles was the least in the specimen with
439 chemical anchors and capitals with no axial load (*A.CA.L0*). The
440 authors consider that this was due to the degradation of the concrete
441 that came into contact with the capital caused by chemical anchors
442 being pulled out.
- 443 - Small tensile strains were measured because angles were not
444 connected to the joint.

Figure 18. Strain of steel angles.

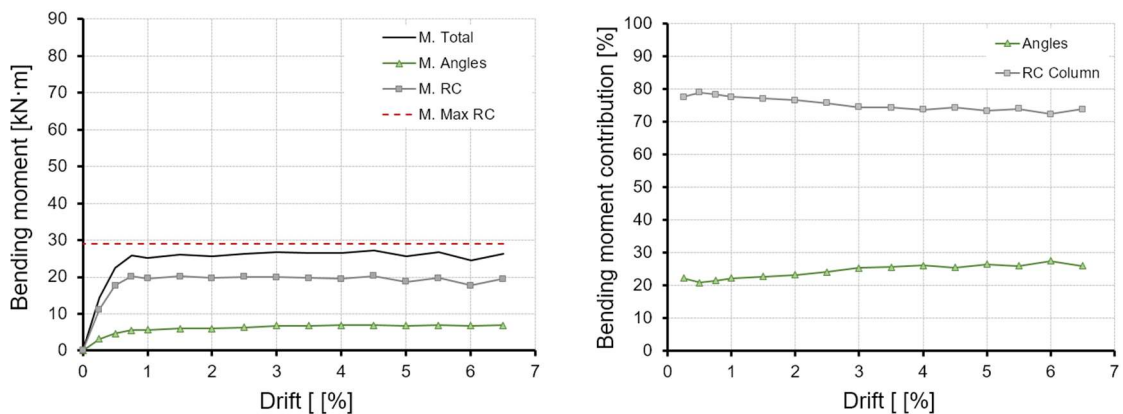
461 The bending capacity of the reinforced concrete column ($M.MaxRC$) was
 462 obtained experimentally from the test run on the control specimen by
 463 multiplying the maximum shear load obtained (Figure 10a, Table 2) by the
 464 distance to the column/joint intersection, where longitudinal reinforcement
 465 yielding occurred. This bending capacity of the reinforced concrete column
 466 can be found in Figure 19a and Figure 19b, denoted by a dashed red line.

467 In the control specimen, the percentage contribution of angles ranged
 468 between 21% and 28% (Figure 19a). This was the lowest percentage as the
 469 contribution was obtained solely via the contact of materials in a short
 470 length (220 mm). Including the capital increased the column's max bending
 471 moment, in which angles contributed 38% at the beginning of the test and
 472 amounted to 68% when it ended (Figure 19b). In specimen $A.C.L1$, the
 473 bending strength was shared almost equally between angles and the
 474 reinforced concrete section (Figure 19c).

Figure 19. Behaviour of the composite column section subject to the bending moment (A.W.L0, A.C.L0) and flexocompression (A.C.L1). On the left, the bending moment resisted by the reinforced concrete section and angles. On the right, the percentage contribution of both elements to bending moment strength.
