Bertolesi, E.; Buitrago, M.; Adam, JM.; Calderón García, PA. (2021). Fatigue assessment of steel riveted railway bridges: Full-scale tests and analytical approach. *Journal of Constructional Steel Research*. 182:1-16. <https://doi.org/10.1016/j.jcsr.2021.106664>

# Fatigue Assessment of Steel Riveted Railway Bridges: Full-Scale Tests and Analytical Approach.

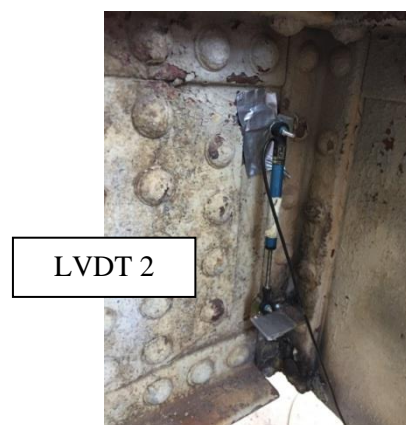
**Figure 4:** Position of the sensors: strain gauges and Linear variable Displacement Transducers.

182 The fatigue behaviour of the riveted element was monitored by four strain gauges (SG) and two  
 183 Linear Variable Displacement Transducers (LVDT). **Figure 4** shows the sensor network, while  
 184 **Table 4** gives their positions. Fatigue cracks can be initiated by abrupt local changes in the cross  
 185 section, such as by the presence of an additional steel plate anchored to the beam bottom  
 186 flanges (see **Figure 3**). One LVDT was positioned below the tested element to monitor vertical  
 187 deflections and another to evaluate possible relative movements between rivet head and the  
 188 lateral profile indicating a possible weak point of the cross beam.

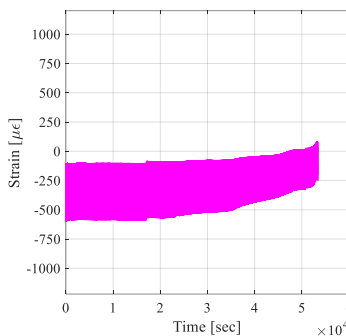
**Figure 5: Fatigue test result envelopes: strain gauge SG 1 (-a), SG 2 (-b), SG 3 (-c), SG 4 (-d) (negative strains mean traction) and LVDT1 (-e), LVDT2 (-f).**

212        increase of the strain increments than the others (see **Figure 5 -d**). As expected, the SG sensors  
213        were all able to warn of the changes in the cross beam's behaviour. Those close to the cracks

214 (i.e. SG 1, 2 and 3) clearly detected the formation and propagation of cracks at an early stage,  
215 while SG 4 was the worst at replicating the spread of the structural failure **(see Figure 5 -a-b-c**  
216 **and -d).**

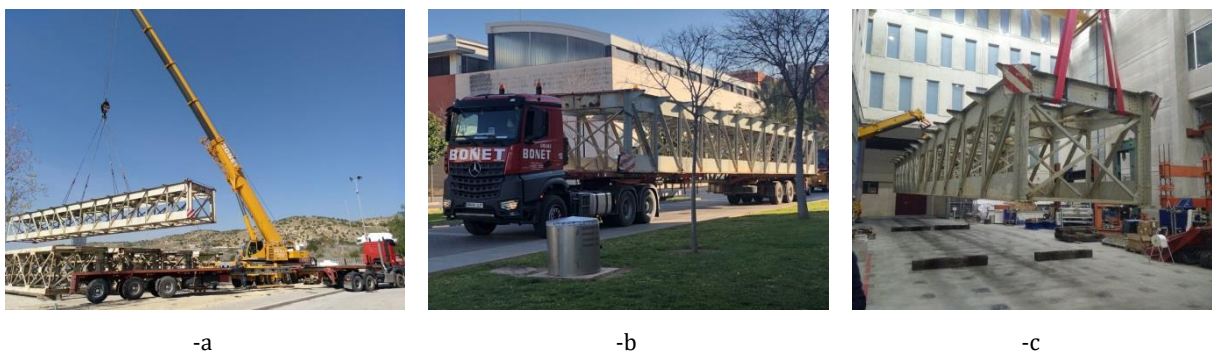
**Figure 8:** Movement phases: taking from storage area (-a), movement (-b) and laboratory placement (-c).

258 A 21 m long isostatic span from the Ferrandet Bridge was moved to the ICITECH laboratories at  
259 the *Universitat Politècnica de València* (Spain) (see **Figure 8**). In the laboratory, the bridge was  
260 positioned on two hinged and two simple supports (see **Figure 9**). A cyclic load was then  
261 applied ranging from 50 to 1300 kN at a frequency of 0.2 Hz (**maximum load and speed of the**  
262 **hydraulic jack**) by means of a hydraulic jack positioned vertically over the centre of the span,  
263 redistributing the load at four points by means of three stiff beams (green and yellow in **Figure**  
264 **9**).

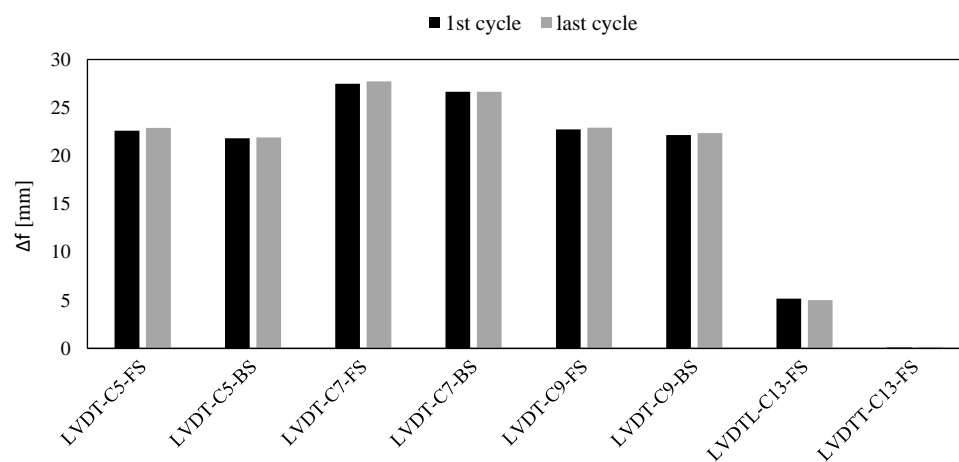
**Figure 11:** Displacement increment computed at the beginning and at the end of the fatigue test.

324 **Figure 11** gives the displacement increments read by the LVDTs on the central portion of the  
 325 bridge (LVDT-C5-FS/BS, LVDT-C7-FS/BS and LVDT-C9-FS/BS) and those that monitored the  
 326 longitudinal and transversal movements of the structure (LVDTL-C13-FS and LVDTT-C13-  
 327 FS/BS). As expected, the maximum vertical displacements were observed in the centre of the  
 328 bridge. As in **Figure 10**, displacement increments did not vary between the first and last cycle,  
 329 again confirming the absence of damage and the elastic behaviour of the bridge. LVDTT-C13-FS  
 330 monitored the possible presence of transversal displacement of the support. As shown in  
 331 **Figure 11**, there were negligible movements in that direction.

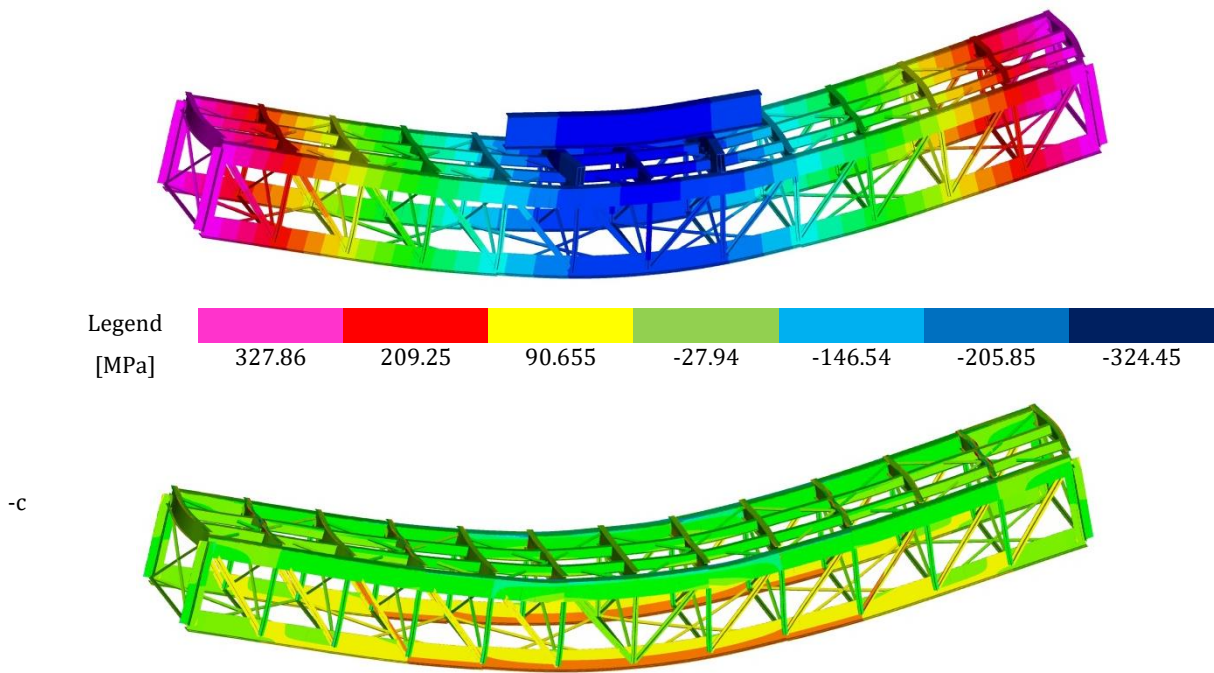
**Figure 12:** Finite Element model developed to analyse the behaviour of the isostatic span tested during the lab investigation (-a), vertical displacements (negative downwards) (-b) and total stresses along the bridge (-c).

332 The experimental results were also compared to the numerical outputs obtained using a 3D  
 333 Linear-Static Finite-Element model (LSFE). The isostatic span tested during the lab investigation  
 334 was modelled by means of two-noded beam elements, as shown in **Figure 12-a**.

337 **Figure 12-b and -c** gives the vertical displacement and **fibre stresses** produced in the structure  
338 by a static load equal to 1250 kN applied on the top of the longitudinal stiff beam. **It is worth**  
339 **mentioning that the stresses depicted in Figure 12-c consider both axial stresses and bending**  
340 **stresses.** The results slightly overestimated the bridge deformability, with 32 mm of vertical  
341 displacement at the centre of the beam, compared with the 27 mm registered by LVDT-C7-  
342 FS/BS. A comparison between the experimental and numerical results in terms of total stresses  
343 is shown in **Figure 13**. The experimental results given in **Figure 13** were obtained from the  
344 average output obtained from each element and their symmetrical counterparts. The model  
345 accurately predicted the stress state of each element. The reliability of the model led to its being

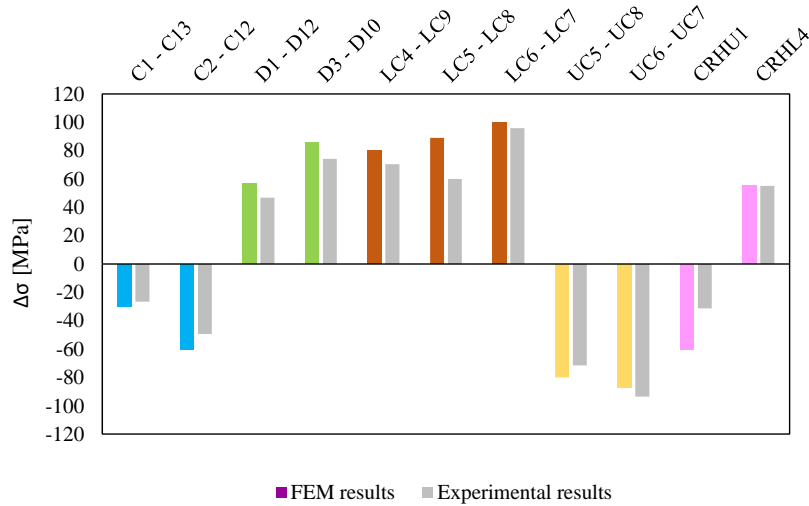
**Figure 13: Comparison between experimental (grey bars) and FE results (coloured bars).**

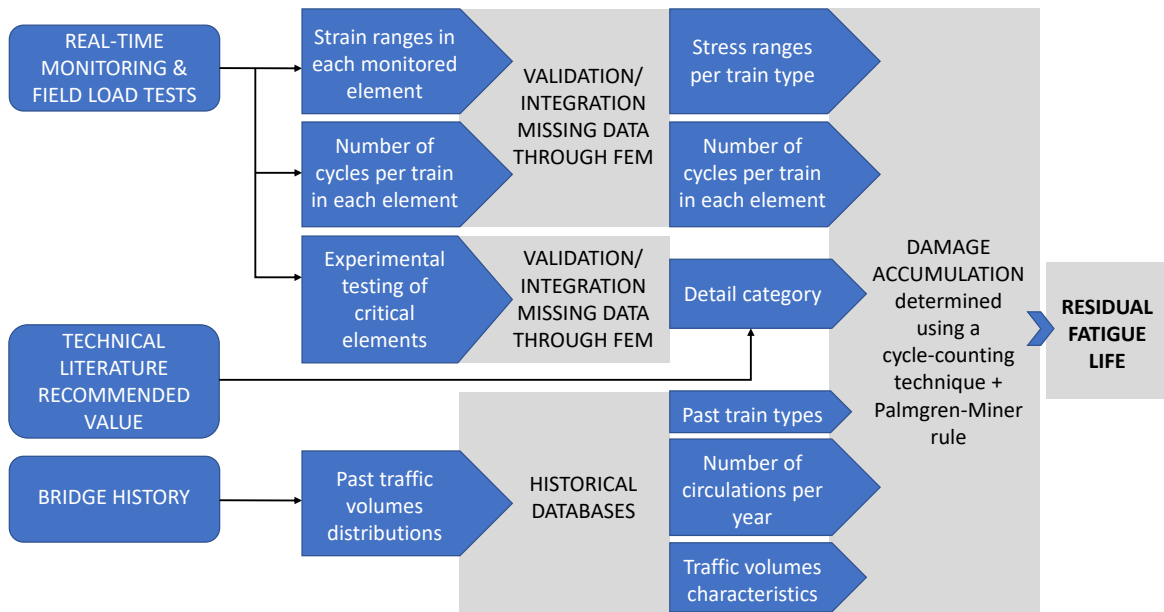
**Figure 14: Relational flowchart of the proposed approach.**

349 This method was defined for a general case and then applied specifically to the Quisi Bridge. The  
 350 analytical assessment following this general method included: (i) load tests on the bridge, (ii)  
 351 experimental results from the double experimental tests described in Sections 4 and 5, (iii) the  
 352 numerical model validated by the full-scale test outputs, and (iv) the recommendations  
 353 proposed by [10]. When all the experimental data is not available, this method also suggests the  
 354 criteria to use.

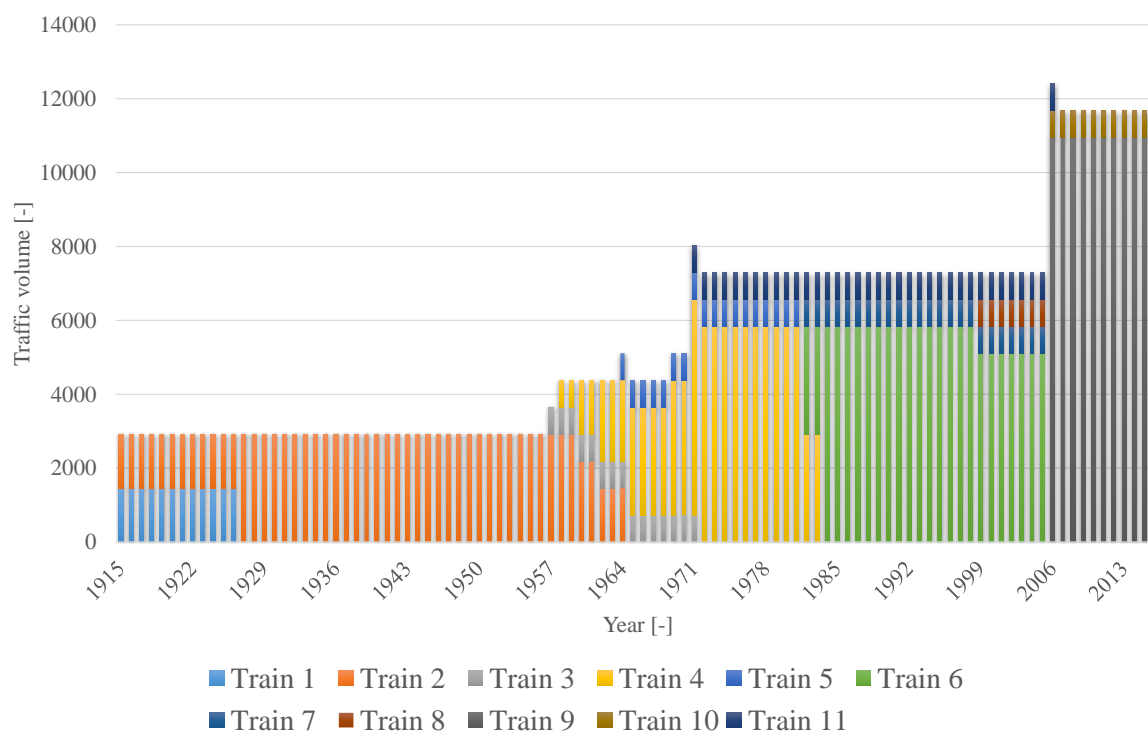
**Figure 16:** Loading history of the bridges during their exploitation expressed by train typology distributions over the years and traffic volumes. Data provided by the railway administration.

398 from the LSFE model). Deformation was found to increase by 30% **in the field tests with respect**  
399 **to the FE analysis**, resulting in a dynamic amplification factor of 1.3. The bridge's detail class  
400 was calculated from the information available on its loading history in service expressed by  
401 traffic volumes and their characteristics (**see more details in Section 6.3**). Assuming a period  
402 dating from 1915 to the present, 11 different types of train passed over the bridge, as can be  
403 seen in **Figure 16**.
