Adobe Constructions – Colonial Chilean House

Maria Graciela Jofré Troncoso¹

Topic: T1.3. Studies of traditional techniques and materials

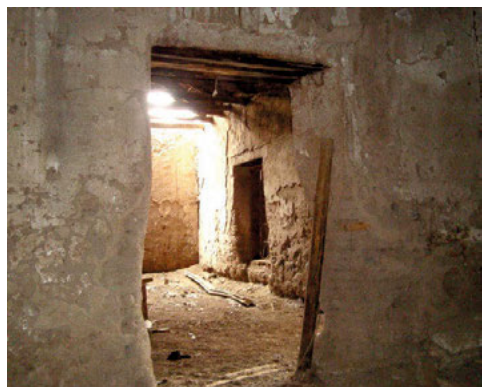
The adobe masonry walls were built with bricks arranged with rope or head; the approximate dimension of this bricks is 60 cm long, 30 cm wide, and 7 to 10 cm high. However, walls of 100 to 120 cm wide have been found. Clay mortar and two layers of clay coating, a thick inner layer with a high level of vegetable fibers, and a thin outer layer. The walls are connected perpendicularly with the lock of their bricks and with ladders or wooden chains, which are distributed to thirds of the height in the meeting of the walls, crowning the upper level of the floor. In some cases, these reinforcing elements may be found throughout the wall and not only in these meeting elements.

Fig. 1. Casona Quilapilún adobe wall. (Source: Contreras & Jofré, 2016)

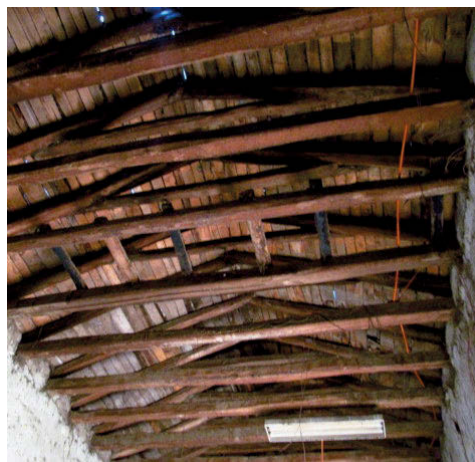
The roof is made up of trusses built by a pair of wood logs with a brace at the base or halfway up, as it is illustrated in figure 2. The trusses are distributed at a maximum distance of one meter. Above the trusses are installed wooden boards, which is the surface to directly receive the clay tiles.

Fig. 2. Example of roof trusses on adobe walls. (Source: Contreras & Jofré, 2016)

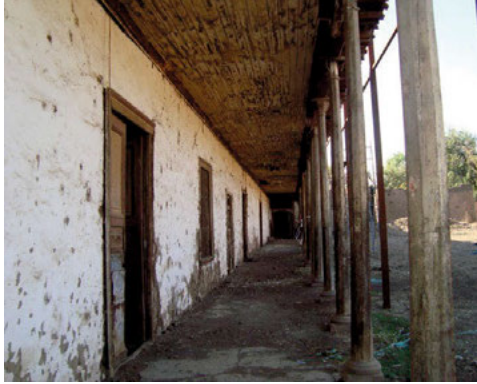
The existence of corridors is a variable characteristic within the complex since they generally are located in the interior perimeter of the house, around the patios. These corridors are developed as a continuation of the main roof, extending with

ieces of wood that connect to the walls of the inner ring of the adobe walls.

Fig. 3. Example of corridors. (Source: Contreras & Jofré, 2016).
