## Vernacular earthen architecture. Construction techniques and restoration. From the international setting to some specific Italian regional cases

**Topic:** T4.1. Conservation and restoration projects of vernacular architecture

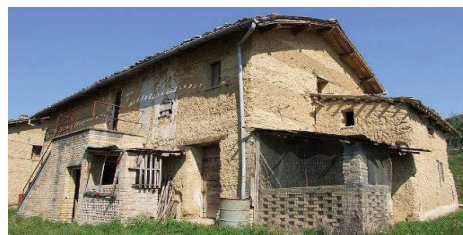
Fig. 1. House in the Macerata area, in accordance with the typical construction technology, 2020.

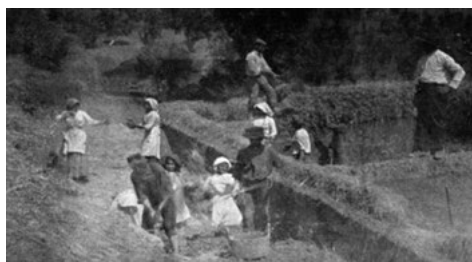
Fig. 2. The construction process involves the entire family, photograph of 1919 from a private archive

Particular attention was devoted to site selection, both to avoid the problem of humidity, and because suitable earth had to be available in the vicinity, since transporting the raw material from a distance was not cost-effective. Foundations were shallow if not absent altogether. Once the building's perimeter was established, the area was dug out to a depth of between 50 and 100 centimetres; the earth was then placed back in the hole in 30/40-centimetre layers, adding water and straw and mashing it to blend together, and then allowed to dry. Once ground level was reached,

the bearing walls began to be raised. The craftsman laid *massone* along the house's perimeter in one layer after the other, in alternating courses, or more rarely in herringbone courses inclined at 45°. Once a layer was completed, the craftsman crushed it down with his feet to fill in the cracks; he then smoothed it inside and out with his spade, sometimes working the earth with water again. As the layers progressed, the *massone* grew smaller, to allow them to be put them in place more easily; the walls thus tapered in, measuring about 80 cm at the base and 50 cm at the top. Given the nature of the material, the intersections of the walls represented the most delicate points in the construction; to solve the problem, the junctions between walls were often reinforced with horizontal connections of olive branches sunken into the structure. For two-storey houses, the floor slab was made at a height of about 220 centimetres, by anchoring poplar, elm, or oak beams to the wall, placed in parallel one metre apart, and topped by a second, denser, orthogonal frame of slats, upon which was placed a layer of mud-daubed reeds woven or twined together, which served as the base supporting the burnt brick floor. The same technique was used to build the roof, whose covering was made with bricks (*penci*) resting upon a mixture of soft earth atop a layer of woven reeds. The roof was rather overhanging – usually by more than 50 centimetres – to protect the walls near the ground. In general, only the north-exposed exterior wall was plastered; far more frequently, the use of plaster was limited to the outlines of doors and windows. For the base, the protection was made using burnt brick or stone, up to the height of about one metre. The analysis shows the great historic and cultural value of these constructions, as productive and life forms, that express the region's identity. Over the past decades, great interest in architectures of this kind has developed, thanks also to the numerous research efforts carried out by universities, the Region, and local institutions that have devoted themselves to studying the most significant

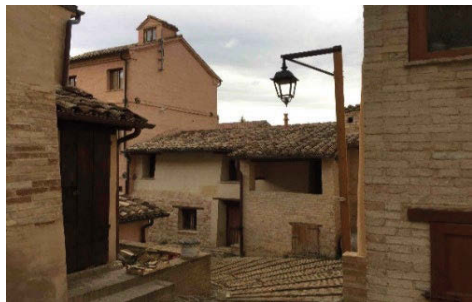
Fig. 3. The village of Villa Finacana in Macerata, after the restoration interventions, 2022.

To prevent the abandonment of this construction technique, an articulated programme was initiated in 2000. In 2014, the Municipality of Macerata held a competition for submissions of design proposals for museum interventions and the recovery of the buildings. The *Recovery Guidelines* defined the field of possible interventions, in such a way as to represent a binding basis for future recovery work, and to harmoniously and sustainably reconcile possible changes with the conservation of all the historical and cultural values that the village possesses. The *Guidelines* provide a working tool able to guarantee a high qualitative standard for future designs; at the same time, intended uses deemed compatible with the typological and size characteristics of earthen houses were identified.

In recent years, this allowed the village to be restored to its original configuration, while also fostering the creation of a “museum of the earthen houses of the Marche.”

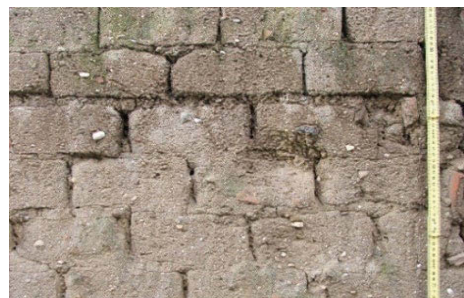
Fig. 4. Earthen wall of a house in the town of Donigala Fenughedu (Oristano) (Source: Putzu, 2015).

In Sardinia, this technique has been attested since antiquity. Clayey earth, in fact, has been found in some early Iron Age nuragic sites, in private buildings from the Phoenician/Punic Age, and in Roman and Medieval sites<sup>23</sup>. The technique in mudbricks (*ladiri*), now more well-known, saw additional impetus during Spanish domination and was employed in subsequent centuries along with other materials (iron, brick, and reinforced concrete). Until the 1950s, *ladiri*, along with stone, was the building material most used in private construction (fig. 4).
