La Vera's vernacular architecture. Structural design and climate protection in timber frame wall houses using constructive systems and local materials.

Topic: T1.3. Studies of traditional techniques and materials.

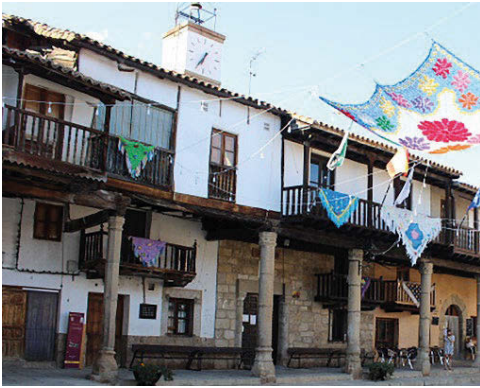
This complex and varied typology, usually on three floors, is associated with the rural way of living described in “*Arquitectura popular de La Vera*” (Chanes & Vicente, 1975). The ground floor might have a portico (Fig.1) before stepping into the hallway. This hall leads to the stairs and to a lower level (40 to 100cms below) with the wine cellar, the henhouse or the stable. Wooden stairs take us to the first floor with small bedrooms and the *vasar* (room where fine china is exhibited).

Fig. 1. Porticos. Valverde de La Vera (Source: Elena Franco, 2020)

Porticos with the function of an outside *zaguán* are sometimes used as an outside living room. When this happens, the upper floors rest on wood posts or stone columns. (Fig.1)

Beam faces are also protected with fretted boards which will be replaced when they get damaged. (Fig.1) Fretted boards have turned out to be a decoration motive typical in La Vera. They are also used as balcony posts. (Fig.11) Roofs always come out from the façade line by a distance allowed by the outcoming structure or by corbels. Roof tiles will stick out several centimetres more. Party walls sometimes also have their roof standing out of the vertical, when the house's roof is higher than the neighbour's.

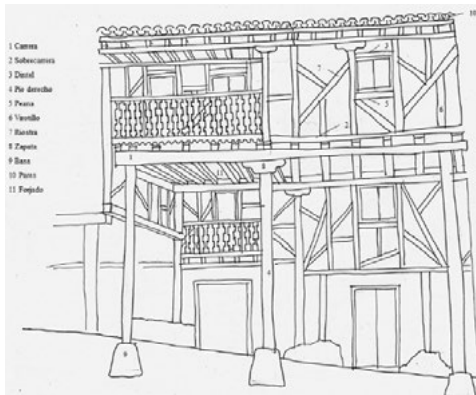
The vertical structure is formed by facades and an inner structure. The facades, from the first floor upwards, are built with timber framed structures. The wooden elements (Fig.2) have been described by various authors (del Río, 1991; Nuere, 2000). Wooden frames in La Vera are usually infilled with sun-dried bricks, although some differently dated bricks are also found.

Fig. 2. Facade in Garganta la Olla (Elena Franco, 2021)

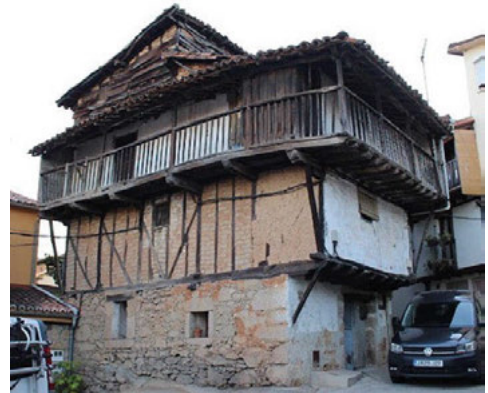
Fig.3. Facade. Villanueva de La Vera (Source: Elena Franco, 2020)

A house in Villanueva de La Vera is analysed (Fig.3). On the first-floor façade there are main posts with a wider section, and thinner wall posts. The inner beams lay on the wall plate on the ground floor wall and so do the main posts, while the upper beams lay on those main posts transmitting the load. The *riostro*s and *viretillos* and secondary posts are used to avoid deformations caused by horizontal movements and to help during the constructive process of the frame.

Sometimes they are supported by the main horizontal structure while other times they have their own beams inserted into the main structure. (Fig.3, Fig.4). If balconies or corridors are designed to support weight, they might have a complex structure (Fig.5) using decorated carpentry solutions.

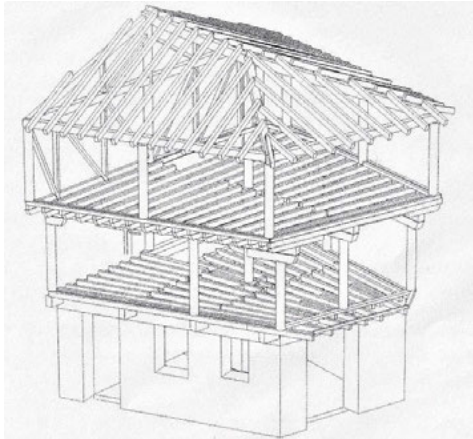
house grows up. The main beams will come out of the façade supporting the next floor and façade wall. (Fig.4)

Fig.4. House structure in Garganta la Olla. (Source: Bujalance, 2019)

The construction system is very efficient. The cantilever supports weight at the ends helping main beams decrease its flexion. The upper floors protect the wood and sun-dried bricks from the rain and sun. Living surfaces are increased and create shade that will cool the streets during the hot summers. These structures were built with large chestnut trunks and other high-quality woods.

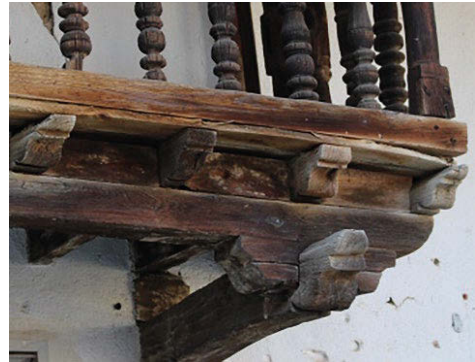
Fig. 5. Balcony in Valverde de La Vera (Source: Franco, 2020)

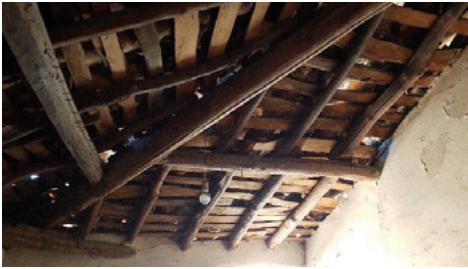
Fig. 7. Roof in Garganta la Olla (Source: Franco, 2020)

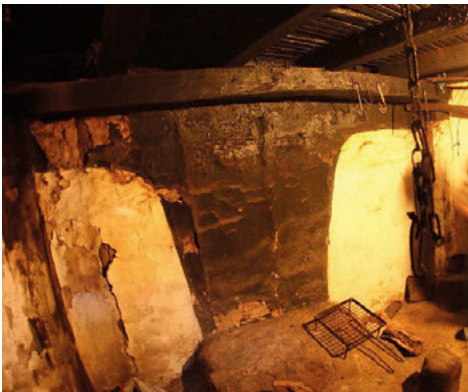
The smoking of pepper was done in the kitchens, on a wooden floor set on the base of the roof level, called *doblaio* (Fig.8). The fire was below, on a back hearth, and skills in handling fire was required to get smoke or flame when needed. The smoke would go up to the *doblaio* and finally come out between the roof tiles.

Fig. 8. Kitchen and *doblaio* (Source: Bujalance, 2017)

Other mixtures were used to get new colours for a specific purpose. The fireplace walls were painted in black (Fig.8). Black paint was made with charcoal, *negro de humo*, mixed with clay or sometimes charcoal mixed with lime. This last mixture turns into a black or grey coloured finish that was also used in outside wall bases. This black paint could easily hide splashes, but also, the lime and charcoal mixture would help transpiration, letting the inner wall dry. This finish also needed maintenance and was regularly applied.

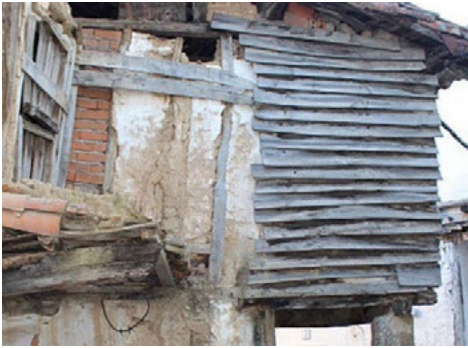
This balancing way of thinking is behind Verata construction and should be considered carefully when restoring because demolishing walls, floors, or even inner walls, might destabilize the whole building. These houses, when restored, will also need careful structural analysis, considering the new use they will have. It is compulsory to have an architectural project when rehabilitating and, in La Vera, it is recommended not to do any demolishing without a technical survey. It is common to see solutions where inner walls are used as a counterbalance for big balconies (Fig.10).

Fig. 10. Plankings. Valverde de La Vera (Source: Franco, 2020)

There is plenty of wood on the outside of Verata architecture that is exposed to sun and water, as is the sun-dried brick infill of the walls. Popular strategies are used to protect them both. The most unique one is its design. Houses follow horizontal growth as they rise to the upper levels. This protects the facades below, but there are other systems helping to protect facades. Weather boarding is very common in La Vera. Wood planking is not used in main facades, and it is always placed on the upper levels. The planks are disposed by pouring water on the lower plank, and they are nailed to the posts. The wood is preserved because it is ventilated. It also protects the sun-dried brick wall (Fig.10).

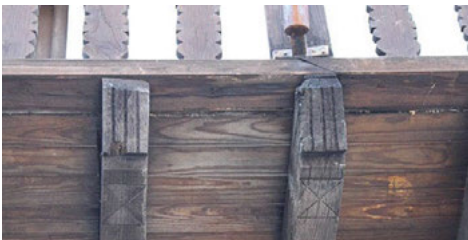
It is very common to see decorated corbels, but it is an extended detail in La Vera to stripe the wood beam facing the street. This does not prevent the beam from moistening but helps it to dry more quickly. Different carved striped designs are finished in oblique, leading water to a drip. (Fig.11, Fig.12)

Fig. 11 Corbel decorations. Valverde de La Vera (Source: Franco, 2020)

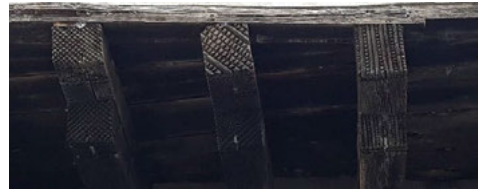
Fig. 12. Corbel decorations. Garganta la Olla (Source: Franco, 2020)

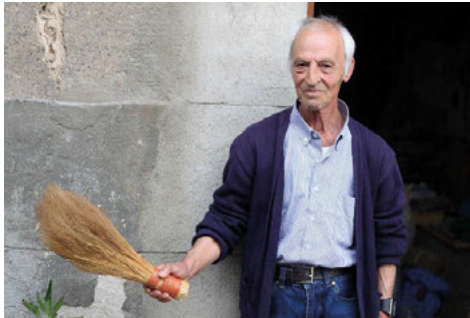
The upper house levels, which were more difficult to reach, were usually painted with a fine clay and water-based paint. Garganta la Olla has a beautiful ochre coloured clay. This upper paint was applied with the *escobillo* once a year, to protect the walls (Fig.13).

Fig. 13. Jesus mother's escobillo (Source: Bujalance, 2017)

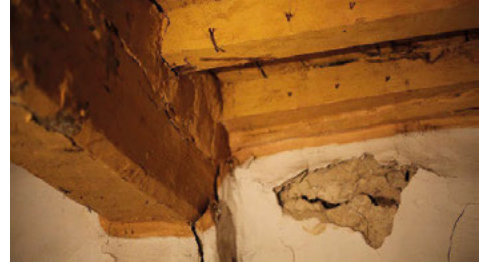
Women used to paint the inner walls with the *escobillos*. They relate how they used it first to take off the spider webs on every corner, as well as in the joint between walls and wood. Then they painted these areas with colour. These paints can still be seen nowadays, sometimes just clay paint, with no maintenance, still stuck to the wood (Fig.14).

Fig. 14. Ochre painting (Source: Bujalance, 2017)
