## Historic tuff masonry in Naples: different approaches to its conservation

**Topic:** T4.2 Materials and intervention techniques for vernacular architecture.

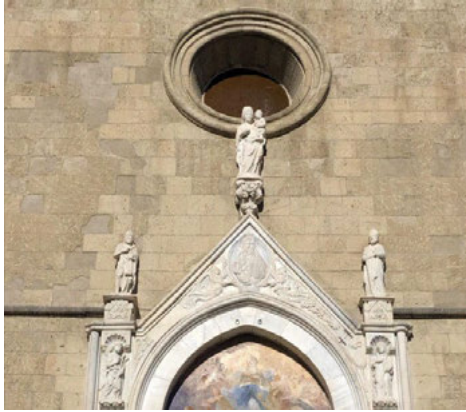
Fig. 4. San Giovanni a Carbonara after the work of conservation (Russo Krauss, 2022).

were treated as one and a single colour was selected to accompany and define this new historic phase of the monument (Fig. 4).

The beauty of the facades of the church of San Giovanni in Carbonara lay in the massive *facciavista* walls, mainly in tuff, but also in piperno. Conceived to be left exposed, the blocks are way larger than in traditional local architecture. They are neatly carved and with very little mortar in the joints. Except for the marble portals there are no decorations and everything is left to the texture of the masonry. It is therefore with particular care that the issue of stone conservation had to be addressed. Almost every block, both original or of replacement, presented a deterioration phenomenon in a more or less advanced stage (Fig. 3). Consolidating and protecting the stones, filling the biggest gaps, which represented both an aesthetic issue and a conservation issue, maintaining the distinction of the intervention while restoring the homogeneity of the wall surface was a difficult task. The choice has been that of the minimum intervention, accepting the aesthetic differences of the blocks, both in their colour and in their texture, consolidating the material and filling the biggest gaps with sub-level grouting. Instead of matching the colour of the mortar in each *lacuna* to the colour of the nearby stone a much less mimetic intervention was chosen. All the *lacune*
