## The paving of ancient paths, testimony of an ancient culture: recovery of a traditional route in Genoa (Liguria, Italy)

**Topic:** T1.3. Studies of traditional techniques and materials

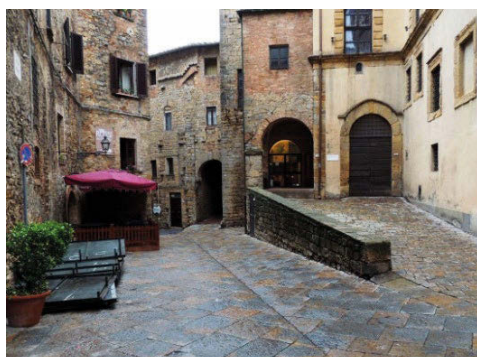
Fig. 2. Traditional paving made of Pietra Panchina in Volterra (Tuscany) (Source: Fabio Fratini).

in Florence on October 20, 2000. Streets and paths bear the traces of an ancient culture, which is manifested by the materials used and the practices of construction and maintenance, which are different in each territory (Fig.1 and Fig. 2) (Musso, 1999; Bosia et al., 2006; Conforti et al., 2006; Decri & Volpato, 2006; Fatta et al., 2006; Gabbaria Mistrangelo, 2006; Galli et al., 2006; Lavisio, 2006; Mannoni et al., 2006). Unfortunately, this significant component of our

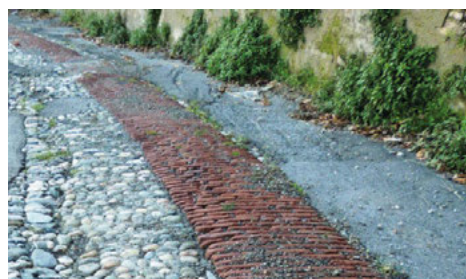
Fig. 4. Cambered profile of the central brick strip and lateral cobble-stone channel (Source: Fratini).

This paper deals with a project for the study, enhancement and recovery of one of the traditional paths that run through Genoa and its territory, from the coast to the mountains. These so-called "*crêuze*" are made up of cobble-stones and a central or lateral strip of bricks laid by side (Fig. 3). The brick strip (called *pagliolo*), which is about one meter wide, facilitates the passage of people in rainy weather, while the cobble-stones made it safe for pack animals to walk. Drainage is facilitated by the cambered surface, while the cobble-stone side channels slow down the flow of water (Fig. 4).

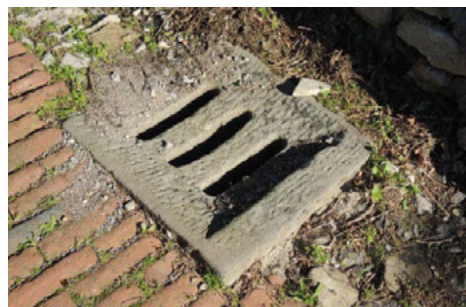
Fig.5. Sandstone storm drain (Source: Fabio Fratini).

The water flows into appropriately positioned sandstone storm drains; these have rectangular apertures (from three to five) or are made up of several elements called "*cords*" (from two to six) (Fig. 5).

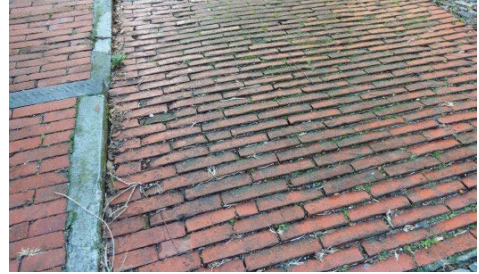
Fig.7. New, smooth bricks on which a thin biological patina is forming (Source: Fratini).

surface, tend to look out of place. With regard to functionality, when it rains or humidity is high, new smooth and fine-grained bricks tend to maintain a liquid film on the surface; over time, this favours the growth of a slippery biological patina (Fig. 7).

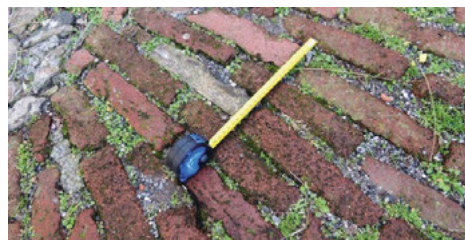
Fig.9. Old bricks with a rough appearance, with a slight tendency to disintegrate (Source: Fratini).
