The *hórreos* in Riaño Mountain, León, Spain. Vernacular architecture between conservation and musealisation

María Pilar García Cuetos¹

Topic: T4.1. Conservation and restoration projects of vernacular architecture

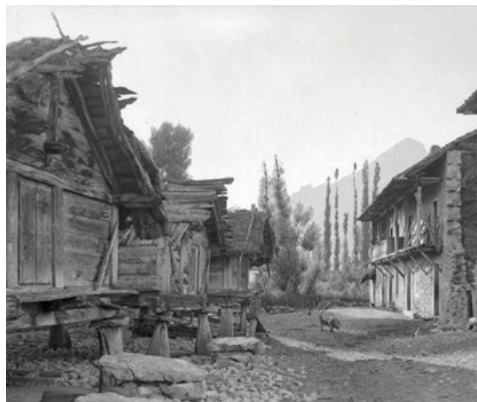
Fig.1. *Hórreos* in Riaño between 1922 and 1936. Photographic library of the Institute of Cultural Heritage of Spain. Ministry of Culture and Sports. Archive Wunderlich number of inventory WUN-07347.

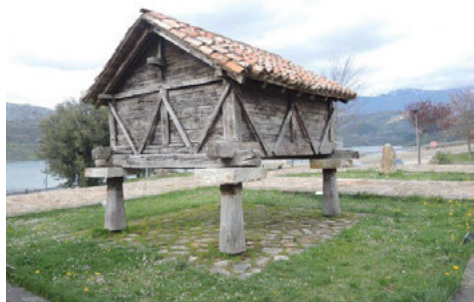
Fig.4. Leonese *hórreo* from Salio dismantled and remounted in Nuevo Riaño (Source: Pablo Herrero Lombardía).

As explained, reference is made to the lost heritage and it is specifically mentioned the vernacular architecture that was devastated and of which only one sample was preserved, placed next to the monumental landmark as a sculpture or a heritage relic. The *hórreo* from Salio cannot be perceived in any other way due to its decontextualisation, the isolation in its disposition and the memorial environment in which it is inserted. It may be concluded that there was not a real interest in preserving the legacy of the singular buildings that *hórreos* meant in Riaño Valley.

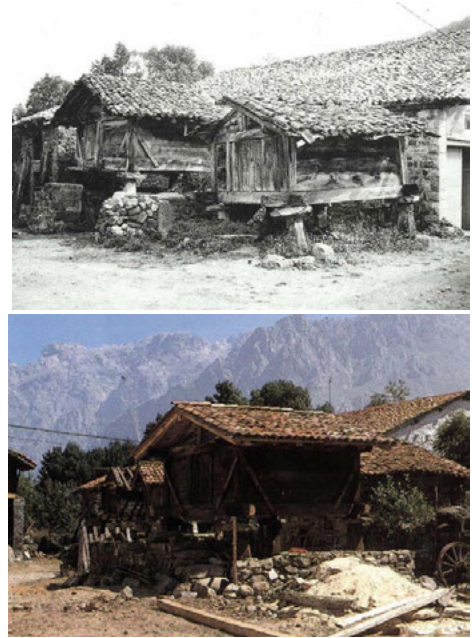
Fig.6. Restoration of one of the *hórreos* in Valdeón (Luelmo Varela, 1995).

Likewise, it is possible that the massive destruction of the *hórreos* preserved in the villages flooded by Riaño reservoir in 1987, had the effect of implementing measures for the protection of those still standing in other areas of Castile and Leon. A pilot programme for the restoration of Leonese *hórreos* was initiated and implemented in the territory of Valdeón. Five intervention campaigns were carried out between 1988 and 1992 (Luelmo Varela, 1995), under the supervision of an architect. These campaigns were conceived as work camps. It was opted for the criterion of minimal intervention and damage repair, avoiding the replacement of parts. In the event that one was partially damaged, the damaged fragment was replaced. Protective products were also applied to the wood. In addition, efforts were made to maintain the tradition of the trades that had survived and the way of acting that had been documented since the 1950s in the valley. The architects considered that the conservation of a living architecture was being addressed, so it was a matter of carrying out a maintenance as the artisans had always done, using at all times the available technologies (Luelmo Varela, 1995, p. 19).

It was also suggested that, in case of making use of other means, which were defined as more purist, the precedent of excessively costly processes could be set, preventing owners from maintaining the initiated dynamic. To carry out rehabilitation operations, the chosen samples were the oldest ones together with those that presented building systems considered 'unique' (Luelmo Varela, 1995, p. 19). In the reproduction of pieces, formal analogy was used and contemporary materials were introduced, such as steel points for piece joints and factory ceramic tile for the roofs. In conclusion, specific criteria for architectural restoration were introduced, such as the rejection of the mimetic restitution of damaged or missing elements and, although local artisans were incorporated, the truth is that unaffiliated elements with that tradition were introduced. The applied criteria may be described as questionable, since they alter the fundamental authenticity of vernacular architecture, based on the transmission of trades and the use of traditional materials.

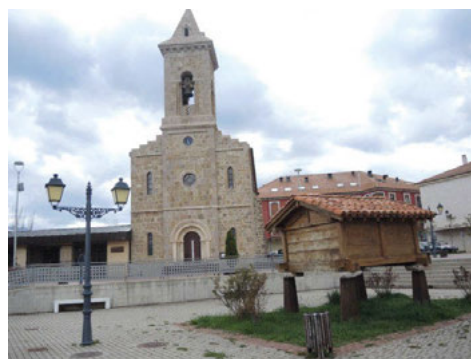
Fig.7. Newly-designed hórreo in Cimadevilla de Riaño square. Photograph by Pablo Herrero Lombardia.

In the 21st century, the desire to recover vernacular culture has crystallized new initiatives. The Riaño Ethnographic Museum was inaugurated in 2004 (Díez, 2019, p. 57). One of its objectives has been to recreate lost traditional lifestyles and crafts. Subsequently, a newly-designed hórreo was built in Cimadevilla Square, next to the museum. The structure was built by a local company, in oak wood from the mountains in the valley and the installation was completed with the placement of an explanatory panel on the characteristics of the Leonese hórreo and with a map proposing a tour of the preserved samples. Curiously, this information was not installed next to the original hórreo coming from Salio and installed next to the monument of the Bells.
