## Vernacular architecture on archaeological remains. Conservation and enhancement of the “Villa San Limato” in Cellole

**Topic:** T4.2. Materials and interventions techniques for vernacular architecture

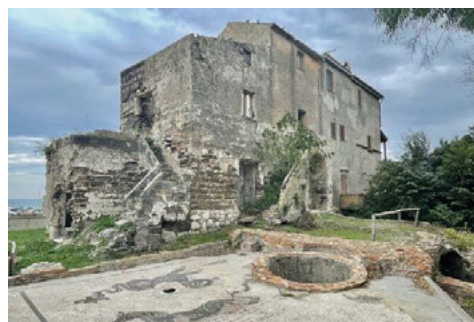
Fig. 1. The rests of the Villa San Limato with the surviving structures of a farmhouse (Source: Cappelli, 2021)

This article follows some older studies concerning the restoration and fruition enhancement of Villa San Limato in Cellole (Italy). Villa San Limato is an interesting case study in the field of built, vernacular heritage, as it embodies the coexistence of the rests of a Roman maritime villa (that probably belonged to the prefect Sofonio Tigellino) with the surviving structures of a farmhouse (that was built on the rests of the Villa in the eighteenth century) (Fig. 1).

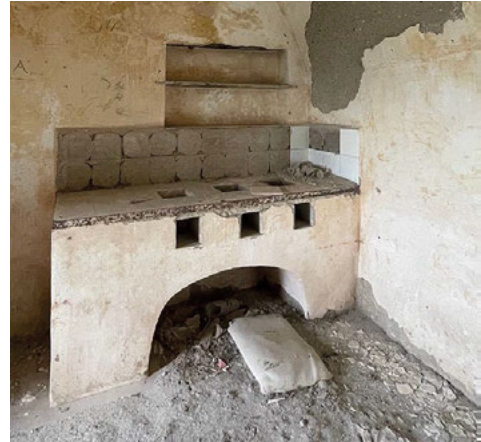
Fig. 6. The ancient kitchen of the farmhouse with holes for fire (Cappelli, 2021)

The higher buildings, one covered with a gabled roof and the other with an orthogonal pitch, have a double entrance on the ground floor. These structures are what is left of the living center of the farmhouse, as there is the kitchen on the ground floor and two other rooms on the first floor, that were probably bedrooms. The two isolated rooms of the first floor are accessible through two external stairs, which rise above the north-east and south-east sides. The stair on the short side was built against an additional building, that had only one floor and only one entrance, intended for external use and equipped with a hob. This building has a flat covering, that functioned as the terrace of one of the rooms on the first floor.

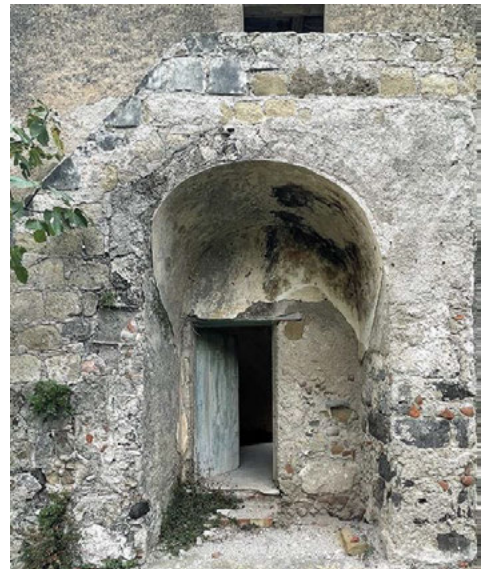
Fig. 7. The ancient access to the farmhouse below the staircase leading to the first floor (Cappelli, 2021)

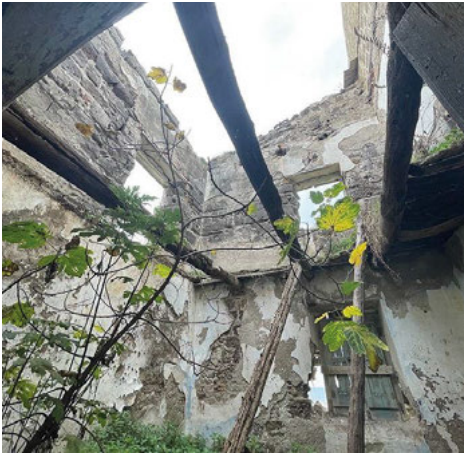
Fig. 8. The wooden beams of the ancient floor of the farmhouse (Cappelli, 2021)

The study of the building techniques and the interpretation of the crack pattern of the farmhouse shows different kinds of instability: holes in the masonry shell (due to the absence of covering and to the collapse of the ceilings), signs of erosion on the walls, gaps in the masonry, due to collapses of the structure and old materials. What is left of the traditional wood ceiling are only a few chestnut wood beams with circular section, now rotted.
