UNIVERSITAT POLITÈCNICA DE VALÈNCIA

PhD Thesis

**CURRENT-BASED TECHNIQUES FOR CONDITION
MONITORING OF PUMPS**

Valencia, November 2022

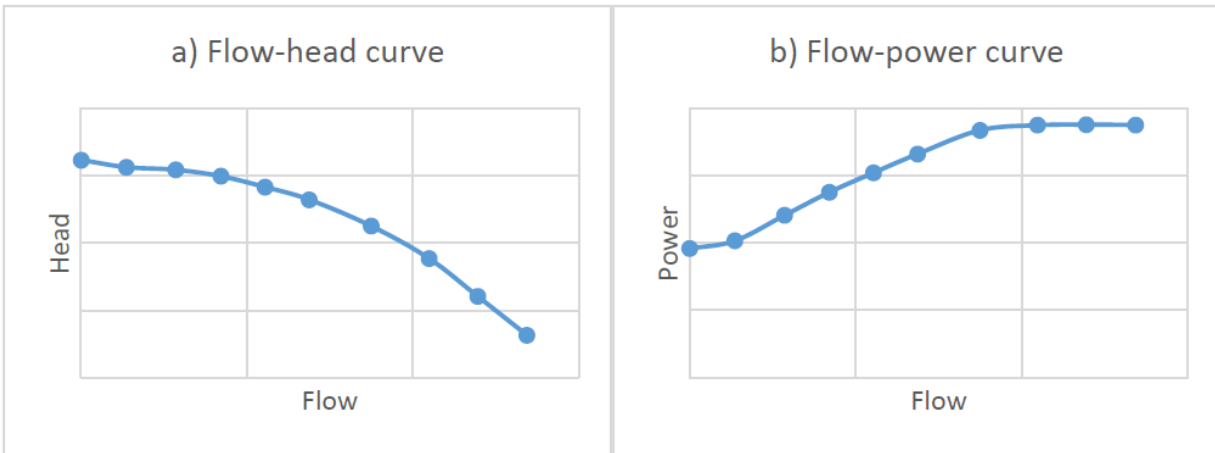
point, the power input only includes electrical, mechanical, and hydraulic losses. With increasing flow, the head of the pump starts to drop, and the input power increases. If the head drops to zero, again the power input only contains the mentioned losses, since the pump efficiency η_{Pump} drops to zero. The point where η_{Pump} is the highest is called the Best Efficiency Point (BEP) of the pump. Most manufacturers recommend operating a pump close to its BEP. The shape of the two characteristic curves varies depending on the design and shape of the pump impeller used.

Figure 2.2: Characteristic curves of a pump: a) flow-head curve; b) flow-power curve

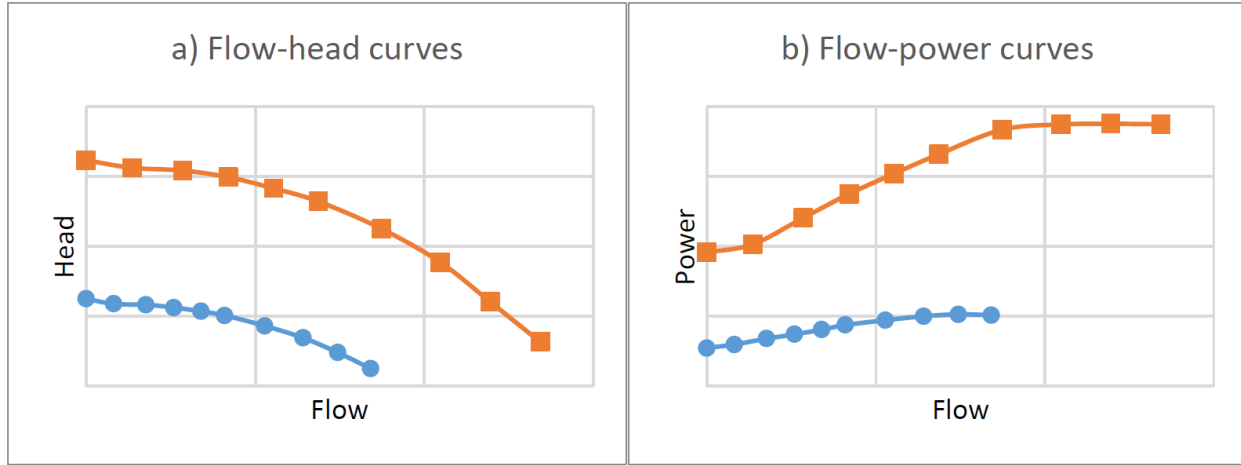
In order to adapt to real-world conditions, values from 2.8 to 2.95, instead of 3, are also used as the exponent in the power equation (Schaab, 2019). The effect of decreasing the speed on the two characteristic curves is depicted in Figure 2.3. If the speed is lowered, for example, by 50%, the flow is decreased by 50%, the head by 75%, and the input power by 87.5%.

Figure 2.3: Characteristic curves of a pump when speed conditions change (orange: nominal speed; blue: lowered speed): a) flow-head curves; b) flow-power curves

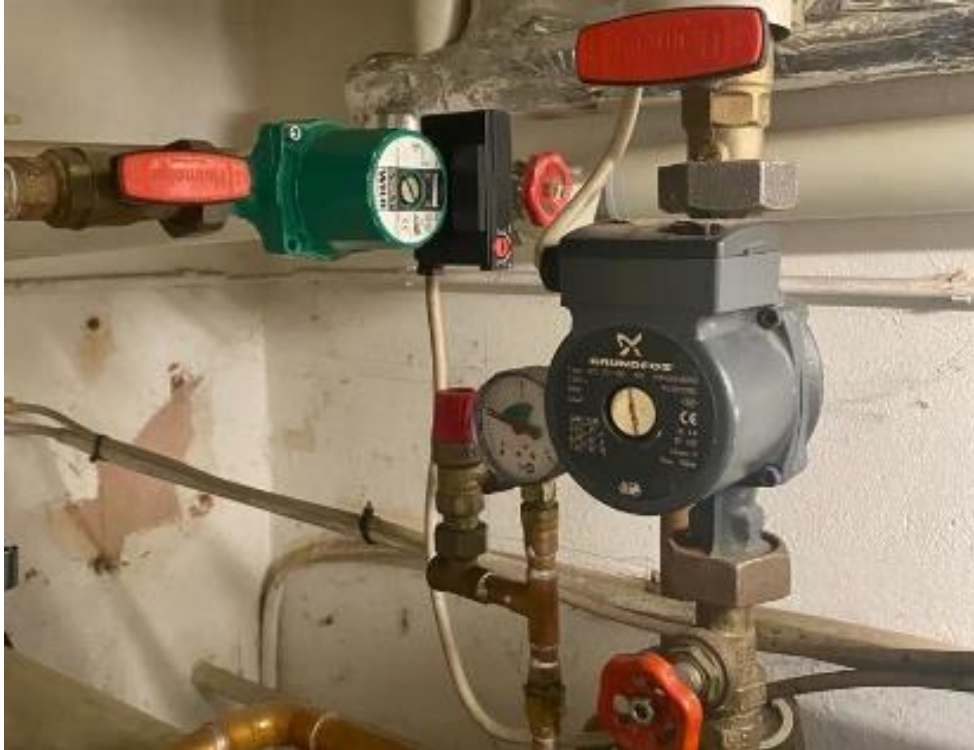
Since ball bearings cannot be used in many liquids, journal bearings are used in wet-rotor pumps. Journal bearings are used for the rotor bearings, with the lubrication of the journal bearings and the cooling of the motor being taken over by the pumped medium. The pumped medium must therefore meet specified viscosity and purity requirements. The load capacity of the journal bearings is based on the formation of a lubrication film in the bearing gap. This gap has to be small in order to be able to provide the load capacity. The lubrication film is formed with increasing speed of the motor. Without a lubrication film, the shaft and the bearing shell are damaged. Consequently, every startup of a wet-rotor pump can increase the risk of bearing wear. In an asymmetrically worn bearing, no lubrication film can be formed. If no liquid enters the rotor space, the bearing will be destroyed within a short period of time. The use of wet-rotor pumps is limited to liquids with good lubricating properties.

Figure 2.5: Picture of two wet-rotor pumps installed in a heating system

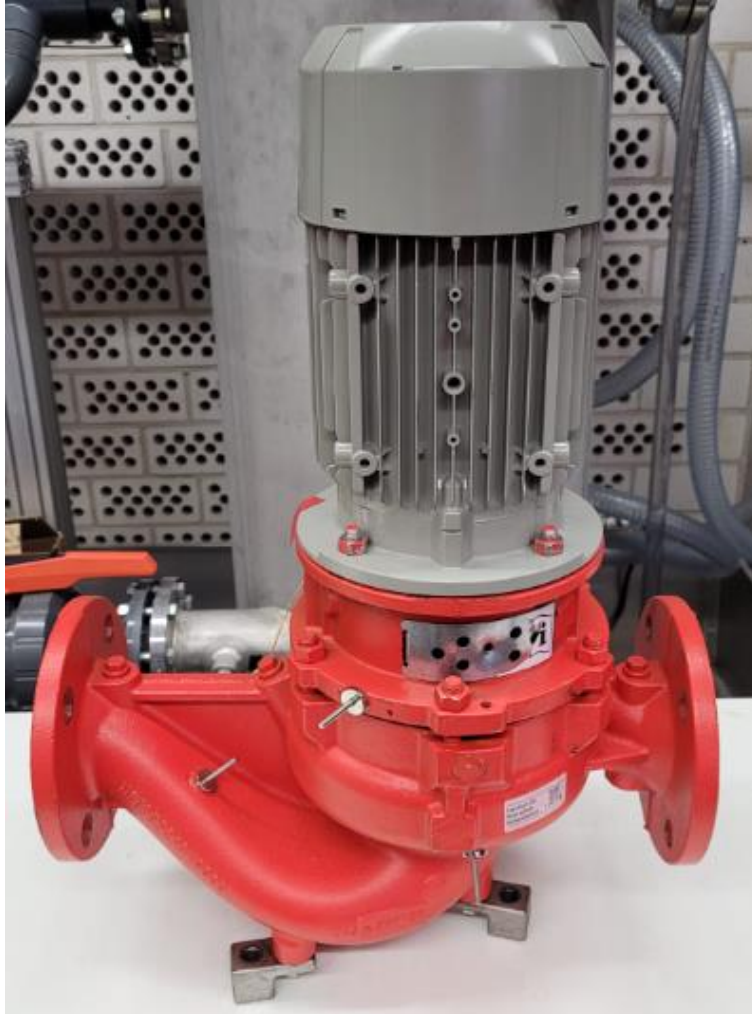
Dry-runner pumps are driven by motors mounted on roller bearings and separated from the pumped liquid by mechanical seals. As with wet-rotor pumps, the impeller is mounted directly on the motor shaft. Figure 2.6 depicts an example of a typical dry-runner pump. For larger drive capacities, standard motors are also used, which means that the impeller has to be mounted on a separate shaft, which is flanged to the motor via a coupling.

Figure 2.6: Illustration of a dry-runner pump

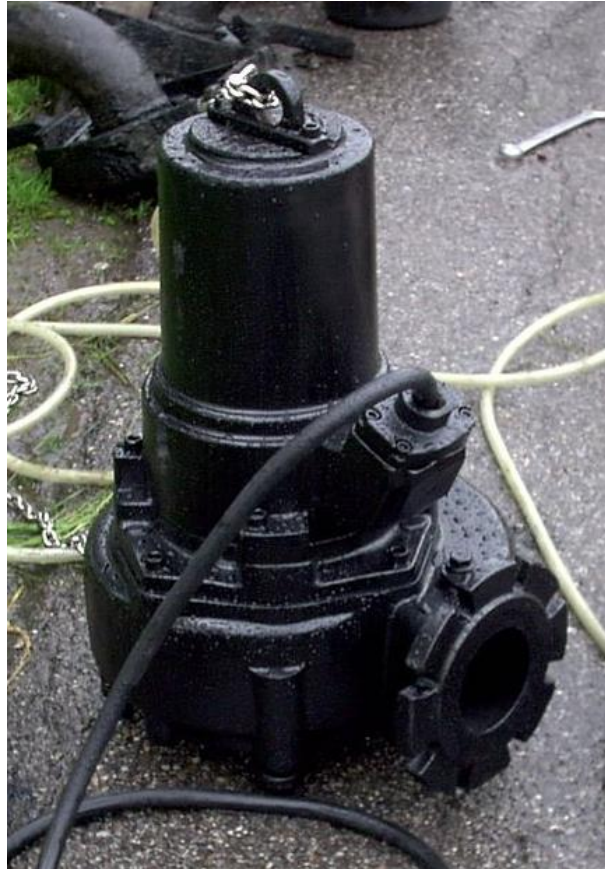
Submersible pumps are centrifugal pumps whose hydraulic components are flooded by the handled fluid. Usually, this type of pump is not fitted with a suction line (KSB, 2022b). A submersible pump is most commonly driven by an electric motor. Electric submersible pumps (ESP) are used in many applications, for example in drainage, wastewater and slurry pumping, but also in water extraction, water and oil wells.

Figure 2.7: Illustration of an electric submersible pump (Dergreg, 2004)

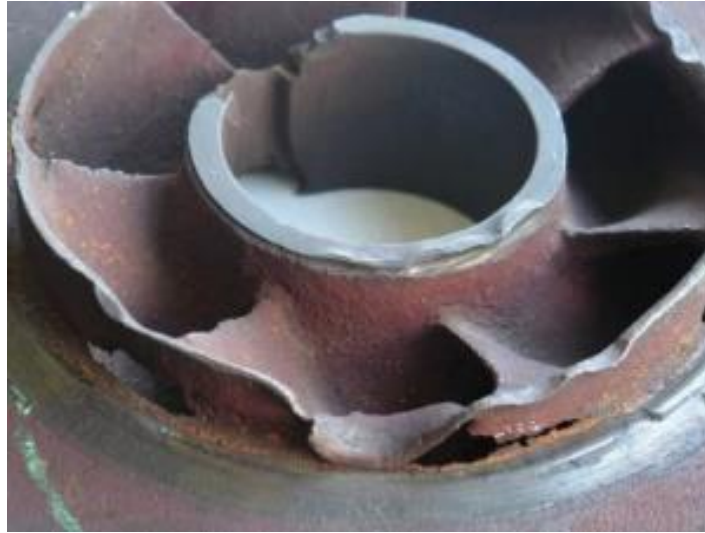
On the one hand, cavitation itself causes a loss of hydraulic power and therefore affects the system parameters. On the other hand, cavitation can be the cause of other faults, including, above all, damage to the impeller; see Figure 2.9.

Figure 2.9: Damage to an impeller due to cavitation (Milan, 2004)

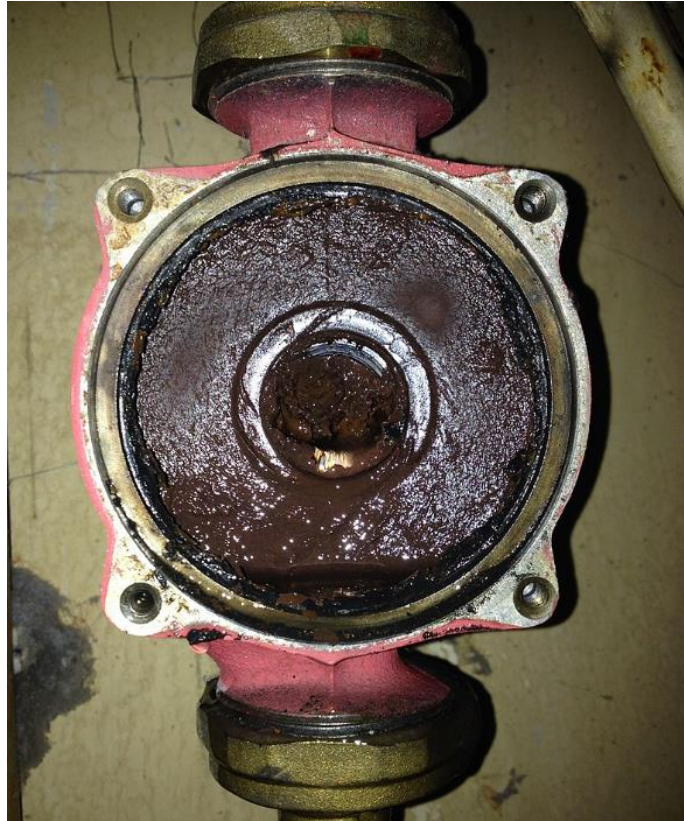
Solids in the transport medium can also be the cause of damage to the impeller. In addition, solids can cause the impeller to clog partially or completely. In wastewater applications, clogging of ESPs is the most common problem; it can cause increased energy consumption and additional maintenance and emergency call-outs (Flygt, 2017). The solids settle in the pump's hydraulic unit and slowly adhere to the pump's impeller and to the inside of the pump casing. In the worst case, the impeller is completely blocked, so that further rotation is no longer possible. If the drive is not switched off in such a case, the pump hydraulics may be mechanically damaged or the electric drive motor may be overloaded. 26% of the lifecycle costs of a wastewater pump are caused by its maintenance and 4% are due to downtimes (Flygt, 2015). The most used maintenance approach is the reactive approach, which means having an employee cleaning the pump while the plant is out of service. Even with circulating pumps, for example, a blockage can be caused by solids or contaminants in the piping system, as can be seen in Figure 2.10.

Figure 2.10: Circulation pump blocked by contaminants (Janlepkowski, 2014)

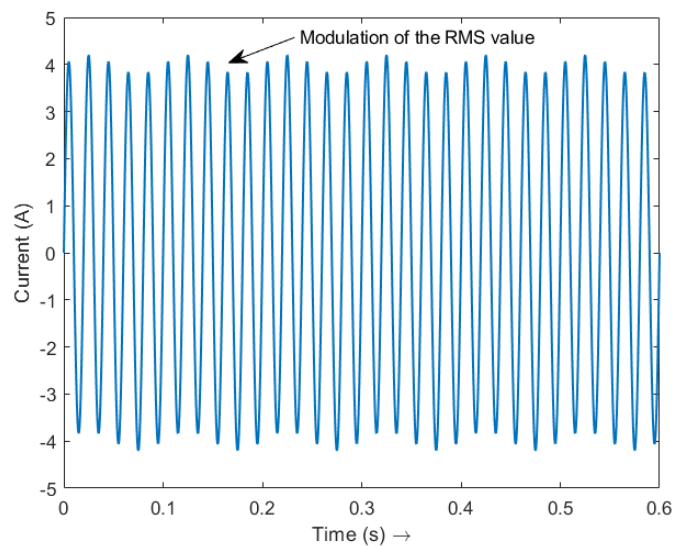
The current signals contain information about the condition of a motor. A simple, rough method is to consider the waveform of the three current signals of a motor. For example, an imbalance between the currents can indicate an electrical problem in the electrical circuit. However, a problem in the supply system can also cause an imbalance in the current signals. Then again, the modulation of the RMS value of the continuous current may be an indication of the presence of rotor damages, although it may also be due to other causes such as oscillations in the driven load.

Figure 2.11: Example of a rough analysis of the current analysis of a motor (Antonino-Daviu, 2019)

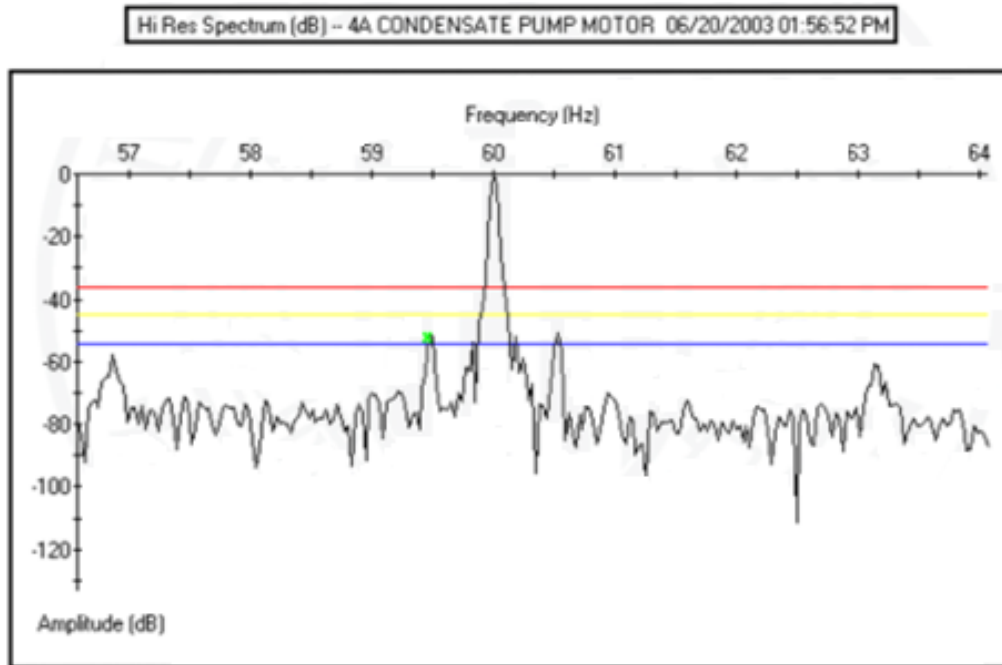
Figure 2.12: Example of an MCSA with implemented threshold systems in the frequency range from 56.5 to 64 Hz (Antonino-Daviu, 2019)

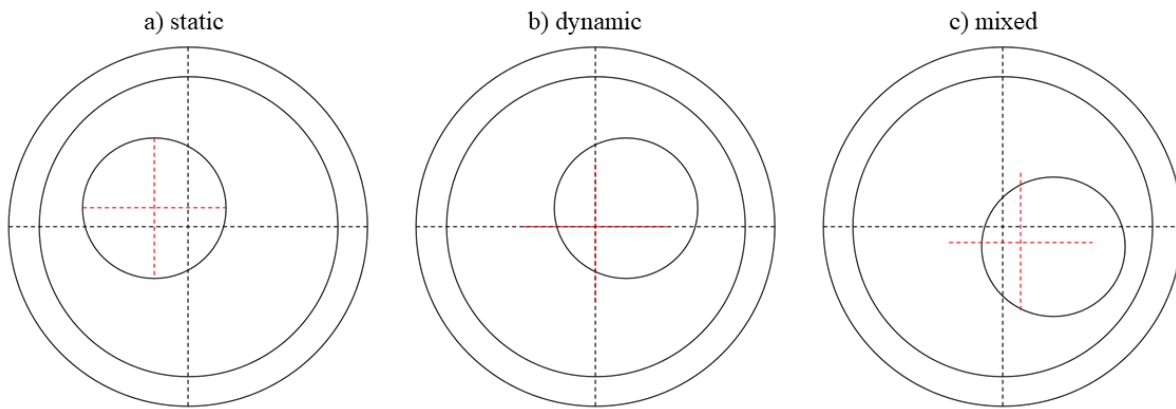
Figure 2.13: Different types of eccentricities in electric motors

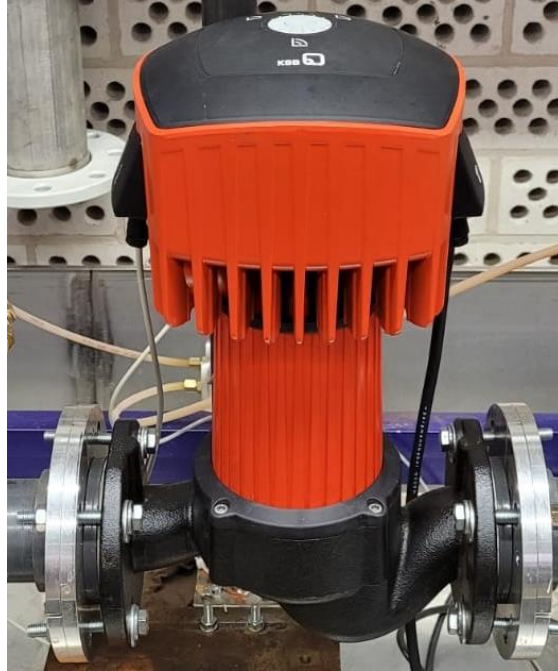
Two different wet-rotor pumps with the same design, but different sizes, were measured in several measurement campaigns. This pump type is applied in one-pipe and two-pipe systems, underfloor heating systems, boiler or primary circuits, storage tank circuits, solar power systems, and heat pumps. The motor power of the first pump was 800 W and that of the second one 150 W. Note that the power rating is based on the rated mechanical power of the motor. The maximum power consumption (typical specification for these pumps) indicated on the pump type plates is higher than the indicated values in both cases. Figure 4.1 shows a picture of the 800 W pump installed in a test bench.

Figure 4.1: Picture of the measured wet-rotor pump with 800 W

As motor technology, a PMSM with a concentrated stator winding (tooth coil winding) was used. The rotor was built with surface-mounted permanent magnets. To control the motor, sensorless field-oriented control was applied. The motor currents were measured on the low side of the insulated gate bipolar transistors utilizing three shunt resistors. The current signals are resolved in 12 bit. The pump was constructed as a wet-rotor pump, and the rotor was sealed against the stator with a can. The rotor of the pump ran in a can filled with water. The rotor shaft was mounted in hydrodynamic journal bearings. In order to cool the stainless steel can, the water circulated in the can. This was achieved by channels in the journal bearings and a hollow shaft. For the impeller, a radial impeller was used.

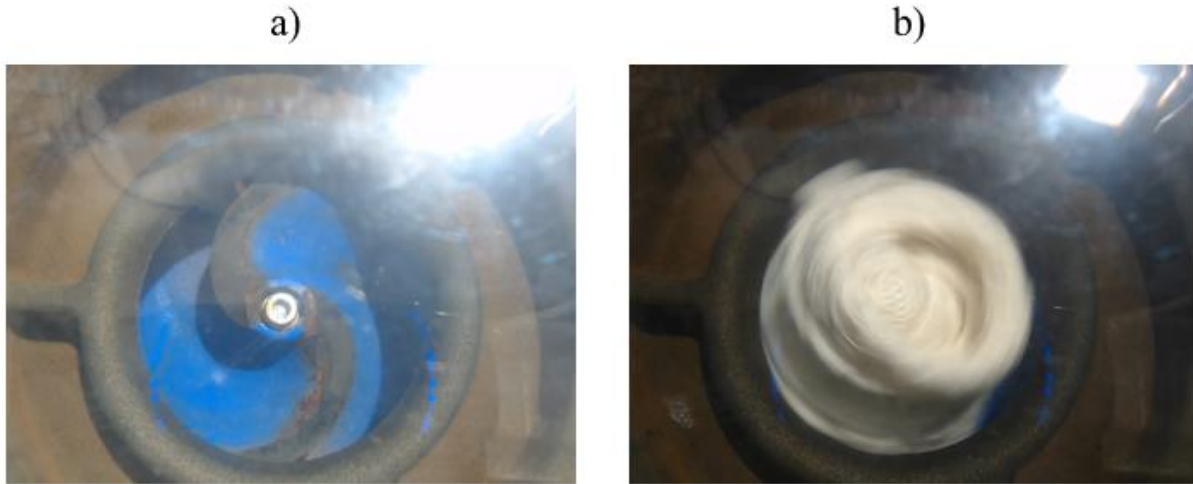
Figure 4.5: Standstill ESP impeller in healthy condition (a) and running with clogging (b)

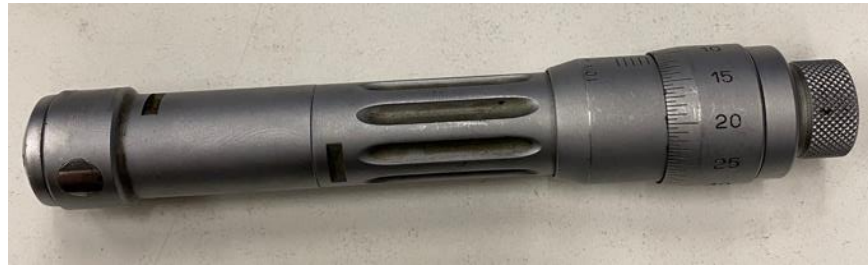
After grinding down the diameter of the bushing, a special measurement device was used to check the measure. After assembling the individual components and measuring, the measurement was

taken again to validate whether the diameter had changed. However, no change in diameter was detected during the measurement in any case.

Figure 4.8: Measurement device for measuring the bushing diameter

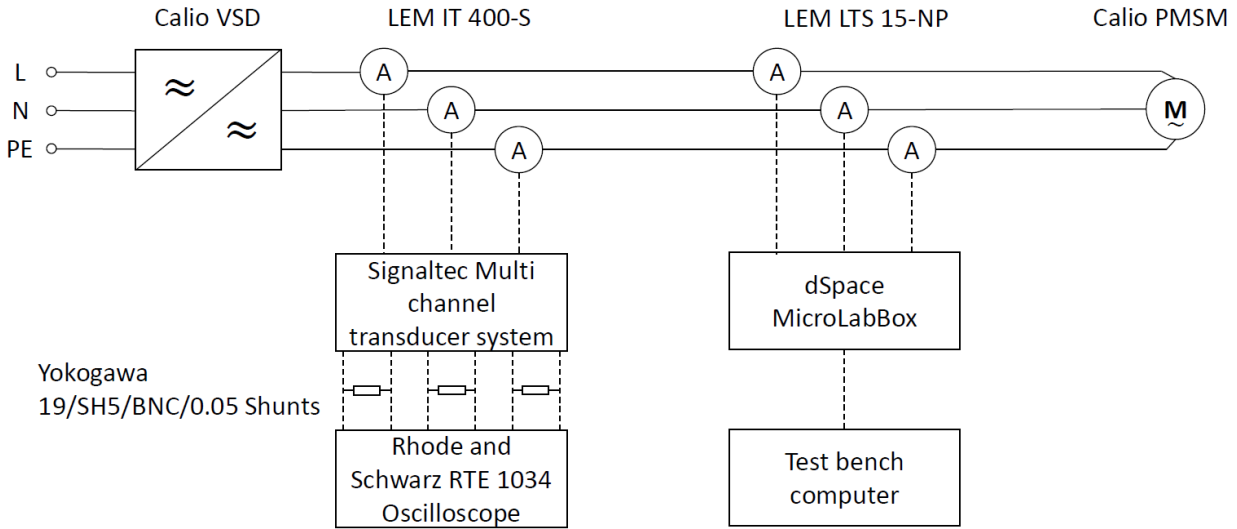
Figure 4.22: Measuring concept of the laboratory test for ARFT validation

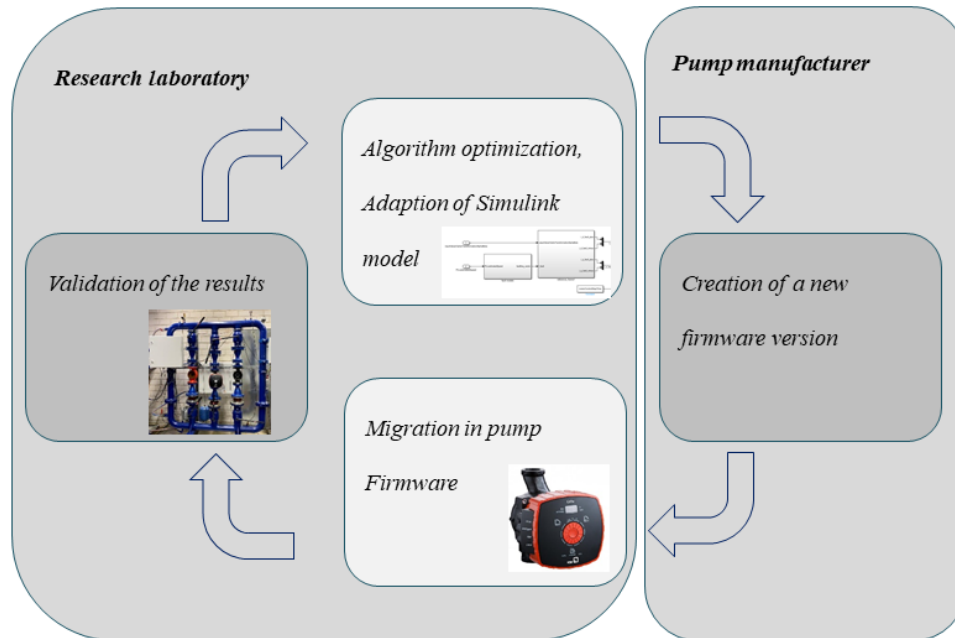
Figure 4.24: Methodology for verifying the function of the ARFT method in a field test

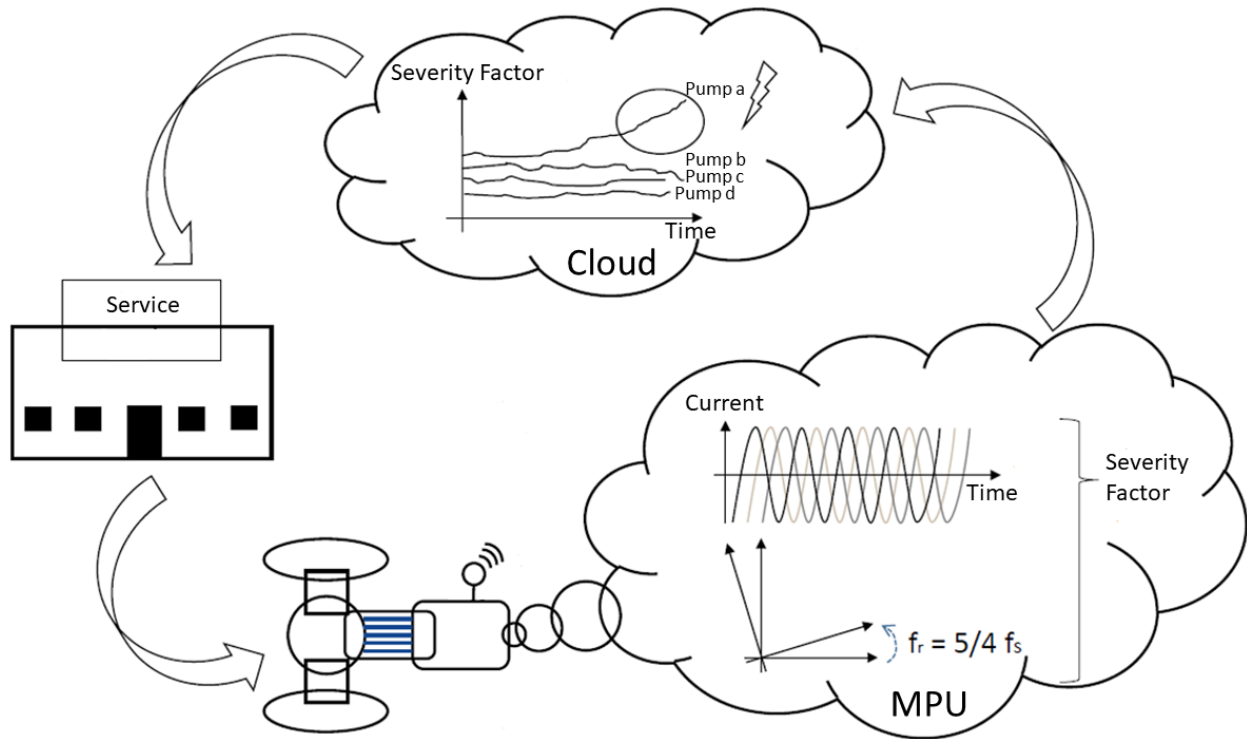
Figure 4.25: Proposal for cloud-based monitoring of a pump fleet based on feature extraction using ARFT

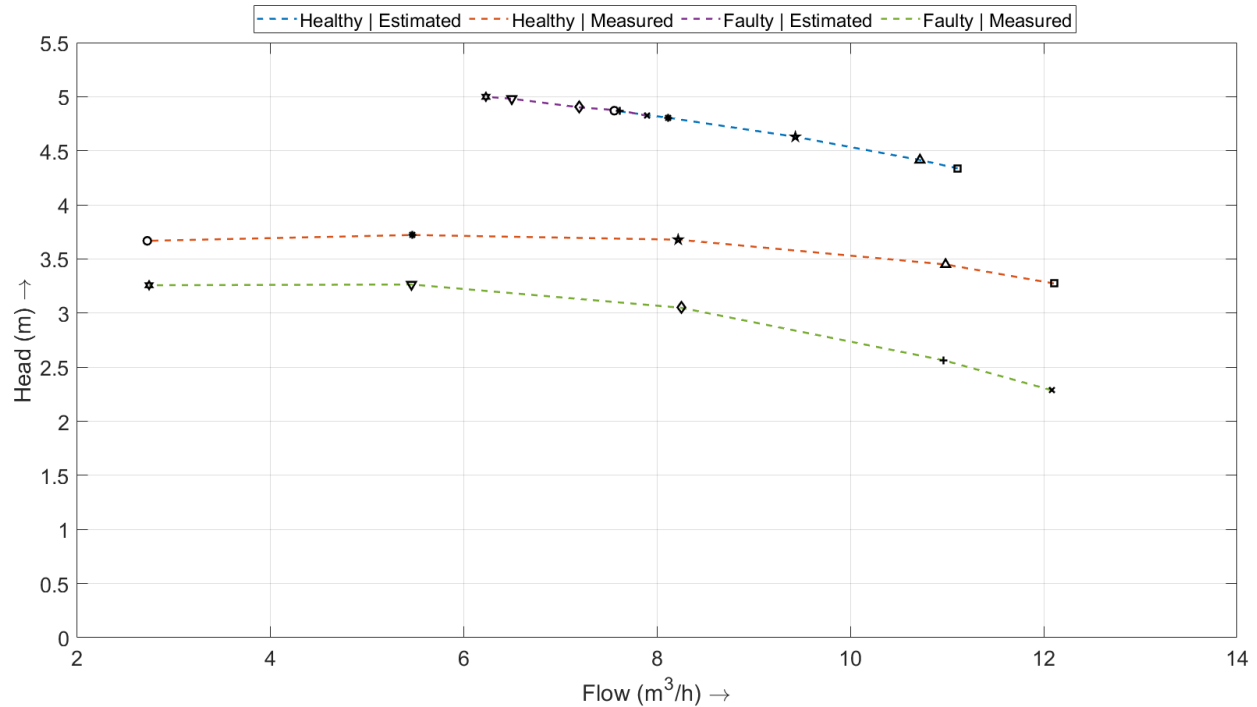
Figure 5.1: Influence of a fault on the parameter estimation of a pump, in the example of a circulation pump (800 W) running at 1870 rpm in healthy condition and with 2 clogged channels. If, for example, the estimated flow decreases in the field because of increasing clogging or impeller wear, the plant operator only observes a trend of decreasing flow and increasing head of the pump, which can be a process over several years. The seemingly low flow could lead to the conclusion that the pump being used is oversized for the process.
