Reuse process for timber elements to optimise residual performances in subsequent life cycles

Stefania De Gregorio

DICEAA, University of L'Aquila, L'Aquila, Italy.
Email: stefania.degregorio@univaq.it

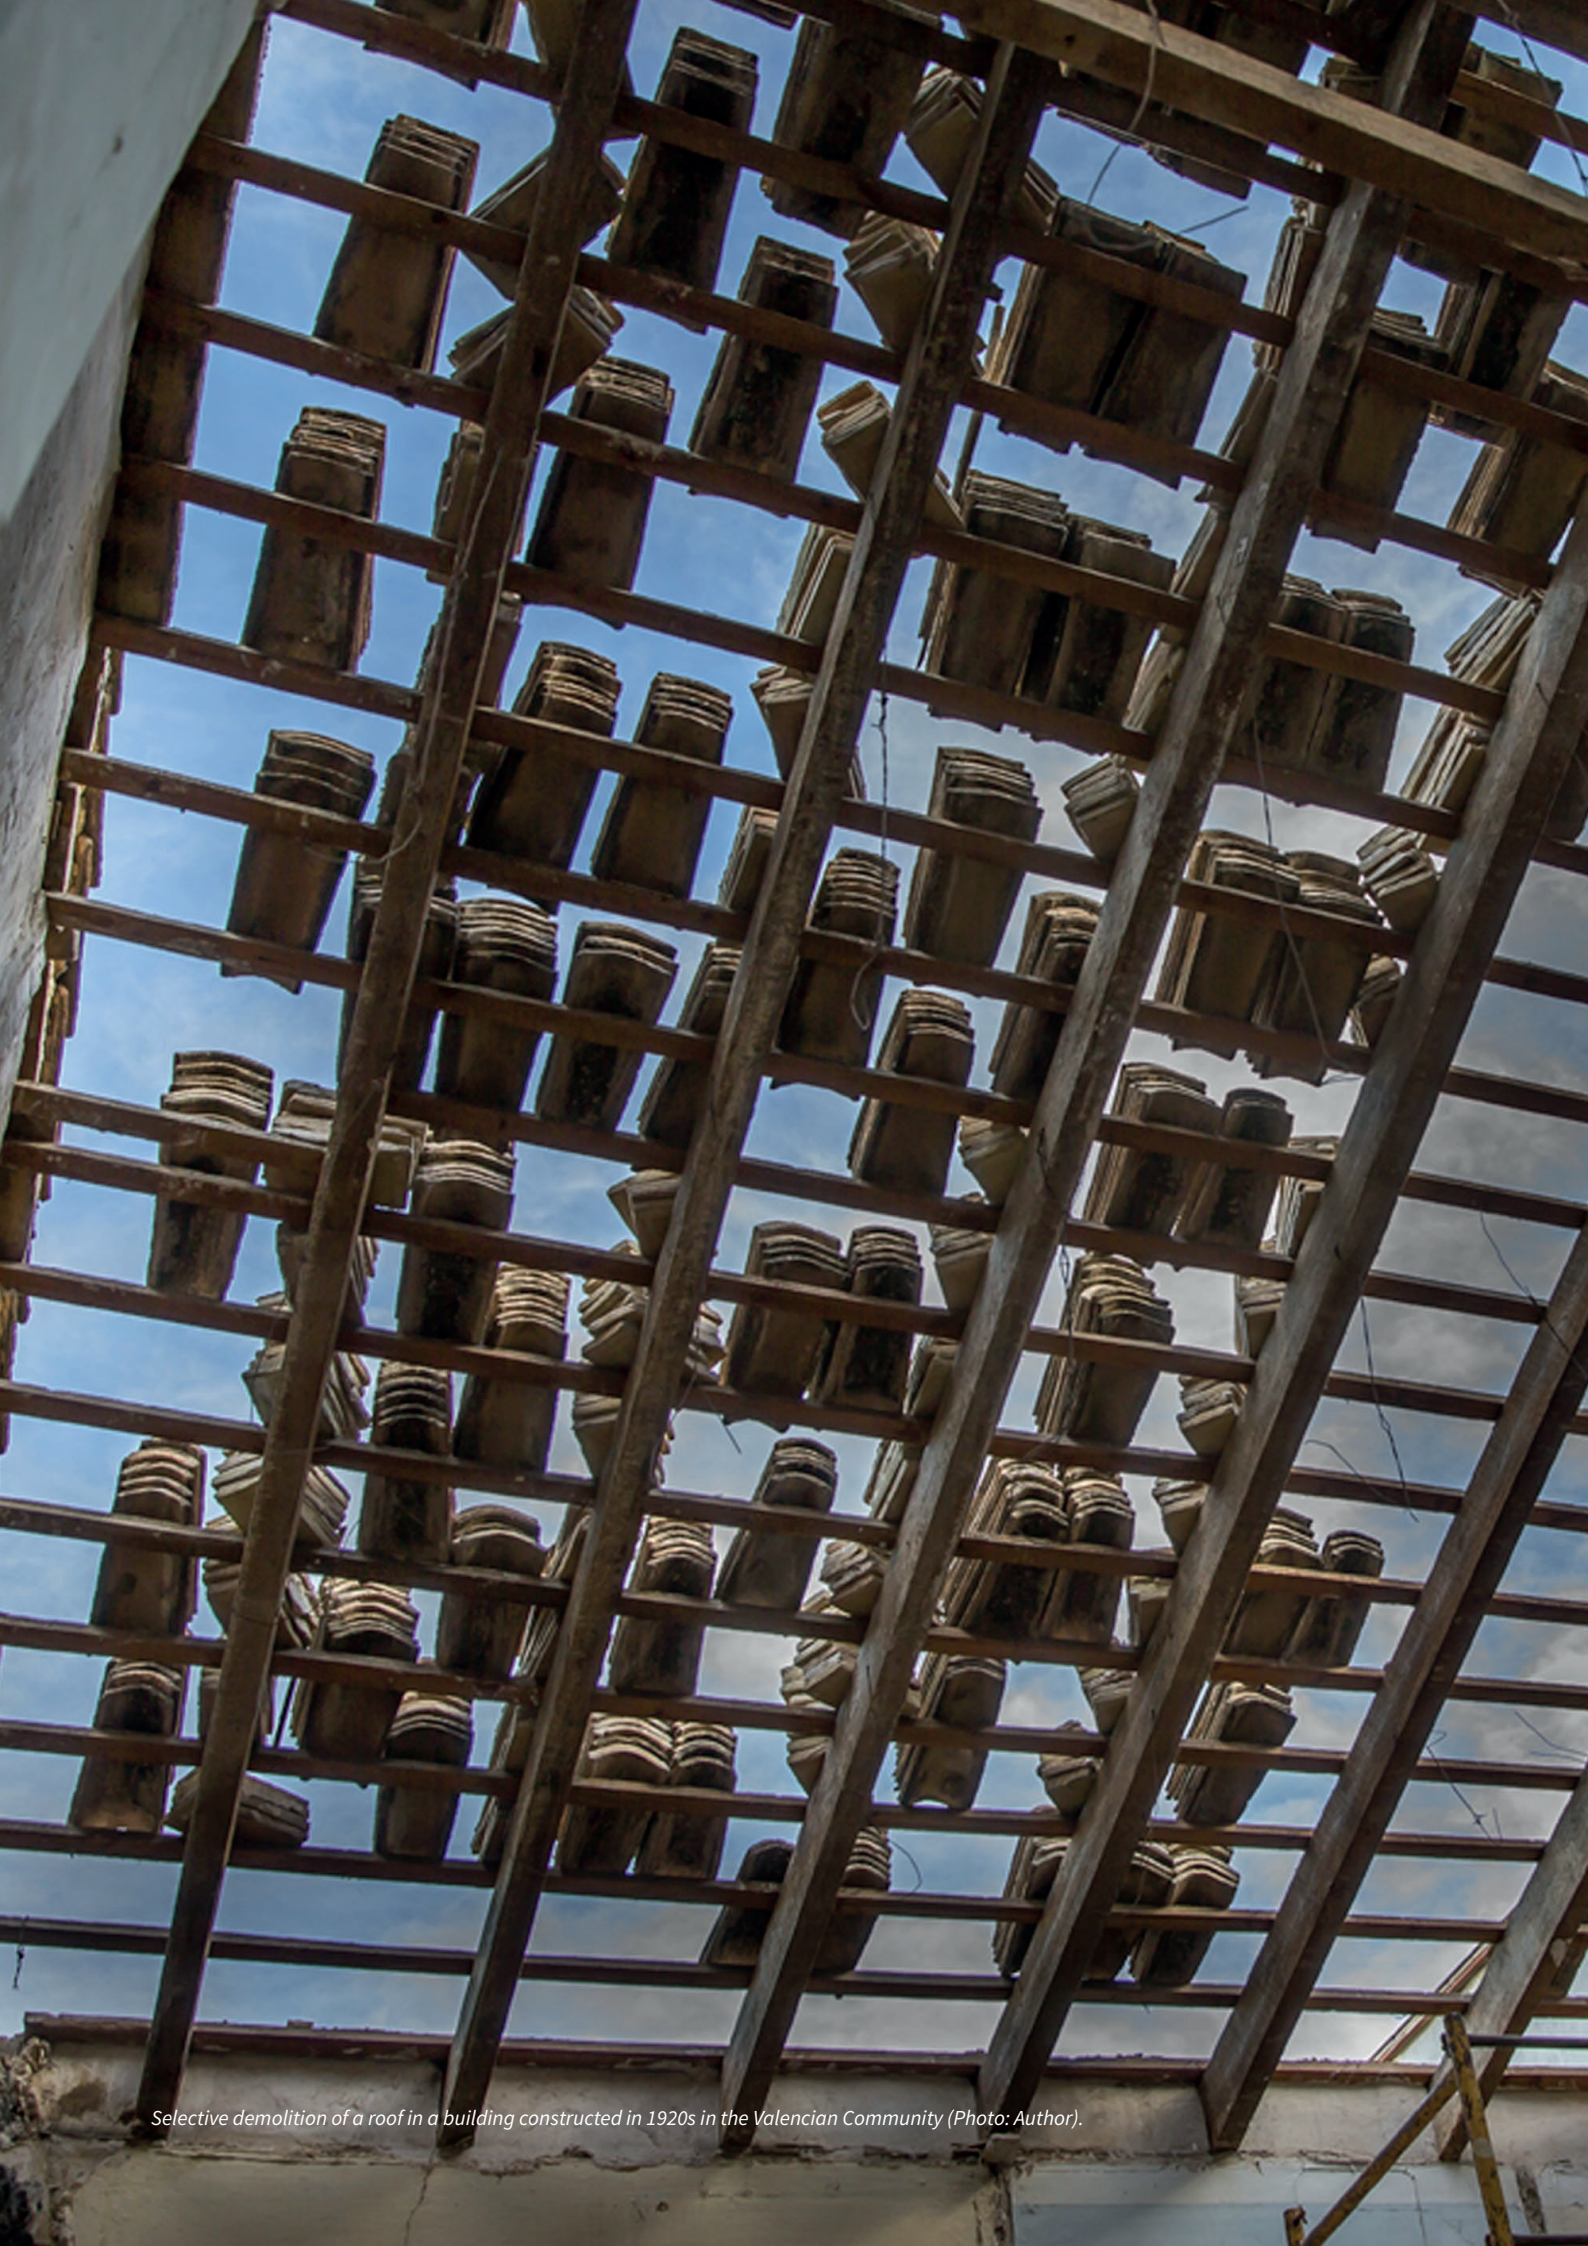
Selective demolition of a roof in a building constructed in 1920s in the Valencian Community (Photo: Author).

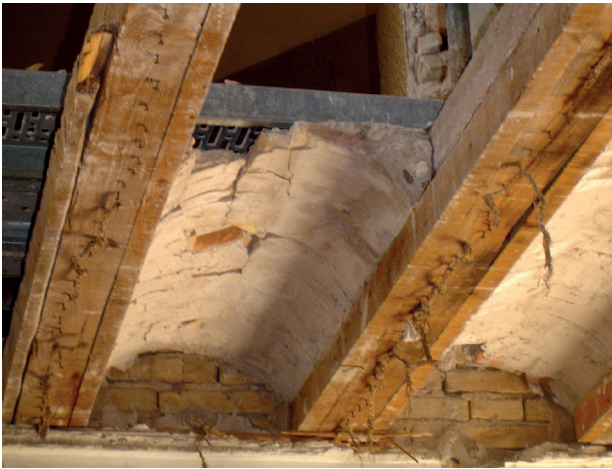
Figure 2 | Jack arch floor in Valencian Community.

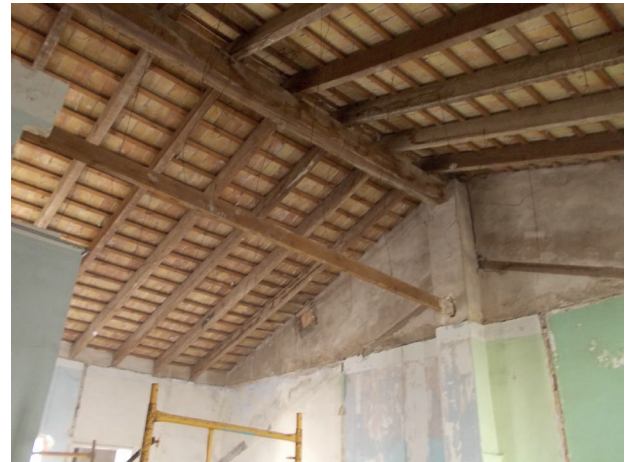
Figure 3 | Traditional roof in Valencian Community
