Pereiro-Barceló, J.; Bonet Senach, J.L.; Rueda-García, L.; Ciurana-Tatay, Á. (2022). Behaviour of retrofited precast UHPC and Ni-Ti SMA column-to-foundation connection with CFRP wrapping layers. *Construction and Building Materials*. 323:1-17. <https://doi.org/10.1016/j.conbuildmat.2022.126536>

# BEHAVIOUR OF RETROFITED PRECAST UHPC AND Ni-Ti SMA COLUMN-TO-FOUNDATION CONNECTION WITH CFRP WRAPPING LAYERS

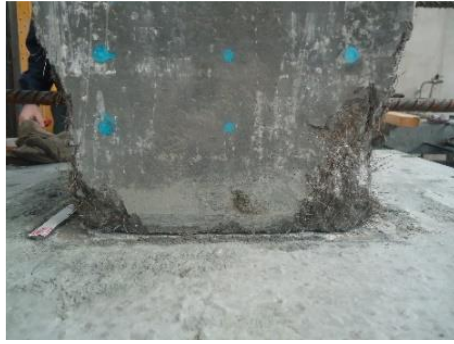
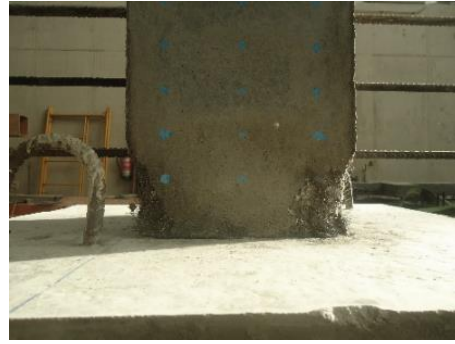
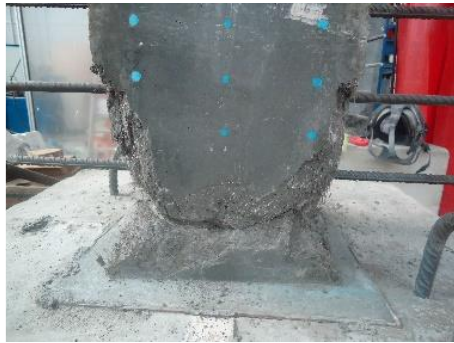
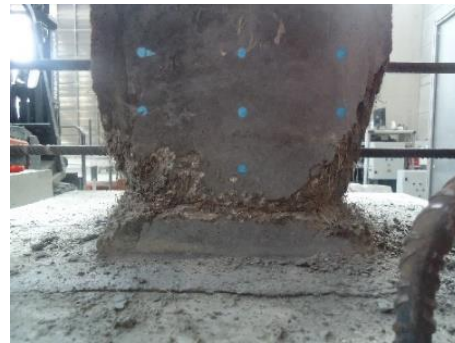
2 *Figure 3: Column damage: (a) specimen Z1R-PBV02-2L; (b) specimen Z2R-PBV02-3L; (c) specimen Z3R-*  
3 *SPV02-2L; (d) specimen Z4R-SPV02-3L.*

Figure 3 depicts the critical zone of the four specimens after removing damaged concrete. As can be seen, the damage in the critical zone depended on the type of connection with the foundation. The specimens with a PB connection (Z1R-PBV02 and Z2R-PBV02) had further reduced damage, which was concentrated at the column/foundation joint at a distance of between 50 and 100 mm (Figure 3.a and b). However, the section at the interface between the column and the foundation remained undamaged in the specimens connected by an SP type connection (Z3R-SPV02 and Z4R-SPV02). The most seriously damaged area was around the main crack in the column, with damage reaching up to 200 mm from the top of the foundation (Figure 3.c and d).

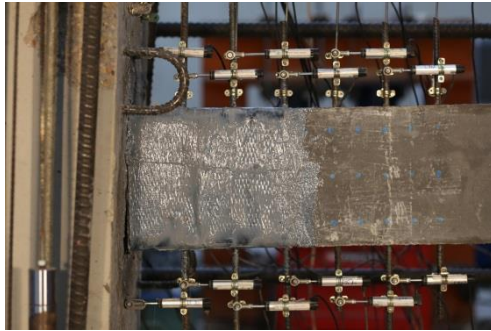
6 *Figure 9: Repaired specimen appearance at ultimate (second test stage).*

7 **Figure 9** depicts the behaviour of the specimens for a drift ratio ( $\Delta/L_s$ ) of approximately 5%, where  
8 the shear force ( $V$ ) was practically zero and there was at least a 20% lateral load ( $V'$ ) loss (**Figure**  
9 **7**). **Figure 10** depicts column damage at the end of the tests after removing the CFRP sheets. The  
10 following general observations were made:

7 2. As found in the first test stage, rocking behaviour took place in the joint between the column and  
8 the foundation in the specimens with the PB connection type (Z1R-PBV02-2L and Z2R-PBV02-3L)  
9 (Figure 9.a and b) due to loss of adhesion between the Ni-Ti SMA bars and UHPC because the  
10 tensile strain required by the gap opening was not concentrated on the joint but was distributed along  
11 the entire length of the Ni-Ti SMA bars. The confinement provided by the CFRP wrapping allowed  
12 both the UHPC and high-strength mortar to achieve high strains without crushing (Figure 10.a and  
13 b). No broken CFRP wrapping was detected in the repaired area. In the Z1R-PBV02-2L specimen  
14 bulging occurred at the end of the test on one specimen lateral face at a distance of 100 mm from  
15 the joint. As at the end of test of specimen Z2R-PBV02-3L, there was slight noise due to breakage

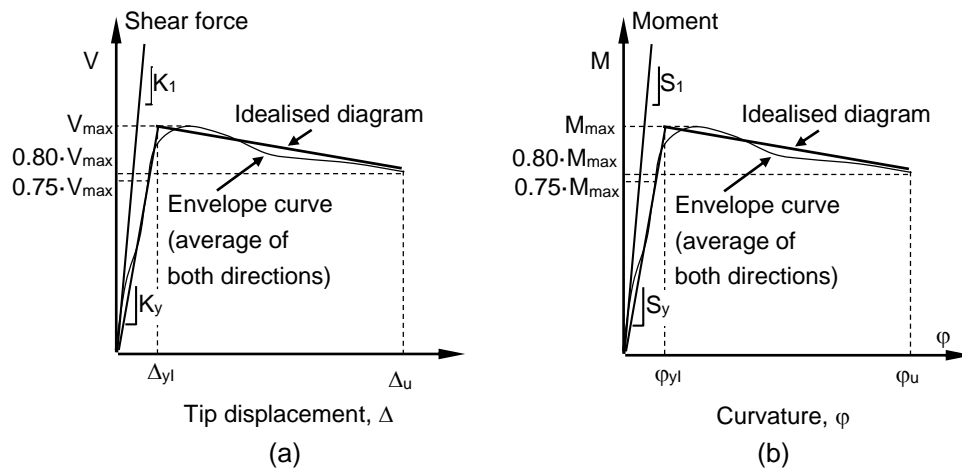
Figure 13: Ideal curve definitions [12].

16 [Figure 13](#) shows the idealisation of the actual envelope diagram [59,60] shear force-tip displacement  
17 ( $V - \Delta$ ) or moment-curvature ( $M - \varphi$ ) in a bilinear diagram made up of an elastic branch and a  
18 decreasing inelastic branch. The bilinear diagram can calculate the ultimate displacement ductility  
19  $\mu_{\Delta u} = \Delta_u / \Delta_{yI}$ , where  $\Delta_u$  is the ultimate displacement of the column at 0.80 of the maximum load on  
20 the descending branch, and  $\Delta_{yI}$  is the effective elastic displacement. The ultimate curvature ductility  
21 is  $\mu_{\varphi u} = \varphi_u / \varphi_{yI}$ , where  $\varphi_u$  is the ultimate curvature of the section at 0.80 of the maximum moment  
22 on the descending branch, and  $\varphi_{yI}$  is the effective elastic curvature.
