URBAN AND HYDROGEOLOGICAL ALERT ON THE MORPHOCLIMATIC RISK AFFECTING QUITO'S WORLD HERITAGE

Commission II - WG II/8

KEY WORDS: Natural Risk, Ravines, Quito, Heritage, Memory

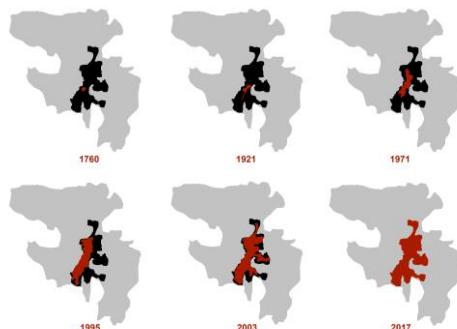
Figure 1. Quito urban growth. Credits: Paola Bracchi.

Enclosed within colonial borders until the 20th century, Quito experiences an important population explosion fairly fast. While in 1902 the city took up 200 hectares of land, this number increased to 1300 hectares in 1950 and currently the whole Distrito Metropolitano (which includes the city and its surroundings) has an area of 290746 hectares. Urbanised land has an area of 43116 hectares. From the second half of the 20th century until now the size of Quito has grown tenfold, with a significant acceleration in the last decade. Its urban population reached 1.98 million people according to the latest census.

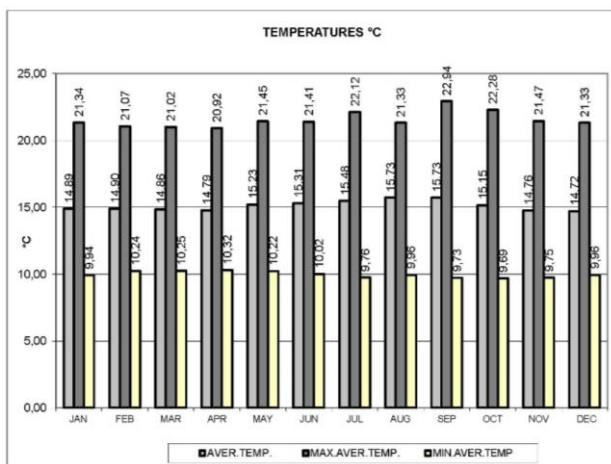
Table 1. Average temperature 2000-2012, INAMHI.

Data from the National Institute of Meteorology and Hydrology (INAMHI, 2015) shows that between 2000 and 2012, the average temperature is roughly 15°C. Regarding maximum temperatures, the average is roughly 22°C, with highs of up to 30°C in dry months (June, July and August). In terms of minimum temperatures, annual average oscillates between 8°C and 10°C, reaching night lows of 4°C or 5°C.

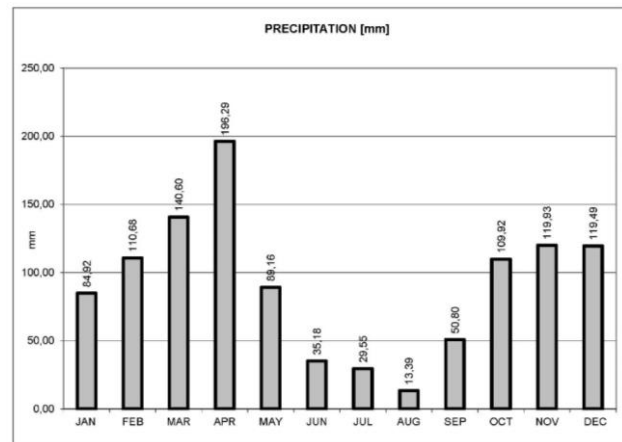
Table 2. Average rainfall 2000-2012, INAMHI.

According to data from INAMHI, between 2000 and 2012, March and April were the rainiest months with average values ranging between 140 mm and 196 mm, and August is the driest month with average rainfall values that reach a meagre 15 mm. The differentiation between the south/central region and the north region of the city should be noted regarding rainfall. As Peltre (1989) points out, "the Pichincha volcano protects the north of the city from the incoming humid air masses from south-west. In addition, the effects of dry and warm winds flowing down through the Guayllabamba basin, which strongly diminishes the concentration of atmospheric humidity in the northern part of the city and in the Perucho, Guayllabamba and San Antonio sectors. The intensity of rainfalls, despite not very voluminous in absolute terms, allows fairly strong drippings in the steep slopes.

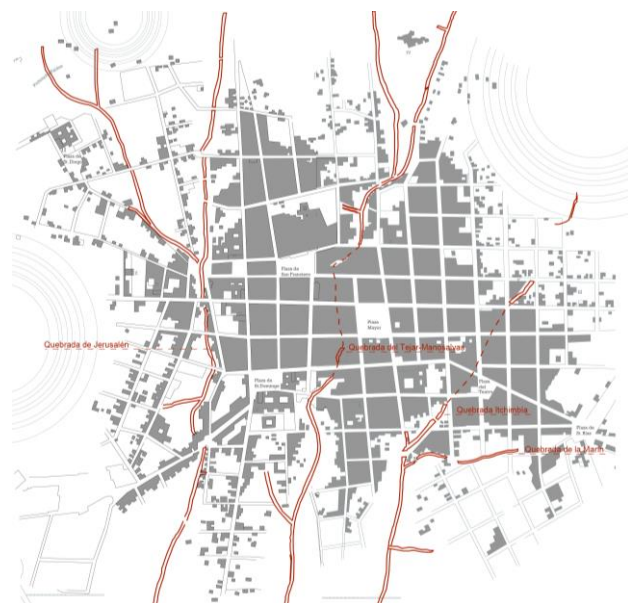
Figure 3. Quito's ravine in relation with the ancient urban fabric of the historical city centre. Credits: Paola Bracchi.

As previously stated, initially the urban fabric of HCQ – before the fillings – was adapted to the presence of ravines which made their way down from the eastern slope of the Pichincha volcano down to the Machángara river. The historical maps provide evidence for the existence of four main ravines. The first one, the Jerusalén ravine, defined the southern rim of the city and it coincides with current 24 de Mayo Street. The second one, Tejar or Manosalvas ravine/s, crossed the central part of HCQ which is completely covered by the urban fabric today. The third one, the Ichimbía or Pilishuaico ravine, crossed through the northern end of the historic centre. It also runs below the urban fabric and borders the current theatre square. The fourth one, the Marín ravine, is a ravine of smaller size which marks the eastern end between the historical centre and the Itchimbía hill.

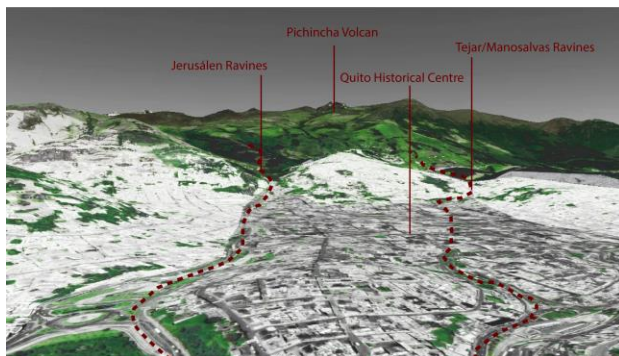
Figure 4. Quito's ravine in relation with the contemporary urban fabric of the historical city centre. Credits: Paola Bracchi.

It is important to point out that none of these ravines is currently visible within the HCQ perimeter. The process of urban growth and the need to answer technical and infrastructural questions of fabric continuation, fulfilment of direct connections and water channelling, determined the gradual filling of the ravines.

From the 18th century onwards, the ravines began to be closed in a fragmented and discontinuous manner according to particular interests. This phenomenon became symptomatic and recurrent when the city began to grow consistently outside the limits of the colonial model, that is, from the 20th century onwards.

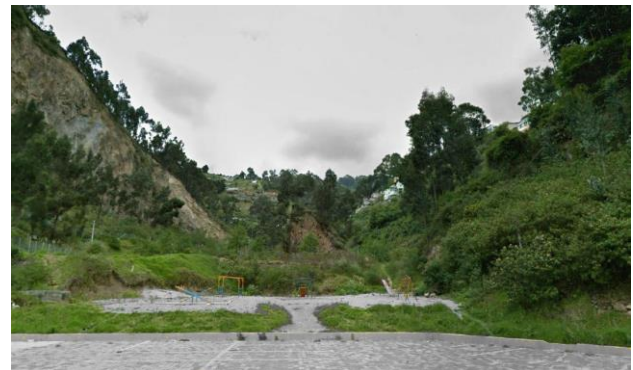
Figure 5. Closer point of Jerusalén ravine.

The first drainage system in Quito began construction in 1905, with the water discharge network placed in the ravines. The first sewer pipe built was located in the Jerusalén ravine, followed by those of Sucre and Manosalvas (found in the Tejar and the Manosalvas ravines). The Tejar sewer pipe was built along the Tejar ravine and connects with the Itchimbía ravine.

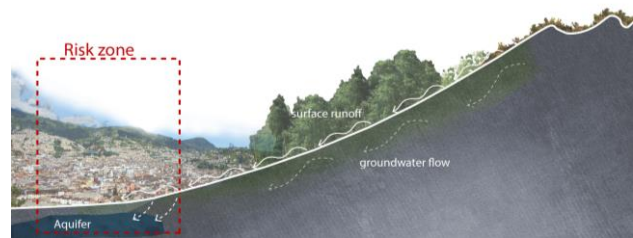
Figure 6. Pichincha slope water system facing with the valley. Surface runoff and Groundwater flow.

The development of the combined evacuation network of ravine waters has contributed to the disappearance of the site's natural drainage. The filling of ravines generates flooding, underground dripping, sinking, mud flow and torrential lava. These are catastrophic phenomena which threaten the city in general and the heritage of HCQ in particular.

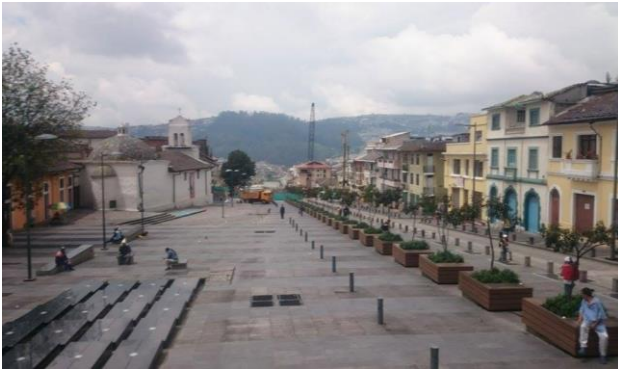
Figure 7. 24 de Mayo Boulevard realized above the Jerusalén ravine. Photo by Marianela Cruz.

The city's first regulatory plan came about in 1944, inspired by maps of European origin which foresaw great axes for wheeled transport. It is in these dates that the avenue Pichincha is realized, that it breaks carelessly in the historical centre and it extends on the filled ravines of Itchimbía and La Marín. Sucre street expanded towards the south above the filled Manosalvas ravine. These two streets, which follow the original ravine's paths, flow into a major transport intersection in HCQ, the Marín bus station.

In the early 70's the latest transformations of the historic path took place, which also modified the relationship with the ravines' natural system, creating significant problems in built-up spaces. At HCQ's eastern rim the San Juan tunnels were built. The great displacements needed to create these underground road systems, caused structural damage to La Merced church and several other buildings in San Diego's neighbourhood. Furthermore, this underground system also breaks up the natural relationship with the ravines and is subject to great flooding during rainy season.

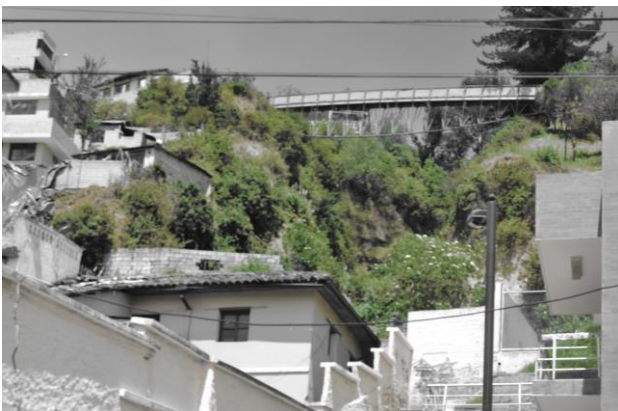
Figure 8. Contemporary condition: constructions above the Itchimbia ravine. San Juan slope. Photo by Marianela Cruz.

2. The ravines have been filled as a consequence of the increasing price of land. Towards the end of the 16th century, Quito experiences a population rise. This rise determines the expansion of the original colonial town. It also defines the willingness of central land-owners to sell their land at good prices. These reasons explain why the Historic Centre's ravines have been filled in a fragmented manner and with no planning. This is obvious at the Tejar/Manosalvas ravine, where various owners had the chance to engage in fillings around the Plaza Mayor with their own money. This became the norm over time, and anyone with enough funds could fill up the part of the ravine within its property area in order to increase buildable space. This is exactly what was found with the Jesuits. Under the Compañía de Jesús church the Tejar/Manosalvas ravine flows. Some excavations undertaken for maintenance have revealed the system of cementation used with an ancient Roman technique known as *sostruzione*.

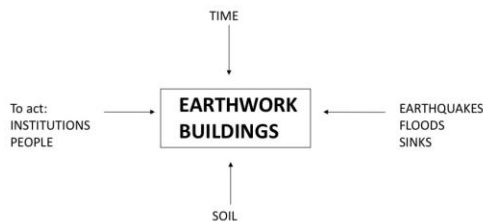
Figure 9. Relation between Ravines filling and built-up heritage. Credits: Dario Giordanelli.
