Article

Above the Ravines: Flood Vulnerability Assessment of Earthen Architectural Heritage in Quito (Ecuador)

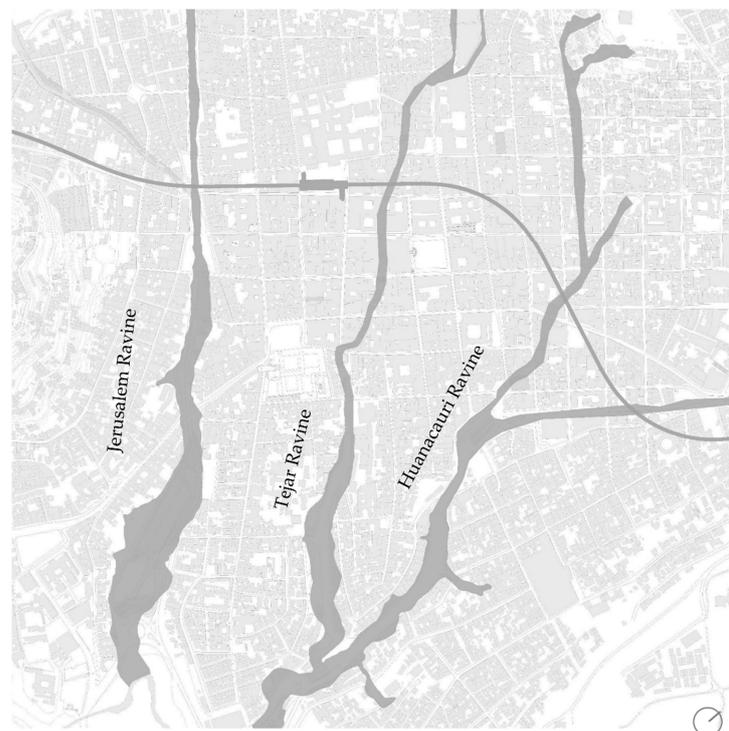
Figure 2. Map of the most exposed area with the hypothetical course of the ravines. Scale: 1:8500.

During the first phase of research, a territorial analysis was carried out to identify the area most affected by flooding risk. Through the study of maps and historical documentation, a hypothetical trace of the course of the ravines was reconstructed, whose footprint today is not visible on the surface. According to the historical sources, three streams influenced the process of the urban development of the founding nucleus of the city of Quito. The ravine of the southwestern end, called Ullugangayucu, successively known as Jerusalem, closed the city by this sector, running at the foot of the Panecillo Hill. On the other side, from the foot of the mountain of San Juan to the south, ran the Huanacauri Ravine. Between these two ravines, the deepest one ran, known as Sanguña and later as Tejar, due to the presence of tile ovens in its proximity. This ravine descended from the slopes of the Pichincha volcano, joining the Placer Hill in the current Ipiales market, and known by the name of Manosalvas and its eastern end. From the XVII century, these ravines were filled very fragmentarily until the XX century, when the final projects of channelling and coating were conducted. Thus, the three ravines that descend from the foothills of the Pichincha constitute one of the most important conforming elements of the city. Up to the XIX century, the perimeter ravines and the temporality of the roads or trails hindered the implantation of a stable grid. The blocks built on the beds of the ravines have an irregular shape, which stand out from the general structure of square blocks of 90 m on each side. Thus, the city has been developing on the ravines. In some cases, the footprint is perceived in the layout of the streets, created as a result of fillings over time; in other cases, the traces of the ravines seem to disappear in the urban grid, leaving space for the full conformation of the blocks. Although these ravines are not visible, they continue to affect the architectural heritage because of the capillarity of the groundwater, as well as the consequences of floods in periods of maximum rainfall when water descends from the slopes of the Pichincha volcano. Through the reconstruction of the course of the ravines and the use of the flood vulnerability map of the disaster risk management plan for the central nucleus of the historic centre of Quito [34], the map of the area most exposed to flood was obtained. Figure 2 shows the hypothetical course of the ravines (dark grey) over the grid of the city.

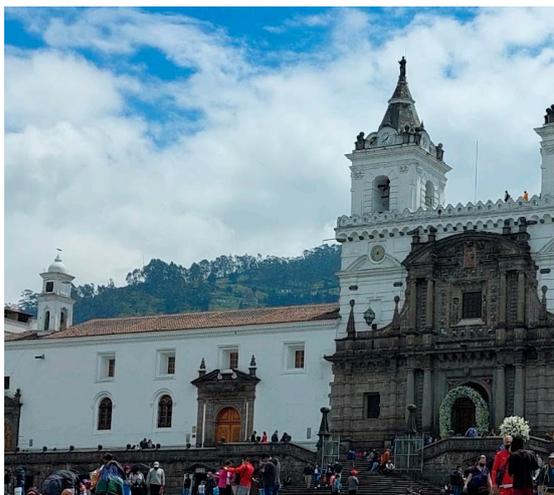
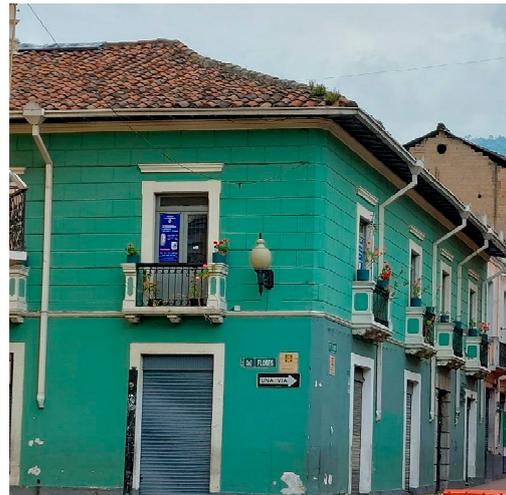
Figure 5. (a) Case study map. Scale: 1:8500. (b) Picture of a religious building. (c) Picture of a residential building.
