INTEGRATION OF RURAL ARCHITECTURAL HERITAGE: THE CASE OF THE ALQUERÍAS IN NORTHERN VALENCIA

Daphné Gosselin Calvignac^a, José Luis Baró Zarzo^b, Laurent Debailleux^a

Gosselin Calvignac, Daphné, José Luis Baró Zarzo, and Laurent Debailleux. "Integration of rural architectural heritage: The case of the alquerías in northern Valencia." In *Proceedings of 3rd Valencia International Biennial of Research in Architecture. Changing priorities*. Valencia. 2022. <https://doi.org/10.4995/VIBArch2022.2022.15233>

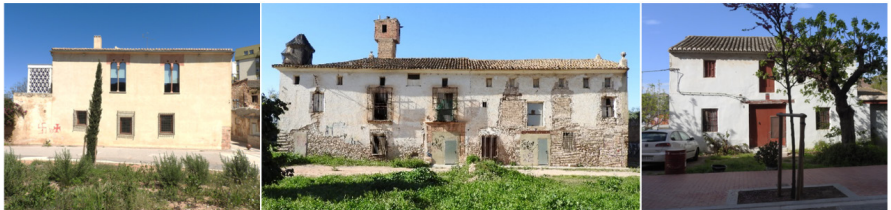
Figure 1. The three main historical types of alquerías: late medieval alquería (alq. del Moro), silk alquería (alq. de Falcó), casa de labrador (alq. Visquet). Source: (Gosselin 2022)

The Huerta de Valencia (*huerta* meaning orchards or fruit trees garden) is a vast irrigated plain where market gardening is intensively practiced. Although it was already cultivated during the Roman period, the current structure of the Huerta is inherited from the medieval Muslim society (8th to 13th century). Therefore, it is a landscape heritage by itself. It also gathers other forms of heritage, such as architectural, like late medieval alquerías (13th to 15th century), silk alquerías (16th to 18th century), *casas de Labrador* (19th and 20th centuries) (see Fig. 1), modest vegetal roof *barracas*, and

remaining today were built from the 17th to the 19th century. Alquería del Moro (Fig. 1) and alquería de la Torreta are the oldest, supposedly built during the Muslim period (13th century, before the Christian reconquest). Thus, it is interesting to notice that, even though the alquerías were invented by the Moors, the great majority of today's remaining alquerías were built after their period of influence.

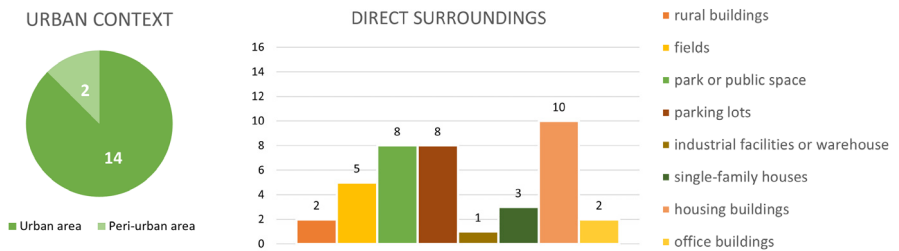
Figure 3. a) Graph of the urban context; b) Histogram of the types of surroundings encountered. Source: (Gosselin 2022)

More than 80% of the alquerías studied are in an urban area (Fig. 3.a), since the area of study, the northern districts of Valencia, was chosen as so. Only two of them, the alquería de Serra and the alquería de Farinós, are still in their original-looking rural environment, although the urban growth threatens the border of the fields. Because the great majority of the studied cases are in an urban area, their surroundings are generally housing buildings and public spaces (Fig. 3.b). One notable point to underline is the presence of parking lots found in half of the cases, which are often the ones in the worst state of conservation. Indeed, these spontaneous parking lots are frequently dirty and anarchic, and thus degrade the quality of the alquería's environment and its overall value.

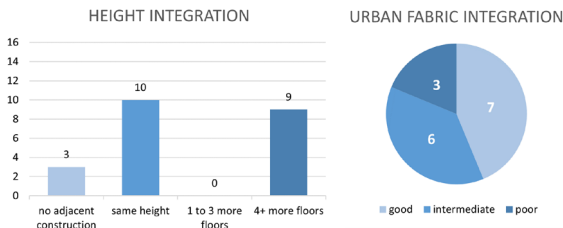
Figure 4. a) Histogram of height integration; b) Graph of urban fabric integration; c) Picture of the alquerías in Olba street. Source: (Gosselin 2022)

The results about height integration (Fig. 4.a) show that most of the adjacent or nearby buildings have the same height as the alquerías or are drastically higher (a difference of 4 floors or more in 40% of the cases). None are slightly

The assignment of the "urban fabric integration quality" (Fig. 4.b) was established based on the streets and buildings' layout in regards to the alquería's layout. In fact, the urban fabric that has formed around the existing alquerías does not always contemplate a transition to the orientation and alignments of the original building, which shows a lack of consideration for this rural built heritage that was supposed to disappear soon. The most obvious example of a poor urban fabric integration is the group of alquerías in Olba street (Fig. 4.c): the 1970's high housing buildings have been built in a 45° angle with the original Olba street alignment (probably because there was no intention to preserve these buildings). The surface

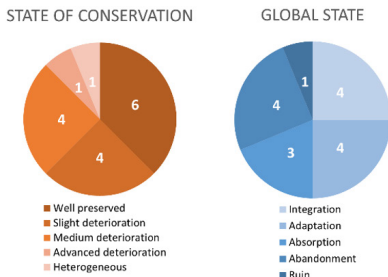
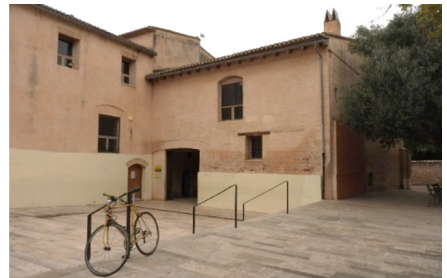
Figure 5. a) Graph of the state of conservation; b) Graph of the global state; c) Picture of the alquería de Barrinto. Source: (Gosselin 2022)

This analysis allowed us to observe certain facts. First, the state of conservation of the studied alquerías in the chosen urban area is very variable (Fig. 5.a). Even though the great majority of the cases has undergone some contemporary interventions (from basic conservation works to full rehabilitation), the integrity and/or heritage value of the building are not always respected, the work done is not always reversible either, and the conservation of the alquería may be jeopardized unintentionally.

Finally, among the 16 studied cases, 3 alquerías could be considered as particularly endangered (Falcó, Torre, and Serra). These buildings are abandoned or already in ruins (Fig. 5.b). If serious actions are not taken soon, their existence would not be guaranteed. On the opposite, one of the best examples of a well-integrated heritage building is the alquería de Barrinto (Fig. 5.c) which certainly benefits from a privileged setting (a building with high historical and artistic values in the middle of a public park). The intermediate cases, absorbed or adapted into their context, must be monitored as themselves and their surroundings include a specific set of opportunities and threats.
