Article

The Influence of Visitors on Heritage Conservation: The Case of the Church of San Juan del Hospital, Valencia, Spain

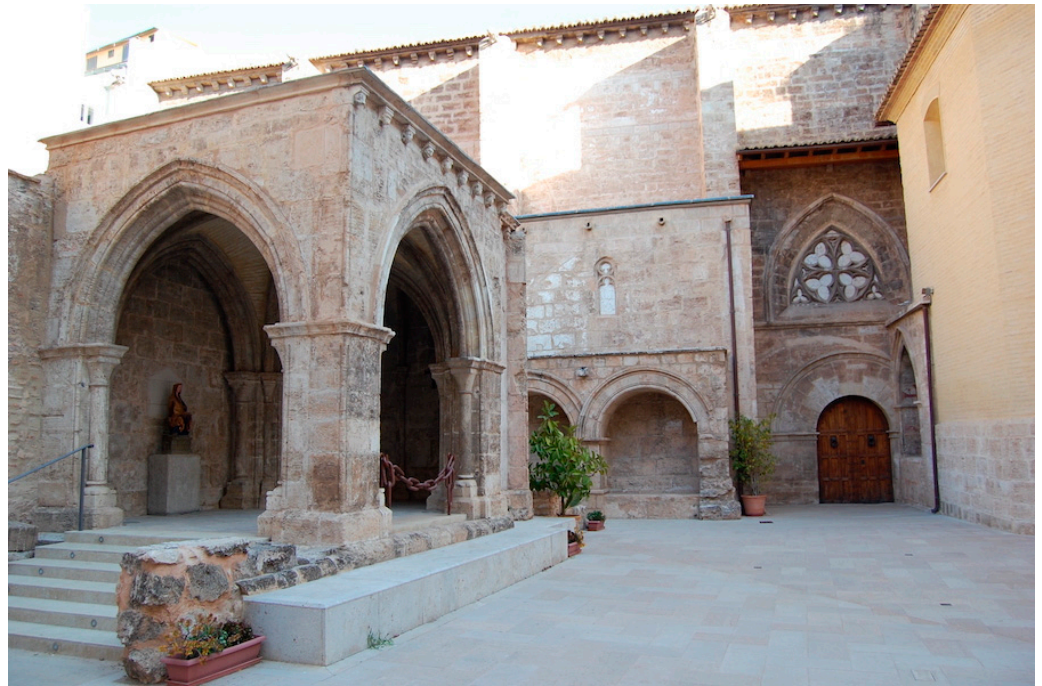
Figure 1. View of the south courtyard, where the cemetery is located, with the chapel on the left and the arcosolium and the South Romanesque doorway behind.

The Church of San Juan del Hospital is in the city of Valencia, Spain. It was chosen as a case study building because it is a good example of heritage that must be preserved, and the church has a high rate of visits throughout the year. San Juan del Hospital is part of an architectural complex that originally consisted of the monks' residence, hospital, cemetery, and temple. It was built in the mid-thirteenth century by the Order of St. John of the Hospital of Jerusalem. It is located next to the Xerea gate of the Arab wall and was a strategic place for the defence of the city. It was the first church consecrated in Valencia after the cathedral in 1238. Only the church and part of the cemetery remain of the original complex. The cemetery is a unique architectural element because it is walled with arcossoliums on its perimeter, and a small funerary chapel on a tumulus located in its centre (Figure 1).

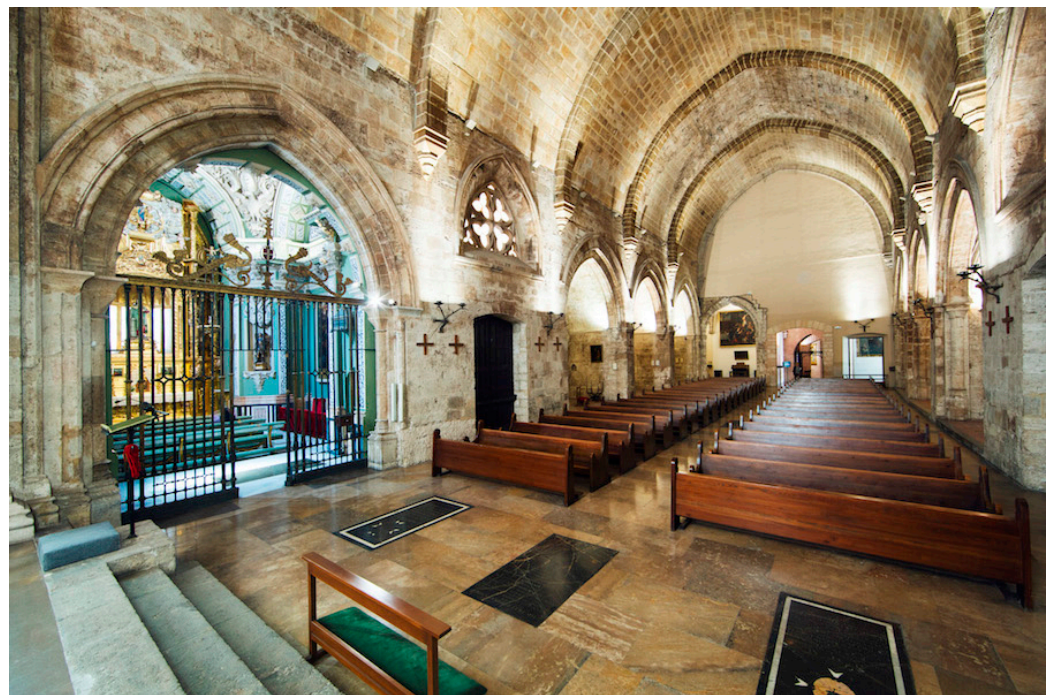
Figure 4. Image of the church interior.

In terms of natural lighting, the windows located in the presbytery are made of alabaster. The church has a lighting system based on fixed projectors. It does not have interior air conditioning equipment, although portable fans are used in the summer for the comfort of the visitors to the church (Figure 4).
