Robustness of a full-scale precast building structure subjected to corner-column failure

Manuel Buitrago^a, Nirvan Makoond^{a,*}, Juan J. Moragues^a, Juan Sagasetta^b, Jose M. Adam^a

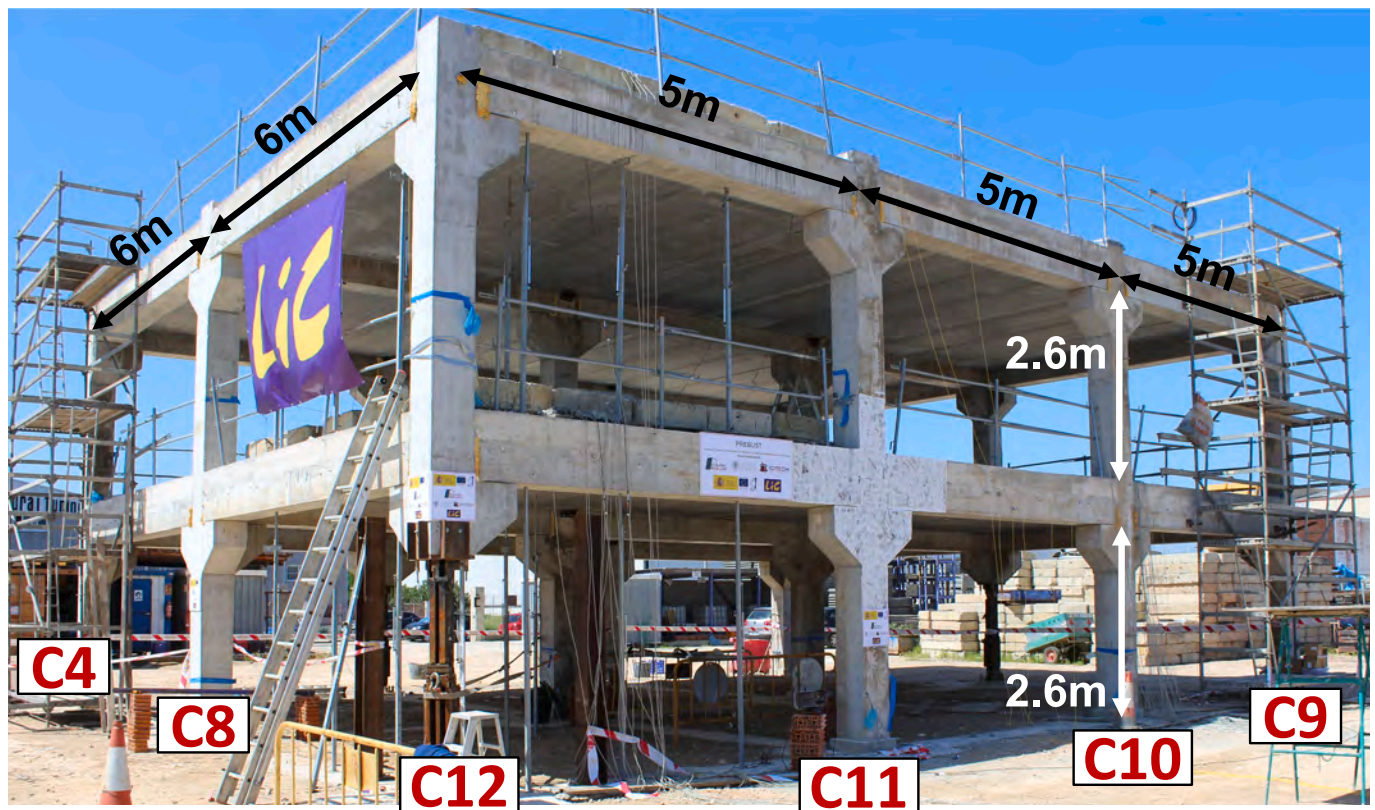
Fig. 1. General overview and dimensions of the building-specimen.

The purpose-built structure had two 2.6 m-high floors measuring $15 \times 12 \text{ m}^2$ in plan, with three 5 m bays in one direction and two 6 m bays in the other (Fig. 1). The building was designed in accordance with Eurocodes [31–33] with 2.5 kN/m^2 dead load and 5.0 kN/m^2 live load (appropriate for use categories C3, C4, C5, D1 and D2 according to Eurocode 1 [32]), and following the recommendations of the Institution of Structural Engineers (IStructE) [6] and the FIB [1,5] for the connections and tying systems for robustness.

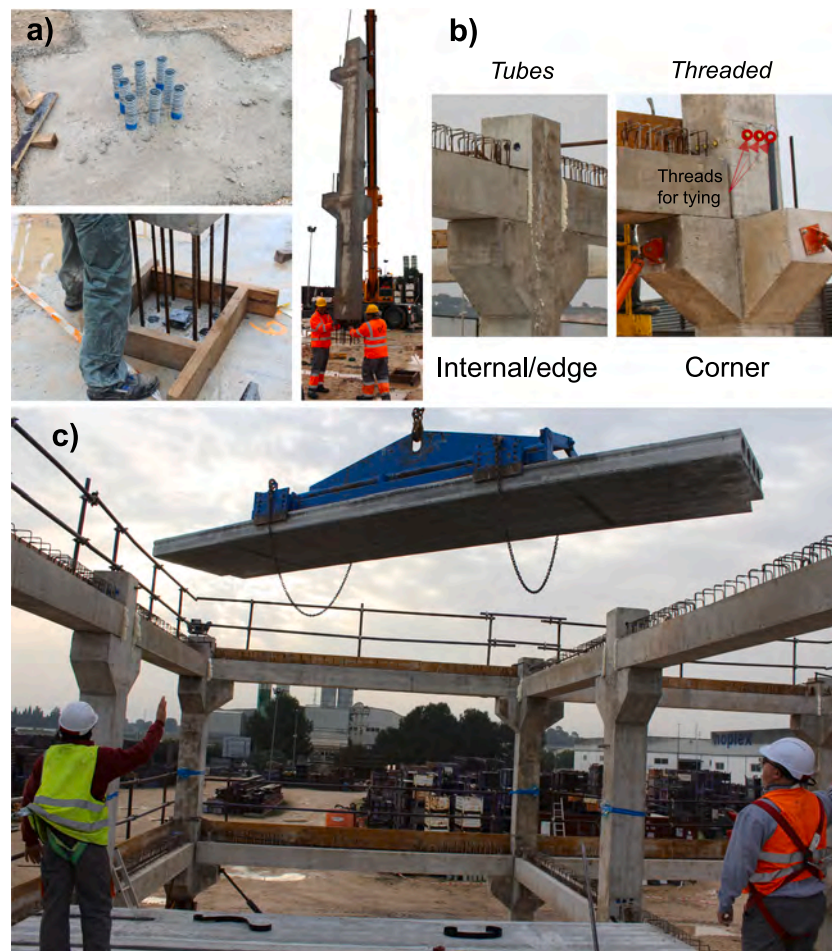
Fig. 2. Details of the building during construction: foundation (a), connections prepared for ties in edge, internal and corner columns (b) and placing of hollow-core units for the slabs (c).

The foundations were cast in place with sleeves to later connect with the concrete columns by grouting (Fig. 2). The $40 \times 40 \text{ cm}^2$ columns were precast and the beams were partially precast and had total dimensions of $40 \times 60 \text{ cm}^2$ (width \times depth; the precast part was $40 \times 35 \text{ cm}^2$, with a cast-in-place topping of around 25 cm). During construction, these beams were simply supported with elastomeric supports on the column corbels (width and length: 40 cm; depth: 30 cm along the variable length plus 30 cm along the constant length), which had two 20 mm diameter dowel bars for their connection. The final beam-column connection was arranged using top continuity reinforcement through 3 ties that crossed the internal columns through the tubular sleeves

(Fig. 2b) and reached the corner columns where the ties were threaded and anchored to the columns (Fig. 2b). 3×20 mm diameter (942 mm^2) tie bars were used in peripheral beams, while 3×25 mm diameter (1473 mm^2) tie bars were used in internal beams (from C5 to C8 only). The cross-sectional area of ties in the beams was similar to that recommended by the DoD [4] (935 mm^2 and 1869 mm^2 for peripheral and internal ties, respectively), with considerably more reinforcement than that recommended by the Eurocode [2] (218 mm^2 and 435 mm^2 for peripheral and internal ties, respectively) but less than that recommended by the FIB [5] (1114 mm^2 and 2227 mm^2 for peripheral and internal ties, respectively), with a limitation of vertical displacement of 1.1 m, the maximum rotation recommended by the DoD). The effective area of tying reinforcements in the building was larger than the values given above due to the slab topping reinforcement (described below). After installing the tie bars, the mortar grouting was injected in column sleeves and beam sleeves for the reinforcement and dowel bars. 20 cm-thick hollow-core slabs, oriented in the direction of the longest span of the building, were simply supported (using elastomeric supports) on

beams during construction until placing of the topping (Fig. 2c). 12 mm-diameter ties between hollow-core units themselves and between hollow-core units and beams were provided (Fig. 3a) following IStructE recommendations [6]. Continuity between bays was also ensured by $503 \text{ mm}^2/\text{m}$ reinforcement bars along the top of the internal beams and connecting with the hollow-core slabs (Fig. 3a). All the structural elements were connected in this way to prevent collapse propagation during an accidental event. After placing a reinforcement layer on the top of the hollow-core units, a concrete topping 6.5 cm thick was placed, together with that of the top part of beams (Fig. 3b). Table 1 gives the reinforcement in the precast elements and in the cast-in-place part of the slabs.

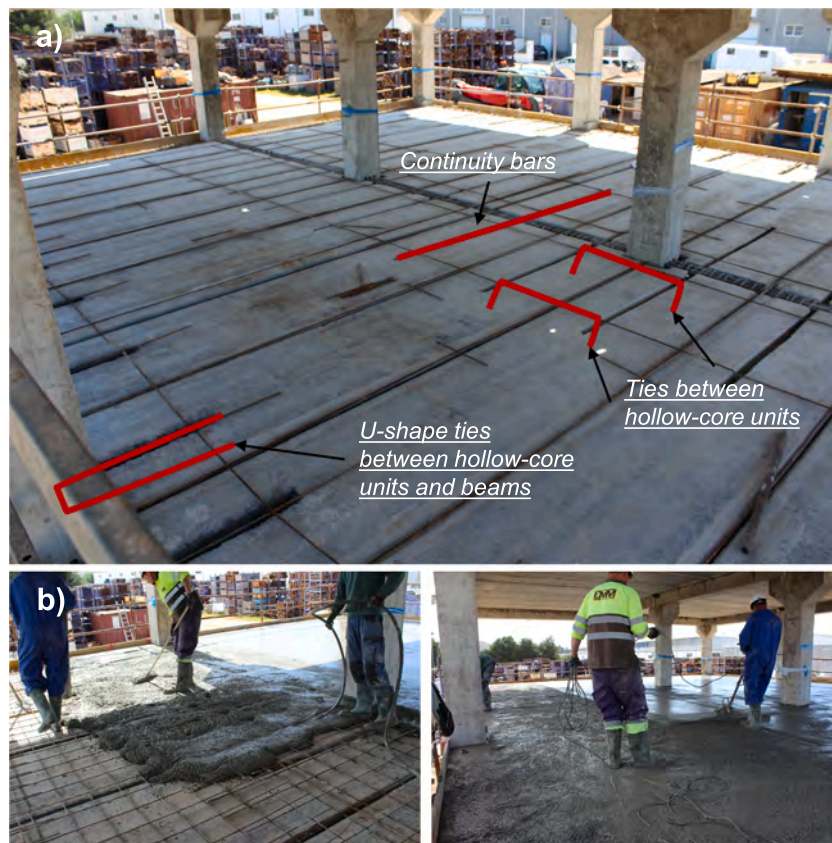
Fig. 3. Details of the slab ties and continuity bars (a) and concrete topping on the slabs (b).

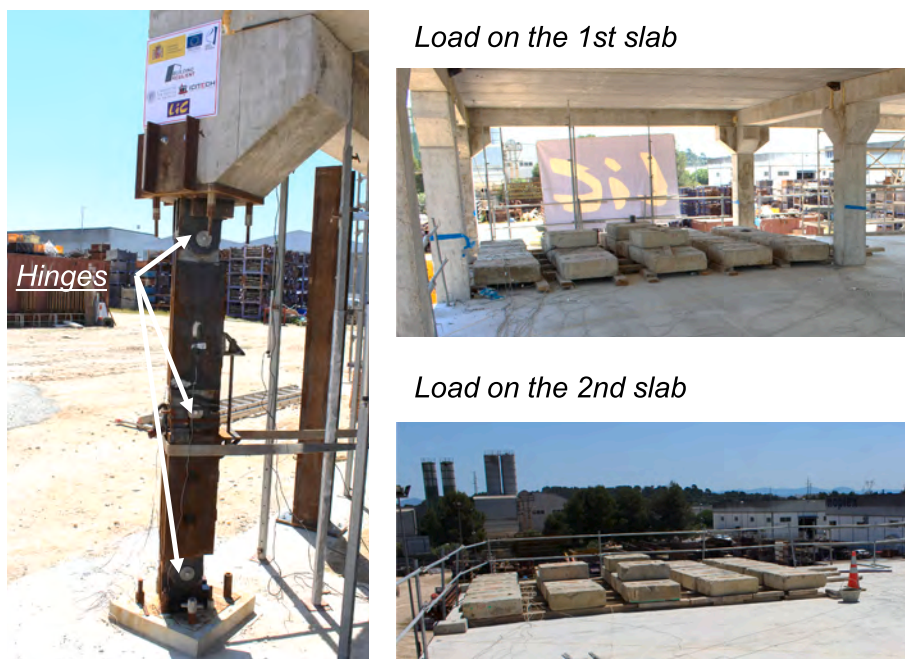
Fig. 4. Steel column designed for the sudden removal and load superimposed on the 1st and 2nd slabs.

triple-hinged steel column (Fig. 4) allowing free movement of the column in the diagonal direction (C12-C7), thus also allowing it to move vertically. For the removal, the central hinge was unlocked by removing different locking systems and a slight destabilization of the column was imposed using a forklift. A similar system had previously been used by the authors [29,30]. A gravity load was introduced in the structure with a value corresponding to the quasi-permanent combination of actions for accidental design situations given in the Eurocode [31] (1.0xDL + 0.3xLL; where DL are Dead Loads and LL are Live Loads). This loading consisted of a uniformly distributed load of 4 kN/m² composed of concrete blocks, applied only in the corner bay of both the first and second floors. Fig. 4 contains views of the steel column to be removed and of the concrete blocks.

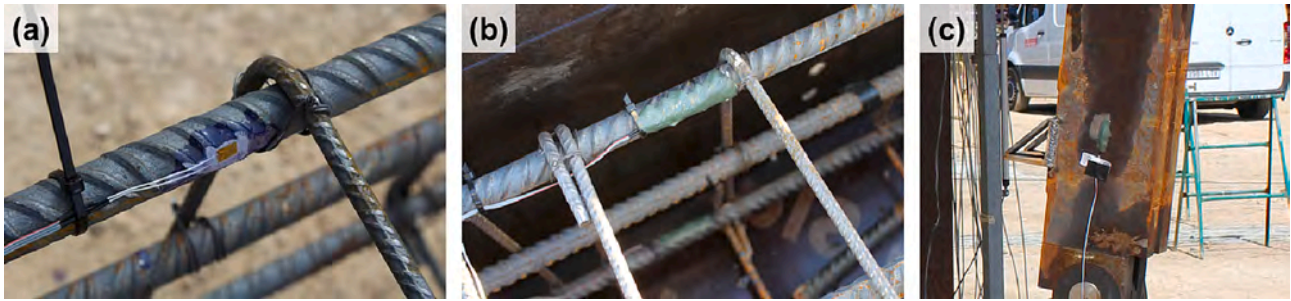
Fig. 5. (a) Strain gauge placed on column reinforcement before applying protective covering putty; (b) Strain gauge placed on column reinforcement prior to concreting; (c) strain gauge placed on collapsible steel column.

As detailed in Table 3, two strain gauges were placed on either side of the collapsible steel column (Fig. 5c) to monitor the change in axial strains due to unloading during the sudden column-removal. The remaining 57 strain gauges were embedded in the concrete and placed either on longitudinal rebars in columns (Fig. 5), on the continuous ties placed in beams, on ties between hollow-core units, on continuity bars and u-shaped ties, on the reinforcement mesh bars in the topping, or on dowel bars.

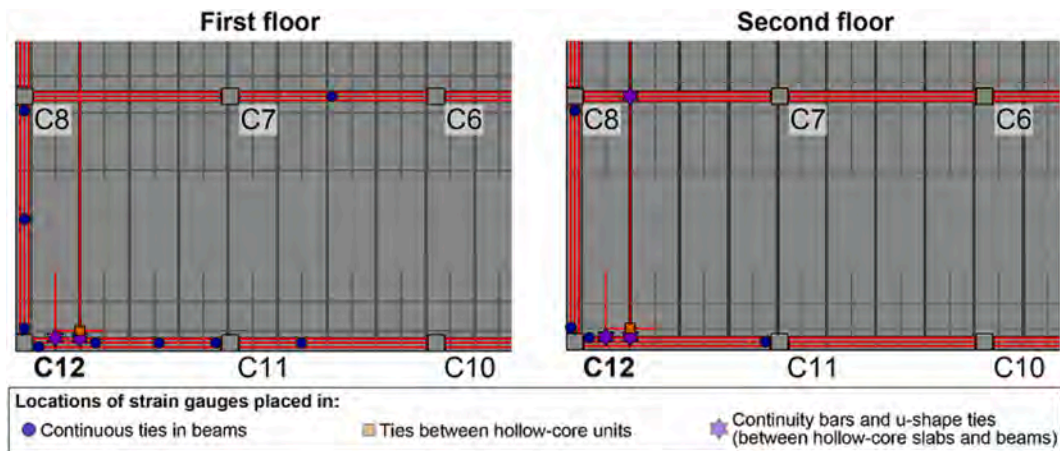
Fig. 6. Locations of strain gauges placed over main reinforcements for continuity in beams and slabs.

The locations of all the strain gauges placed on the continuity reinforcement of the beams and slabs are shown in Fig. 6, while the locations

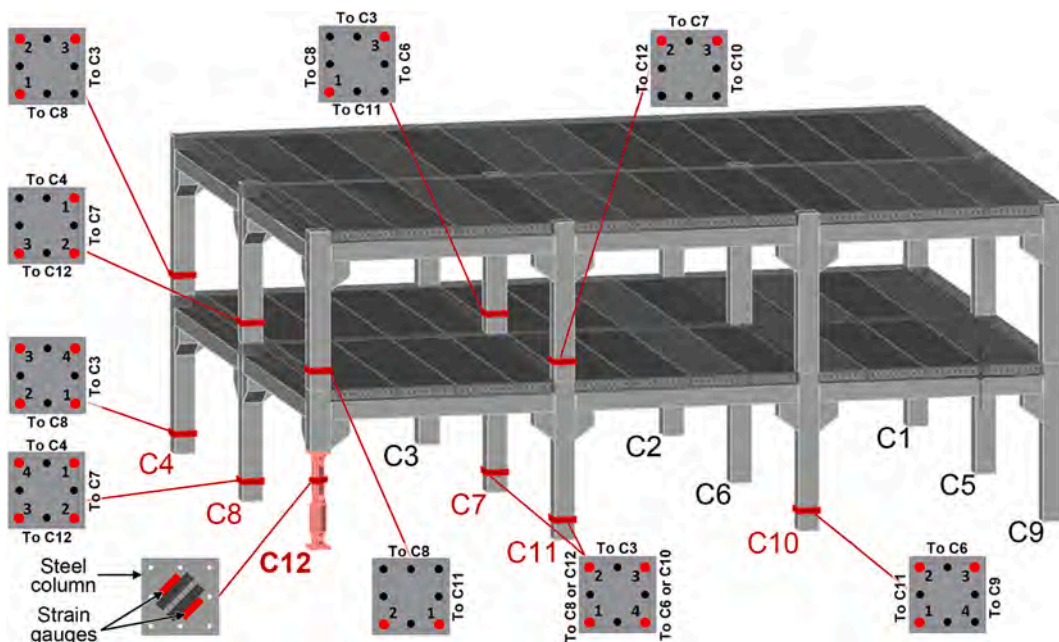
Fig. 7. Locations of all strain gauges placed in columns.

of those placed in columns are shown in Fig. 7. It should be noted that the strain gauges on the bars of the reinforcement mesh in the topping and on dowel bars are not shown in Fig. 6. Of the three strain gauges placed on the reinforcement mesh, two were on the first floor and one on the second floor, in close vicinity to column C12. With respect to the two strain gauges placed on the dowel bars, one was on a corbel in column C12 and the other on the opposite corbel in column C11 on the side with three 5 m-span bays.

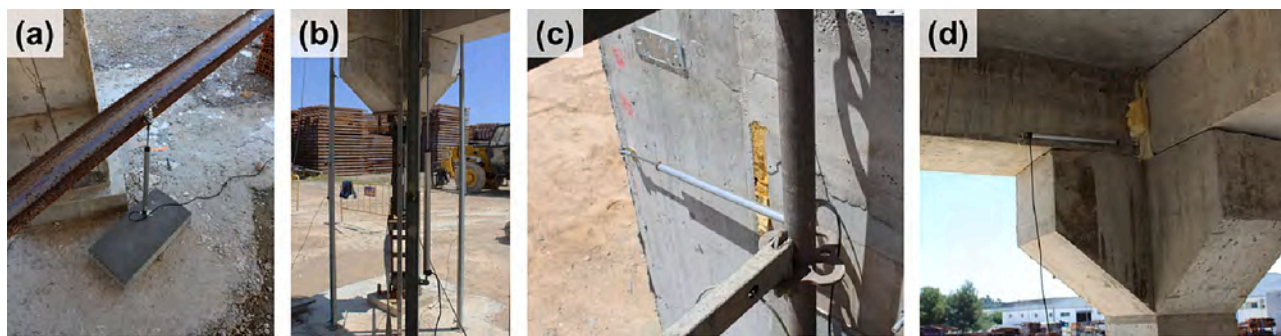
Fig. 8. Displacement transducer used to monitor: (a) vertical settlement of foundation, (b) vertical displacement of first floor, (c) building drift (connected to detached auxiliary structure), and (d) horizontal contraction at the bottom of beam-column joint.

(Fig. 8b) or between the first and second floors. The horizontal transducers were used to monitor building drift (Fig. 8c) or the horizontal expansion and contraction on the top or bottom of beam-column joints (Fig. 8d) or between the hollow-core precast units.

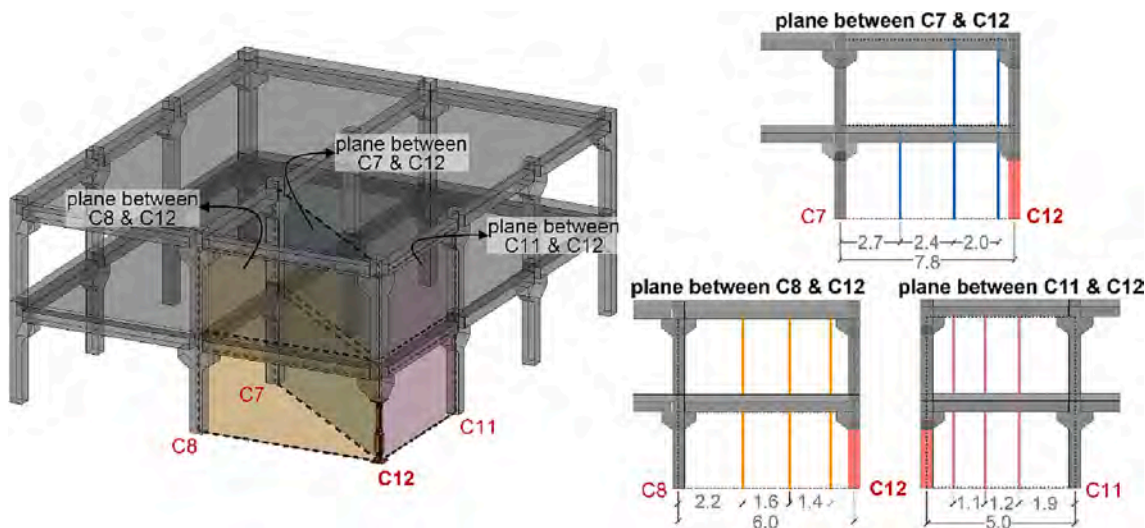
Fig. 9. Locations of all displacement transducers used to measure relative vertical displacement between floors (all dimensions shown in m).

The exact locations of all the displacement transducers used to measure the relative vertical displacement between floors are shown in Fig. 9. The three transducers used to monitor foundation settlements were placed above the C7, C8 and C11 column foundations. The positions of the horizontal displacement transducers are shown in Fig. 10.

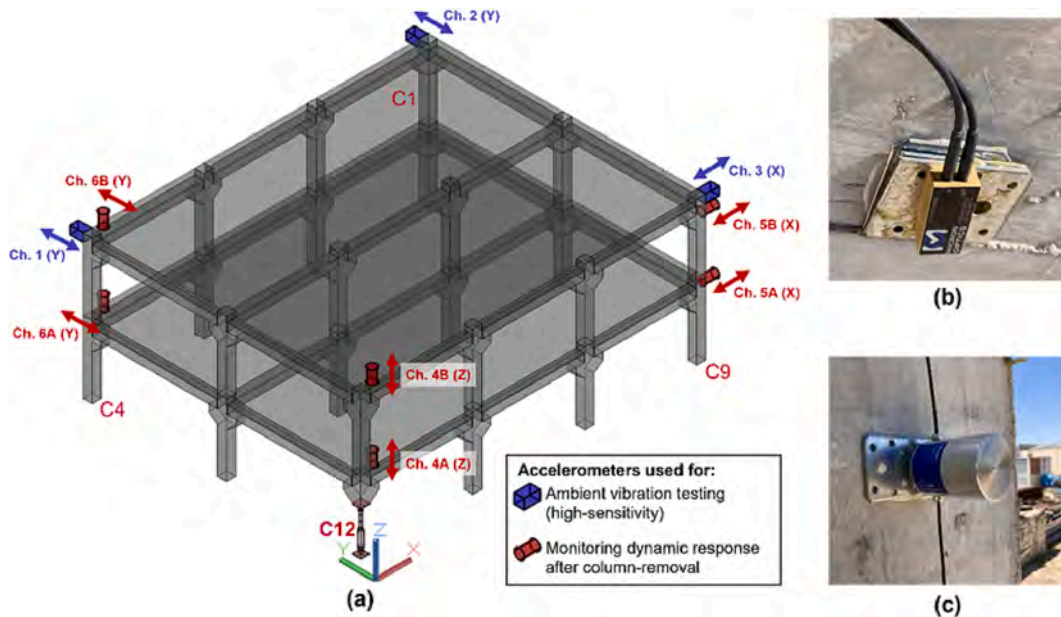
Fig. 11. (a) Locations and direction of measurement of all accelerometers used; (b) High-sensitivity accelerometer used for ambient vibration testing; (c) Accelerometer used for monitoring dynamic response after column removal.

sensors. Of the 9 sensors, 6 were based on Fibre Bragg Grating (FBG) technology and used for monitoring the dynamic response of the structure after the sudden column removal. The remaining 3 were more sensitive Fabry-Pérot (FP) accelerometers. These were used prior to column removal for ambient vibration tests of (i) the undamaged structure, (ii) the structure after the column removal, and (iii) the damaged structure after returning the collapsible steel column to its original position. The positions of the accelerometers and their measurement directions are shown in Fig. 11.

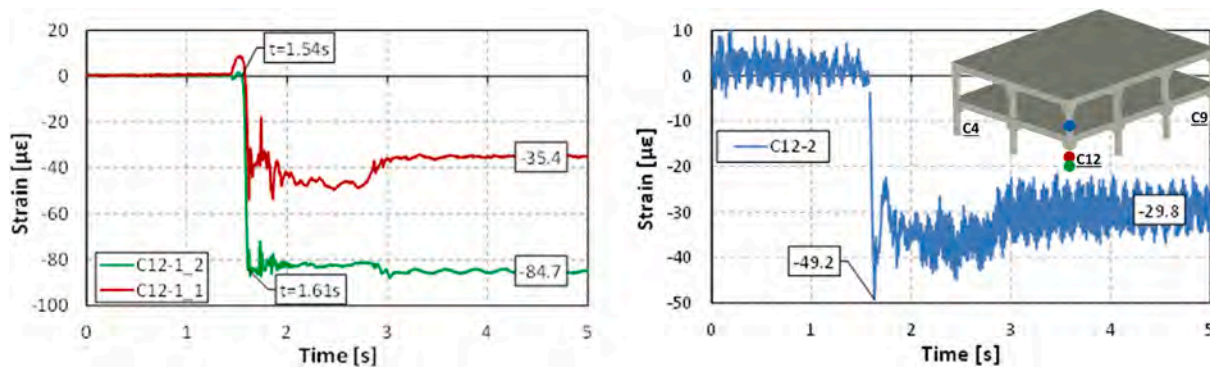
Fig. 12. Strain readings on the first-floor steel C12 column (left) and average strain reading on the second-floor concrete C12 column (right). Positive values indicate compression.

Fig. 12 gives the results obtained from column C12 in the sudden

corner-column removal on the ground floor. The readings from the first-floor gauges show that the total unloading time was 0.07 s. The results from the second-floor show that column C12 unloaded (49.2 $\mu\epsilon$ at peak value and 29.8 $\mu\epsilon$ at the residual value), causing the column to change from an axial compression state (106 kN) to an axial tension state (130 kN at peak and 37 kN at residual value). In no case did the tension reach the concrete cracking strength and always remained below 0.82 MPa.

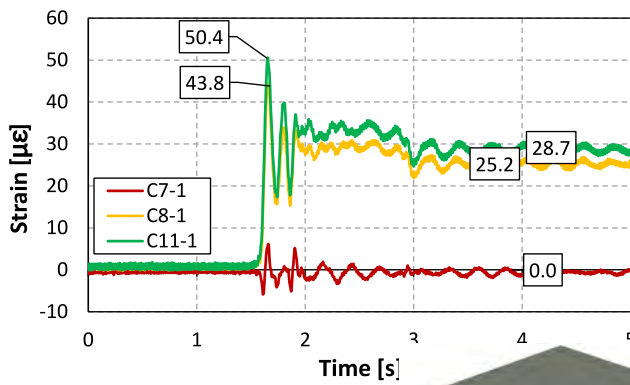
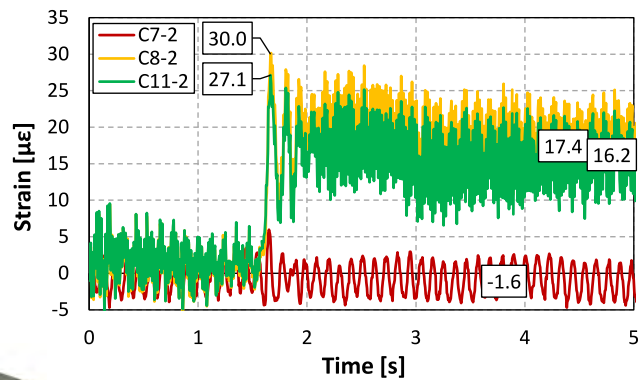
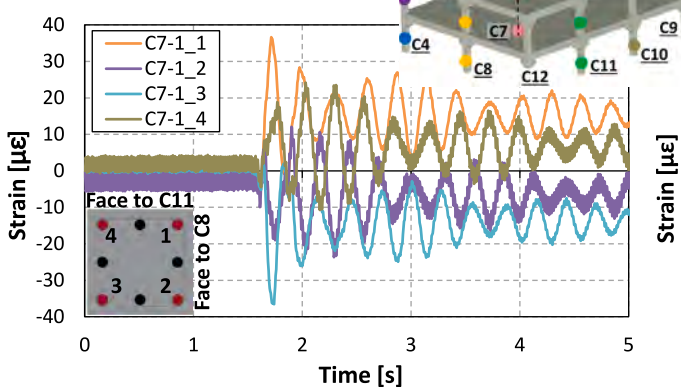
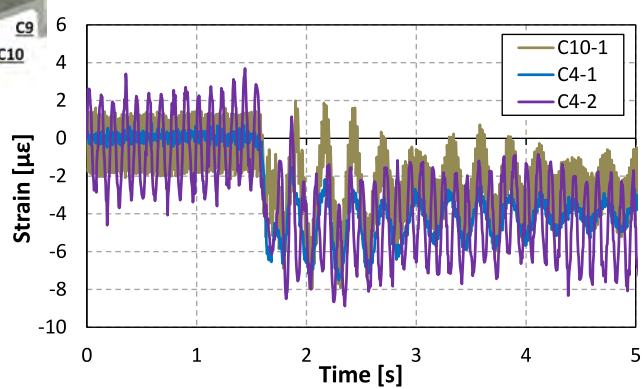
(a) 1st floor of columns C7, C8 and C11

(b) 2nd floor of columns C7, C8 and C11

(c) 1st floor of column C7

(d) 1st and 2nd floor of columns C4 and C10

Fig. 13. (a-b) Average strain readings of the columns closest (Columns C7, C8 and C11) to the removed column; (c) strain readings of all sensors of columns C7, and (d) average strain readings of columns C4 and C10. Positive values indicate compression.

Fig. 13 gives the results of Columns C7, C8, C11 (Fig. 13a-c), C4 and C10 (Fig. 13). Fig. 13a-b,d gives the average reading of the different strain gauges as a representative measure of the axial strain readings of the column, whereas Fig. 13c shows all the strain readings of column C7. Column C7 did not experience a rise in its mean deformation (see Fig. 13a), although there were significant variations in individual deformation values (see Fig. 13c), which indicate the rotation of this column towards the removed column C12. In columns C8 and C11, a similar response can be seen, both on the first (Fig. 13a) and second floors (Fig. 13b). In both cases, the columns suffered higher compression. In columns C4 and C10, however, slight axial decompression can be seen, confirming the rocking effect of the outer frames.

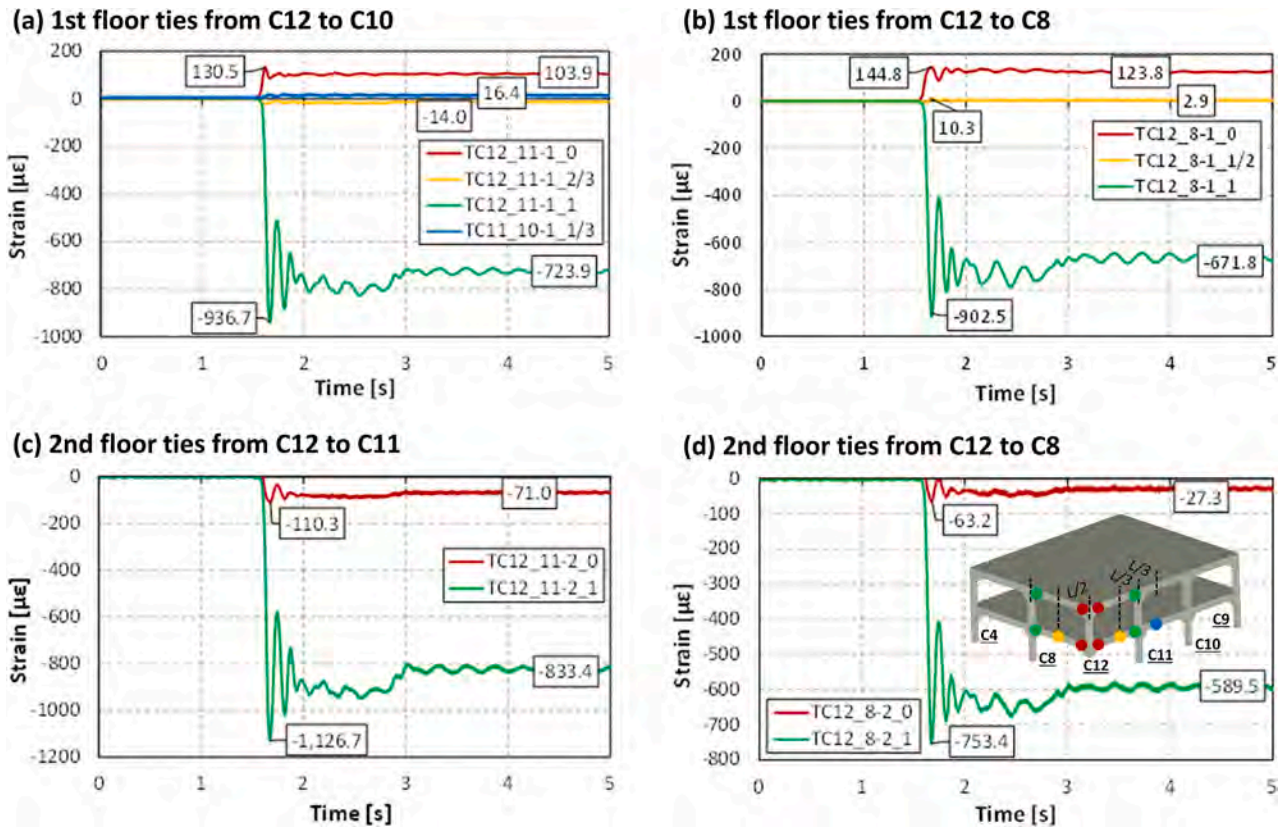
Fig. 14. Strain readings on first and second floor ties. Positive values indicate compression.

Fig. 14 shows the strain results from the peripheral ties on beams both close to columns and at mid-span between columns. It can be seen that (i) the strains were well below the plastic deformation (over 2500 $\mu\epsilon$) and (ii) the positions close to the nodes present very high tensile deformations (shown in green in Fig. 14a-d) which are much lower than at mid-span. These results suggest that the ties were not activated by catenary action but by large bending moments due to Vierendeel action. This was confirmed by the compression values measured in the strain gauges in the ties close to the removed column C12 (shown in red in Fig. 14a-b). The values were generally higher in the C12-C11 beam than in the C12-C8 beam, due to the former being shorter (5 m) than the latter (6 m).

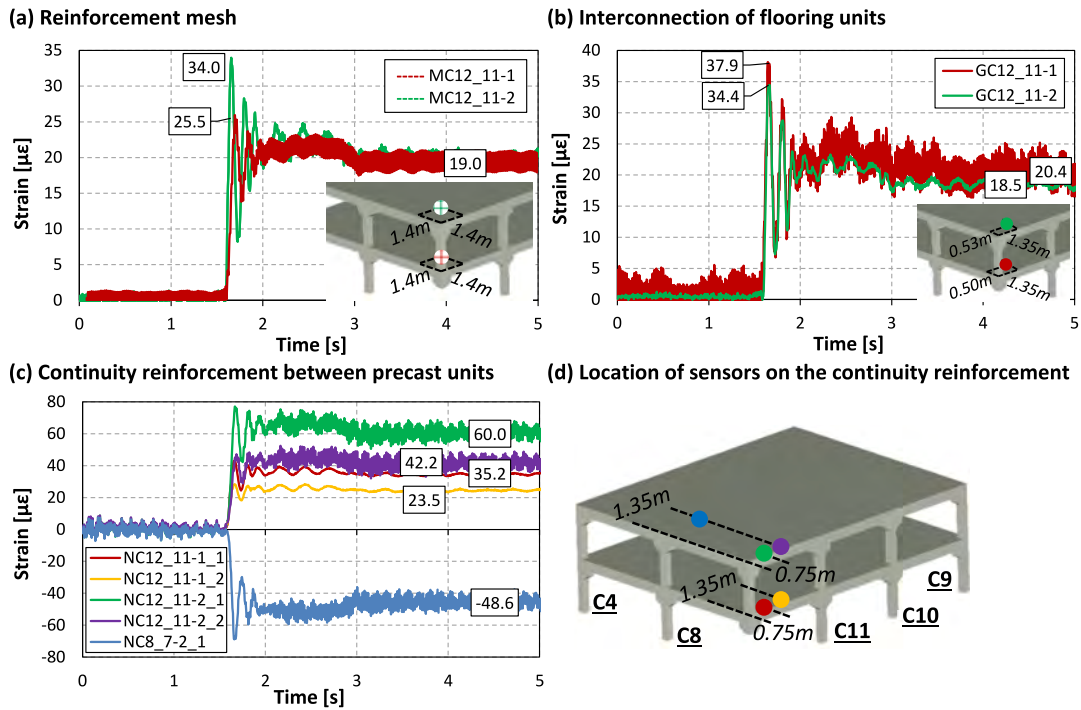
Fig. 15. Strain readings on (a) reinforcement mesh (M) and (b) interconnection of flooring units (G) of the first (red) and second (green) floors, and on (c-d) the continuity or tying reinforcement between precast units (N). Positive values indicate compression. (For interpretation of the references to colour in this figure legend, the reader is referred to the web version of this article.)

Fig. 15 shows the results from the reinforcement mesh of the concrete topping, the reinforcement in the interconnection between precast units in the transverse direction, the continuity bars between precast units (longitudinal directions), and U-shape ties between precast units and beams. The results from the reinforcement mesh (Fig. 15a) show compression values, again demonstrating positive bending moments in the zone near the removed column C12 due to Vierendeel action. These compressions in the slab topping also show the important contribution of the slabs to redistributing loads and searching for ALPs after the column removal. Similar conclusions can be drawn regarding the ties

between precast units in the transverse direction (Fig. 15b), although this reinforcement was not allocated to the slab for this purpose, but to avoid the separation of precast units under tension. The positive values registered in the continuity reinforcement between precast units and beams (Fig. 15c) confirm the previous findings, showing that compressive strains were registered on these strain gauges. The results of the continuity reinforcement between precast units in the longitudinal direction (shown in blue in Fig. 15c) show that this reinforcement worked under tension loads providing continuity to the slab and avoiding the precast units from being separated from the framed structure.

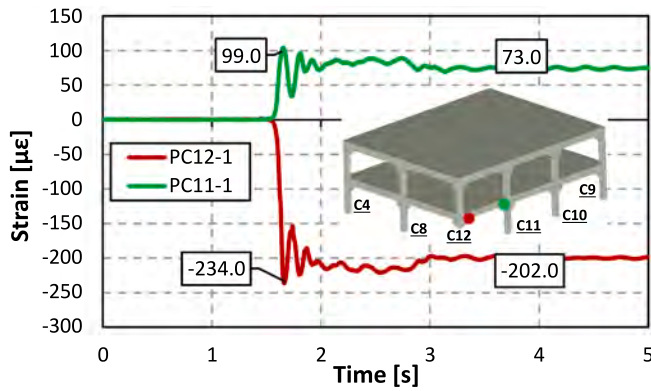
Fig. 16. Strain readings on dowels of Columns C12 and C11 (1st floor). Positive values indicate compression.

Fig. 16 shows the strain readings for the dowel reinforcement at the corbels. Significant differences can be seen between the dowels located at column C12 and the dowels located at C11. The dowel located at column C12 worked under tension loads since the beam tended to pull out of the corbel, but this slip was restraint by the ties and the dowel at the corbel. The dowel in C11 worked under compression loads due to the increased beam vertical reaction on the corbel after the removal of C12. More details about the behaviour of the dowels can be found in Section 4.3.

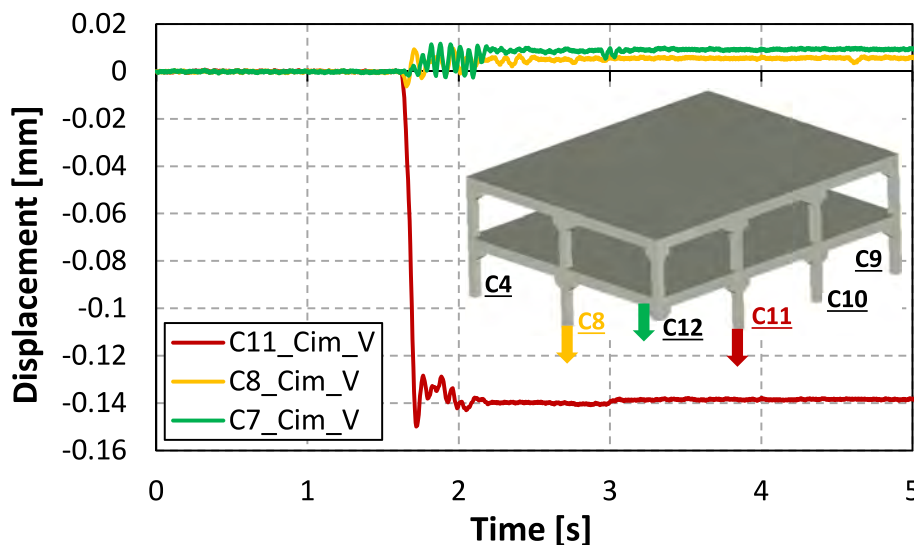
Fig. 17. Displacement measurements on foundations of columns C7, C8 and C11. Positive direction upwards.

Fig. 17 shows the vertical displacement of the foundations closest to the removed column (C7 shown in green; C8 in yellow and C11 in red), which were used to correct the results obtained in the building in the case of significant displacement. The vertical displacement was almost negligible for C11 (0.14 mm) and practically zero for C7 and C8.

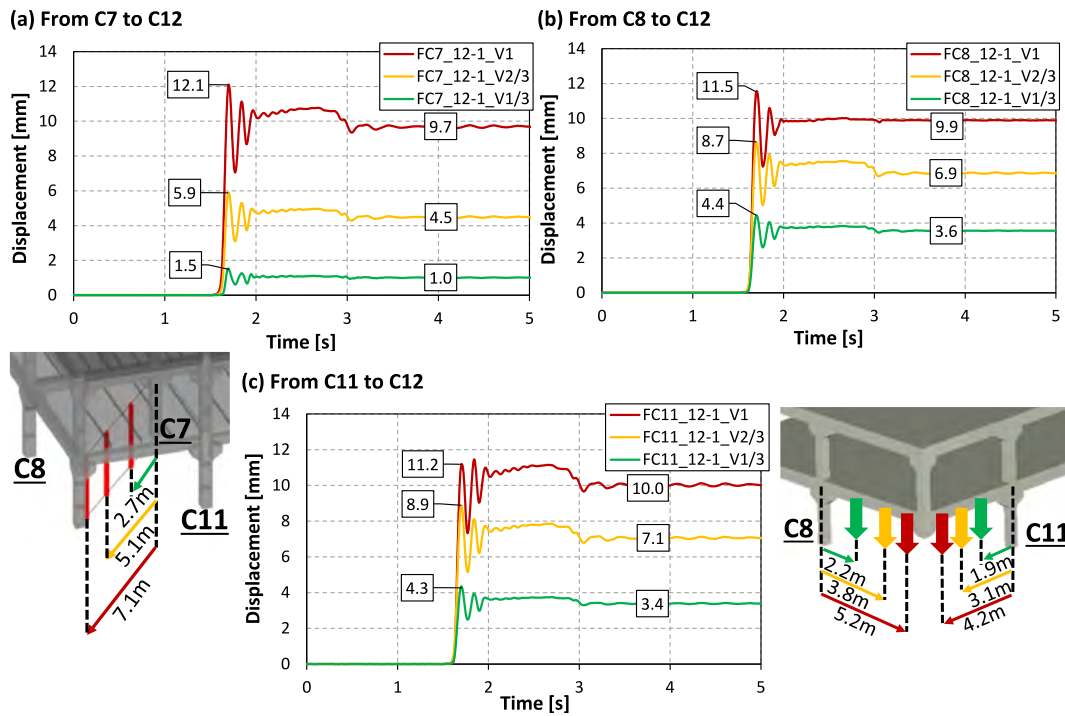
Fig. 18. Vertical displacement measurements on lines from columns C7, C8 and C11 to C12. First floor. Positive direction downwards.

Fig. 18 shows the vertical displacement or deformed shape of the C7-C12 profile (Fig. 18a) and of peripheral beams C8-C12 (Fig. 18b) and C11-C12 (Fig. 18c) on the first slab, in which the maximum drop registered reached a peak value of 12.1 mm. The relative vertical displacements between the first and the second slabs were small along profiles C7-C12 and C8-C12 as shown in Fig. 19; the measurements were taken at the same distance from the columns as in the first slab. A detailed analysis of these results can be found in Section 5.1.

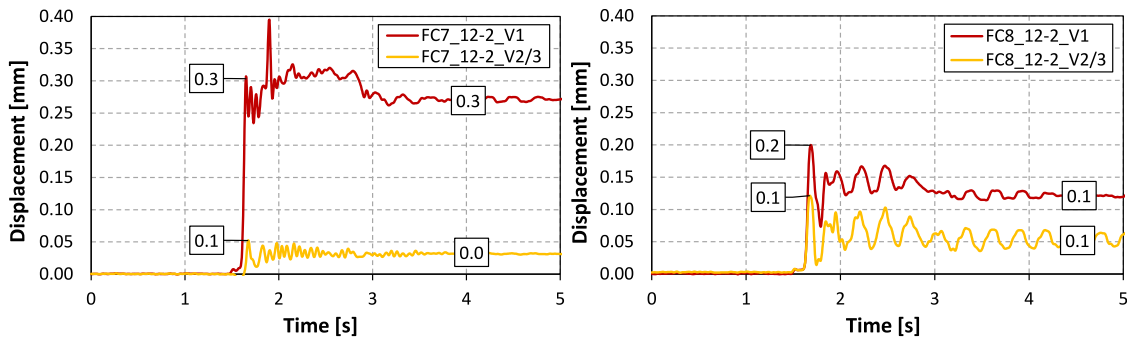
Fig. 19. Vertical displacement measurements on lines from columns C7 and C8 to C12. Second floor. Positive values indicate shortening.

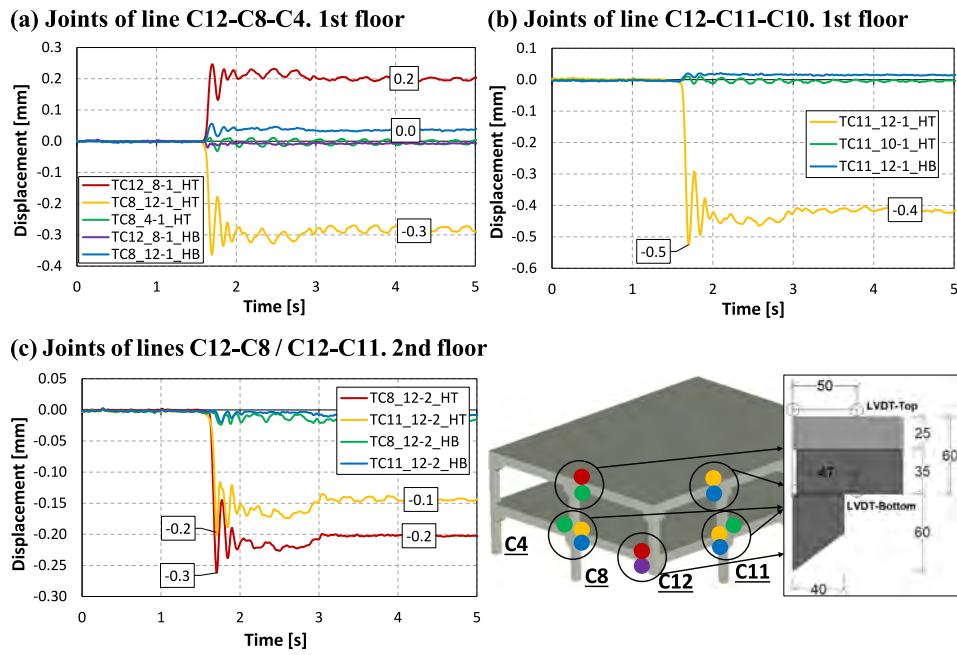
Fig. 21. Representative bending horizontal measurements of first (a-b) and second (c) floor beam-column joints. Shortening displacements are positive.

Another set of LVDTs measuring horizontal displacements were employed to estimate bending moments and deformations in beams close to the columns shown in Fig. 21, which gives the results obtained in the first slab (Fig. 21a-b; lines from C12 to C4 and from C12 to C10) and second slab (Fig. 21c; lines from C12 to C8 and C12 to C11). These results show the activation of Vierendeel action, with negative bending moments (hogging moments) in all beam-to-column joints except in the one near the removed column C12, where positive bending moments (sagging moments) were found. In general, the LVDTs that registered shortening displacements according to the above-explained criteria show very small values. These bending moments in the joints show that the semi-rigid corbel connections used between beams and columns (only the tie reinforcement passed from the beams through the columns) were able to mobilise bending moments due to the contribution of: i) the dowels working under shear loads (Fig. 22a-b); and ii) the cast-in-place upper part of the beam working under local bending moments (Fig. 22b).

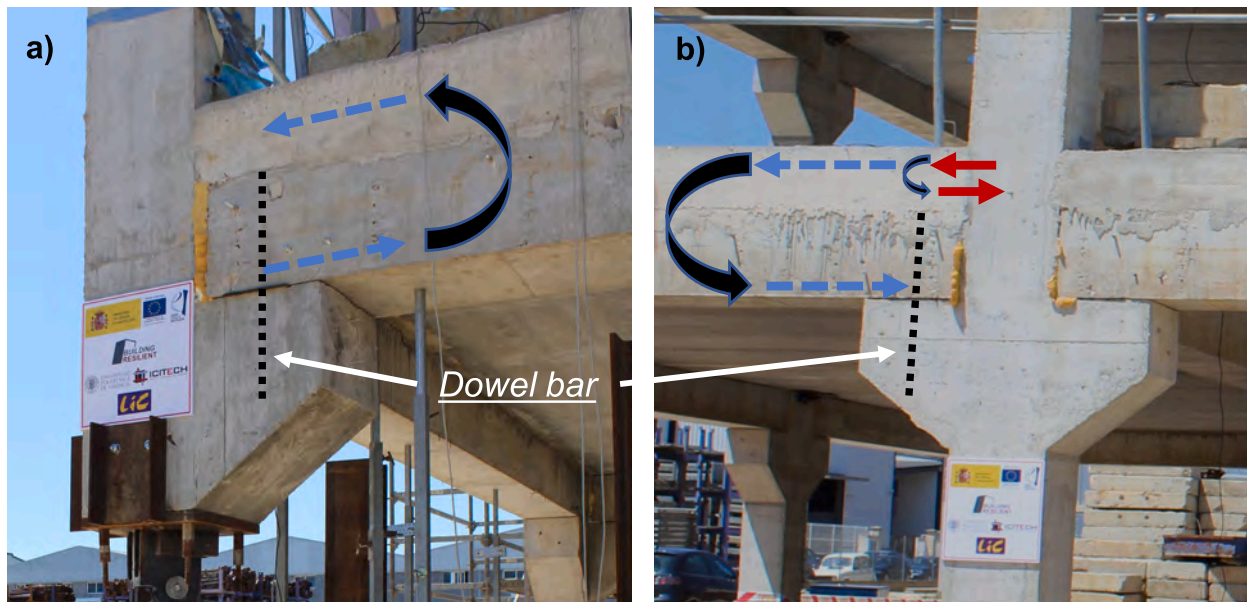
Fig. 22. Moment transfer on beam-column joints with the help of: dowel bars working under shear loads (a and b) and the cast-in-place upper part of the beam working under local bending moments (b only).

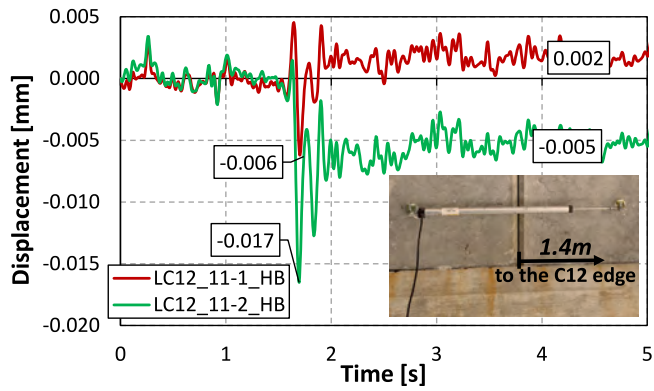
Fig. 23. Measurements of the separation between precast units on the first and second floors. Negative values indicate separation.

Fig. 23 shows the measurements of the separation between the precast units in the first (red) and second slabs (green). The values measured were quite small and were higher in the second slab (0.017 mm) than the first (0.006 mm). These values show negligible separations between the precast units close to the removed column C12 and confirm a Vierendeel action that generated tension forces in the lower part of the slabs in these zones.

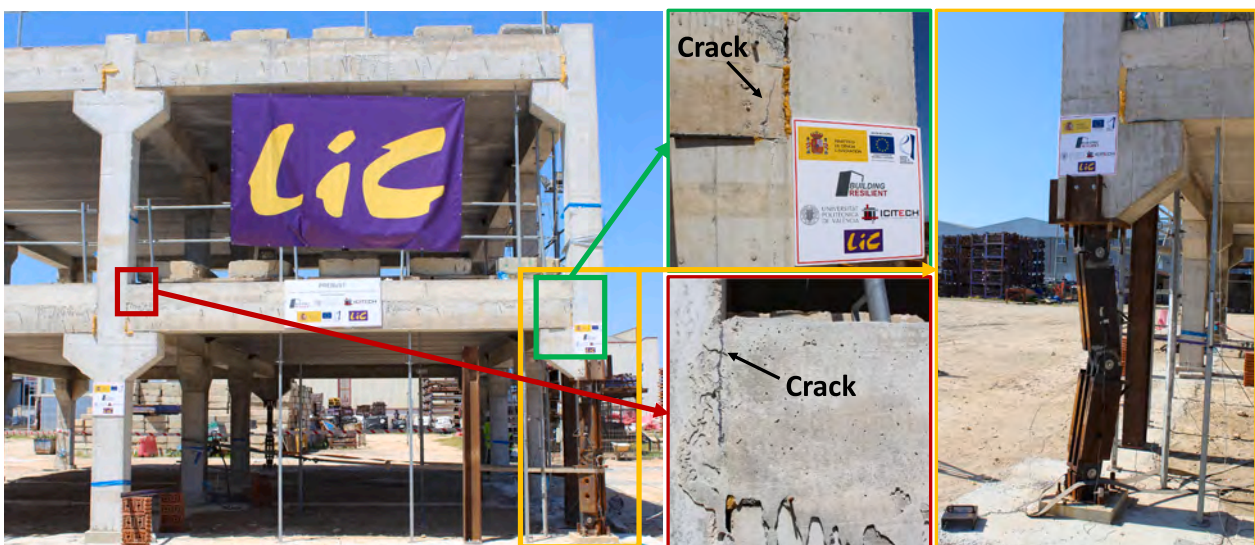
Fig. 25. Structure after the test.

The structure only showed some minor residual damage after the column removal (cracking) around the beam-column connections. The state of the structure after the test can be seen in Fig. 25, which shows the state of the building with the hinged metal column (yellow box) that allowed the free fall of the corner (12.1 mm maximum drop). The cracks found after the test are also highlighted in the first slab beam-column joint C8 (red box) and C12 (green box). The first crack was due to hogging moments, as previously commented. The second crack was generated by the impact of the beam on the column due to localised compression in the beam where it touches the column.

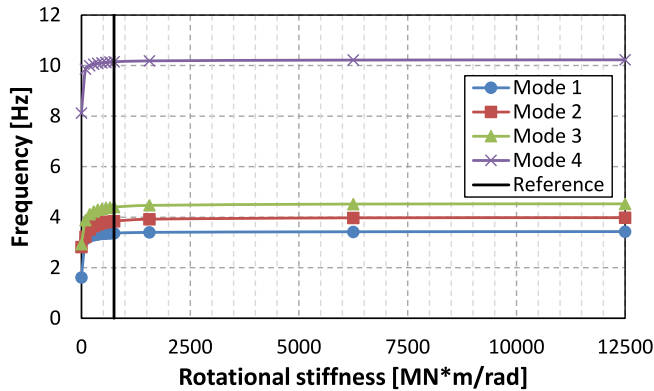
Fig. 27. Natural vibrational modes of the structure depending on rotational beam-column stiffness variation.

building used in the present study, including the values of the elasticity modulus for each of the elements, as described in Table 2. Columns, beams, and hollow-core precast units were modelled using beam elements, while the concrete topping in the slabs was modelled using shell elements. All the connections in the model were rigid to accurately represent the building, except those between beams and columns. The actual building had semi-rigid beam-column connections, represented by the tie reinforcement (acting as continuity reinforcement in the upper part of the beams), and the beams were also supported on the concrete corbels and connected by the dowel bars. These partially fixed connections can be represented by equivalent rotational springs. The real (unknown) exact situation can vary between simply supported (perfect hinge with zero rotational stiffness) and totally fixed connections. A rotational stiffness of 750 MN·m/rad was considered as representing a

totally connected beam-column joint (see Fig. 27). This value was adopted because the vibration modes of the FE model configured with such joints were in good agreement with those of an FE model with fixed connections. In addition, as shown in Fig. 27, further increasing the rotational stiffness causes no significant change in the vibration modes. Then it is understood that the stiffness of the structure does not vary because the beam-column joints have reached the condition of being rigidly connected (Mode 1: 3.37 Hz; Mode 2; 3.85 Hz; Mode 3: 4.41 Hz; Mode 4: 10.15 Hz). Fig. 28 shows the model developed in SAP2000, which was validated using the results presented in Section 5.1 (Table 6).

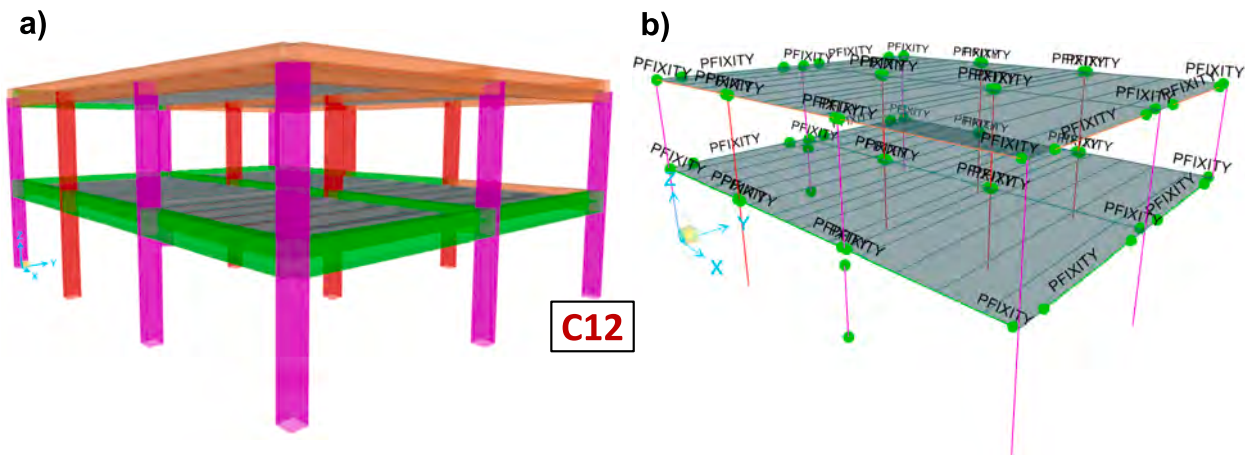
Fig. 28. FE model developed on SAP2000 with elements and material representation before column removal (a) and with the structural model with the springs after column removal (b).
