Post-fire assessment of composite steel-concrete box-girder bridges: Lessons from a recent incident

Juan José Pagán-Martínez^a, Ignacio Paya-Zaforteza^{b,*}, Antonio Hospitaler-Pérez^b

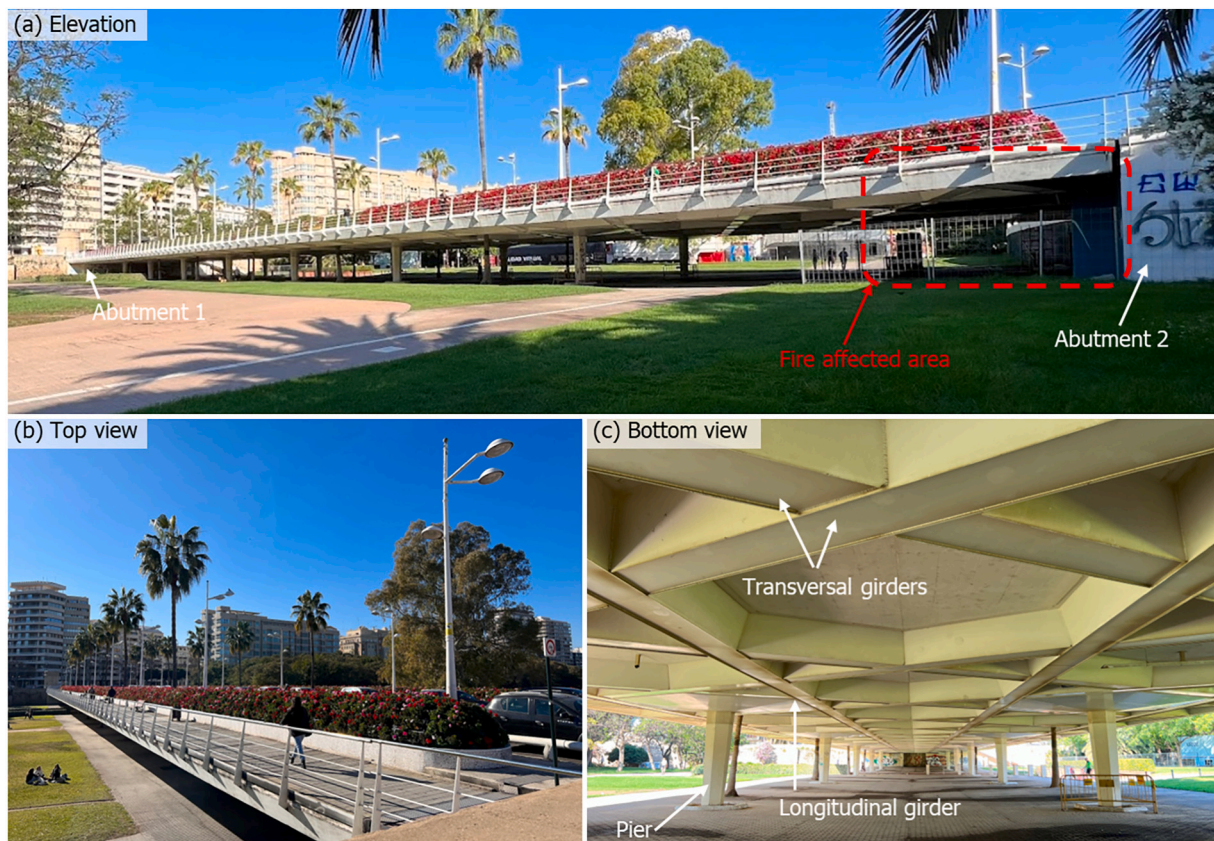
Fig. 1. Views of the “Puente de las Flores” showing also the area affected by the fire. Elevation (a), top (b) and bottom (c) views of the “Puente de las Flores”.

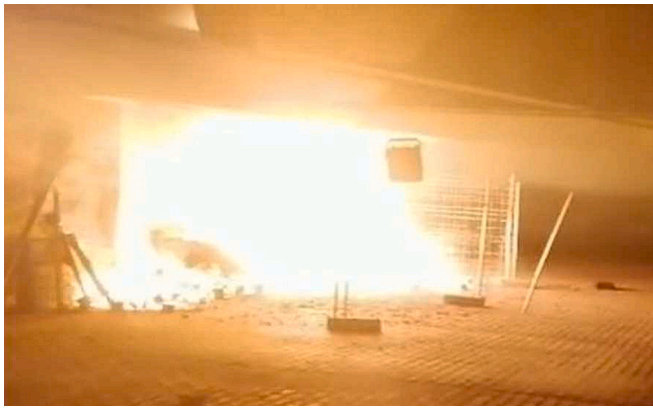
Fig. 3. Fire development under the bridge.

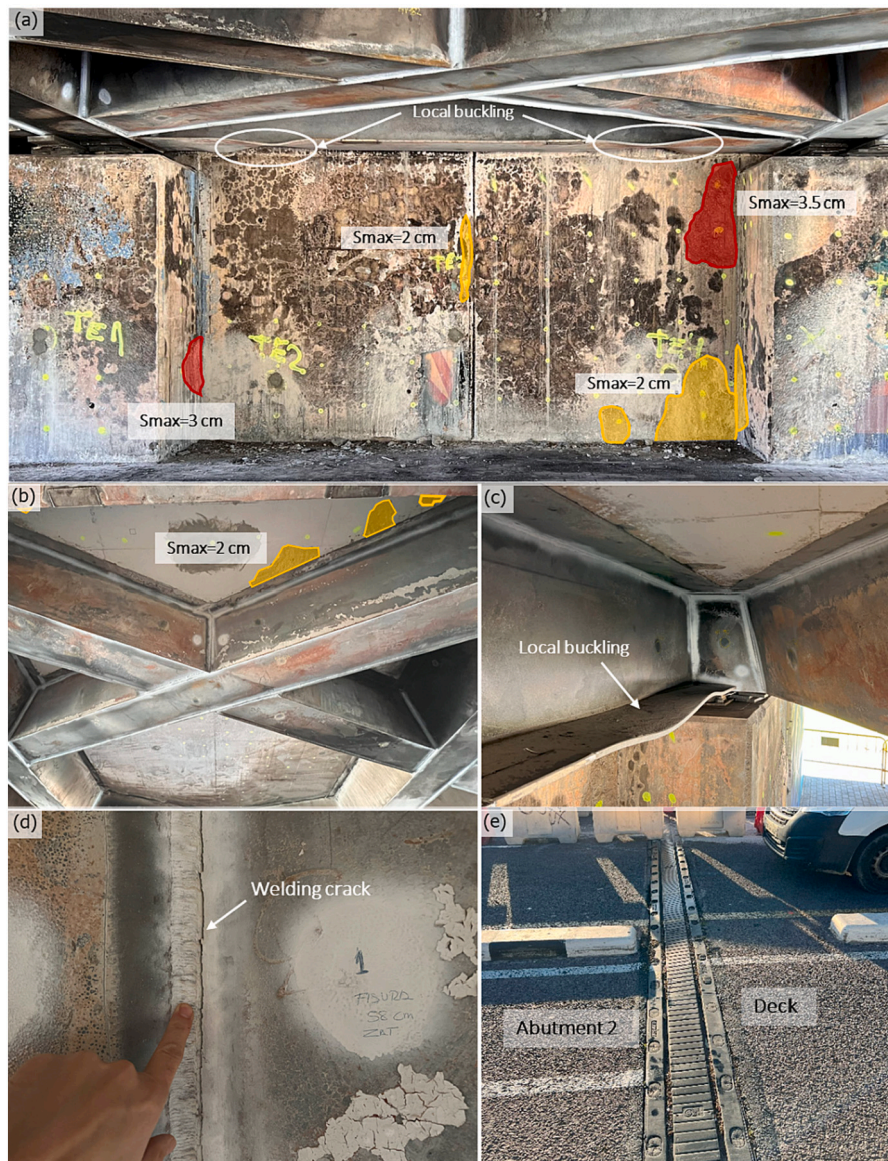
Following the fire, the central lane of the bridge was closed to traffic, allowing only light vehicles and pedestrians to use the rest of the bridge. As repair works on the bridge began, this restriction was further extended to exclusively accommodate cyclists, scooters, and pedestrians. The post-fire condition of the bridge showed that spalling had occurred in the walls of Abutment 2 with a maximum depth of 3.5 cm (see Fig. 4a) and, in a more limited extension, in the triangular deck module close to Abutment 2 (see Fig. 4b) with a maximum depth in the order of 2 cm. Additionally, visual inspection also revealed an important local buckling in two segments of the bottom flange of the diaphragm girder as well as out of plane displacements in sections of both longitudinal and transversal girders (Fig. 4a, b and c). Cracks with different length also appeared in three weldings (see Fig. 4d). An elevation of the deck in the area close to the abutment was also observed (Fig. 4e).

Fig. 4. Post-fire visual inspection of the bridge. (a) Overall view of the most damaged area indicating maximum spalling (S_{max}) in Abutment 2 as well as the diaphragm girder main damage. (b) Concrete deck spalling and overall view of out-of-plane displacements. (c) Detail of local buckling on diaphragm girder. (d) Detail of welding crack, (e) Detail of deck uplift movement noticed by the inclination of the expansion joint.

- A 3D scanning of the steel elements in the fire affected area was conducted and confirmed local buckling in portions of the transversal girders.
- A levelling was also undertaken to determine the relative vertical displacements of the bridge deck with respect to the Abutment 2. It revealed a vertical uplift of the central part of the deck in the area close to the Abutment 2 with a maximum value of 4.2 cm.

- The bridge structure remains stable 25 min after the start of the fire, showing no signs of collapse during the incident.
- The numerical model is unable to reproduce the concrete deck uplift observed on site along its central part next to Abutment 2 (see Fig. 4e). Furthermore, in the numerical model, the central area near

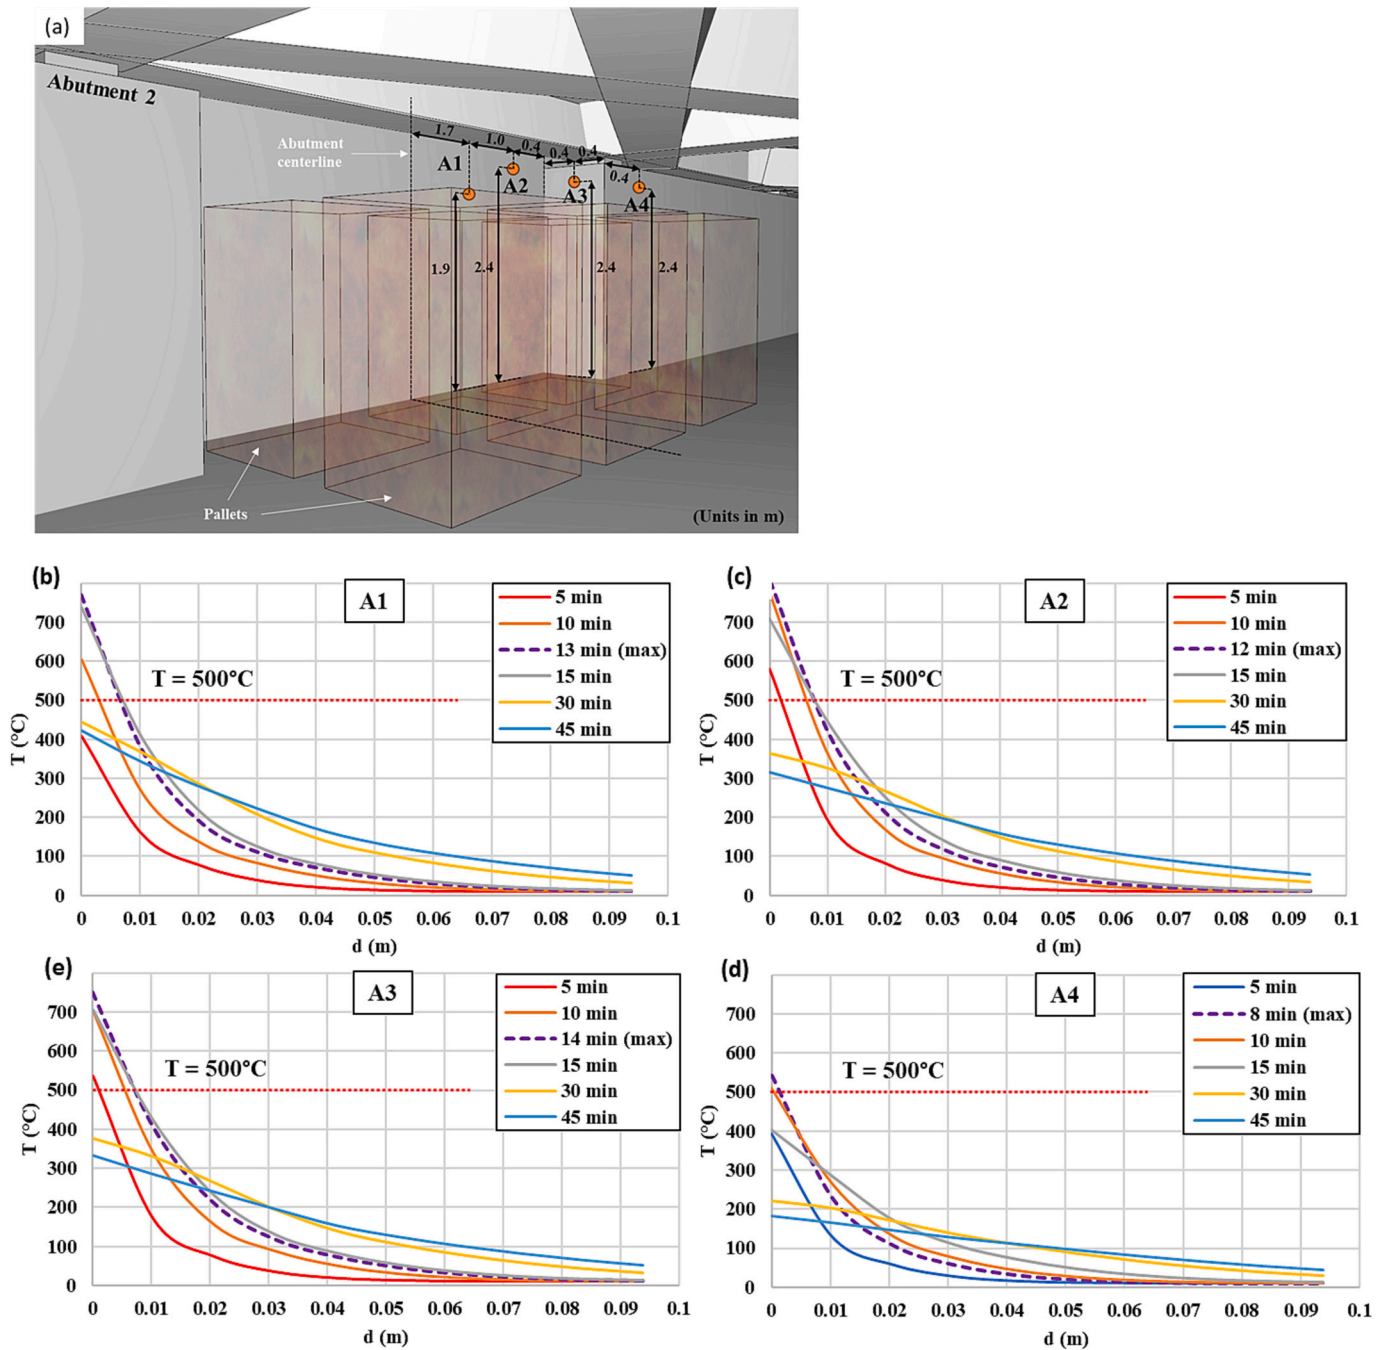
Fig. 13. Temperature evolution within the abutment in the vicinity of the fire.

Fig. 13a depicts the locations of representative points in the concrete of Abutment 2. Fig. 13b to 13d illustrate the evolution of concrete temperatures (T) at these points as a function of depth (d) from the exposed concrete surface and time (t). The temperatures exhibit symmetry along both sides of the abutment. Based on the results, the following observations can be made:

- The highest temperatures occur in the area along the abutment recess close to the corner, in the upper zone (A2). This temperature reaches

a maximum value of 805 °C after 12 min. The next zone is the center-lateral zone along the abutment recess (A1) with a maximum value of 770 °C after 13 min, followed by the lateral zone (A3), reaching a maximum value of 750 °C after 14 min. Finally, the farthest upper lateral zone (A4) reaches a maximum value of 542 °C after 8 min. These temperatures are significantly higher than those measured in the concrete slab (detailed in Section 3.4.2), which explains the more pronounced spalling in these areas compared to the limited spalling in the slab.

- b) Fig. 13b to 13d also show a horizontal line representing a constant temperature of 500 °C. It should be noted that this temperature marks the threshold from where concrete (excluding steel rebars) is assumed to lose its structural capacity in the Isotherm 500 method outlined in EN 1992-1-2 [26]. Although the method assumes that structural elements are subject to the ISO834 standard fire curve or similar heating regimes, this threshold can be used for qualitative estimations since both, ISO 834 and the fire under the case study bridge are cellulosic fires. The 500 °C threshold is only exceeded within the first 6 mm (worst-case scenario, A2) from the exposed abutment surface, which means that the reduced section (i.e. section excluding those concrete areas exceeding 500 °C) practically coincides with the original section when following the Isotherm 500 method for a qualitative analysis.

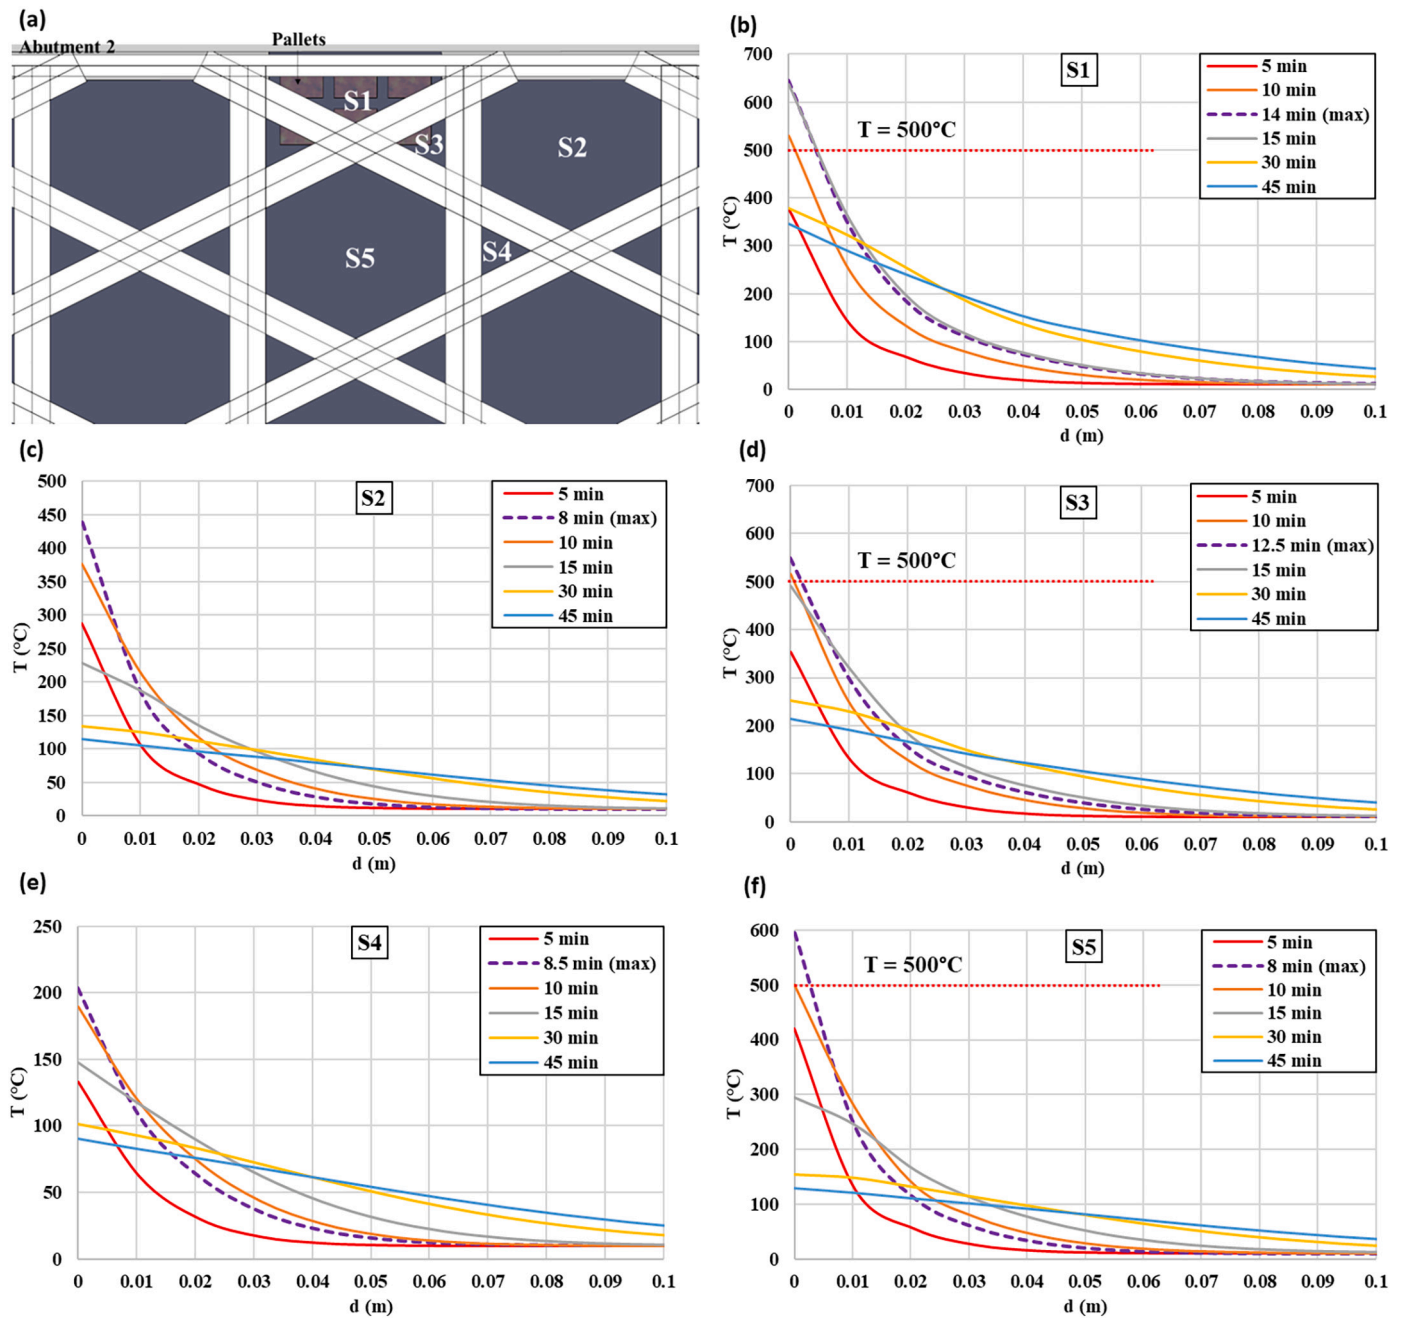
Fig. 14. Temperature evolution within the concrete slab in the vicinity of the fire.

Fig. 14 shows the evolution of temperatures in the concrete slab at representative surfaces S1, S2, S3, S4 and S5 located in Fig. 14a. It should be noted that a homogeneous temperature is assumed for each

- FDS analysis showed that maximum T_{AST} is punctually reached along S5 surface. However, higher temperatures remain longer within the closest surfaces to the fire location due to the smoke reservoir created by the steel beams and concrete slab. This configuration delays the hot gases movement away from the area and explains the spalling along surface S1 in lieu of S5. The highest surface temperatures occur in section S1, located immediately above the position of the pallets. This temperature reaches a maximum value of 636 °C after 14 min. The next most affected sections are S5 and S3, where the maximum temperatures are 516 °C and 594 °C, respectively. In the remaining sections (S2 and S4), the maximum temperatures remain below 400 °C. This explains the limited extent of spalling in the concrete slab (temperatures never exceed the mean onset value of 740 °C for spalling proposed by Hua et al. [19]) and why it appears only in section S1.

- a) Temperatures have significantly exceeded 500 °C only in the concrete section S1. However, the slab thickness at which this temperature was exceeded is minimal, approximately 5 mm. Therefore, the reduced section practically coincides with the original section and concrete damage is minimal. This is supported by the positive results obtained by the indirect measurement of slab compressive strength using the impact rebound hammer.
- b) Since the concrete cover of the steel rebars (as prescribed in the project drawings) is 35 mm, the maximum temperature reached by the slab reinforcement is around 174 °C. This temperature is much lower than the temperature at which the reinforcement starts losing strength (300 °C for cold-deformed steel and 400 °C for hot-rolled steel), indicating that the reinforcement has not suffered any loss of strength.
