Building for the Future: Durable, Sustainable, Resilient

Proceedings of the
fib Symposium 2023 – Volume 2

Large-Scale Tests on RC Purpose-Built Buildings for Improving Robustness

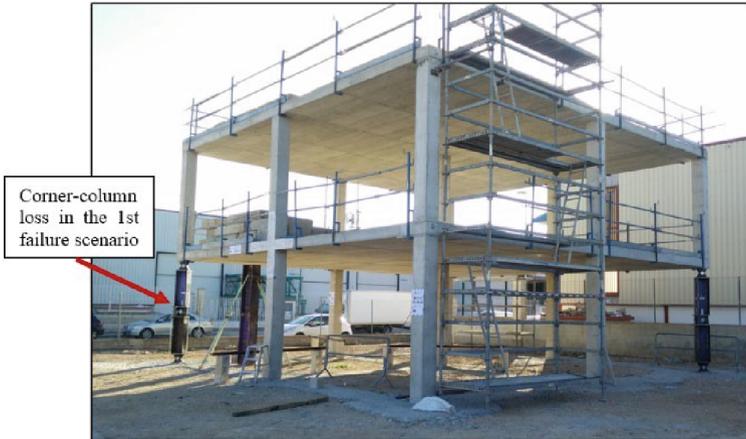
Fig. 1. Building and definition of the first failure scenario.

Two experimental tests for two different failure scenarios were considered in this study. In both cases, a corner-column loss was considered, selecting two opposite corners columns to avoid the influence of a damaged structure in the second test. These columns were steel-based (HE-300B profile) and prepared with a mechanism to reproduce a sudden failure. Only the structure of the building was tested for the first failure scenario, whereas infill masonry walls were also introduced for the second failure scenario. These masonry walls were only constructed on the first floor and in those modules with more influence in the defined corner-column failure scenario. Figure 1 and Fig. 2 show the actual building prepared for the first and the second failure scenarios, respectively. A complete description of the building and test can be found in Adam et al. and Buitrago et al. [9–11].

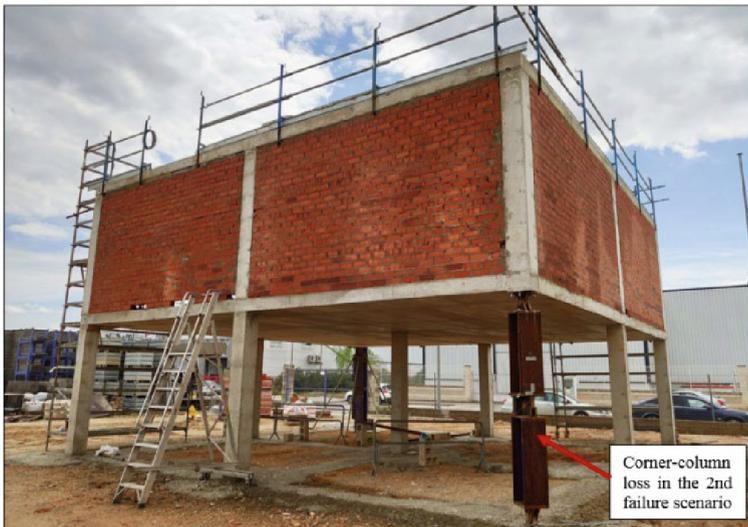
Fig. 2. Building and definition of the second failure scenario.

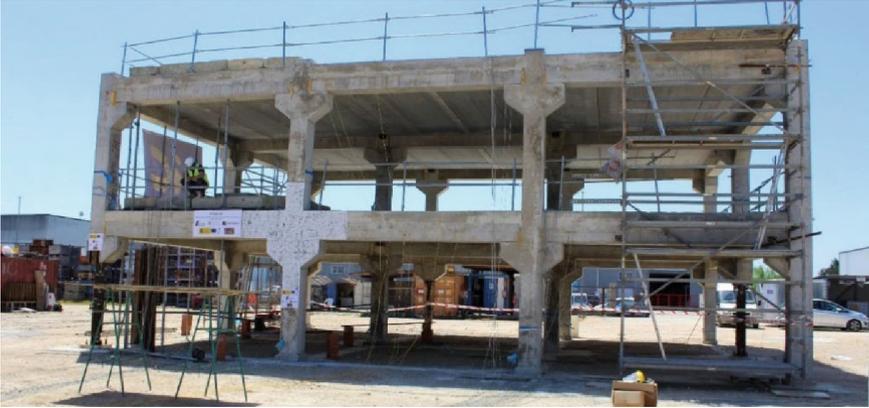
Fig. 3. Completed building specimen prior to testing.

The building specimen constructed for the purpose of this study (Fig. 3) has a rectangular shape with six bays in plan and two floors. The longest 15 m side consists of three 5 m spans, while the shorter 12 m side consists of two 6 m spans.

The design of the building was based mainly on conventional techniques typically used for precast concrete construction with hollow-core slabs. The structure consisted of precast columns and beams used to construct a skeletal frame on which the hollow-core slabs were rested before pouring a topping layer. However, some simple design measures were introduced to improve structural robustness [12]. This included casting the concrete columns with prepared sleeves to allow continuous horizontal ties to be placed above all perimeter and central beams in each floor. These ties were then joined via couplers to prepared anchors in the corner and relevant edge columns. Additional tying reinforcement was also placed between hollow-core planks based on recommendations in guidelines issued by the Institution of Structural Engineers [12]. A more detailed description of the building and test can be found in Buitrago et al. [13].

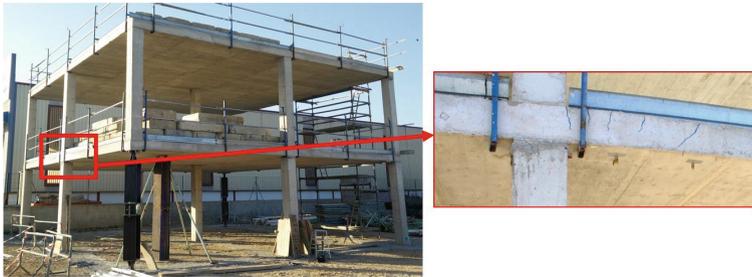
Fig. 5. Cracks on the slabs near the slab-column joint next to the failed column after its sudden failure.

As an example of what occurred in the experimental test, Fig. 5 shows a photo of some cracks produced on the slabs near the slab-column joint attached to the failed column after the accidental event.

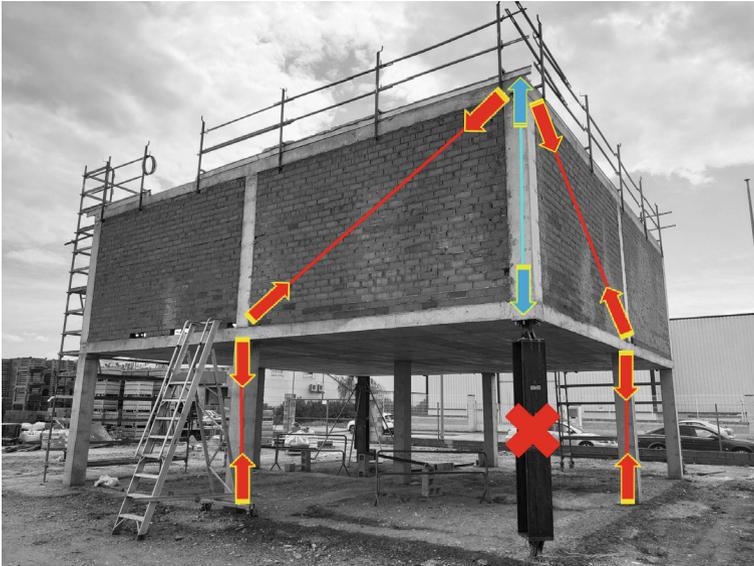
Fig. 7. Activation of an alternative load path based on the infill masonry walls.

Results showed that the main alternative load path comprised the activation of the infill masonry walls, as represented in Fig. 7.

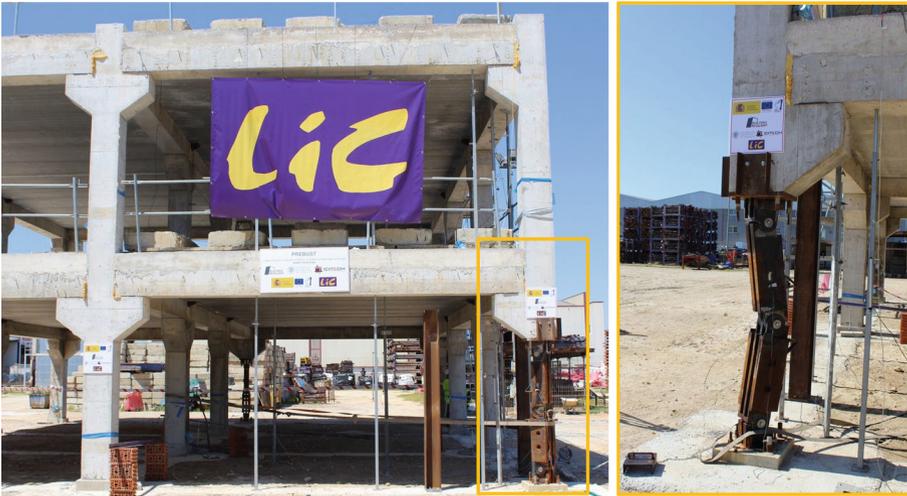
Fig. 10. Structure after the test.

After the test, the structure only showed minor residual damage (cracking) around the beam-column connections. The state of the structure after the test can be seen in Fig. 10, which shows the state of the building with the hinged metal column (yellow box) that allowed the free fall of the corner (12.1 mm maximum drop).
