1 **Detecting Wire Breaks in Prestressed Concrete Pipes: An Easy-to-** 2 **Install Distributed Fibre Acoustic Sensing Approach**

12 The escalating water stress resulting from drought conditions in certain global regions
13 underscores the imperative to minimize water losses, particularly within drinking water supply
14 networks. One way to achieve this is by improving pipe monitoring systems to allow the early
15 detection of possible structural collapse of the pipes. One type of pipe widely used in water
16 mains is the prestressed concrete pipe, whose main cause of structural failure is the breakage
17 of prestressing wires. This research paper analyses the ability of an easy-to-install DAS
18 (Distributed Acoustic Sensing) monitoring system using fibre optics to identify and locate the
19 acoustic signal produced by the wire breaks in prestressed concrete pipes to make early
20 detection of possible structural failures. For this purpose, a large experimental pipeline stretch
21 was built (approximately 1 m in diameter and 40 m long) where wire breaks were simulated.

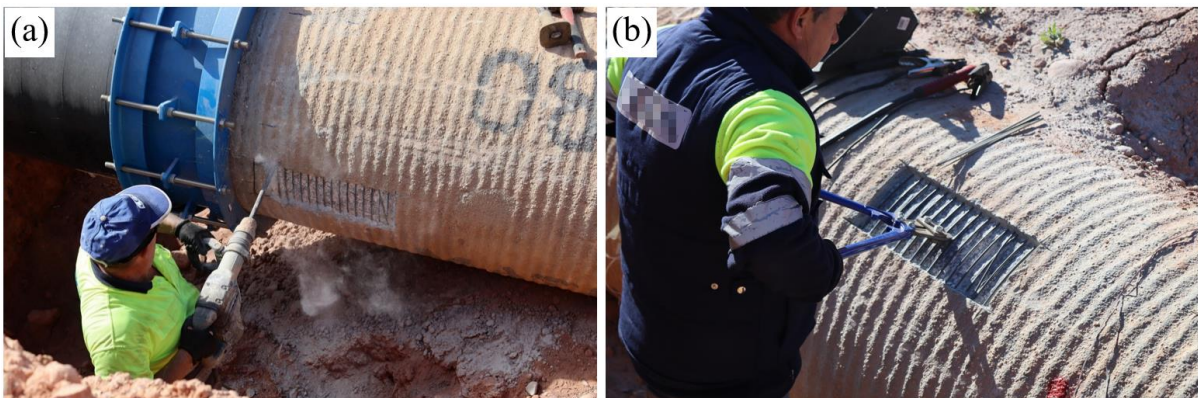
242 Figure 4: Preparation of prestressed concrete pipes. (a) Example of opening a 15 cm high window in one of the
 243 prestressed concrete pipes. (b) Wire break with a shear.

244 Wire breaks in PCNPs were simulated by cutting with a shear (see Figure 4b), as other authors
 245 did²². This method was chosen for its simplicity, speed and for reducing the extra noise during
 246 cutting compared to other tools, such as the radial saw. The aim was to simulate as closely as
 247 possible the wire break that would occur in an actual situation due to corrosion of the
 248 reinforcement. Furthermore, the suitability of this method was confirmed by the publication of
 249 Li et al.¹⁵, where the wires were artificially broken with a radial saw and electrochemical
 250 corrosion, and it was found that the signal generated by the corrosion was almost identical to
 251 that caused by the artificial breakage of the bar.
