The Castle in Paphos, a fascinating, iconic, neglected, abused remain of a layered fortification

Giorgio Verdiani^a, Alexia Charalambous^b

Abstract

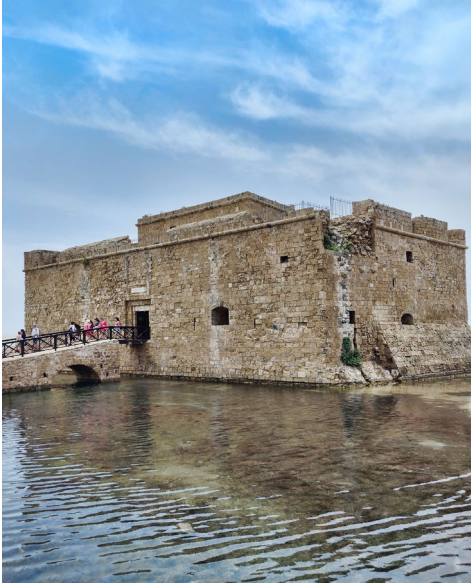
Fig. 1- The Paphos Castle, view from the harbour, June 2023 (photo by the Authors).

The Castle appears as a visible and clear landmark at the end of the public spaces of the harbour (Fig. 1), it is surrounded by restaurants and services for tourists and locals, and it helps in easy orientation in the different directions of this area. These buildings were erected during the British colonisation of the island.

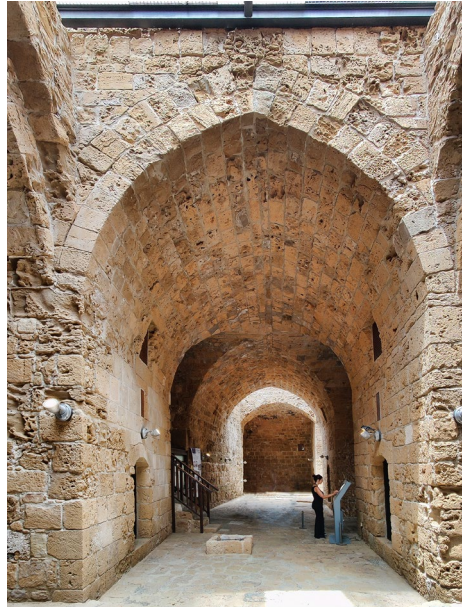
Fig. 2- The Paphos Castle, interior view of the main court, June 2023 (photo by the Authors).

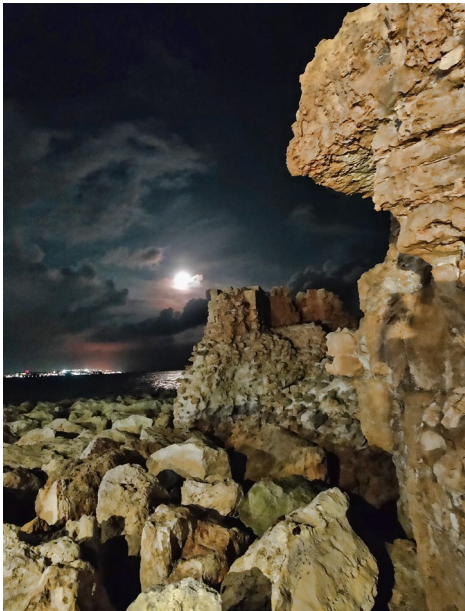
Fig. 3- Ruins of fortifications in the nearby of the Castle, June 2023 (photo by the Authors).

Outside the main building, an extensive system of ruins testifies to the former existence of the prior existence of a large fortification of the entire harbour (Fig. 3). With the beginning of the British occupation, the castle lost its military function and was used by the colonial government as a salt depot until it was declared a historical monument in 1935. Since then, it has been maintained by the Department of Antiquities and is considered one of the landmarks of the Paphos district.

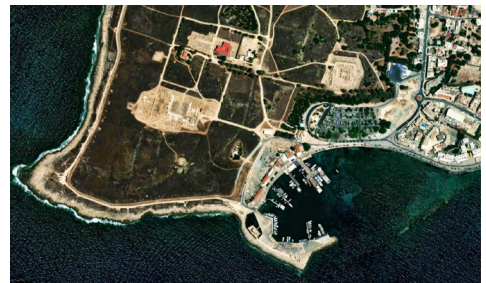
Fig. 4- The Paphos Castle, view of the area (Microsoft Bing, 2023).

These large, stone-built bonded warehouses surrounding the fortress were used to store imported or local products. The castle stands isolated along the sea dam, with a series of bold ruins of fortifications on the left and a large artificial pool on the right. At the edge of the pool, there is a courtyard that has been re-landscaped for a small urban park with services, which, to be honest, does not look very promising. At the back of the castle, there is the new large artificial cliff, which is not easily accessible and has various blocks placed to reduce the possibility of

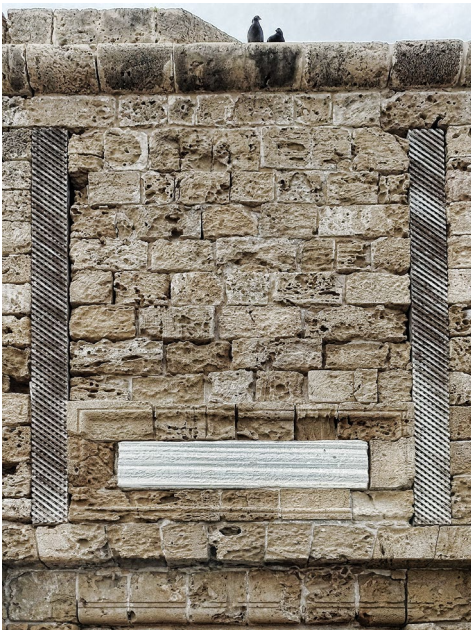
Fig. 5- The marble slate over the main entrance of the Castle, June 2023 (photo by the Authors).

The date is attested by the inscription on the large marble slab by Ahmet Pasha (1589-1593) (Lysandrou et al., 2018) placed above the main entrance of the castle. Over time, it was used as a fortress and also as a prison and later as a salt warehouse. The ruins of the eastern tower of the Frankish settlement are still visible at a distance of about fifty metres to the East of the castle. Architecturally, the main part of the castle consists of a large square tower with an enclosed

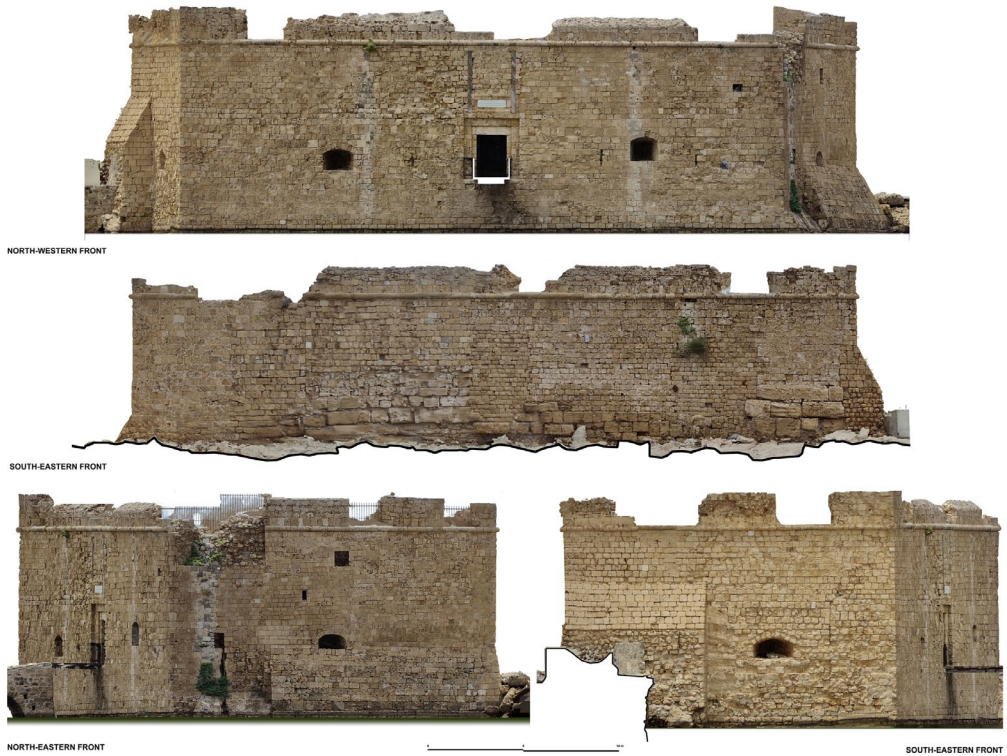
Fig. 6- The orthophotos obtained from the photogrammetry in June 2023 (photogrammetry and processing by the Authors).

The final result is a full mesh describing the whole external masonry surface, made of 800 million triangles capable of producing optimised orthophotos up to 60.000x14.000 pixels (840 Megapixels) for the longer sides. The production of four orthophotos brought to a first

downsampling (directly applied in RC) with the main size reduced to 32.000 pixels making the resulting image more compliant with standard software and more manageable on standard computers. The resulting frontal views are extremely detailed in the lower part of the walls and show only a few sparse artefacts. The effective resolution has pixels of one millimetres at the real size. In the upper part, the entire front of the terrace is more problematic due to the thin metal fences and the low visibility of the inner parts from the ground. Overall, the representation of the main fronts was excellent and while taken with a rapid and pocket-sized tool like a smartphone, it was even more satisfying. About processing, it is worth mentioning that various software tools currently offer direct capture from smartphones, using APP solutions to directly create a textured 3D model, thus, in this case, it was highly preferred to operate in a more "traditional" way, taking the shots and processing them later on, so to fully exploit the resolution of the camera and allowing the best possible quality in the final output.

The high-resolution graphic map obtained from photogrammetry allows us to read and interpret the stratigraphy of the masonry by distinguishing the different construction phases, the restoration interventions and all the specific elements that characterise the castle. Also, the state of decay is well depicted, with all the main alterations of the stones easily recognizable, presenting the principal spots, cracks and consumption of the surfaces. This level of detail allows to operate a direct reading even from a distance. The captured system of fronts is then a proper base for reading and understanding the castle even a second time after the visit. The overall aspect of the masonry testifies to a certain uniform use of the materials in single interventions, the past restorations re-integrated large surfaces consumed by the salty sea, by the wind and by the weather, but the result, once again quite eroded by time and agents, appears in good continuity with the older parts. Keeping the use of the same material, probably coming from the same quarry or from the immediate nearby, made possible such a result. The deterioration of the façades appears to be under control overall, with no significant cracks or detachments. The most evident pathology is the patina and consumption caused by the water following the surfaces, which is conveyed by the shape of the building itself, with large paths, where the stone blocks fade into greyish colours. This set of orthophotos is also an efficient documentation of the state of the building in Spring 2023, documenting how a long series of transformations brought in the end to a coherent result, which has an iconic value and at the same time represents a clear landmark in the area.

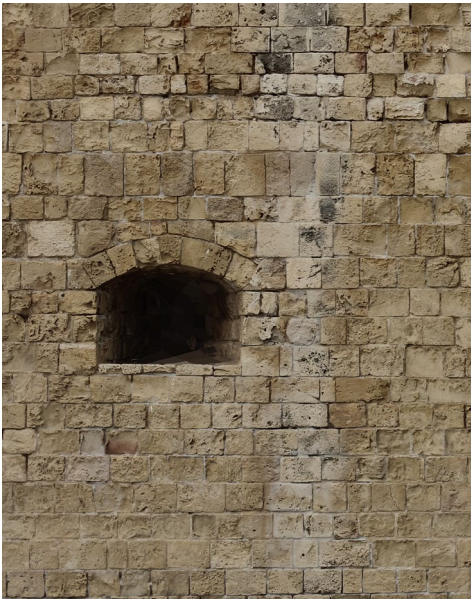
Fig. 7- A detail from the photogrammetry of the north-eastern front (the Authors).
