# Thin-walled concrete beams with stay-in-place flexible formworks and integrated textile shear reinforcement

Minu Lee<sup>1</sup>

<sup>1</sup>Institute of Structural Engineering, ETH Zurich, Zurich, Switzerland

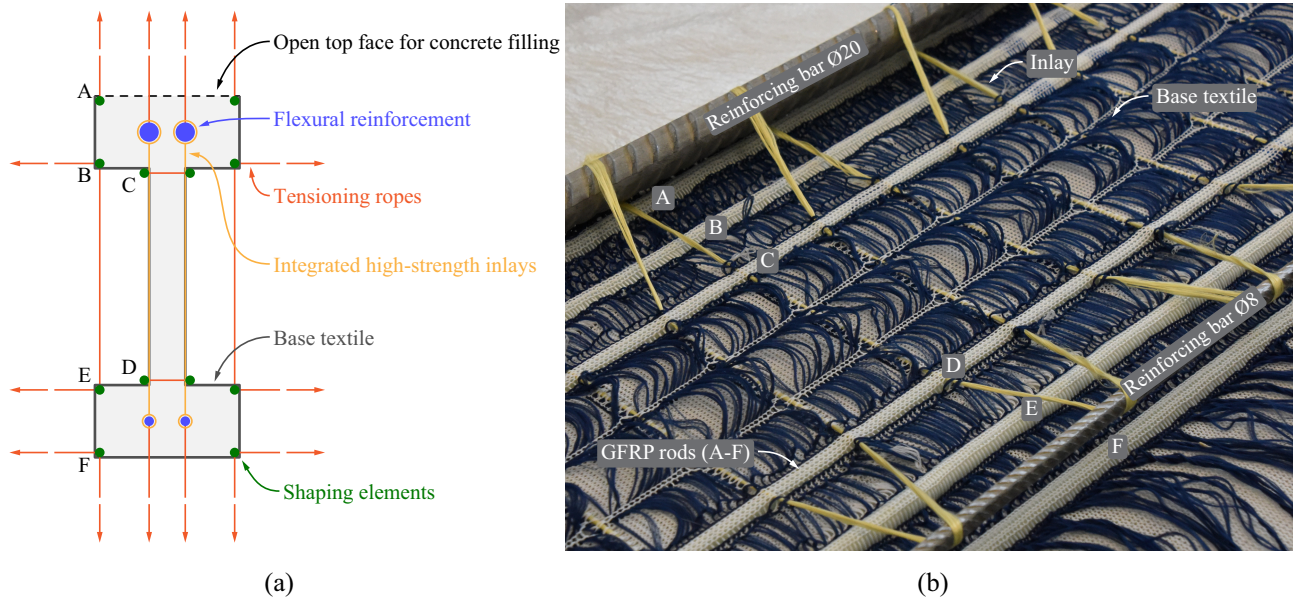
**FIGURE 1** Thin-walled concrete beams from folded textiles: (a) cross section (in upside-down casting position); (b) flat textiles before tensioning with integrated flexural and textile reinforcement, and shaping elements.

This study explores an alternative method where the cross section can be formed by folding a flat textile into the desired shape, with cables or bending-active rods defining the vertices, and being tensioned using ropes in a scaffolding frame. In contrast to tubular textiles, one side of the cross section is left open (as shown in Figure 1a), allowing the concrete to be cast with the

beam in a horizontal position. The inlays are only integrated into the straight part of the web and form a loop around the longitudinal reinforcing bars in the tension and compression flange (Figure 1b). The direct connection of the textile roving around the longitudinal reinforcement ensures proper anchorage. Furthermore, it fixes the position of the reinforcing bars as an integral part of the textile, considerably simplifying the placing of the reinforcement during construction.

The textile formwork was produced in one piece using a gauge 7 CNC flat-bed knitting machine (Steiger Libra 3.130). The knitting was done in the length direction of the beam, with the sectional perimeter (outline) of the beam representing the weft direction of knitting. Two polyester yarns (PES 167 t 30/2) were used to create a sheet of textile that includes longitudinal channels for the insertion of shaping rods, as described in Section 2. Straight inlay aramid yarns were automatically placed during the production process in weft direction, having the correct length and spacing. These inlays formed two continuous zig-zags side-by-side along the length of the textile, thus, connecting the longitudinal reinforcement in the bottom and top flanges of the cross section, which was inserted into these zig-zags (Figure 1b).

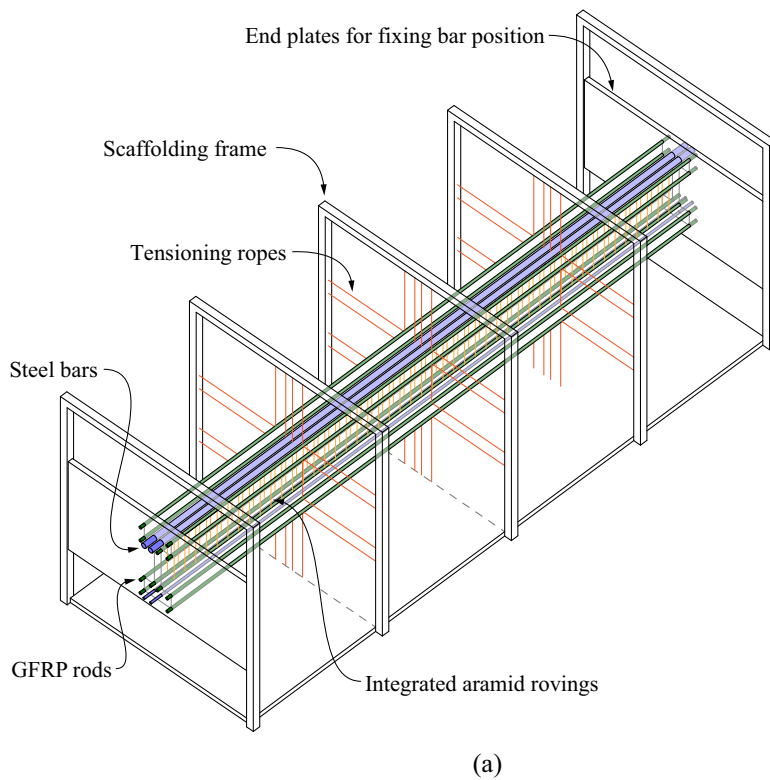
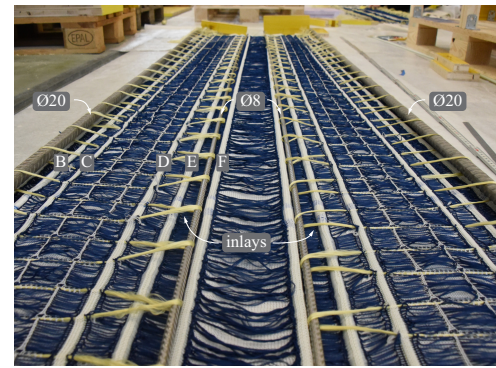
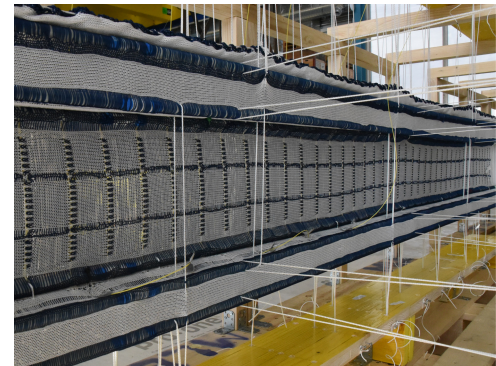
**FIGURE 2** Manufacturing of thin-walled concrete beams with stay-in-place formworks and integrated textile reinforcement: (a) scaffolding frame and assembly, (b) textile before tensioning with deformed steel bars and GFRP rods threaded in inlay loops and channels within the fabric, respectively, and (c) tensioning of textile within frame.

The manufacturing procedure generally followed the principles introduced in Section 2, tensioning the textile in a scaffolding frame as illustrated in Figure 2a. The steel reinforcing bars and the GFRP rods were threaded through the loops created by the inlays and the channels within the textile, respectively, while lying flat on the ground, as shown in Figure 2b. The longitudinal bars and the rods were then fixed at the end plates of the scaffold. The beams were cast upside down with the main flexural reinforcement (steel bars with Ø20 mm) in the upper flange. This creates more space in the geometrically tight conditions of the lower flange (given that the steel bars in the compression chord had a lower diameter) and ensures the proper flow and distribution of the concrete within the formwork, but required the specimens to be flipped before testing. The textile was tensioned in the wooden

framework using ropes to maintain the shape of the cross section and the position of the reinforcing bars over the length of the beam (Figure 2c). The epoxy coating was applied on the textile using paint brushes while the formwork was suspended in the frame. After the coating had hardened, the bottom ropes were cutoff, and a temporary wooden pedestal to support the formwork from the bottom was inserted. The concrete was cast from the top side along the whole length of the beam. At the supports and the point of load application, concrete diaphragms, as illustrated in Figure 3, were cast using conventional formwork, and the surface was leveled with local epoxy beds.

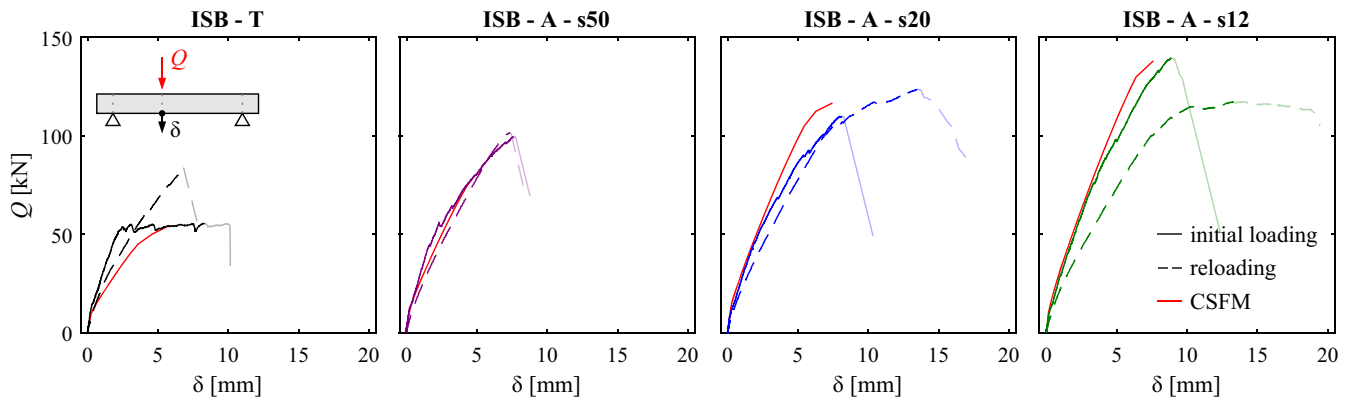
**FIGURE 4** Load–deflection relationship of concrete beams with thin-walled I-profile sections: experimental results and predictions based on Compatible Stress Field Method (CSFM) assuming nominal dimensions.

The predictions using CSFM were validated with the experimental results regarding their global load–deformation behavior, the ultimate load, and the failure modes. The load–deflection relationships denoted as red curves in Figure 4 generally compared well with the

tested beams. The postcracking stiffness of Specimen “ISB-T” was underestimated, and the simulation did not capture the distinct crack sliding prior to failure. While the load–deflection curve of Specimens “ISB-A-s20” and “ISB-A-s12” exhibited good agreement in the initial postcracking phase, the flexural stiffness slightly decreased in the experiments once the governing shear crack started forming (as described in Section 4.4 and shown in Figure 12), which did not occur in the CSFM simulations as the postcracking stiffness was fairly linear and only decreased shortly prior to failure. The shear forces at failure are illustrated in Figure 6 and Table 4, which show an excellent correspondence between the experiments and the model predictions. The largest deviation occurred in Specimen “ISB-A-s50” (17%), which, however, was on the conservative side. Figure 14 shows the utilizations of the textile (red) and steel (blue) reinforcement and the concrete (green), with the location of the maximum value (i.e., utilization = 1) marked as yellow dots. While the reinforcement carried the forces in the directions of their axes, the principal directions of the stresses in the concrete are denoted as the inclinations of the plotted lines, which can be interpreted as the representation of the stress fields transferring the loads within the beams. All specimens with high-strength inlays exhibited the failure in the textile reinforcement at the interface between the web and either the top or bottom flange, which agrees well with the observations in the experiments, where the failure crack in the textile was initiated in one roving and propagated over the height of the web and along the web–flange interface, as described in Sections 4.1 and 4.3. The stresses in the rovings did not exhibit distinct peaks but were fairly uniform over the entire height of the beam due to the small contact area between the concrete and the roving (resulting from the small circumference of the roving and the modeling of zero concrete cover, as described in Section 5.2), leading to a limited stress transfer. The inclinations of the principal stresses—which coincide with the cracks, as described in Section 5.1—corresponded well to the experimental results, lying in a similar range around 25°–30°, as shown in Figure 11.

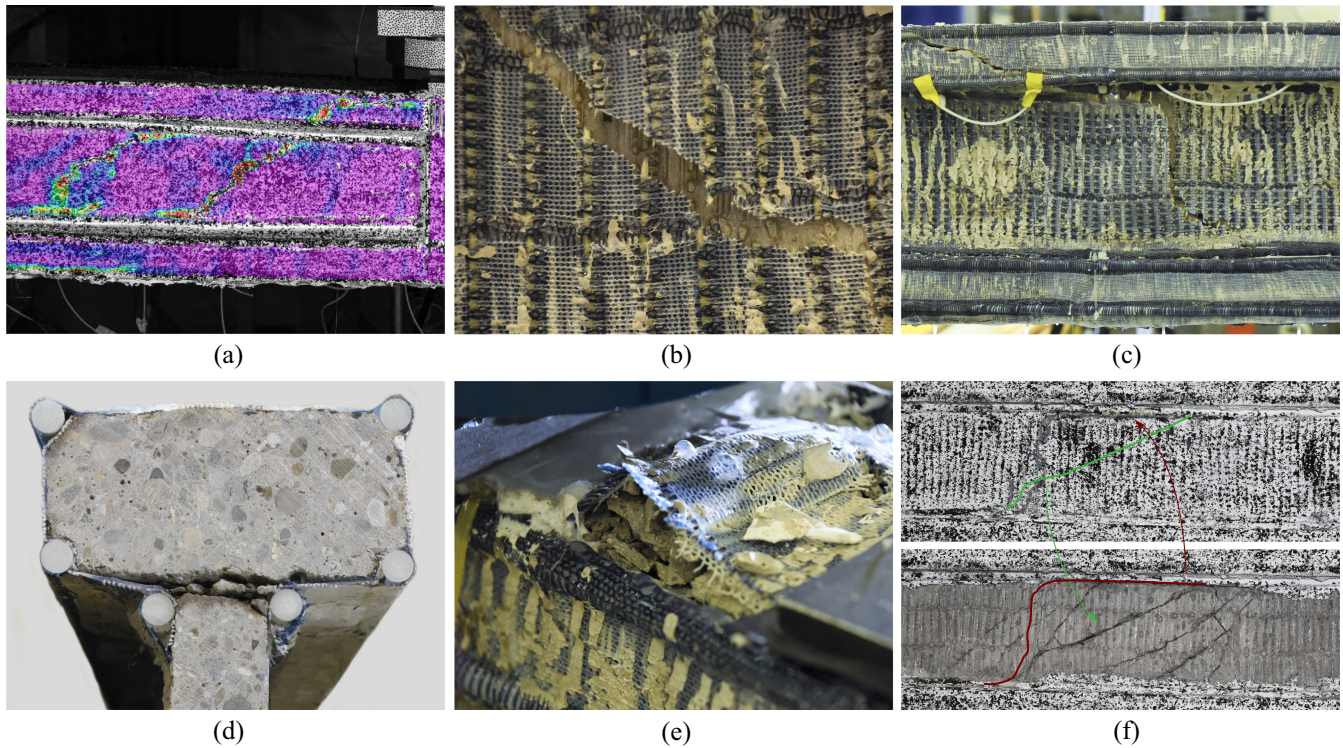
**FIGURE 5** Crack and failure behavior of tested concrete beams: (a) substantial crack in textile of Specimen “ISB-T” before failure (illustrated by the measured principal tensile strain field); (b) ruptured aramid rovings in “ISB-A-s20”; (c) propagation of shear crack along web–flange interface and into compression chord; (d) cut specimen after testing (“ISB-T”); (e) concrete crushing in compression chord; (f) governing crack in the concrete (green) and failure crack in textile (red) after testing.

All beams with high-strength inlays exhibited a sudden drop of the applied force and rupture of the aramid rovings when reaching the ultimate load (Figure 5b) in the first loading cycle. The shear cracks, which formed as expected in the shorter span, propagated to the flanges, causing horizontal cracks at the web–flange interface and in the compression chord, as shown in Figure 5c,d. The failure loads increased with the transverse reinforcement ratio, as shown in Figure 6, highlighting the significant beneficial influence of the aramid inlays on the shear strength.

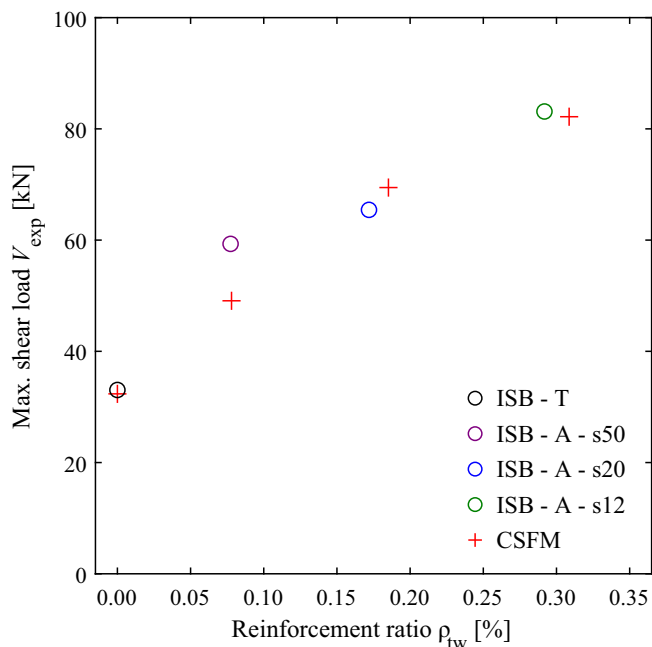
**FIGURE 6** Shear force in short shear span at failure versus transverse reinforcement ratio  $\rho_{tw}$  under initial loading: experimental values (circles) and predictions based on Compatible Stress Field Method (CSFM) assuming nominal dimensions (crosses).

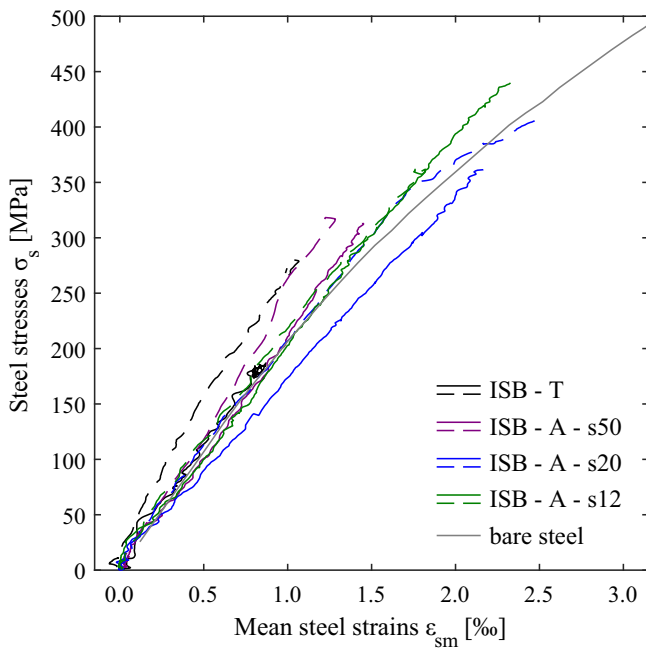
**FIGURE 7** Stress-strain relationship of the steel reinforcement in the tension chord compared with bare steel.

Figure 7 shows the resulting stress-strain relationship of the steel reinforcing bars in the tension chord. The tensioning stiffening effect from the interaction of the longitudinal reinforcement with the surrounding concrete was practically zero as most specimens closely followed the behavior of the bare steel obtained from the material tests, as described in Section 3.1.2. Specimen “ISB-A-s20” displayed even larger strains than the bare steel at the same stresses, but the stiffness for loads close to failure coincided fairly well. This suggests some unwanted slip due to insufficient bond and anchorage at lower load levels until the reinforcement was properly activated. The reloaded specimens exhibited some peculiar behavior while approaching the ultimate load, such as the sudden change of the stiffness as in Specimen “ISB-A-s20,” which presumably originated from the failure of the flexural compression zone. Specimen “ISB-T” exhibited a stagnation of both stresses and strains close to the ultimate load, which underlines that the large deformations observed in Figure 4 were indeed not the result of plastic deformations in the tension chord but were rather caused by the substantial crack sliding, as described in Sections 4.1 and 4.4.

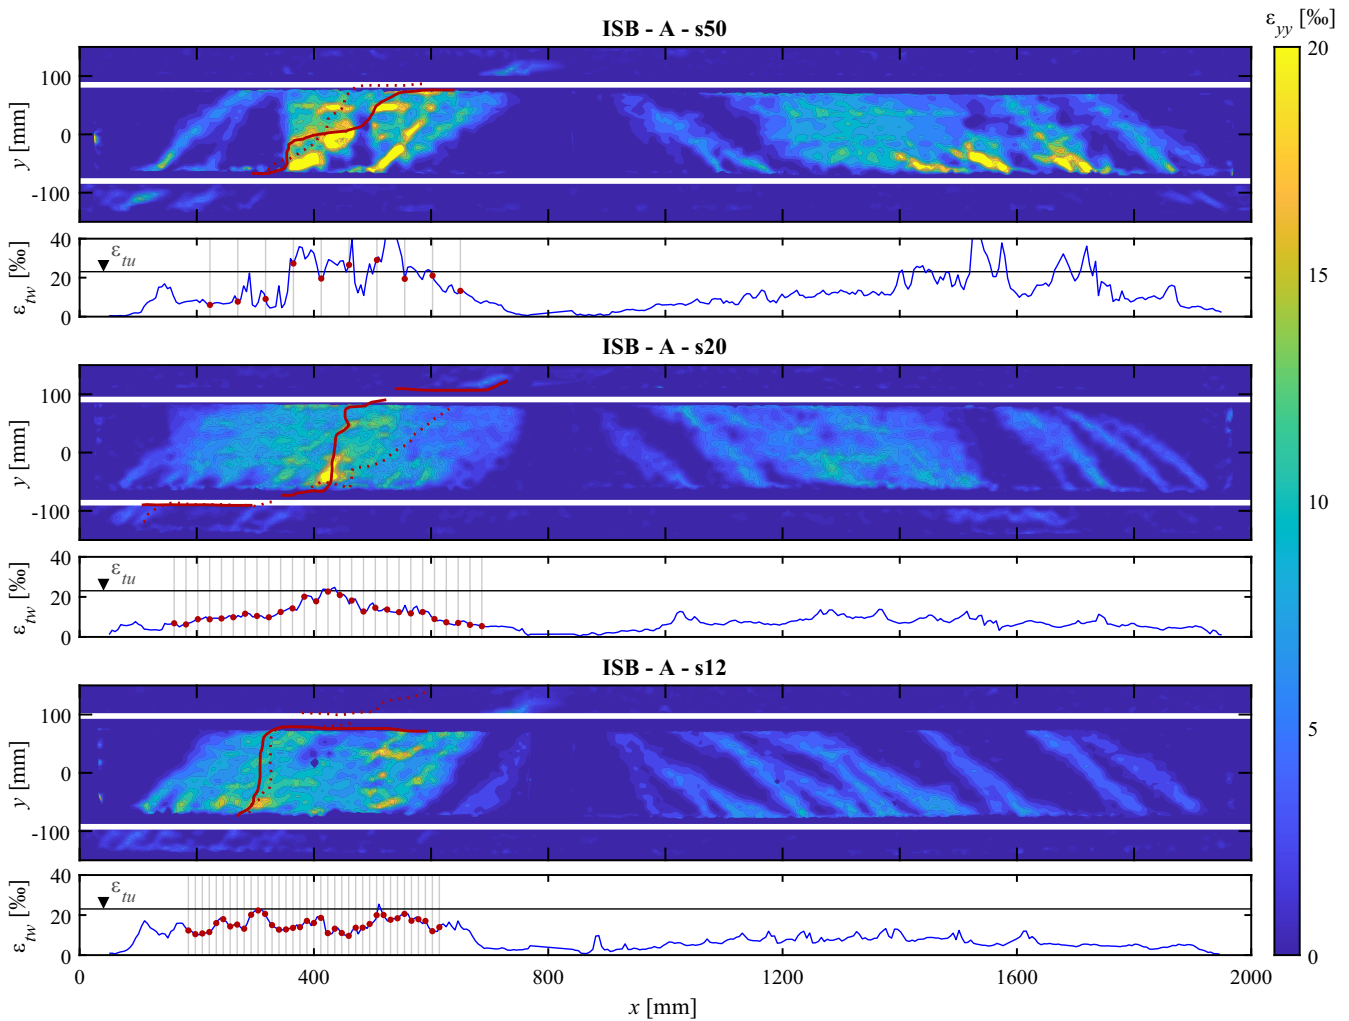
**FIGURE 9** Full field strain measurements in direction of aramid inlays ( $\epsilon_{yy}$ ) and maximum strains ( $\epsilon_{tw}$ ) along the beams, with the gray lines denoting the inlays crossing the governing crack in the concrete, the red dots denoting the representative strains in the rovings considered for the textile contribution, and the red solid and dotted lines denoting the failure crack in the textile on the front and back side of the specimen, respectively.

where  $\epsilon_{tw,i}$ , representative strain in one roving activated in the stress field (denoted as red dots in Figure 9);  $A_{rov}$ , cross-sectional area of one roving;  $n_{rov}$ , number of rovings activated in the stress field (denoted as gray lines in Figure 9). It was assumed that the strains in the rovings were the same on both sides of the web since there were no measurements available from the back side of the specimen. Table 4 summarizes the resulting forces

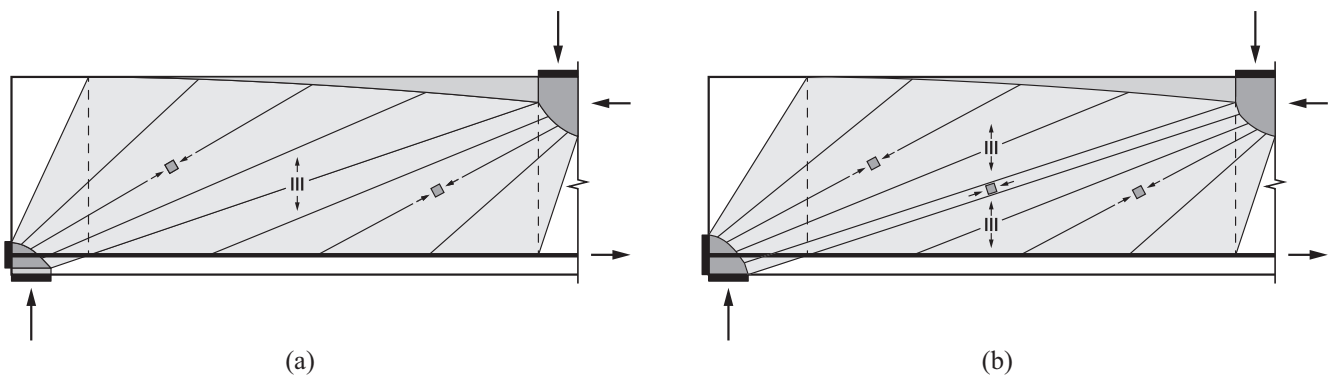
**FIGURE 10** Load suspension mechanism in beams under point load: (a) pure fan action; (b) combined fan and direct strut.

force in the experiment and the measured contribution from the textile reinforcement crossing the crack can be explained by flatter inclinations of the compressive stresses in the web, enabled by aggregate interlock in the steeper cracks, as well as direct strut action, as illustrated in Figure 10b.

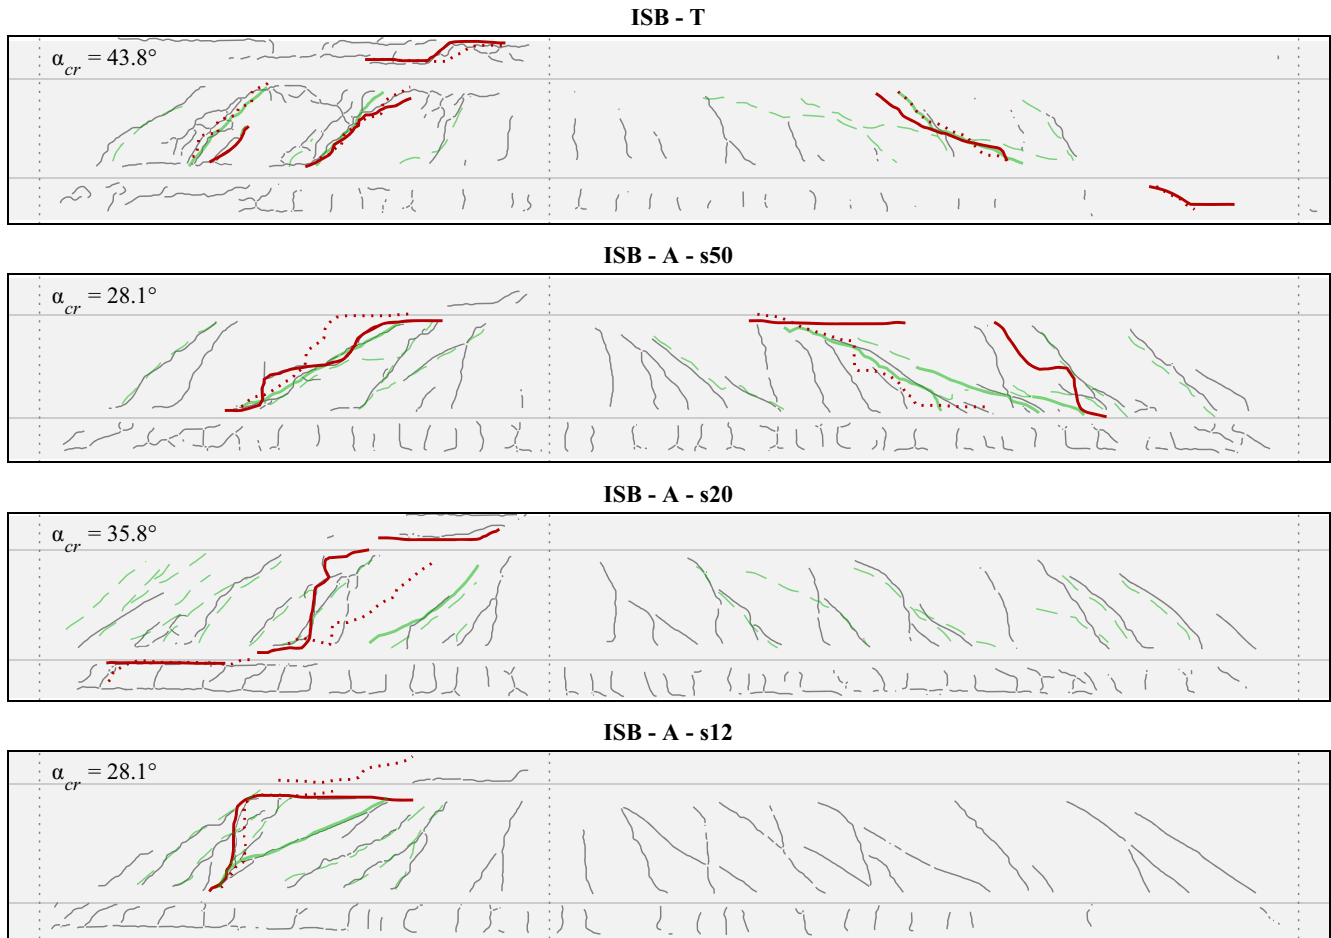
**FIGURE 11** Crack patterns in the textile detected with digital image correlation and Automated Crack Detection and Measurement (gray lines), failure cracks in the textile (red lines), and cracks in the concrete from visual inspection after testing (green solid and dashed lines denoting governing and secondary cracks, respectively) with average inclination of governing crack ( $\alpha_{cr}$ ).

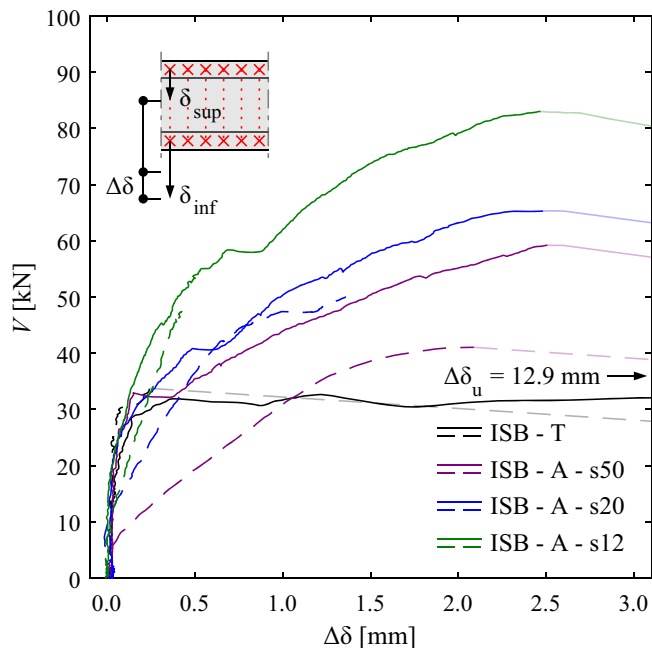
**FIGURE 12** Shear force ( $V$ ) versus maximum vertical component of shear crack opening ( $\Delta\delta$ ).

estimate the shear crack opening consists in measuring the relative deflections of the top and bottom chord of the concrete beam, as described in Ref. [18]. Figure 12 shows the shear force in the governing span ( $V$ ) against the maximum vertical component of the shear crack opening ( $\Delta\delta$ ). The shear cracks started opening within a close range of the applied shear force in all specimens under initial loading, whereby the subsequent load increase was dependent on the inlay spacing. All specimens with transverse textile reinforcement exhibited a similar crack opening at failure in the initial loading cycle. However, the governing crack in Specimen “ISB-T” grew to a considerably higher opening without increasing the load, supporting the hypothesis of substantial crack sliding as described in Sections 4.1 and 4.2, while the reloading cycle and the failure in the longer shear span occurred at a small crack opening, as expected in concrete beams without transverse reinforcement. The shear force-crack opening relationships of the specimens that failed due to concrete crushing in flexure (“ISB-A-s20” and “ISB-A-s12”) followed relatively closely with the curve obtained under initial loading. However, Specimen “ISB-A-s50” displayed the opening of the governing shear crack at much lower load levels, suggesting that a substantial shear crack had already formed under initial loading, which presumably had caused the lower failure load in the reloading cycle.

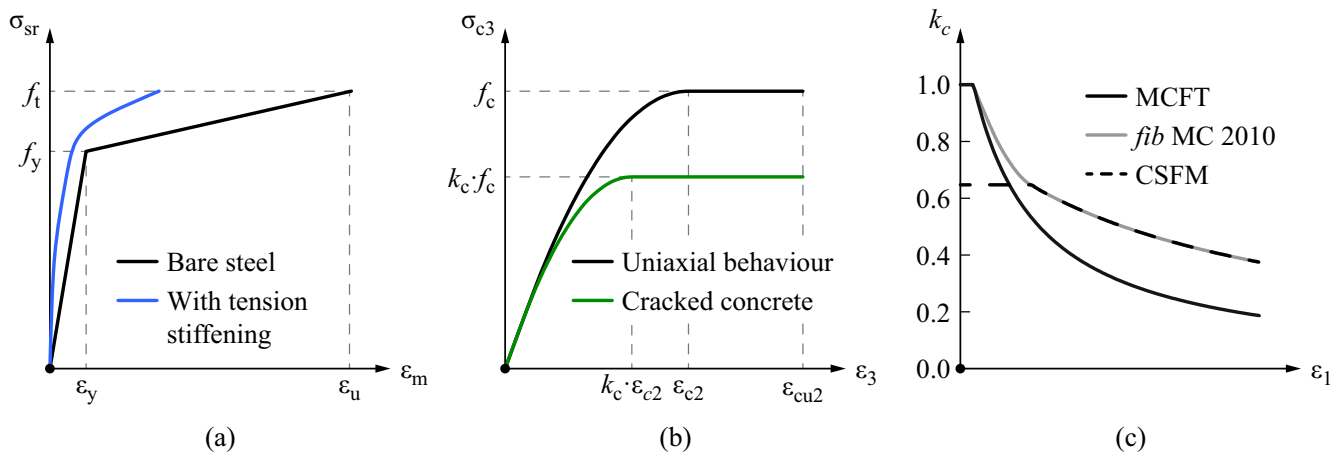
**FIGURE 13** Modeling of constitutive laws in Compatible Stress Field Method: (a) tension stiffening effect in reinforcement, (b) compression softening in concrete, (c) compression softening law. MCFT, modified compression field theory.

The CSFM models the response of reinforced concrete elements under in-plane loading by assuming fictitious, rotating, stress-free cracks, where the principal directions of stresses and strains coincide. The tensile strength of the concrete is neglected, except for its tension stiffening effect, which allows capturing the mean strains in the reinforcement ( $\epsilon_m$ ), as shown in Figure 13a. Tension stiffening is implemented by modifying the stress–strain relationship of the bare reinforcing bars to consider the average stiffness of a bar due to its interaction with the concrete, where the effective area activated in tension is calculated based on the geometric layout of the reinforcing bars in the tension chord (for a more detailed description, see Ref. [34]). The constitutive law of concrete follows the parabola-rectangle diagram of EN1992-1-1,<sup>36</sup> and its strength is adjusted according to the compression softening effect for cracked concrete based on the principal tensile strain ( $\epsilon_1$ ) using the  $k_c$  reduction factor, illustrated in Figure 13b,c. This

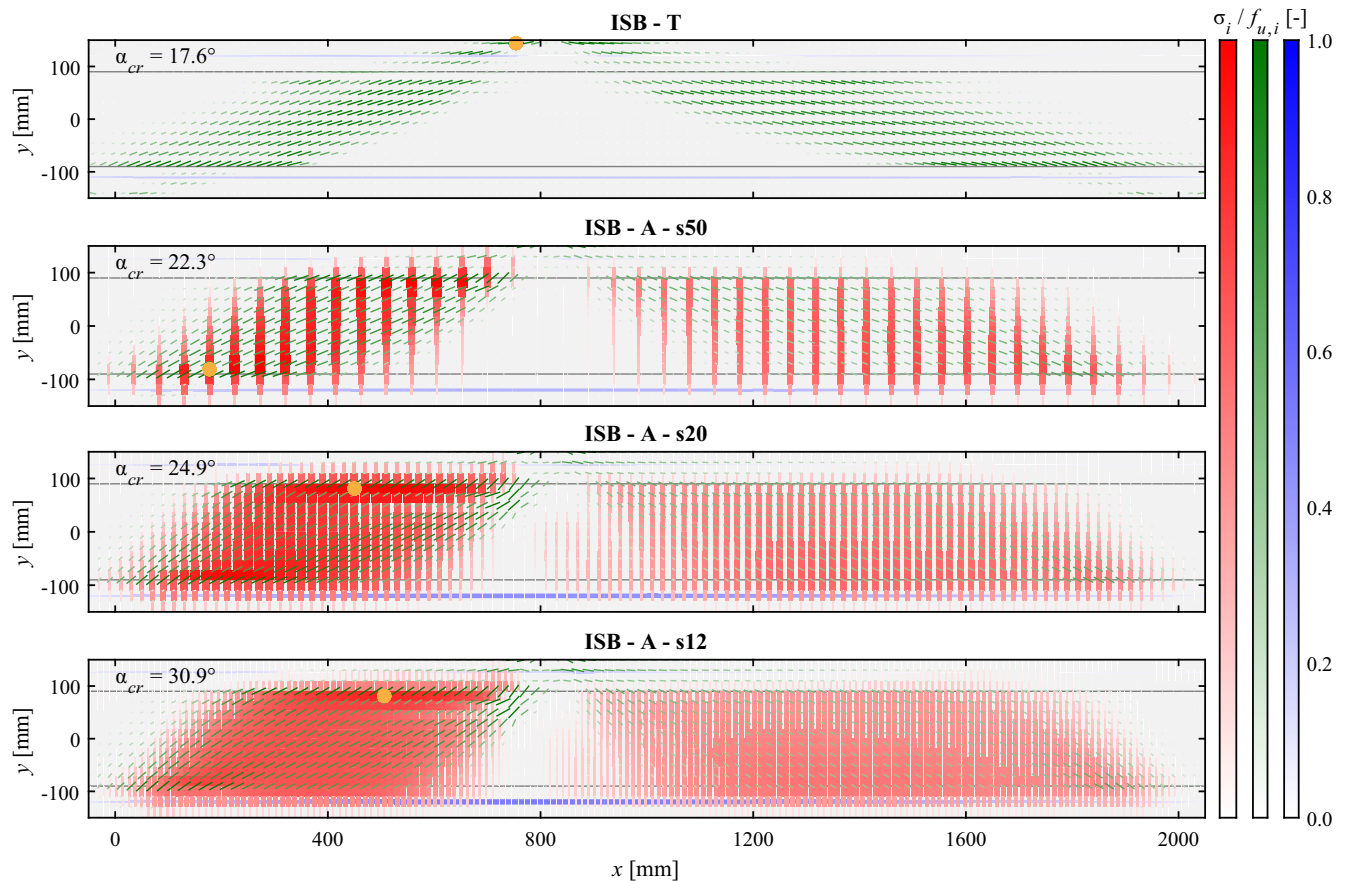
**FIGURE 14** Utilizations (stress divided by effective strength, admissible stress, and yield strength, respectively) predicted with compatible stress fields for transverse aramid rovings (red), concrete (green, inclinations of lines according to principal direction), and deformed steel bars (blue), with thicknesses of reinforcement and line lengths of compressive stresses proportional to their magnitudes, and yellow dots denoting governing element (utilization = 1).

The predicted load transfer of Specimen “ISB-T” without high-strength inlays (shown in Figure 14) mainly depended on the formation of a direct strut from the load introduction to the support, which is reflected by a flat inclination of the compressive stresses. Clearly, the model assumption of stress-free, rotating cracks differs from the actual behavior due to the absence of transverse reinforcement, as observed in the experiment, where the governing shear crack exhibited a steeper inclination and hardly any flatter cracks formed. The failure eventually
