RESTORATION OF THE NUMBER 2 BLAST FURNACE AT SAGUNTO: RESTORING VESTIGES OF IRON AND STEELWORK

Carmel Gradolí, Luis Francisco Herrero and Arturo Sanz
 Instituto Universitario de Restauración del Patrimonio de la Universidad Politécnica de Valencia.
 Unidad de análisis e intervención en el paisaje y el patrimonio rural

ABSTRACT: *The Number 2 Blast Furnace is the most significant remains of what was the major iron and steelwork industry of the Mediterranean basin. Besides its powerful imagery and commemorative nature, its educational potential was a determining factor in preventing its demolition in 1984. In 1992, the Valencia Community Foundation for Sagunto's Industrial Heritage proposed the restoration of the Blast Furnace for it to become the centrepiece of the Industrial Archaeology Museum of Sagunto.*

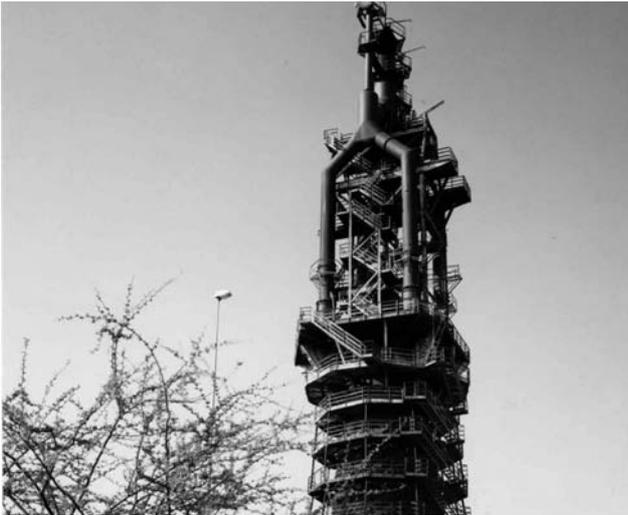
Figure 1. View of the Number 2 Blast Furnace before its restoration

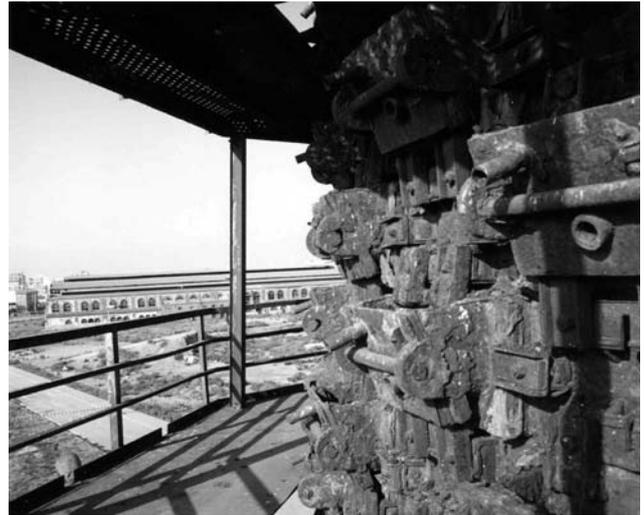
Figure 2. View of one of the barrel platforms. In the foreground, the cooling unit is covered in rust

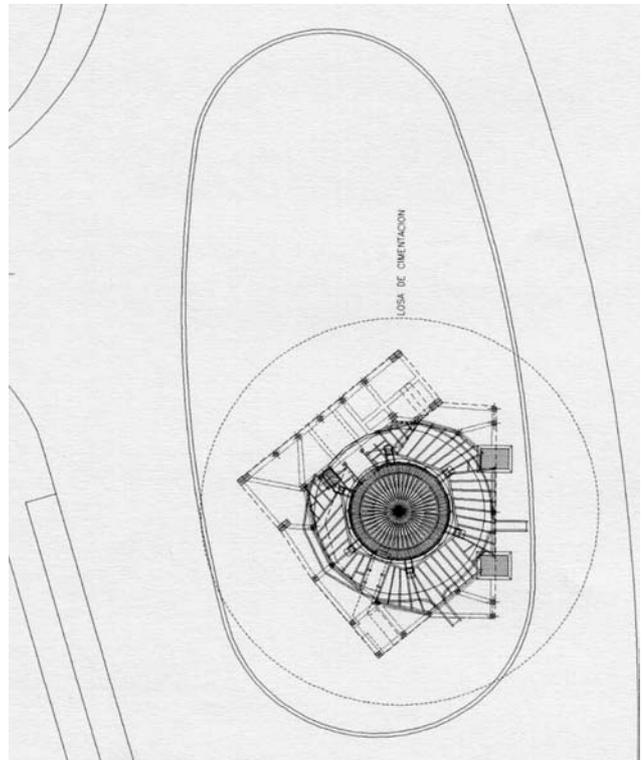
Figure 4. Elements conserved from the Number 2 Blast Furnace as they were left on the traffic roundabout

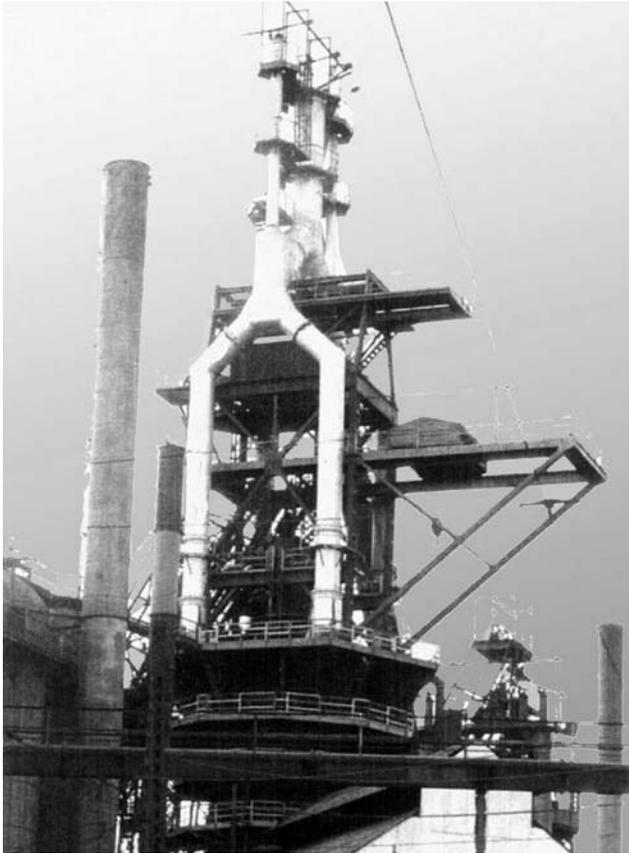
Figure 5. The Number 2 Blast Furnace after rebuilding in 1974. The travellers bestow a characteristic directionality on the whole complex. The colouring of some of the elements can be seen, in particular the safety signs of the handrails

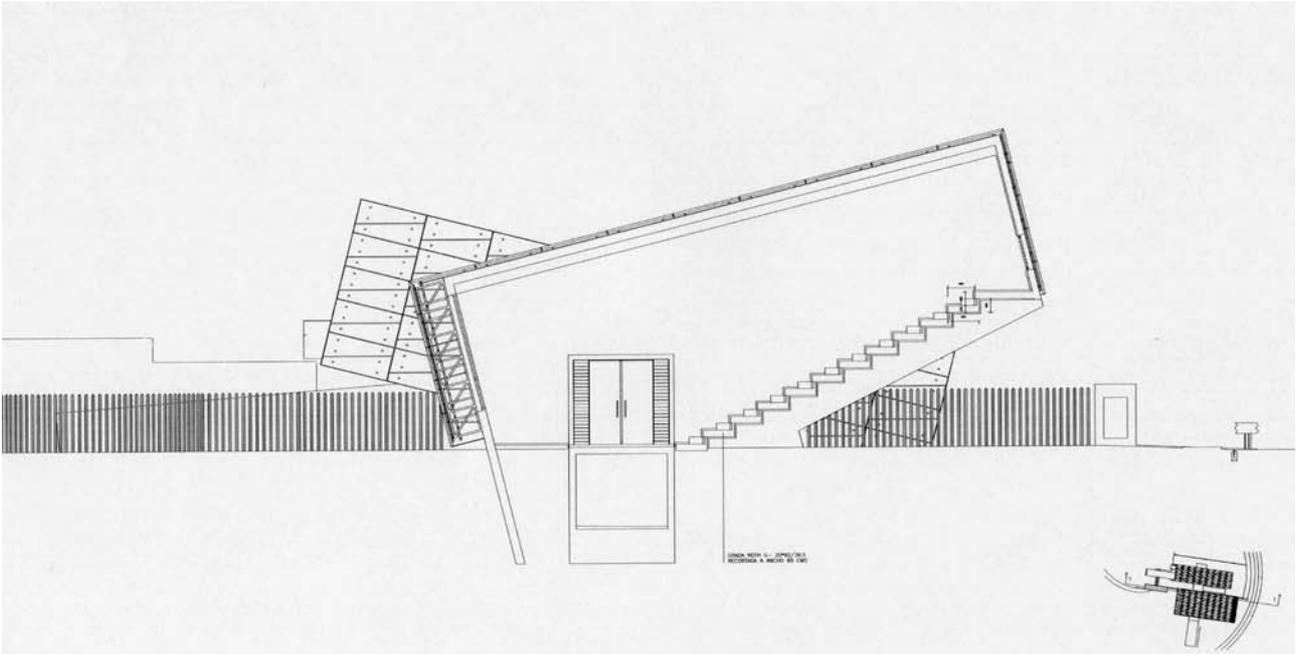
Figure 8. The cross section of the reception pavilion through the multi-purpose hall. Its sloping volume corresponds to the inclination of the stands which are set against the inclination of the access and the toilets (behind). The central corridor acts as pivotal axis for both volumes

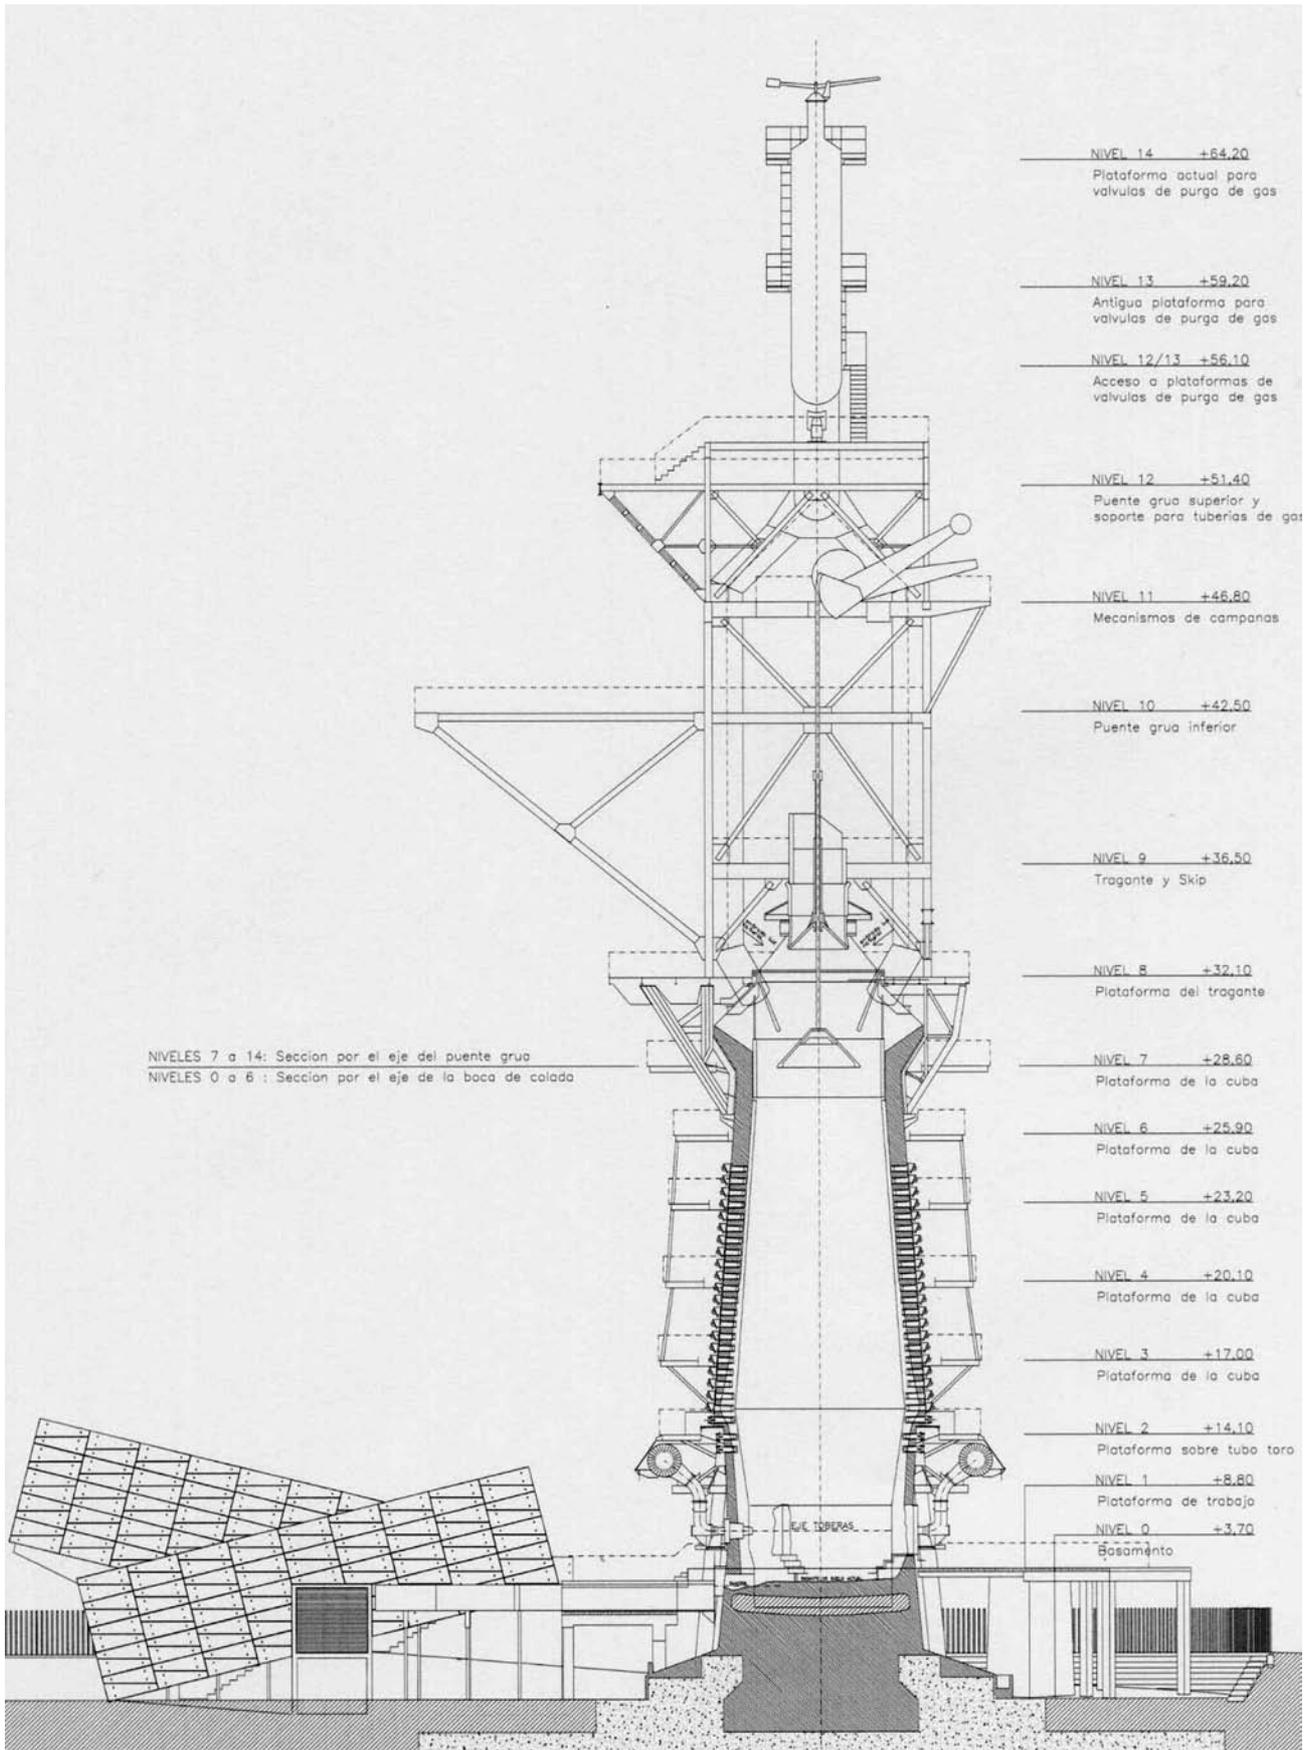
Figure 9.:Section of the Blast Furnace and its different levels

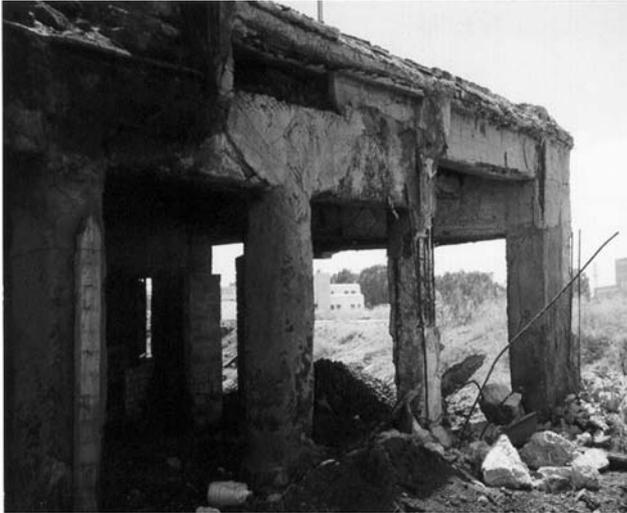
Figure 10. The work platform before intervention

- Repairing the concrete of the work platform by replacing the corroded steel reinforcement and using high-strength concrete made with cement that withstands the aggressiveness of the marine environment and the sulphates detected in the ground water.

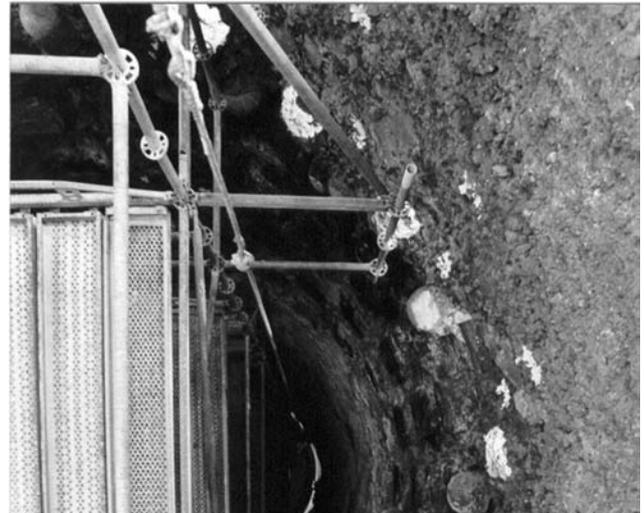
Figure 12. Cleaning and consolidation work on the refractory coating inside the barrel

- The loose material inside the furnace was removed.
- The huge metal crusts bonded to the side of the refractory lining were removed as they were impossible to secure using normal means with any minimum safety guarantees given their weight and dubious stability.
- After removing these crusts, the surface refractory lining was cleaned by removing the loose parts.
- The loose plates of the inner side of the lining were secured with galvanized steel bars on the most solid part of the refractory blocks.
- Two stressed meshes of different gauges were placed near the bosh hoop to protect visitors from possible detachments of small pieces breaking or peeling off the refractory lining

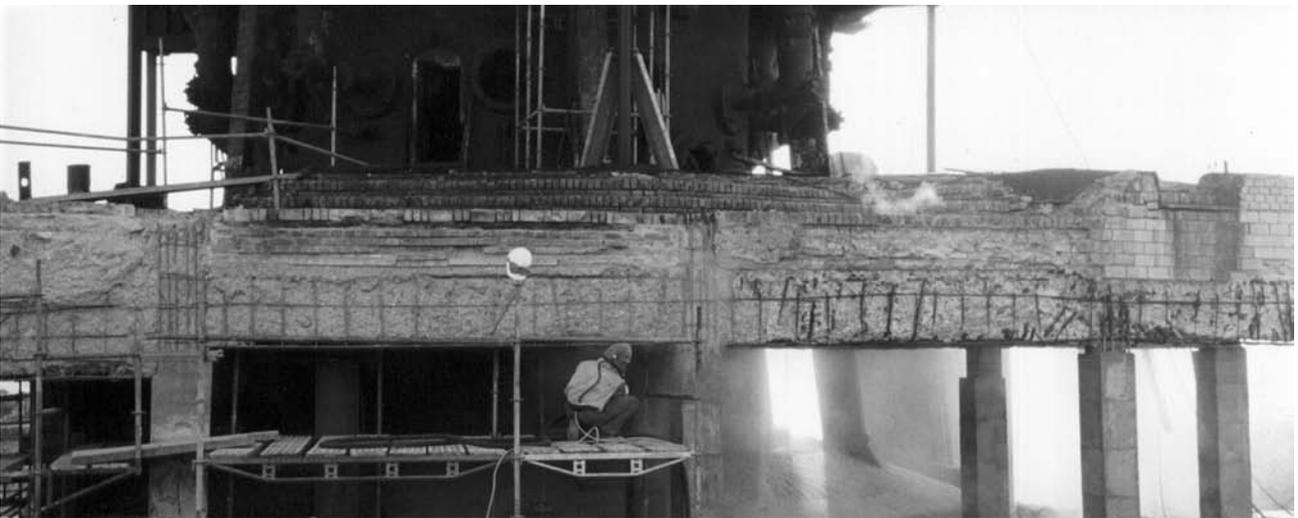
Figure 11. Repairs to the work platform

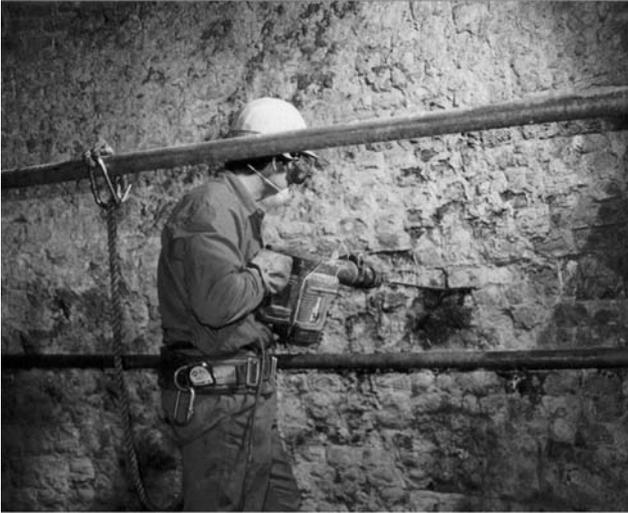
Figure 13. Consolidation work on the refractory coating inside the barrel

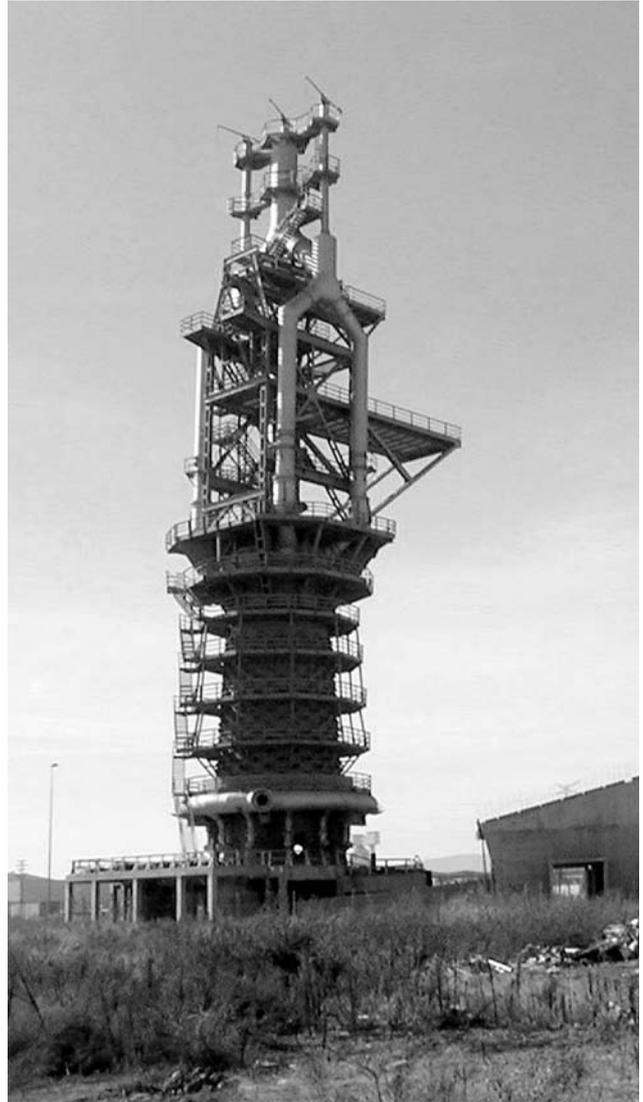
Figure 14. State of the furnace on 2 November 2002
