Report on System Development, Method Applicability and Pipeline Condition Data for Modeling Purposes

D46.2

Final Version for Distribution

June 2013

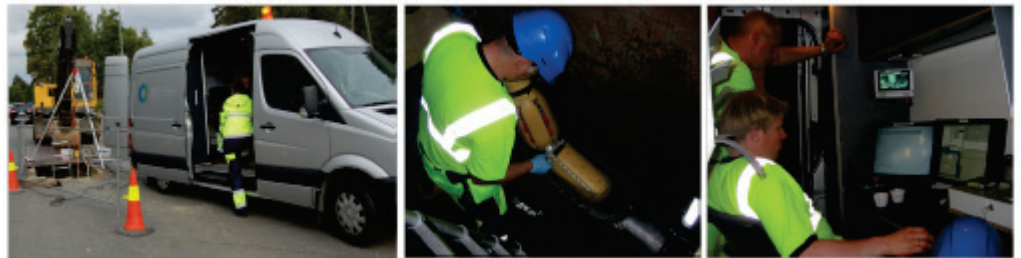
Figure 2.2. The inspection unit and PipeScanner field operation

- The inspection vehicle, which is equipped with data collection, control and communication equipment.
- The inspection crew (2 people)
- The PipeScanner
