# JURISDICTIONAL BOUNDARIES IN SPAIN

## SURVEY AND MARKING OF BOUNDARIES IN TERUEL (SPAIN)

### ABSTRACT

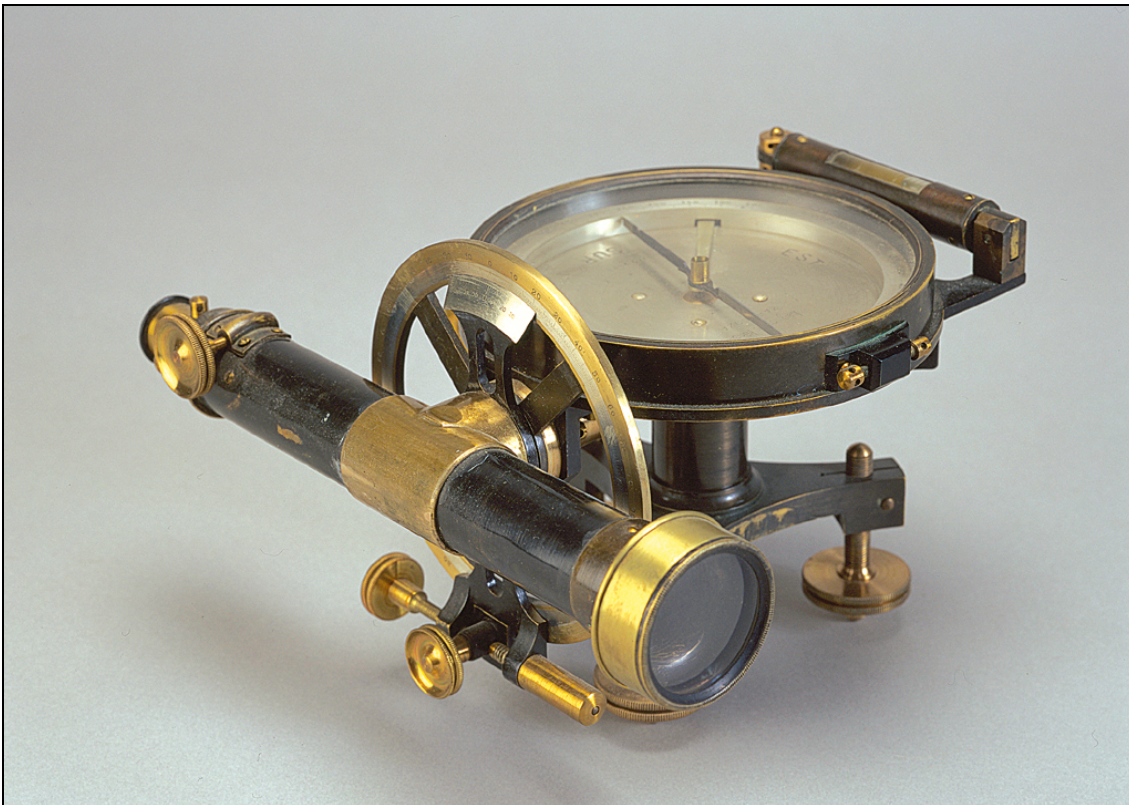
Figure 2. Tachymetric compass. Laguna de Rins Brand. Year 1980. Source: IGN [www.ign.es/ign/home/cartografia/museovirtual/instrumentos.jsp](http://www.ign.es/ign/home/cartografia/museovirtual/instrumentos.jsp)

In most cases the instrument used was a tachymetric compass, as shown in Fig. 2. This instrument was used to measure direction and angles with the help of a compass orientation referenced to magnetic north. Consequently, measured angles are called magnetic bearings and it is necessary to know the magnetic declination at a specific time in a specific place. The advantage of this instrument is that it is very easy to use, but a tachymetric compass offers very poor precision, owing to the periodic variation of terrestrial magnetism and isolated magnetic anomalies of the terrain.

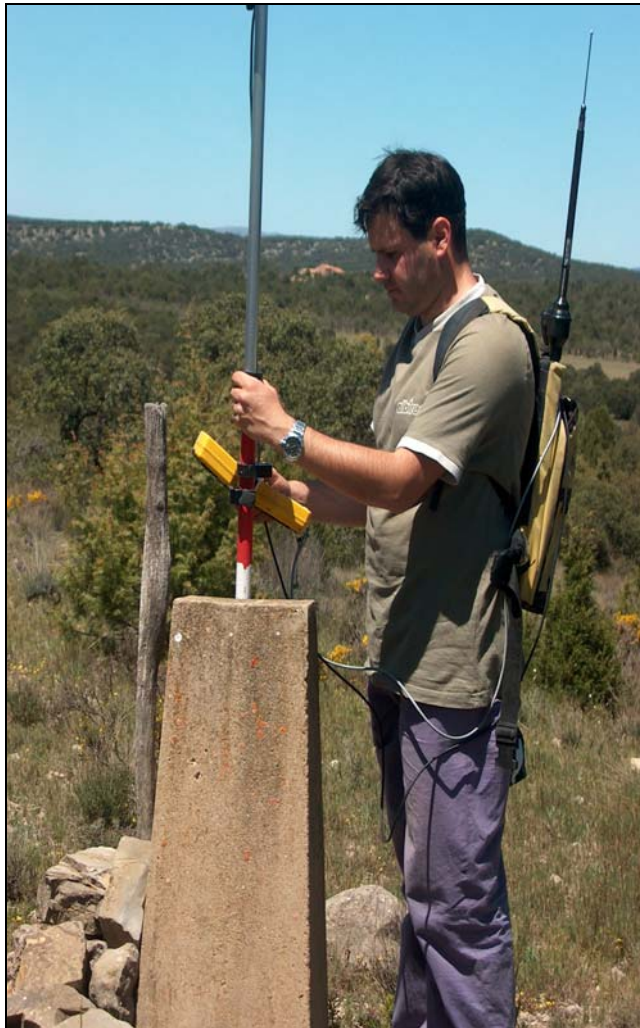
Figure 4. Georeferencing the monument n° 1 by GNSS methodology

This new point was used to georeference the existing monuments by means of GNSS-RTK (Real Time Kinematic) surveys, as shown in Fig.4.

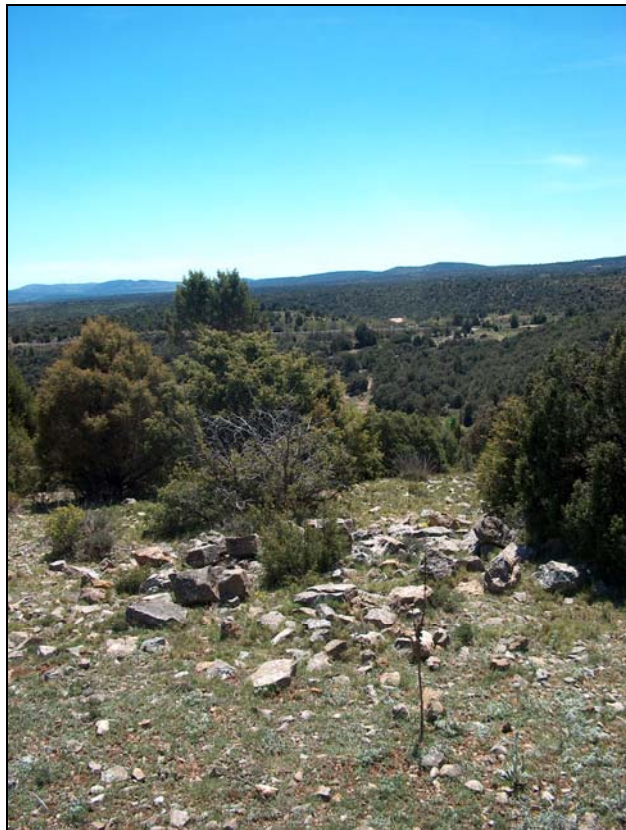
Fig. 5. Second Monument tumbledown remains, located about 6 meters from the calculated point with IGN field tablets data.

Using the coordinates obtained, the lost monument's layout was determined, the disappeared monument was searched for at this point. At about 6 m from the pointed place, a pile of scattered stones of about 4 metres was found; although it was quite low, and it could be easily found because there were the only big stones in that area, which is evidenced in Fig.5.

It was near the layout point and there were no big stones nearby. Therefore it was easy to deduce that this was the monument built 109 years ago. Once identified, its

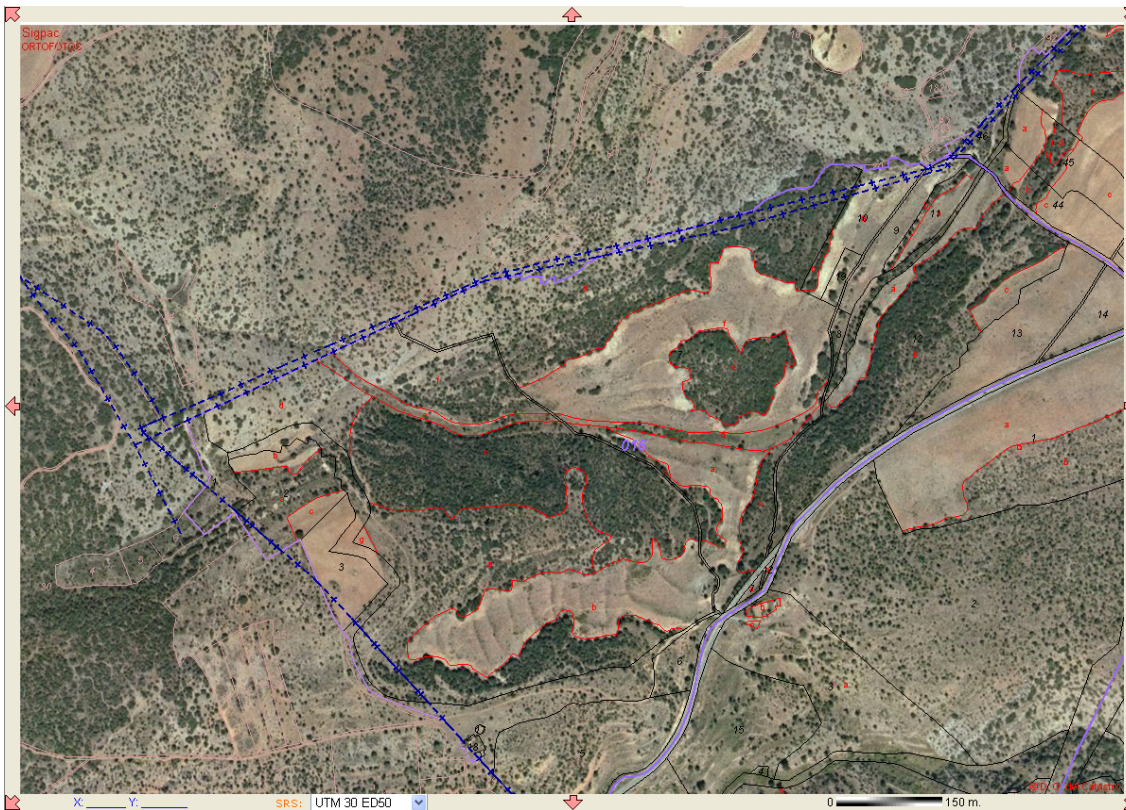
Figure 6. Ortophotography taken from the Spanish Cadastre's official web page showing the boundary line involved.

The last step consisted of comparing the boundary line cartography obtained with the boundary line included in the cadastral cartography. The error in relation to this boundary line was calculated to be more than 17 meters, which means that the boundary line in the studied area was moved 17 meters to the South along the 1.5 km of its length, all of which implied that solely in the studied area, there was an error of 25500 m<sup>2</sup> in favour of the municipality of Albentosa. This area was erroneously assigned to Sarrion's municipality in the Cadastre.

This error is evidenced in Fig.6, which is an image taken from the official web page of the Spanish Cadastre. Looking carefully at the boundary line in blue with a plus and minus symbol, it can be observed there is not a single line but two lines defining the same boundary. That means that discrepancies even exist in the cartography of the same official agency.

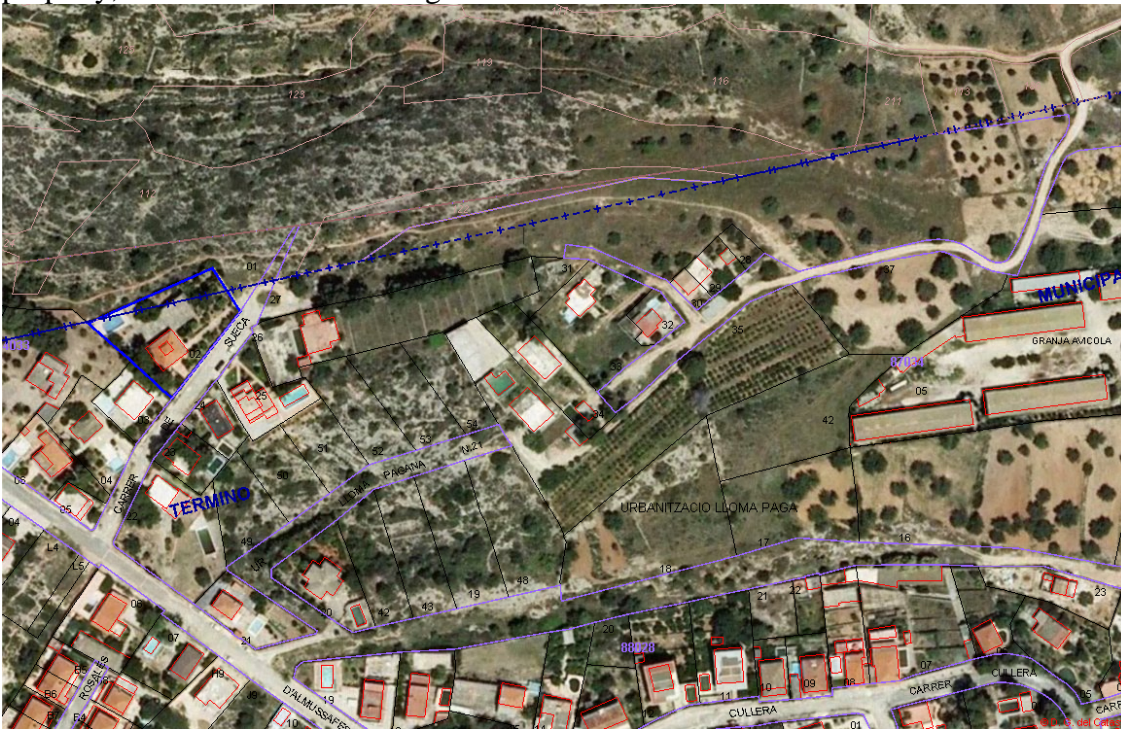
Figure 7. Ortophotography taken from the Spanish Cadastre's official web page showing a boundary line crossing an urban property in the town of Catadau (Valencia).

Fig.7 and Fig.8 show the discrepancy between two municipal boundary lines, even shown by Spanish Cadastre. In this case, the boundary line (in blue) crosses an urban property, but there are no building structures.
