Galindo, J.; Serrano Cruz, JR.; Dolz Ruiz, V.; López Hidalgo, MA.; Bouffaud, F. (2013). Behavior of an IC Engine Turbocharger in Critical Conditions of Lubrication. SAE International Journal of Engines. 6(2):1-9. doi:10.4271/2013-01-0921.

Behavior of an IC engine turbocharger in critical conditions of lubrication

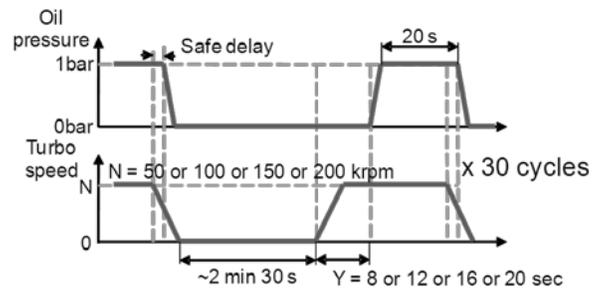
Figure 1 Lubrication delay test

In these tests, the turbocharger is accelerated and decelerated from zero level up to 50000 rpm, 100000 rpm, 150000 rpm and 200000 rpm. These acceleration-deceleration cycles are generally repeated 30 times. When turbocharger accelerates the lubrication is reconnected with different delays (8, 12, 16 or 20 seconds delay), as shown Figure 1.

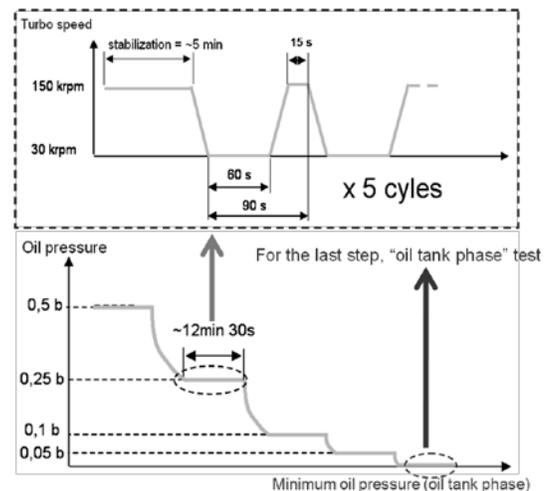
Figure 2 Resistance test

In these tests, the turbocharger is accelerated and decelerated from 30000 rpm to 150000 rpm. These acceleration-deceleration cycles have been repeated 5 times. After, turbocharger inlet pressure is decreased as shown Figure 2, until the “oil tank phase” with a minimum oil pressure, when an oil tank feeds the lubrication circuit and the inlet oil pressure is determined by an oil column of about 1m in height.

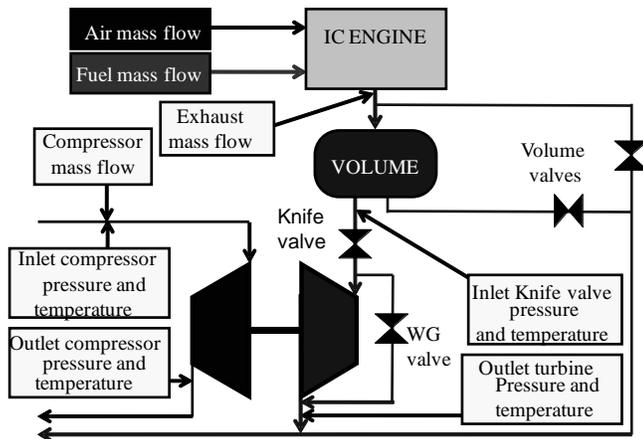
Figure 3 Sketches of air and exhaust gasses circuits

The tests of this study have been made in a turbo test bench that uses an IC engine to generate exhaust gases which provide energy to the turbine [3]. Figure 3 shows a sketch of this test bench.

In Figure 3, the white squares show where are located the pressure, temperature and mass flow sensors. The volume valves are slow control valves, which serve to control the pressure before the turbine. By contrast, the knife gate valve is a valve used to test rapid accelerations and rapid decelerations of turbochargers.

The turbo shaft was blocked in the first cycle of the test, 15 seconds after the acceleration without lubrication. **Figure 5** shows pressures, temperatures and compressor mass flow measurements during this acceleration. Note that the P_IKGV is the pressure upstream the knife gate valve. Figure 3 shows the setup of the installation and the place where this pressure is measured.

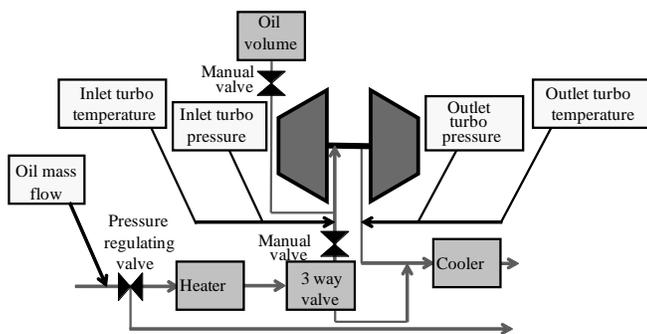
Figure 4 Lubrication circuit sketch

The oil circuit has been modified to perform the required tests. Figure 4 shows a schematic of the turbocharger lubrication system.

As in the previous figure, the white squares show where there are located the sensors of pressure, temperature and mass flow. The heater and cooler are used to control the temperature of oil in the turbocharger lubrication circuit. The three-way valve bypasses turbocharger to simulate lubrication system failures. In addition, the oil pressure to the turbo inlet can be controlled with a pressure regulating valve. It's possible feed the lubrication circuit of the turbo using an oil volume (during the "oil tank phase" of the resistance tests) that can be connected to the turbocharger by mean a manual valve, which allows the operation of the turbo with small oil pressures.

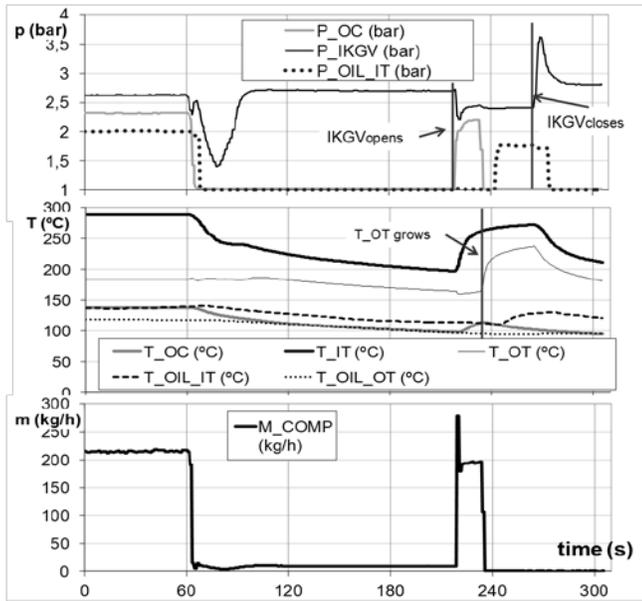
Figure 5 Lubrication delay test, pressures, temperatures and compressor mass flow measurements

The turbo shaft was completely blocked in the second 235. At this point, the compressor stops working and it is possible to see a temperature increment at the turbine outlet, because the shaft is stopped. Figure 6 shows the shaft motion measured with the camera during this first cycle.

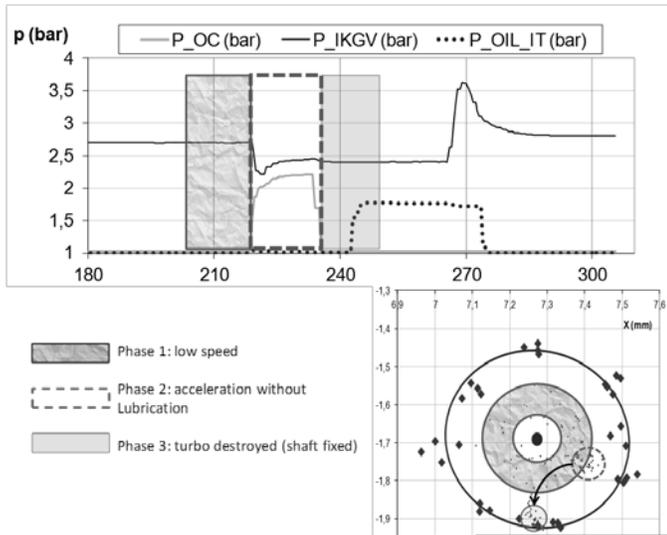
Figure 6 lubrication delay test, shaft motion

This shaft motion can be studied in three phases:

Phase 1. The turbocharger rotates at very low speed (about 5000rpm) and the shaft moves through the area of the figure marked in centre circle of Figure 6.

Phase 2. The turbo is accelerated without lubrication and the shaft moves concentrated in the area of the figure marked in right circle of Figure 6.

Phase 3. The turbo shaft is fixed and it moves following down arrow way and is concentrated in the area of the figure marked in down circle of Figure 6.

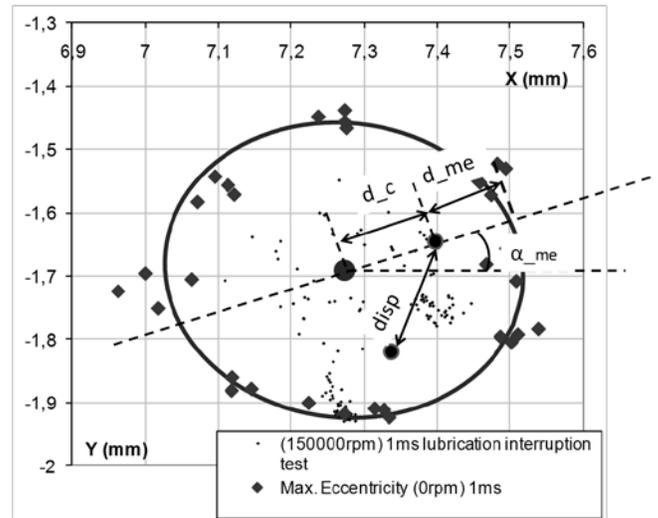
Figure 7 Parameters of shaft motion

In order to represent the shaft tip motion in 2D graphs during this experiment, four parameters have been defined and calculated to be analyzed. Figure 7 shows an sketch with these four parameters; The distance to centre (d_c) shows an evolution during the test of the relative distance between the shaft tip and the centre of the maximum eccentricity, the distance to maximum eccentricity (d_{me}) shows the minimum distance from the shaft tip to the maximum eccentricity, the angle of maximum eccentricity (α_{me}) shows an angle that is counting from the positive X axis in clockwise direction and the displacement ($disp$) shows the displacement between two consecutive positions of the shaft tip along the experiment.

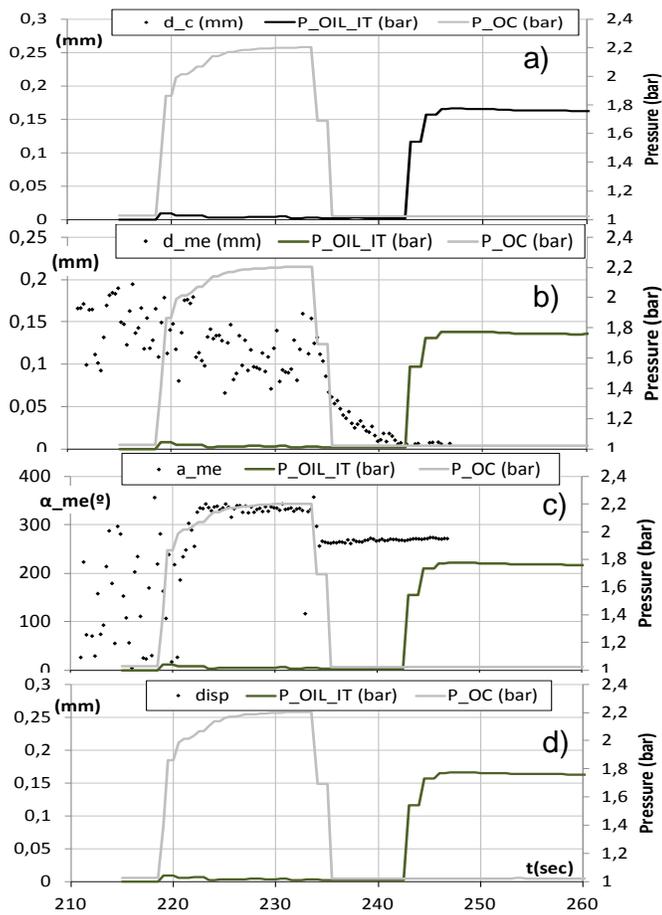
Figure 8 Relative position of the shaft

Figure 8 shows these parameters versus time during the test. Figure 8.a. shows the distance to center (d_c). This distance increases slightly when the turbocharger increases its speed without oil (between 220s and 240s) and it arrives to the maximum eccentricity (0.25mm approx.) when the shaft is blocked at 240s. Figure 8.b. shows the distance to maximum eccentricity (d_{me}) and the behavior is the opposite side of the previous parameter. Figure 8.c. shows the angle, which increases to 340° when the turbocharger accelerates without oil up to reaching 2.2 bar of boost pressure, due to the concentrated movement of the shaft and it decreases to 270° when the shaft is blocked. Finally, Figure 8.d. shows the displacement ($disp$). When the shaft is spinning at low speeds, the displacement is the biggest, due to the scattered movement of the shaft at these low regimes. After, when the turbocharger accelerates, the shaft motion is concentrated and the displacement is reduced. Finally, when the shaft is blocked, the displacement trends to zero.

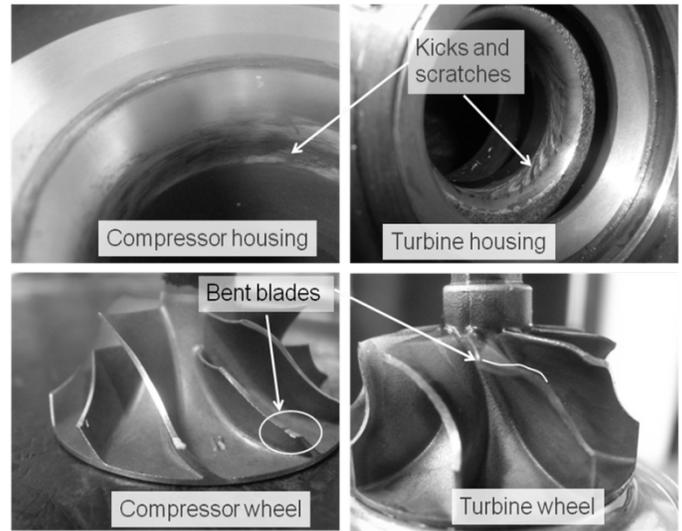
Figure 9 Compressor and turbine wheels after the test

When turbocharger was disassembled, it presented kicks and scratches in turbine and compressor wheels and housing, as can be observed in Figure 9. These hits produced the bending of the blades showed in Figure 9. In this test, only one blade in compressor wheel and one blade in turbine wheel presented big deformations, they can be observed in the figure. Additionally, the shaft had material addition from radial and axial bearings due to the contact shaft-bearing. Moreover, the compressor nut was completely unscrewed (the nut could be extracted by hand when the compressor wheel was disassembled), due to the abrupt deceleration of the shaft when it was blocked. Probably, a small shaft imbalance produced that the closest blades to this imbalance zone hit the housing during extreme operating conditions of the test (high speed and without lubrication). This behavior causes wear of the bearings and finally, the shaft is blocked, producing an abrupt deceleration and as a consequence the nut unscrewed.

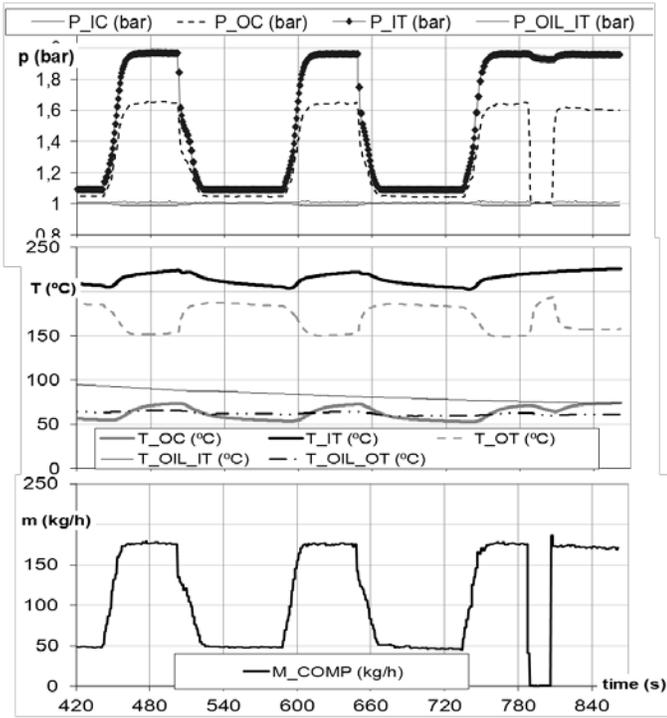
Figure 10 Resistance test, pressures, temperatures and compressor mass flow measurements

These tests have not presented notable incidents until the final phase (oil tank phase). Figure 10 shows pressures, temperatures and mass flow measurements for this last part (oil tank phase).

Figure 10 shows the increasing and decreasing in pressure and mass flow, when turbocharger is accelerated and decelerated. Only at the end of the test, between the second 780 and the second 840 approximately, can be seen that there is an apparent "turbocharger failure", because the compressor stops boosting and the turbine works with poor performance (the gas temperature at turbine outlet increases). This is due to an erratic shaft motion that lasts a few seconds and returns to normal motion spontaneously. The turbo never stops during this phase as recorded films showed.

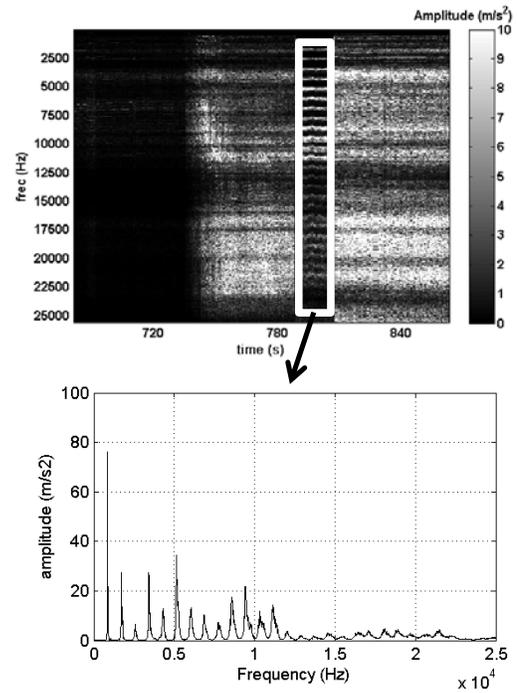
Figure 11 Resistance test, accelerometer signal

In the accelerometer signal, Figure 11, it is possible to observe that the intensity of vibration in this conflictive phase of the test has increased significantly at specific frequencies. The bottom graph of Figure 11 shows the frequency spectrum of the accelerometer signal during this turbocharger failure. Figure 11 shows the main frequencies of the spectrum are multiples of 900 Hz and these multiples are attenuated above 11700 Hz. Probably, the erratic movement of the shaft during this period is due to kicks of part of the wheel against the turbocharger stator, which are occurring at that frequency of 900-Hz.

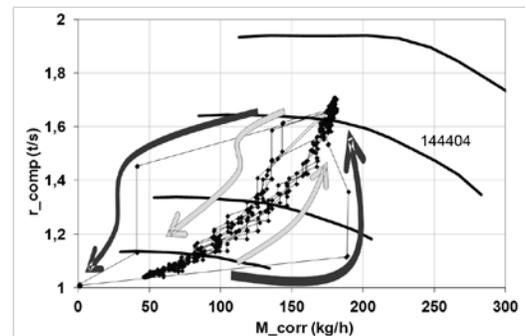
Figure 12 Resistance test, compressor map

Figure 12 shows the operating points on turbocharger compressor map, during this oil tank phase. The central arrows indicate the 5 paths of turbocharger speed decrease and increase, during the 5 cycles. The path followed to increase and decrease turbocharger speed is very similar. The external arrows indicate turbocharger behavior, when it suffered the failure between 780 and 840 seconds in Figure 10. It's possible to observe that when the turbocharger speed decreases, it takes place close to surge zone (first air mass flow decreases and then compression ratio), but when speed increase, it takes place close to choke zone (first increases air mass flow and then compression ratio).

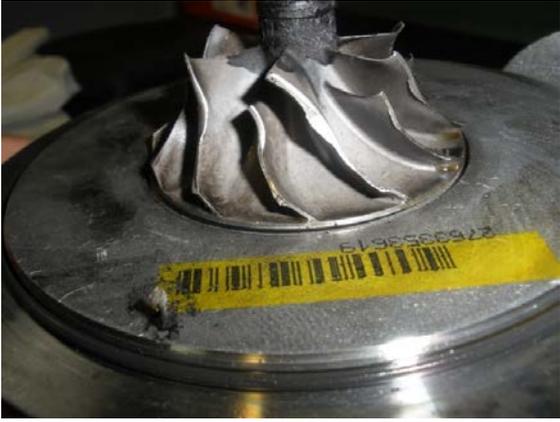
Figure 13 Damaged impeller

by the damaged impeller of Figure 13. The turbo was tested at different steady conditions with two different resistance curves. These points are represented in the compressor map in the Figure 14. The points tests were performed with the same thermodynamic parameters in the turbine (same pressure, temperature and turbine mass flow), in order to compare the performance of the two configurations (new impeller and damaged impeller). Figure 14 shows the performance loss of the turbocharger due to the damaged compressor wheel, for each of the two resistance curves. This test demonstrates that the destruction of the turbo (complete loss of the compression ratio) is not only due to the damage of the compressor wheel. It seems that the compressor wheel with damaged blades affects to the aerodynamical behavior of the air through the compressor wheel. Consequently, it decreases the compressor efficiency, but it not produces the complete compressor destruction (when compressor can't compress the air). Other words, defects in the shaft and bearings are the main causes of this complete loss of compression ratio.

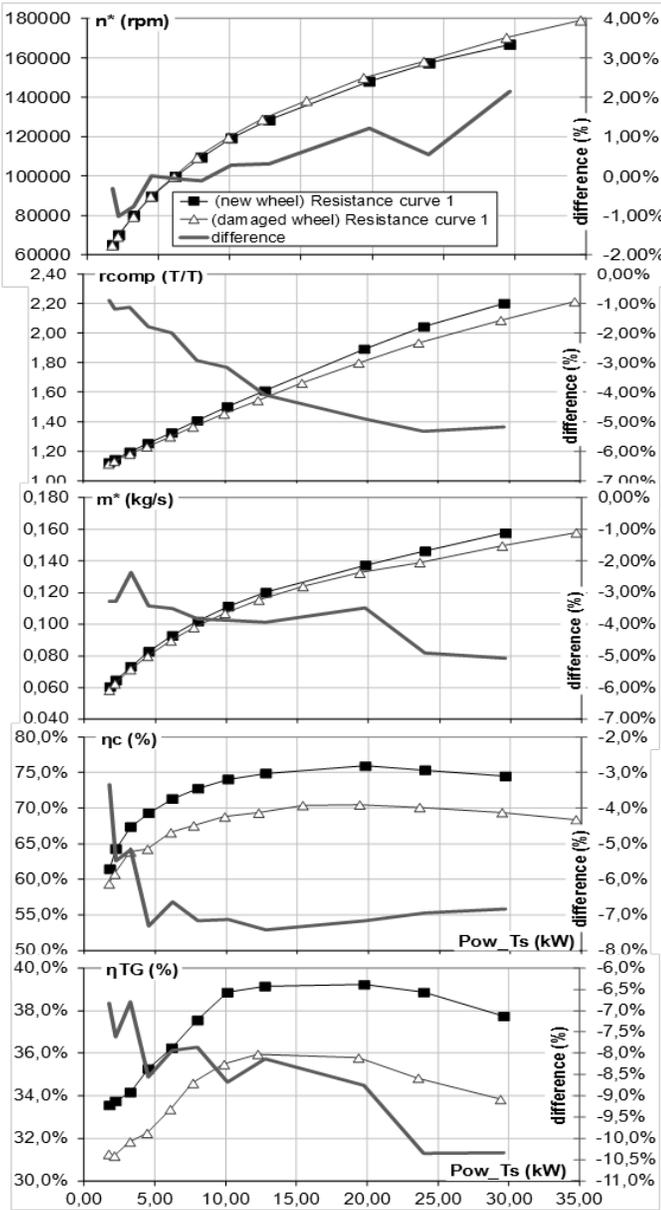
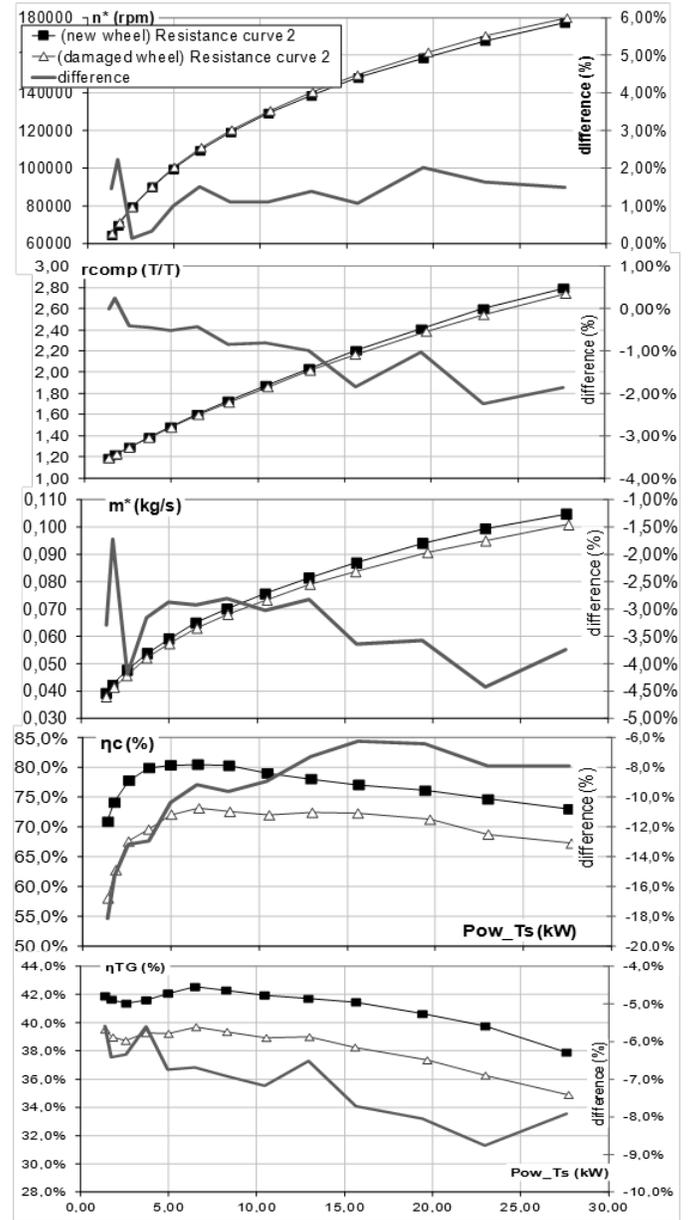
The following figures Figure 15 and Figure 16 shows changes in the corrected turbocharger speed, compression ratio, corrected mass flow, compression efficiency and turbocharger efficiency between the new turbo and turbo with the damaged wheel, in the two resistance curves. These figures show that the most significant effect of the damaged compressor wheel is a substantial loss of turbocharger efficiency defined as (1).

Figure 15. Variables of the damaged wheel test (Resistance curve 1)

Figure 16. Variables of the damaged wheel test (Resistance curve 2)
