Early concrete heritage in Istanbul, Turkey

Görün ARUN

Prof. Dr., Yıldız Technical University, Istanbul

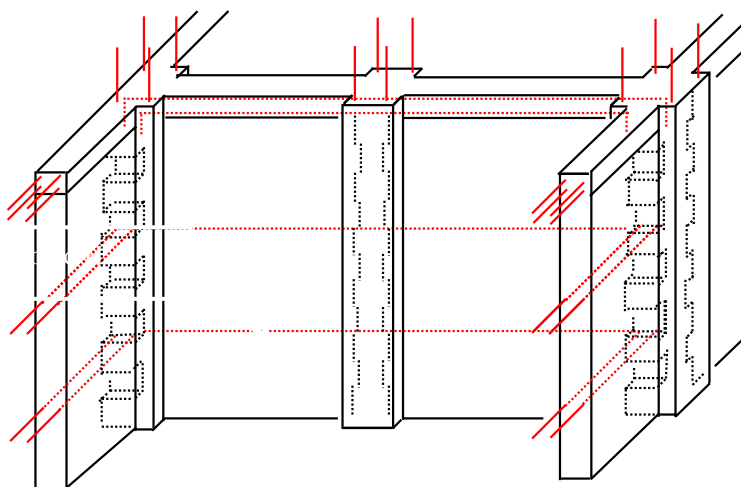
adopted even in the early applications of reinforced concrete buildings. If the columns of the system were of ferro concrete, the bars of the masonry walls were riveted to the iron profiles. If the columns were of reinforced concrete, walls were constructed first, then the bars of the columns were placed and concrete was cast. The joints between masonry walls and reinforced concrete columns were zigzagged. Such a system can also be considered as masonry wall with vertical ties. Figure 1 showing this application in reinforced concrete construction is drawn as described in the contracts made with architects.

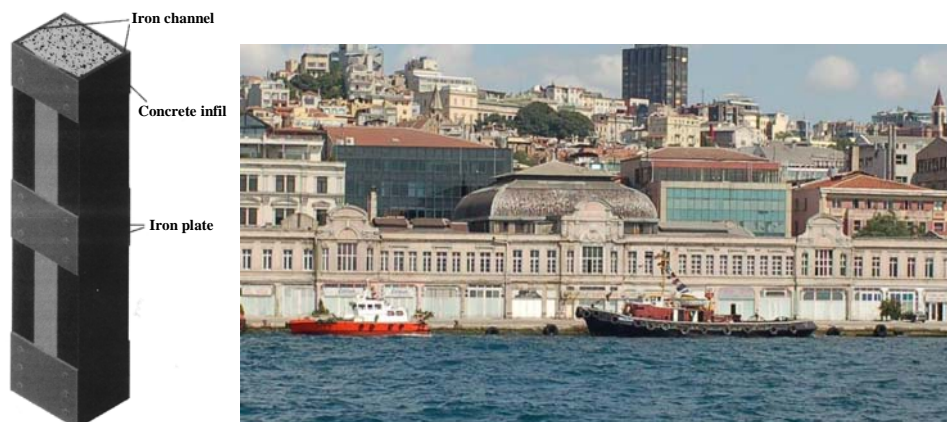
The building situated on the seaside had a foundation of timber piles tied with iron mesh embedded in 1.80m thick concrete. The closely spaced columns of ~350x500mm are of ferro-concrete with double iron channels filled with concrete (Fig. 2). The ferro-concrete

~500mm high beams and columns are connected in gussets and arches. Closely spaced ~350mm high secondary beams support the ~150mm reinforced concrete floor. This is a transition from the jack arch floor system that was used from late 19th century on to the reinforced concrete system.

Figure 2: Galata Customs Building- column detail and façade

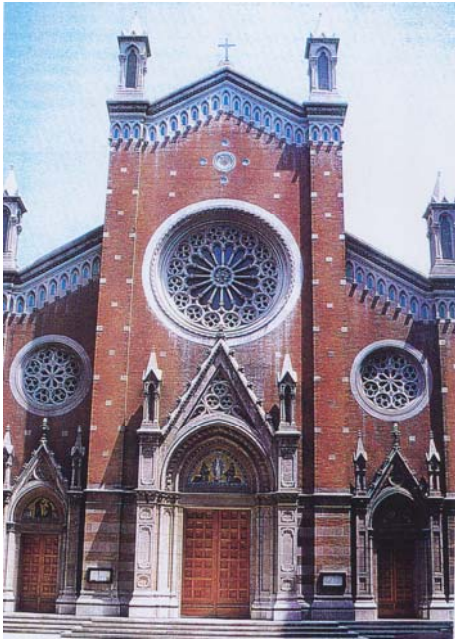
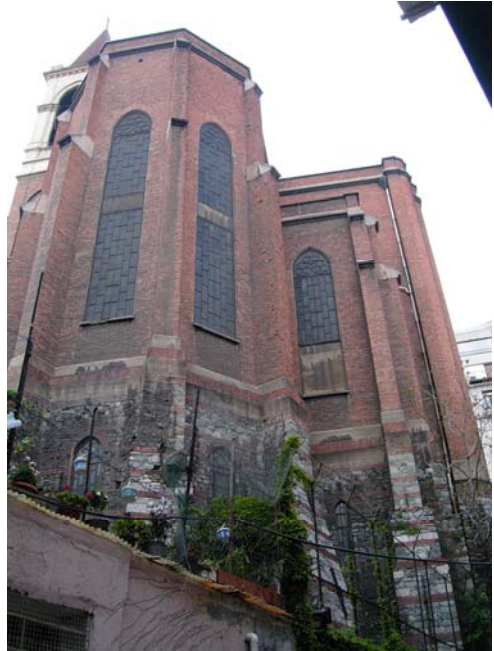
The church in the form of Latin cross of 20x50m in dimension is constructed on a sloped area that the ground floor is 26m above the back street (Fig. 3). Thickness of the foundation and basement walls of stone and brick laid alternatively are ~ 3100mm at the base and 1800mm at the top. The reinforced concrete ground floor is constructed over the reinforced concrete arches that tie the basement walls. The church of 23m in height have crypt in Romanesque style and façade reproducing the 14th century Tuscan-Lombard style. The brick veneered external walls are of stone and brick that are laid alternatively and strengthened with iron bars up to the arch base and solely brick above. Internal columns,

the arches tying the external wall piers and columns and the vaults above the arches are of reinforced concrete.

Figure 3: The church of Saint Anthony- front and back facade and floor plan

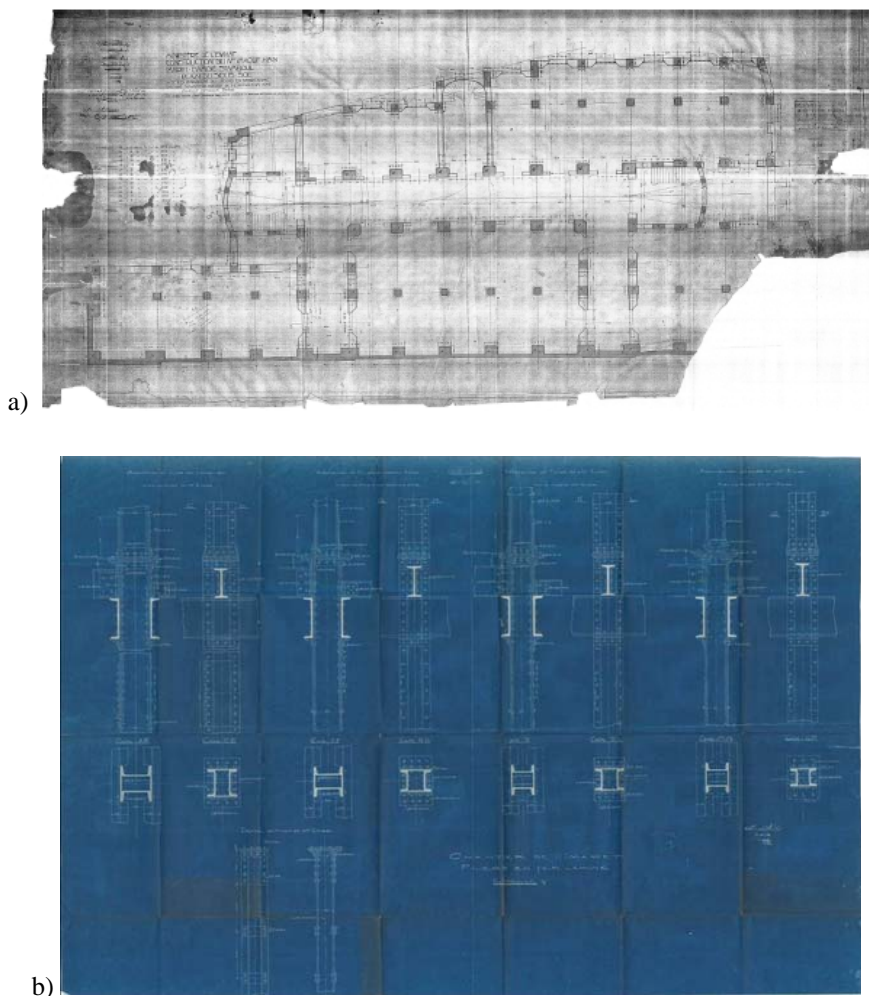
The projects of 4th Vakıf Commercial Building were first made by Le Mari for “Societe Anonyme Ottomane de Constructions” firm in 1911 and was approved in 1912 (Fig. 4a). It is not known if the construction had started but in 1917, another project in ferro-concrete system was prepared by a German firm, Reitschel & Henneberg GMH (Fig. 4b). In 1919, before the construction was finished, the building was used by French soldiers as headquarter named “Caserne Victor” [2]. The construction was finished in 1926 after the Republic was established.

Figure 4: Plans of IV. Vakıf Commercial Building a) in 1912, b) in 1917

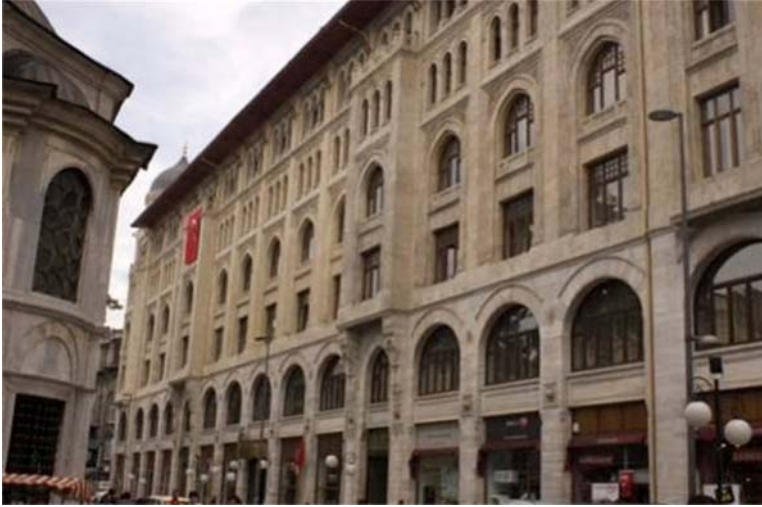
Figure 5: IV. Vakıf Commercial Building

The building of 78.7-59 x 32.6m in dimension and 27.21m in height consists of a basement and 6 office floors (Fig. 5). The atrium in the center is closed with iron frame and glass at first floor. During the restoration in 2004, it is seen that the columns of reinforced concrete of 800x1000mm and 800x1500mm at basement rest on a mat foundation. The columns of the ground floor and first floor of 500x500mm and upper floors of 300x300mm in dimension are of ferro-concrete with double iron channels filled with concrete. The beams tying the columns are of 2NPI300 iron. The 150mm thick floors are of iron jack arched floor with NPI240 joists. The thickness of the exterior walls veneered with stone on entrance facade and brick on the opposite façade becomes 800-1000mm.

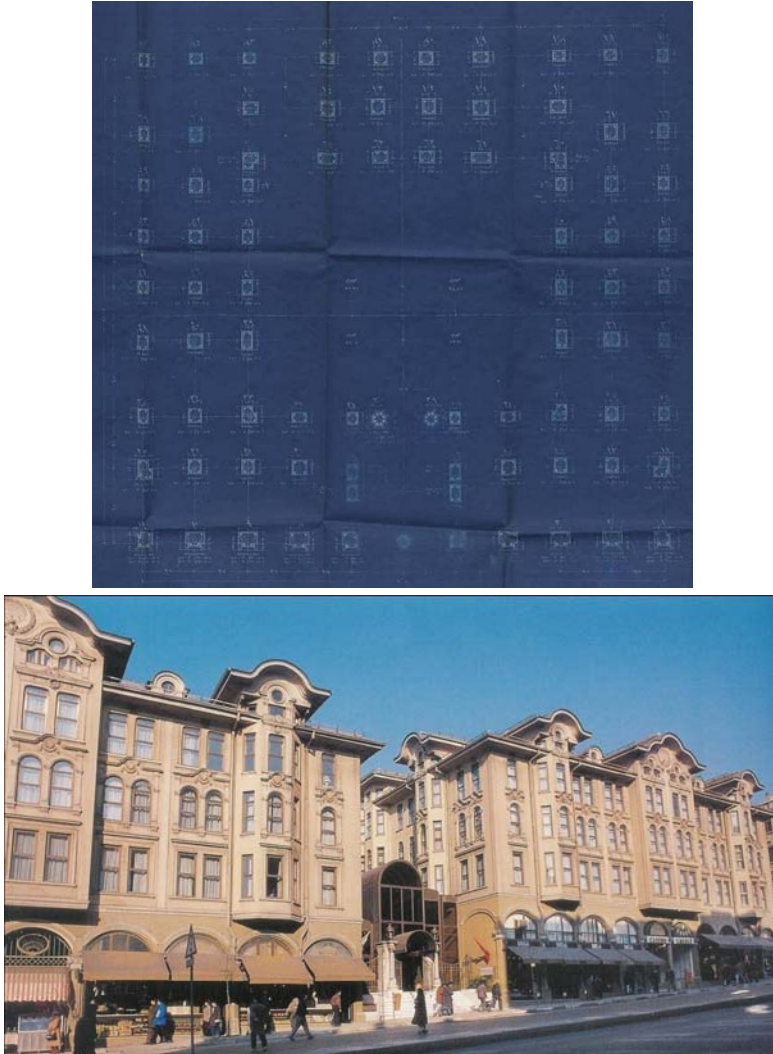
Apartment houses in Laleli district were constructed to house families whose houses were destroyed during 1918 fire. The construction started in 1919 and completed in 1922. The project designed by architect Kemalettin, a government architect, consists of identical four apartment houses of four storey at the corners of a cross road. Each block of approximately rectangular shape has square patio in the center. This is the first apartment house and first completely reinforced concrete construction of Ottoman period (Fig. 6). The structural system of closely spaced two way reinforced concrete frame with secondary beams laid in 1.5m distance to support the reinforced concrete floor and the roof structure follow timber construction technique.

Figure 6: Apartment Houses of Harikzadegan- structural plan and elevation
