Oporto's Sports Pavilion - Aspects of the design, construction and renovation.

Abstract

The Oporto's Sports Pavilion was inaugurated in 1952 occupying the place of a Crystal Palace dated 1865 that was demolished. After performing well as a sports and multifunctional arena during more than 50 years, this remarkable building is now going to be renovated to become a modern multipurpose facility. The Sports Pavilion's main feature is the roof that is a dome made of ribbed reinforced concrete forming a spherical cap covered by copper sheet giving it the characteristic green colour. The structure is now being studied and evaluated prior to rehabilitation. A structural assessment and inspection of the building is being conducted to evaluate the structure present condition. Supplementary to these observations a structural analysis is carried out by means of numerical models to find out if the concrete elements are in agreement with current safety standards. Based on original documents and statements of the personnel involved with its construction between 1951 and 1952 and having the unique opportunity to work with the architect of the original design, that is still participating enthusia

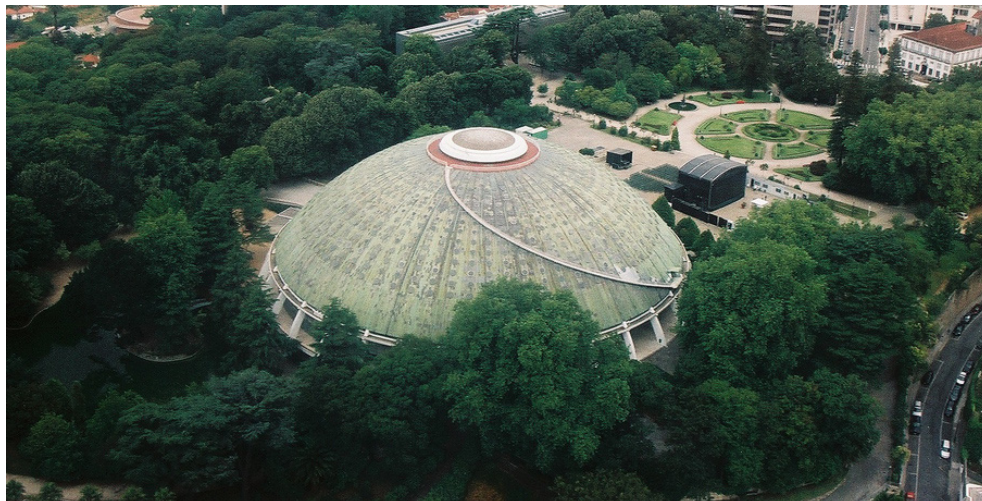
Figure 1: Oporto's Sports Pavilion, aerial view

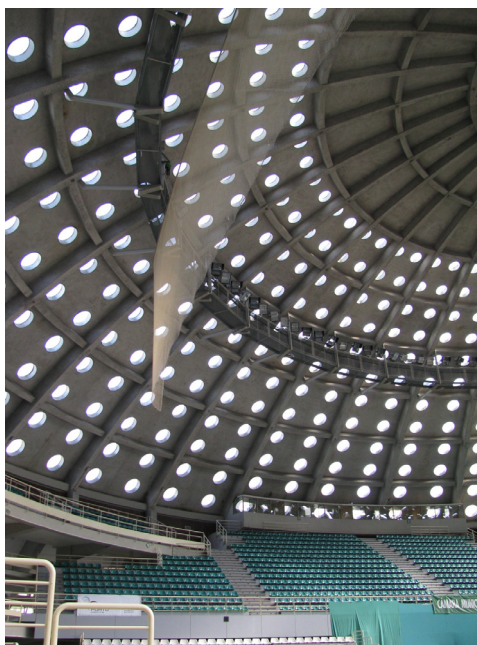
Figure 2: Internal view

The Sports Pavilion has a basement, a main floor, four galleries and a dome shaped roof. The building has a 90m diameter circular plan. The main structural feature is a dome made of ribbed reinforced concrete elements that forms a spherical cap.

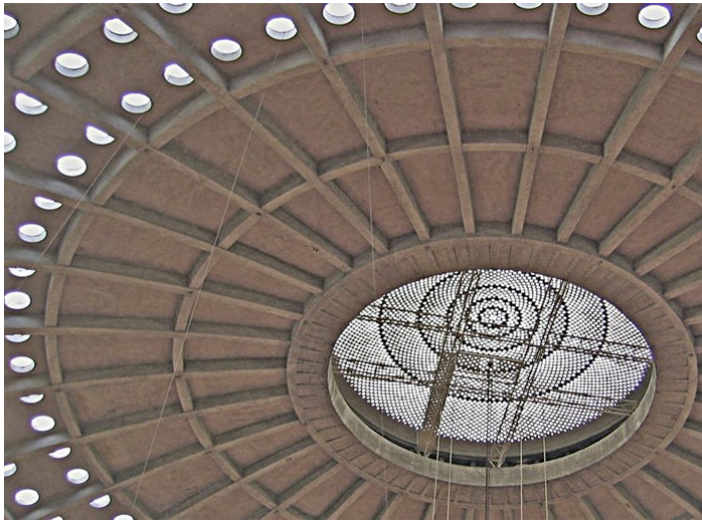
Its apex concludes with a 13,4m wide skylight made of “transparent concrete” (10cm thin concrete shell with glass elements).

Figure 3: skylight made of “transparent concrete”

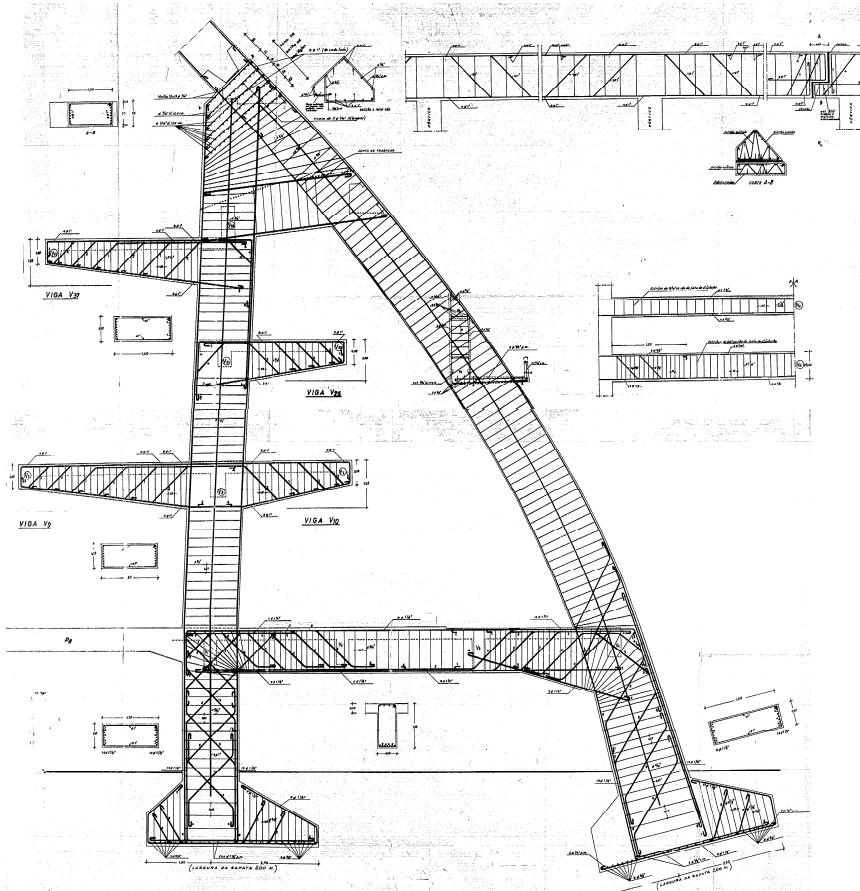
The entrance level slab (elevation 3.3m) is divided into 9 parts by expansion joints; one is circular and defines the central stage and the other 8 are radial and exist without duplication of structural elements. The two way slabs are 25cm thick and are supported by a grid of beams. These slabs applied a technology known as *Stahlton* slab system that was developed in the United Kingdom in the 1950's. The system developed around a high strength extruded ceramic tile with formed grooves open to the top surface into which longitudinal reinforcement (stressed high tensile wires) and steel ties or stirrups were placed and then the grooves were grouted using a portland cement grout. In the other direction the reinforcement is made of mild steel.

Figure 4: original drawing of triangular frame's concrete detailing

There are four levels of access galleries above level 3.3m. These galleries are supported by the column inside the triangular frame. Its unidirectional slabs are also 25cm thick pre-stressed and supported by a grid of beams. The galleries are also divided by eight radial expansion joints on the same vertical planes of the joints in the 3.3m level.

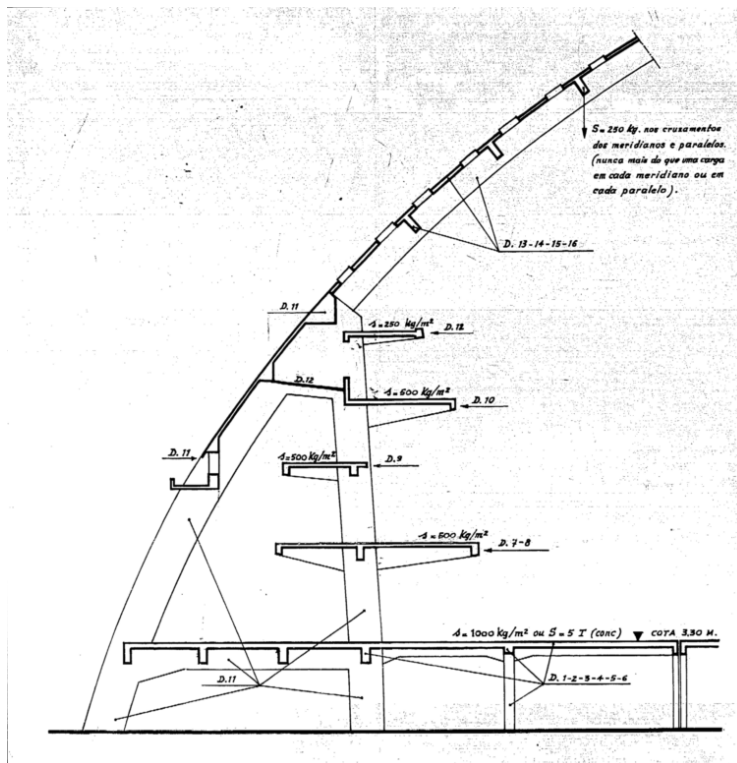
In the original design the live load was considered to be 5 kN/m^2 except for level 3.3m where 10 kN/m^2 was the imposed live load. This is justifiable because the stage located at this level has the slab to support the weight of the demountable stands and the loads from the use of the stage itself.

Figure 5: original drawing showing the live load distribution

It is interesting to note that given the type of slab adopted, the punching shear resistance was determined experimentally. According to the description found on the calculation report several loads were tested and the report says explicitly that a load of 9 tonnes on a $0.40 \times 0.40 \text{ m}^2$ area can be safely applied on the centre of the slab panel.

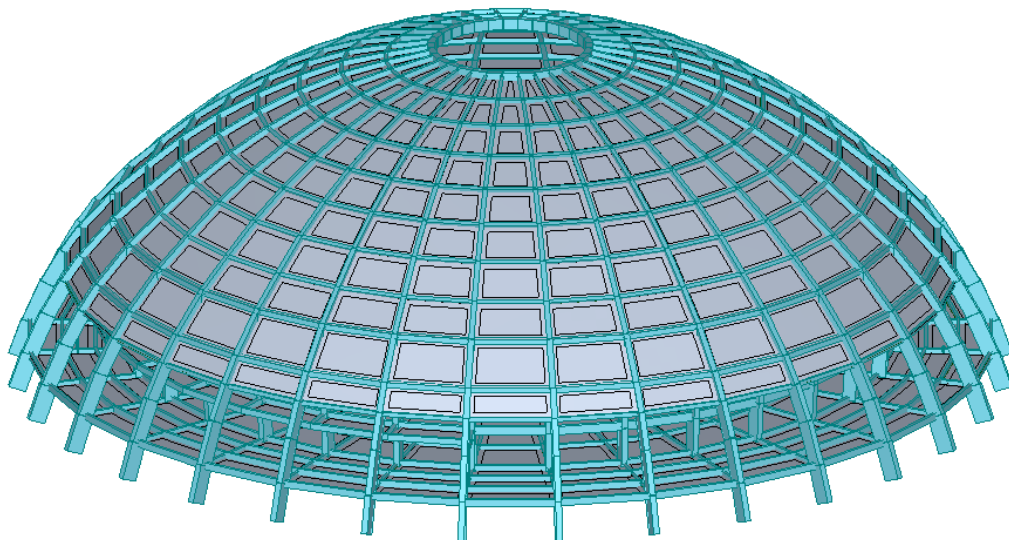
Based on the information provided by the available documentation a preliminary analysis was carried out by means of numerical models. This served as an initial approach to understand the structural behaviour and will serve as a reference for analyzing the impact of the intervention to be undertaken.

Figure 6: Perspective of the numerical model adopted

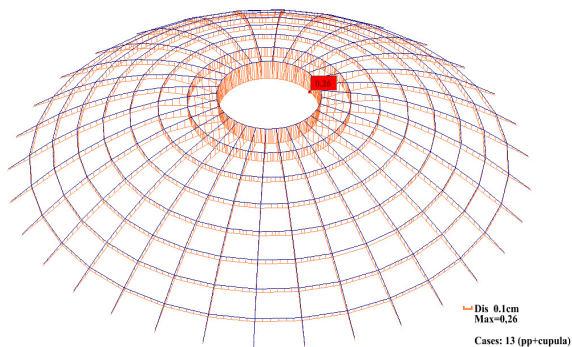
Figure 7: Deformation diagram due to the self weight and dead load

The deformation results due to self weight and dead load were near 3 mm and quite similar to those predicted by the scale model tests. The axial load, due to self weight and dead load, is nearly 800kN at the foundation level, being the level of axial stress below 8.5 MPa and is almost constant along the meridians due to the variable cross-section.

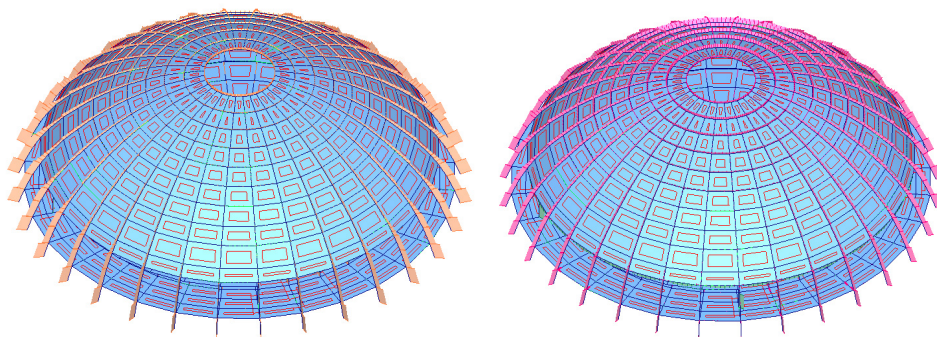
Figure 8: meridians' axial forces and stresses diagrams due to the self weight and dead load

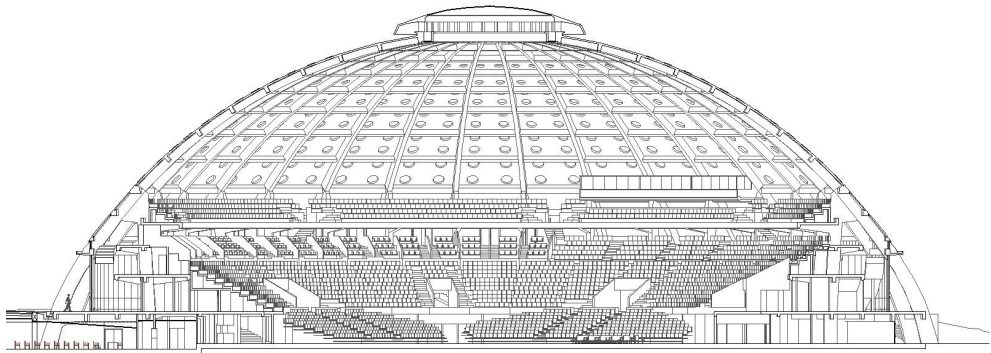
The project for the renovation of the building involves the construction of new structures outside the perimeter of the existing building and some alterations on the existing structure. The main alteration is the demolition of the central area of the 3.3m level to allow for the increase of seating capacity being the stage moved to the lower level. The impact of this change is little since this area is already delimited by an expansion joint with the duplication of structural elements.

Other alteration is the installation of permanent stands that imply the construction of steel frames attached to the existing structure to support the terrace units.

On the dome the main alteration is the need to support a suspension grid over the stage that can be on different positions and introduces an unbalanced loading.

Figure 9: section of the sports pavilion's new design
