In situ experimentations for the compatibility and durability of the restorations: the case study of the Sassi of Matera.

Ippolita Mecca ¹

¹ Department of European and Mediterranean Cultures, University of Basilicata

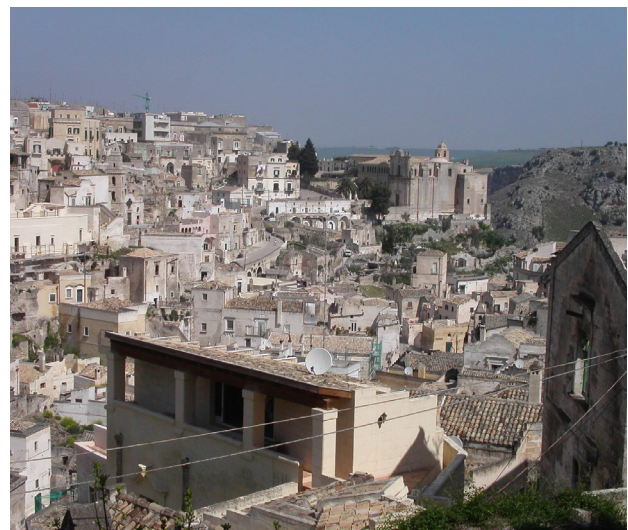
Figure 3.
View of the dwellings of Sasso Barisano

made terraces, is articulated by means of a vertical succession of levels, sometimes excavated or partly excavated and partly built, the number of which varies in the districts on the basis of the original shape and height of the calcarenitic slope. It follows that, while there are only three levels in the Malve district and six up to twelve levels in the Civita neighborhood.

The caves, which open in each order of terraces, are set side by side and branch out, intersecting in the most varied ways. They are characterized by various forms and a planimetric evolution, which is sometimes extremely irregular. They are clearly fixed from time to time during excavation works and imposed by the variation presented by the calcarenite in the degree of cementation (Guida, 2005).

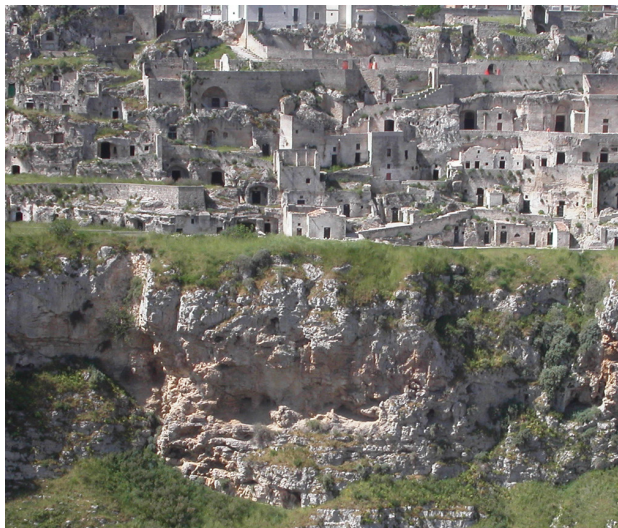
Figure 3.
View of the dwellings of Sasso
Caveoso

The Sassi architecture typological schemes come from the cave-house, a space set out by two parallel walls and an arched ceiling, a final wall made up of a mass of rocks and the façade made up of tufa blocks, in which there is only one door with a fanlight to light and ventilate the environments.

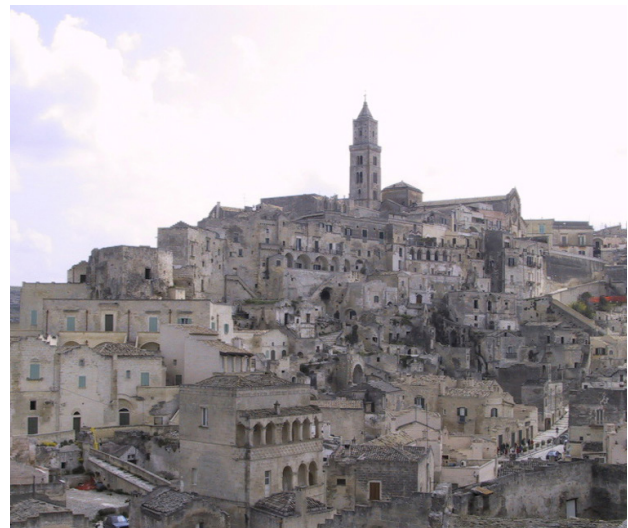
Figure 4.
The Civita

This points out the *building structural regularity*, constituted by a single material, the tuff; everything is made of blocks of tuff, from small decorative elements to the partitions of a house until the entire urban aggregate (Giuffrè, 1997).

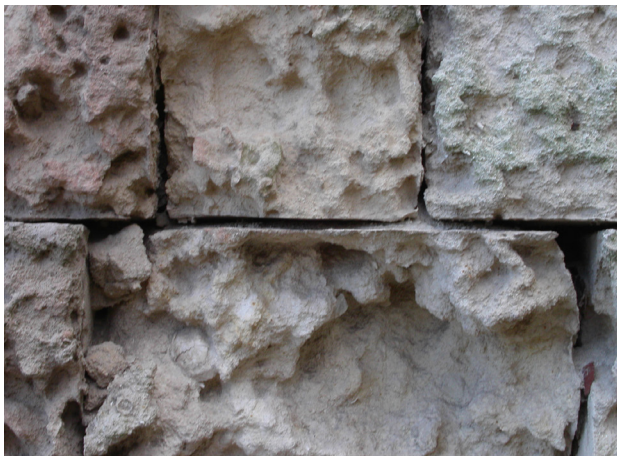
Figure 6.
Alveolization of calcarenite

But the main degradation is due to the presence of water, poor ventilation and weatherability, and they are manifested in the form of black crusts, runoff of surfaces, alveolization, microbiological alteration, saline efflorescence, mold and lichens.

The dissolution of calcium due to acid rain occurs on the outer surfaces. This phenomenon causes a further increase of the porosity. The condensation phenomena occur on the repaired surfaces and, by depositing of the particles suspended in the air, they form black crusts, which are cemented by recrystallization of the external calcium carbonate. The alveolization phenomenon is linked to the presence of runs, produced during the processes of sedimentation of calcarenite, filled with mud. It is caused by the internal movement of the moisture, which causes the crystallization of soluble salts with the consequent phenomenon of efflorescence. This phenomenon is

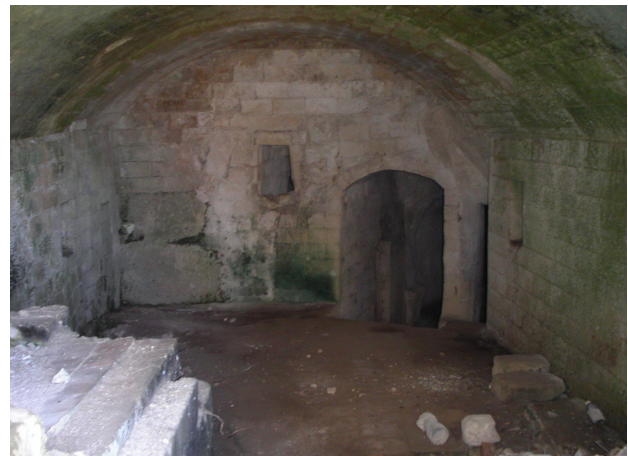
Figure 7.
Hypogeum with moss and lichen

also accentuated by small eddies that the wind creates into the already formed cavities causing an effect of mechanical abrasion by particles suspended in the air. Another widespread degradation, present both inside and outside of the hypogeal environments, is the microbiological alteration that causes darkening of the wall, and the proliferation of mosses and lichens. So on the internal and external facades of the Sassi is likely to get these phenomena both separately and jointly with the superposition of the effects.

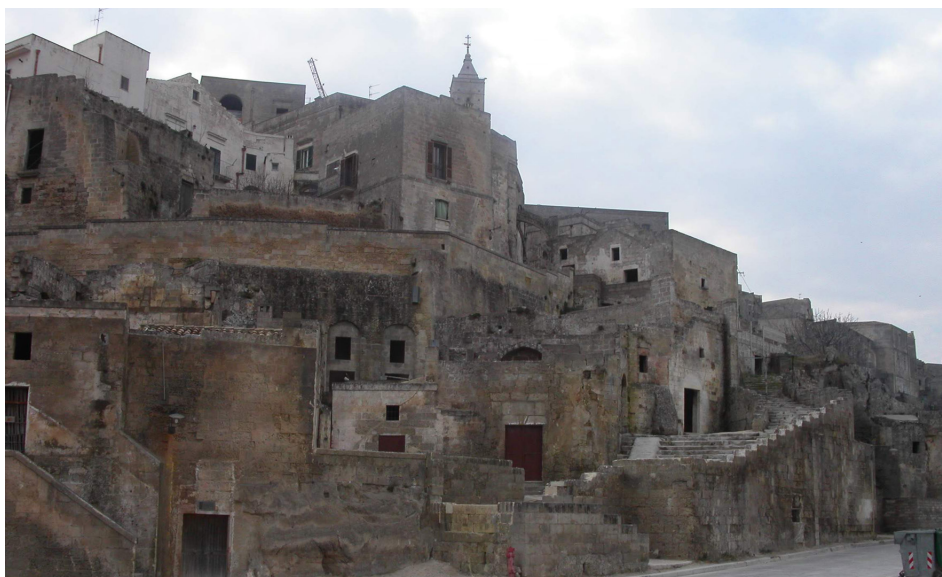
Figure 8.

Compartment subject to intervention

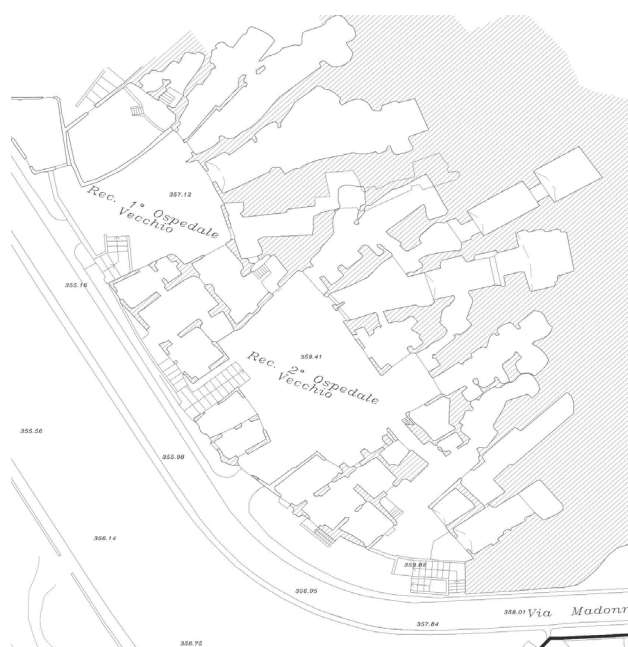
Figure 9.

Planimetry of the compartment subject to intervention

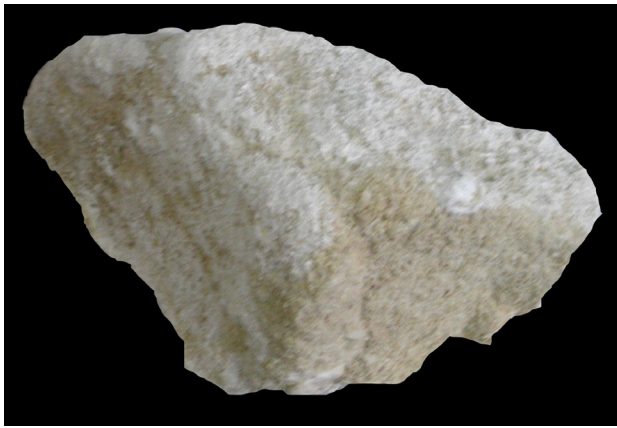
Figure 11.

Sample treated with P.S.

environments being studied, which were treated with a stabilizing material. An inorganic material with specific characteristics that are well suited to the needs of the site was used for this experiment: reinforcement that doesn't impede the characteristics of the limestone, that is suited to the chemical structure of the base material (limestone), that allows the limestone to maintain its porousness, that is very durable, not very invasive and which doesn't alter the natural color of the rock. The main active ingredient of the product used is a mixture of soluble Aluminium. The property of reinforcement is due to the formation of an Aluminium gel, which moves into the pores of the stone, creating a type of electrostatic interaction that increases internal cohesion, and reduces crumbling. Experiments brought about the decision to use products with a Lime base (P.C.), an Aluminium base (P.A.) and a Silicon base (P.S.).

Aside from the results obtained from the following experiments, the choice to use the P.S. mixture and not the other two for reinforcement is due to a prediction of greater durability for the intervention, because such a product has the same base composition as the original rock and hypothetically it should have the same degradation. After having evaluated the results of the application in the laboratory, the same consolidating was also applied in situ, where obviously the environmental conditions are much more variable than those recreated in the laboratory. After just a few months from the application and with the only visual monitoring, the result of in situ experiment seems to be comparable to that one obtained in the lab. We are making a constant monitoring in order to assess effectively the durability and the degradation processes.

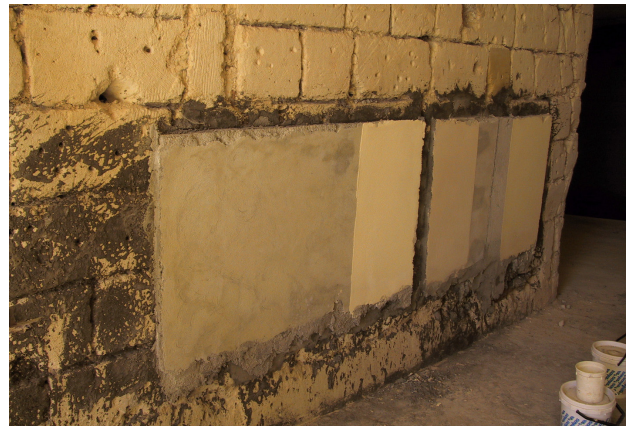
Figure 12.

Electron microscope images after consolidation with P.S.

The results obtained have been confirmed both by visual comparison as well as using images from electric scanning microscopes, of all samples. The best mixture used for intervention was the P.S. one, in fact, it has the best response in terms of density, porousness and variation; the best visual impact, in the almost unaltered coloration of the rocks; in the net improvement of the technical characteristics.

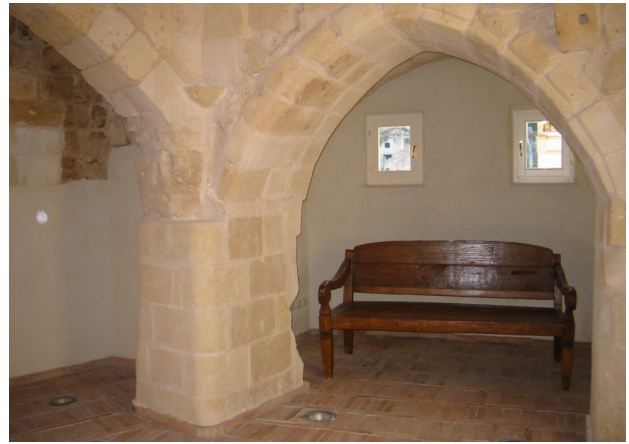
Figure 14.

Application of macroporous plasters

At this point, we have tested in situ two types of macroporous plaster of two different manufacturers. The plasters were applied for small samples with identical dimensions on the same wall at the same site, so with the same environmental conditions. The first qualitative and visual feedback were done limited to the scope and to the short time observation (just a few months). Between the applied products, Terrasan Calcideis the one having less alteration ant not having stains and traces of efflorescence.

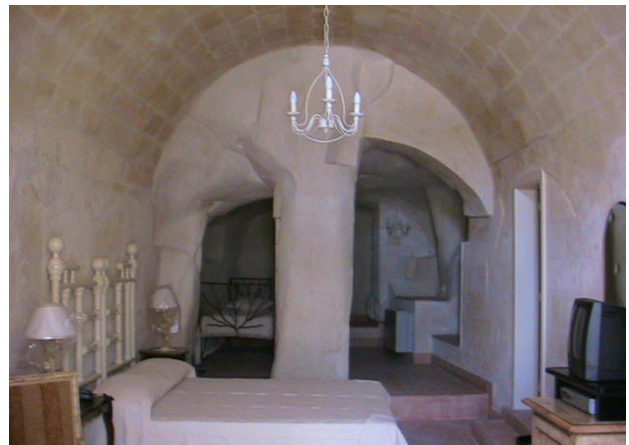
Figure 15. 16.

Inside of the Hypogeum after recovery with application of P.S and macroporous plaster

Again, after the experimental activity, following the indications of the producing sheets, the macroporous plaster that gave the best results was used extensively in some parts of Sassi during a restoration.
