Merello Giménez, P.; Beltrán Medina, P.; García Diego, FJ. (2016). Quantitative non-invasive method for damage evaluation in frescoes: Ariadne's House (Pompeii, Italy). *Environmental Earth Sciences*. 75(2). doi:10.1007/s12665-015-5066-3.

1 Quantitative non-invasive method for salts efflorescences damage 2 evaluation in frescoes: Ariadne's House (Pompeii, Italy)

13 **Abstract:** The preventive conservation is based on acting on the causes of deterioration of
14 cultural heritage to minimize damage, extending its lifetime and minimizing the costs of
15 restoration. In these terms, damage caused by salts is one of the main focuses of study in
16 immovable heritage. In this paper a quantitative method of recording and assessment of damage
17 in frescoes caused by salt efflorescences is presented. Damage mapping has been performed
18 with a colour scale of six values for two fresco paintings of two walls at Ariadne's House
19 (Pompeii, Italy), subsequently this information has been transferred to a data matrix which and
20 statistical analysis of Variance (ANOVA) has been applied . ANOVA results show significant
21 differences for the vertical and the horizontal axis depending on the

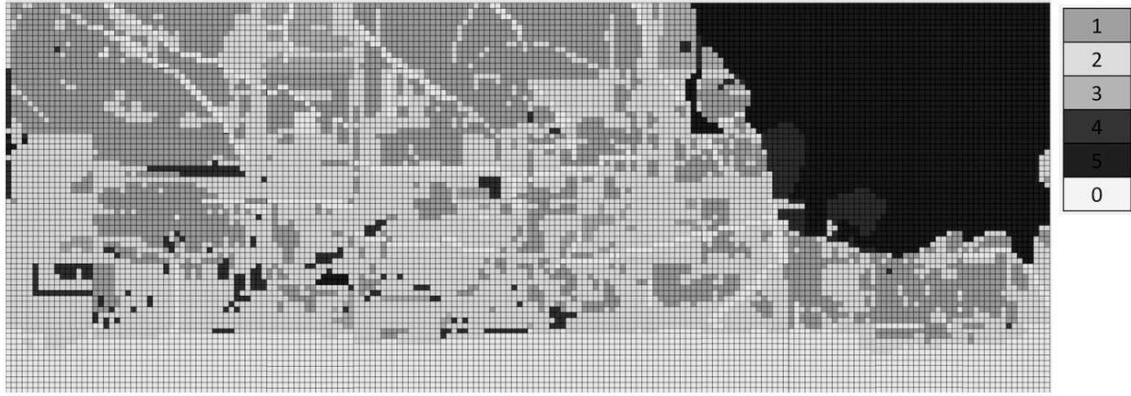
35 Two maps of damage have been performed, one for wall 3 (Figure 3) and another for wall 4 (Figure 4).
36 Through visual assessment of these maps simple conclusions can be drawn. The presence of more cracks
37 in wall 3 (not restored) as well as that the original fresco closest to the soil is lost in both walls is
38 highlighted by the maps.

39 **Fig. 3** Damage mapping of Wall 3 (facing to the west) of room 2. Legend of equivalence between the
40 grey scale and numerical scale of damage stages is represented

4 The interaction between orange and white damage stage is different (Figure 6.b). The average height X_{ij}
 5 that blends orange and white damage stage (157.38 cm, standard error = 12.13 cm) is significantly higher
 6 than the average height where there are those colours in the absence of the other ([89.50 cm, 122.14 cm]
 7 for orange, [59.03 cm, 93.08 cm] for white). The average height of white damage stage is conditioned by
 8 the fact that this damage stage is easily found on the lower parts of both walls, however it is noticeable
 9 that in the case of wall 3 is also dispersed in the form of cracks in the entire height of the wall, and one of
 10 these cracks crosses one of the two Intonachino/Intonaco layer areas (orange damage stage) of the top of
 11 the monitored area, (Figure 3).

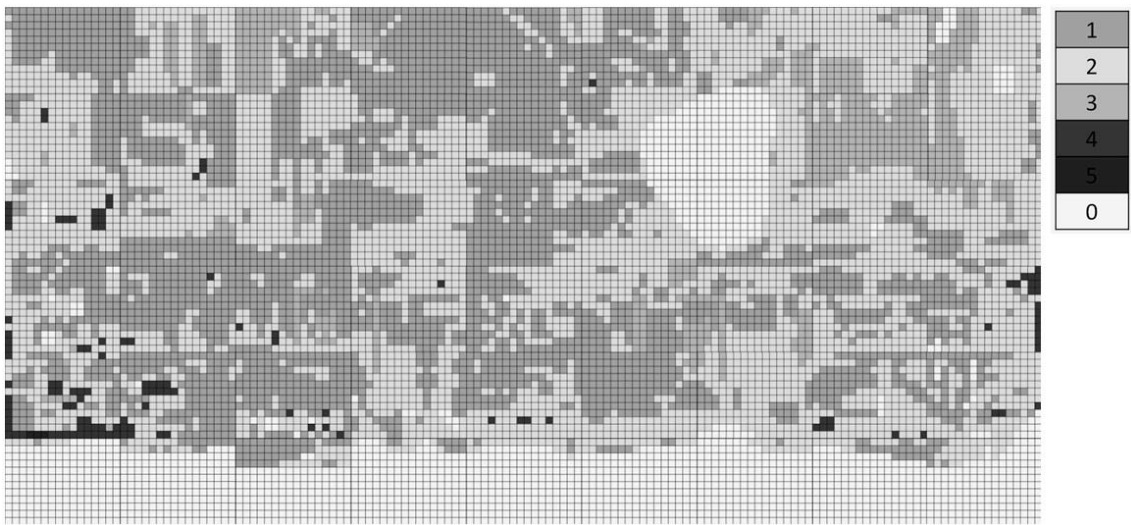
2 **Fig. 4** Damage mapping of Wall 4 (facing to the north) of room 2. Legend of equivalence between the
 3 grey scale and numerical scale of damage stages is represented

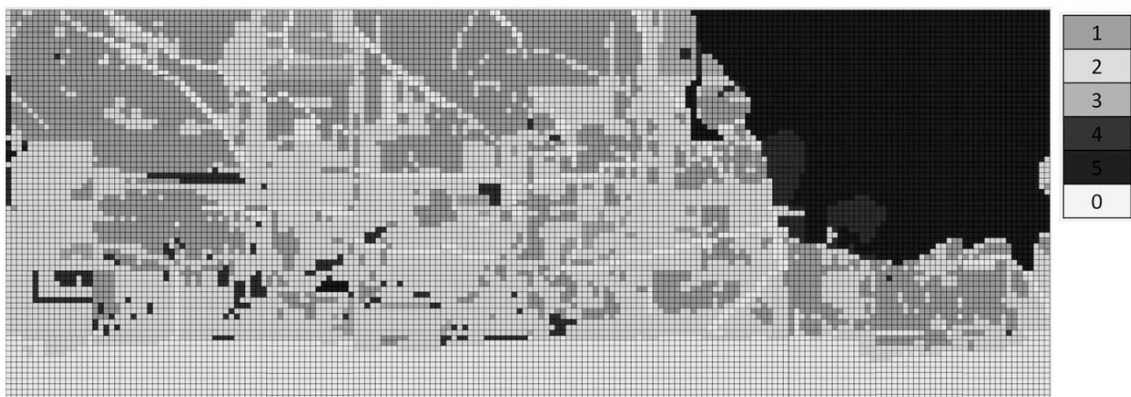
23 **Fig. 3** Damage mapping of Wall 3 (facing to the west) of room 2. Legend of equivalence between the
24 grey scale and numerical scale of damage stages is represented

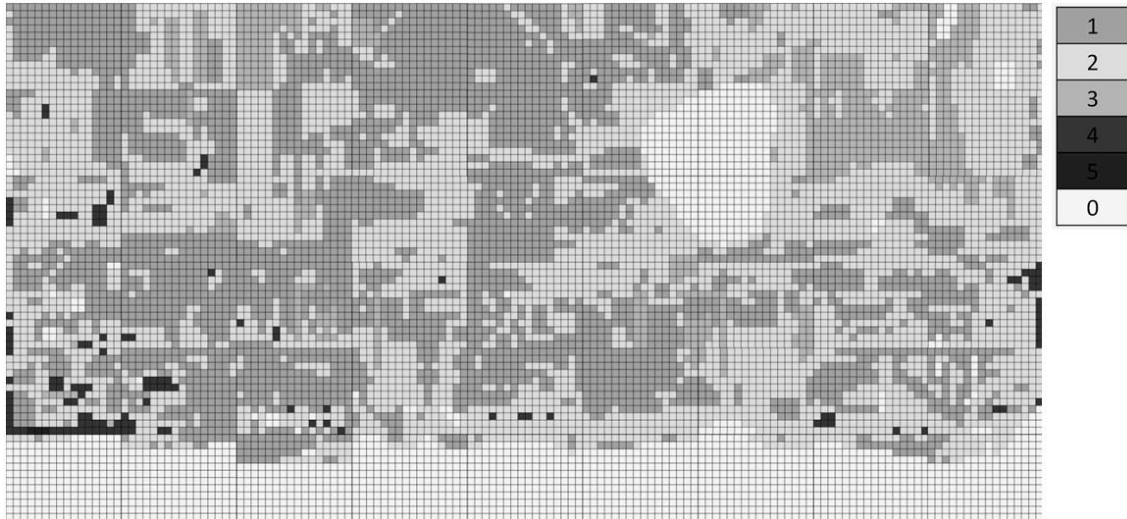
25
26 **Fig. 4** Damage mapping of Wall 4 (facing to the north) of room 2. Legend of equivalence between the
27 grey scale and numerical scale of damage stages is represented

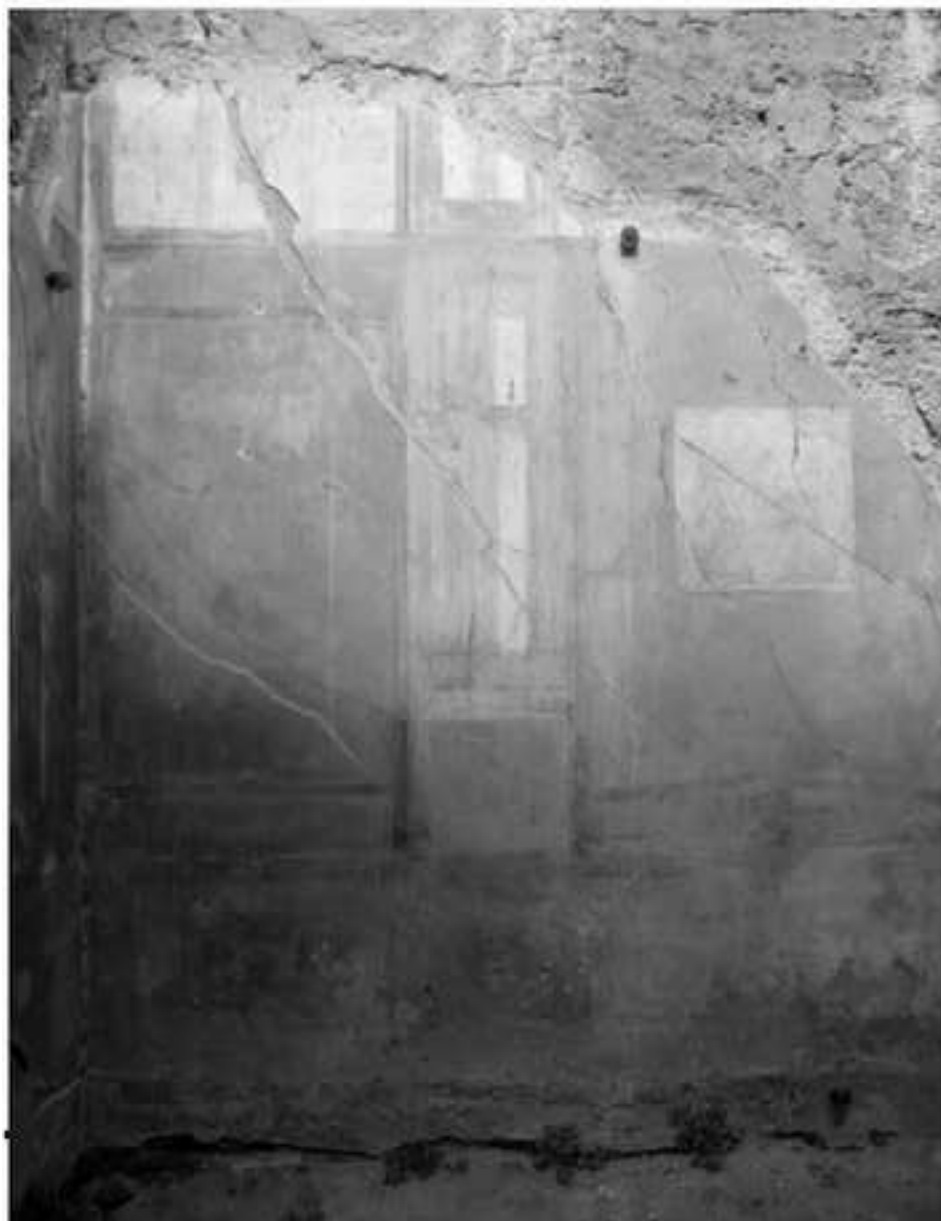
a)

12 Wall 3 (Figure 2.a), facing to the west, has measures of 450 cm x 480 cm. Monitored dimensions are 180
13 cm (height) x 480 cm (width). A total of 72 (6x12) photos were taken.

29 Wall 3 (Figure 2.a), facing to the west, has measures of 450 cm x 480 cm. Monitored dimensions are 180
30 cm (height) x 480 cm (width). A total of 72 (6x12) photos were taken.

Fig. 2 A) Frescoes in wall 3 (facing to the west) of room 2. B) Frescoes in wall 4 (facing to the north) of room 2

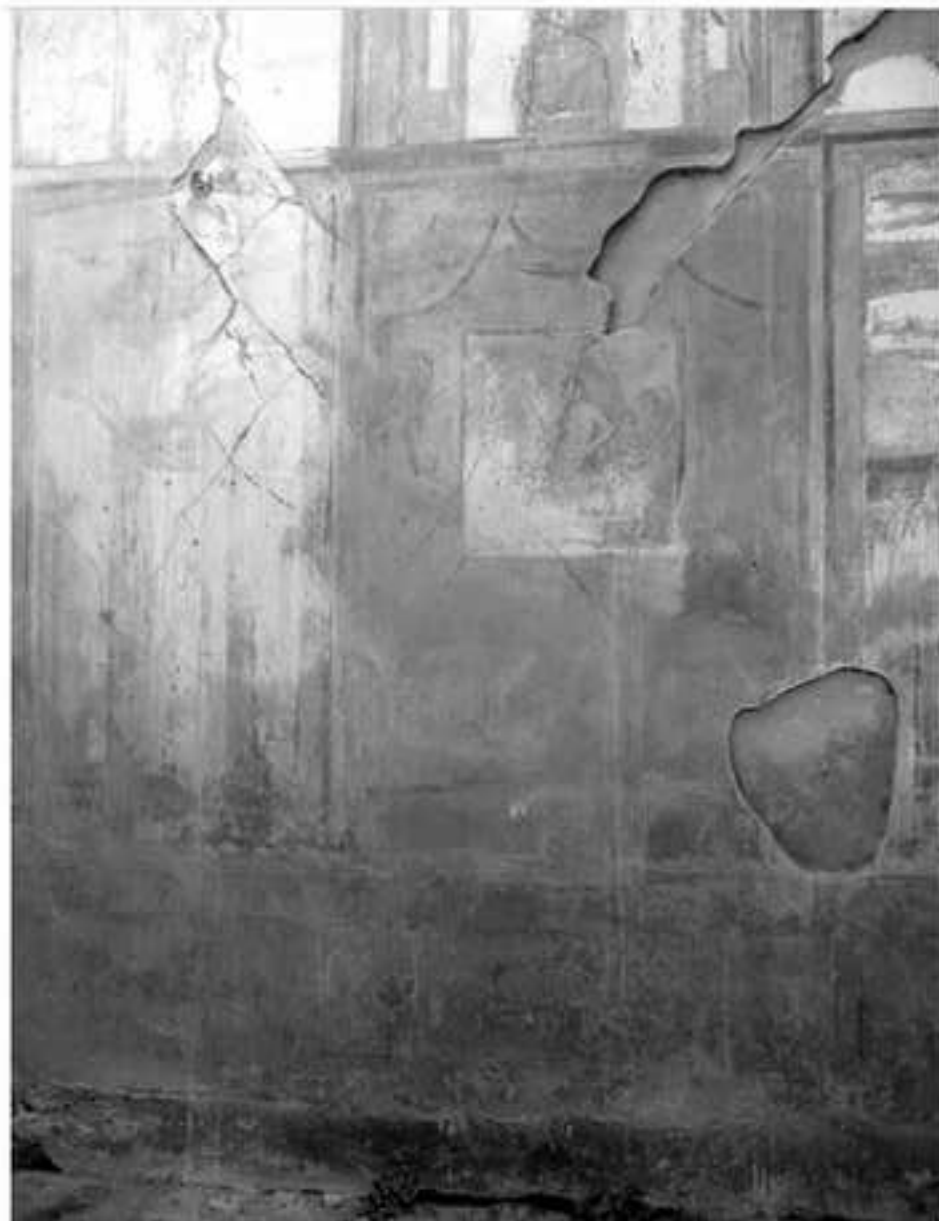
b)

9 In this paper, two walls with frescoes of a roofed room (Figure 1) of Ariadne's House are evaluated. Wall
10 4 (Figure 2.b), facing to the north and restored in 2012, with measures of 450 cm(high) x 360 cm (width).
11 Monitored dimensions are 180 cm (height) x 360 cm (width). A total of 54 photos (6x9) were taken.

26 In this paper, two walls with frescoes of a roofed room (Figure 1) of Ariadne's House are evaluated. Wall
27 4 (Figure 2.b), facing to the north and restored in 2012, with measures of 450 cm(high) x 360 cm (width).
28 Monitored dimensions are 180 cm (height) x 360 cm (width). A total of 54 photos (6x9) were taken.
