V.Genovés; C.Riestra; Borrachero Rosado, MV.; Eiras Fernández, JN.; Kundu, T.; Paya Bernabeu, JJ.; riestra (2015). Multimodal analysis of GRC ageing process using Nonlinear Impact Resonance acoustic Spectroscopy. *Composites Part B: Engineering*. 76:105-111. doi:10.1016/j.compositesb.2015.02.020.

# Multimodal analysis of GRC ageing process using Nonlinear Impact Resonance Acoustic Spectroscopy

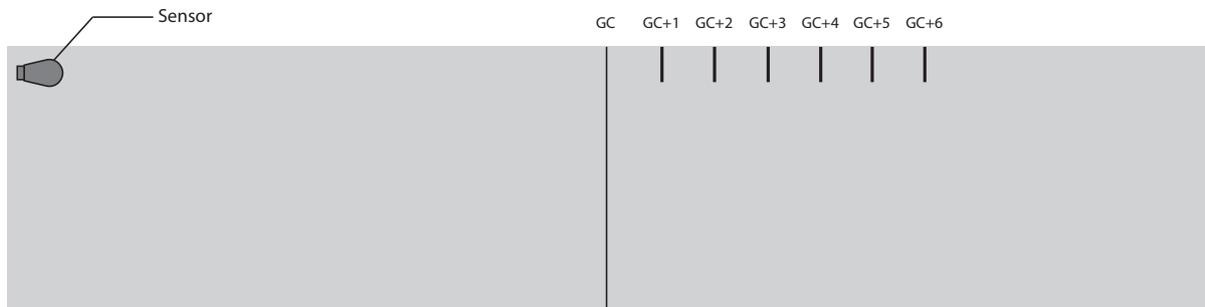
Figure 1: Point of impact layout

In order to optimize the location of the hammer impact point, multiple points of the specimen were hit by the hammer and corresponding response spectra were recorded. Figure 1 shows different impact point locations on the specimen and the sensor location.

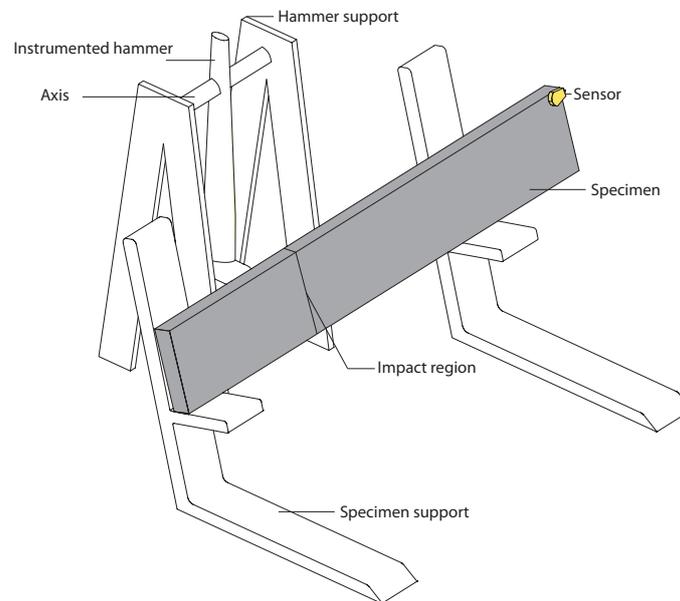
Figure 2: Tests disposition: Specimen and apparatus

Figure 2 shows the test configuration. It is composed of one hammer support attached to a rigid base and both sides of the support are linked by a metallic axis that makes the impact hammer to rotate, for hitting the specimen with different levels of impact energy.

There are also two additional supports for placing the specimen in the required position when it is struck by the hammer. The specimen support frame is attached to the same rigid base where the hammer support frame is attached.

The test disposition permits the specimen vibrates without constraints (a case of free vibration).

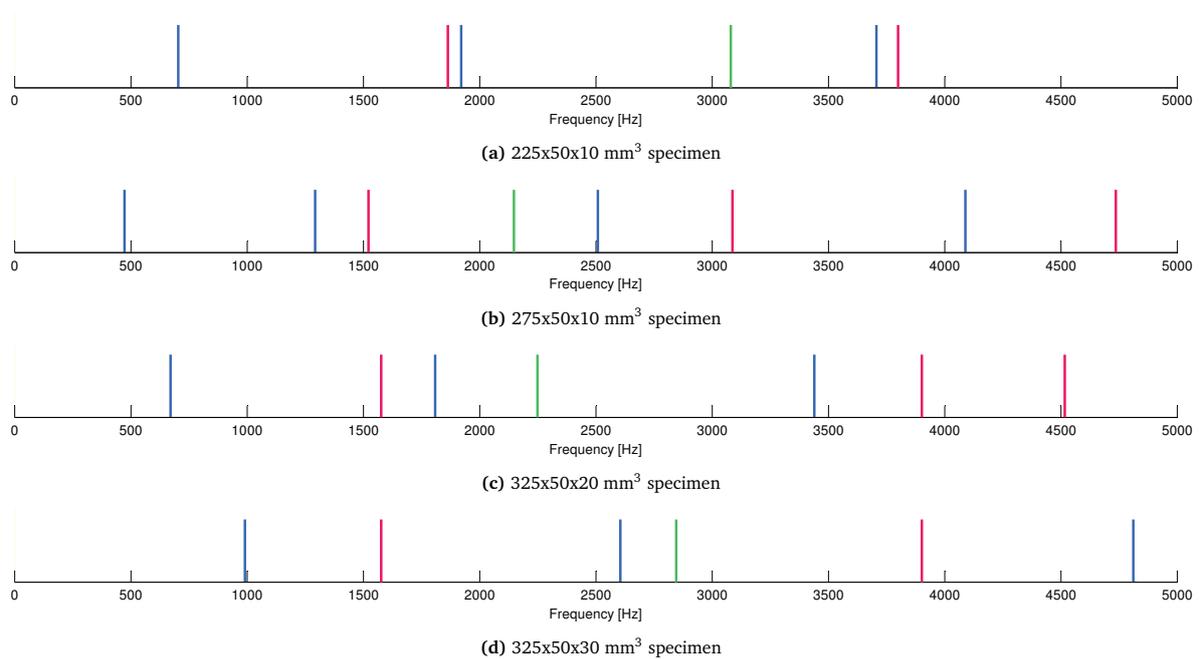
More than four geometries were simulated for the modal analysis, but only the most interesting ones are plotted in figure 3. Colour code used in this figure indicates specimen's vibrational modes. Blue color is for

flexural xy modes, red color is for torsional modes and green color is for flexural xz modes. Figure 3a shows bad spectrum distribution: some modes (2<sup>nd</sup> flexural xy and 1<sup>st</sup> torsional, 3<sup>rd</sup> flexural xy and 2<sup>nd</sup> torsional) appear too close to one another in the spectrum, leaving some wide empty frequency bands. When two modes appear too close to each other then it is a problem because then two close peaks having finite width. Figures 3b and 3c have a good number of well-separated peaks in the spectrum, however 3b, have more modes to analyse and therefore is a better distribution choice. In addition, 275x50x10 mm<sup>3</sup> specimens require relatively less amount of material to make. Figure 3d shows only six modes in the frequency range of analysis and this specimen also needs more material and was discarded for that reason.

Figure 3: Modal analysis simulations done with FEM software for different specimen geometries

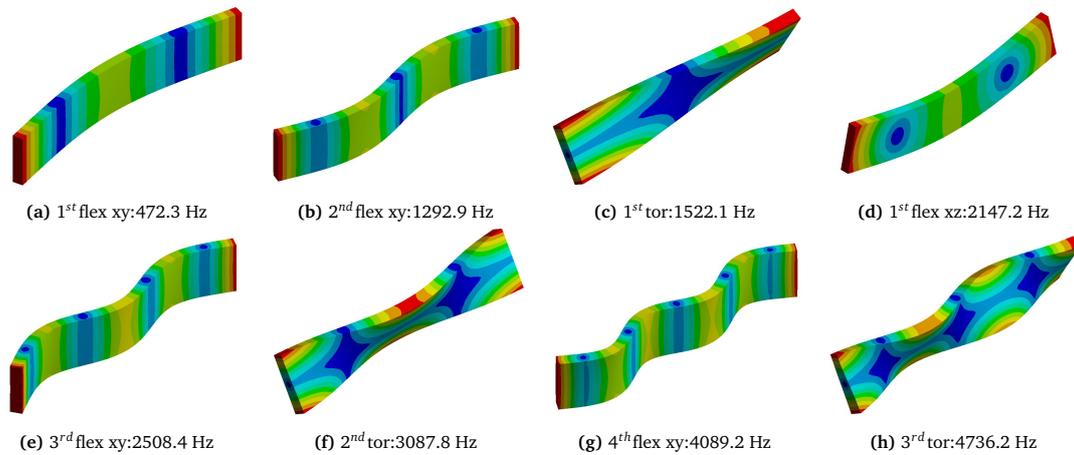
Figure 4: FEM total deformation modal analysis

A complete analysis was then performed for the selected specimen geometry 275x50x10 mm<sup>3</sup>. Figure 4 shows the mode shapes for displacement variations for the extracted modes. From these diagrams a fixed location for the accelerometer at the corner of the specimen where the deformation is maximum was selected. This mode shape analysis gave important information about how to choose the point of impact location. Hitting at a high deformation location made the specimen capable of exciting the desired number of modes. For instance, 1<sup>st</sup> flex xz (figure 4d) mode could not be excited due to the specimen disposition on the testing support (the impact direction is normal to the plane of displacement).

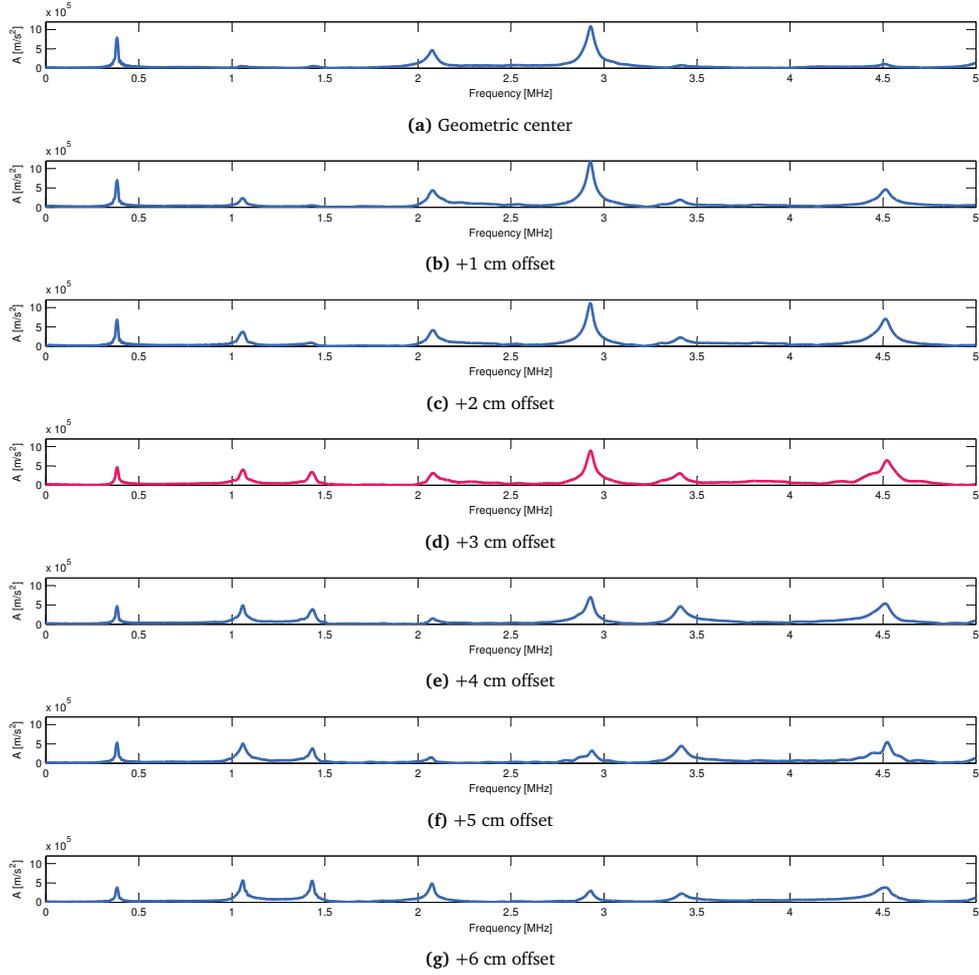
**Figure 5:** Frequency response of the same specimen for different impact locations as shown in figure 2

centimetre from the geometric centre towards one end of the specimen. Response spectra for the same impact energy level for different impact locations plotted in figure 5. Impact at the geometric center of the specimen generated only a few modes. This observation can be justified from the fact that for many modes geometric center is a node position and hitting at the node position cannot generate that specific mode. Thus, impacting on geometric centre of the specimen (figure 5a) activates only three modes (first flexural, third flexural and second torsional, figures 4a,4e and 4f) because second flexural and first torsional (figures 4b and 4c) have a node (zero displacement) at that impact point.

As the impact point is moved from the geometric center, other modes start to appear. One and two centimetres offsets from the geometric centre (figures 5b and 5c) show low amplitude modes near 1000 to 1500 Hz frequencies. Three centimetres offset from the geometric centre (figure 5d) seems to be the most appropriate position since the modes are stable and have relatively high amplitudes. Other positions also have interesting spectral response (figures 5e,5f and 5g) but were discarded because the specimen became unstable on the test support for those cases. First flexural xz (figure 4d) mode could not be excited for obvious reasons (no peaks at 2147 Hz).

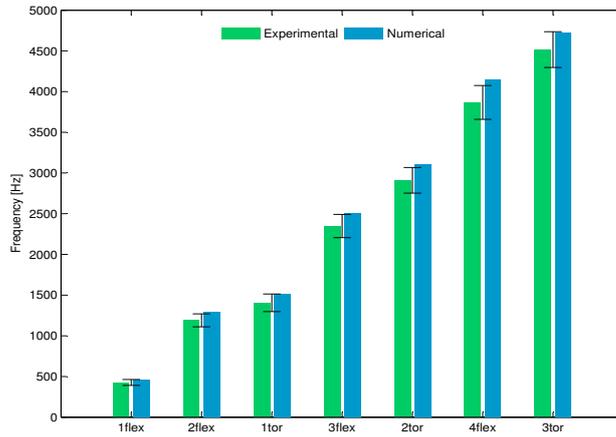
Figure 6: Theoretical and experimental frequency comparisons

The experimental and the theoretical resonance frequencies are plotted in figure 6. The slight difference between these two series on the graph is due to the plate cutting and manufacturing. The experimental data correspond to 28 specimens after being cured at 20 °C in wet chamber for 28 days, before any ageing or fibre degradation.

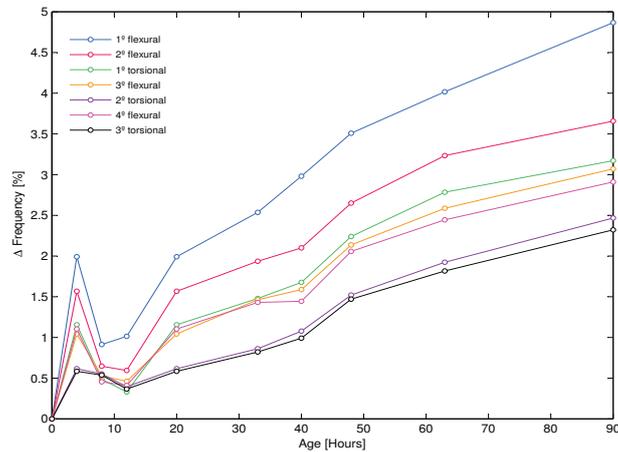
Figure 7: Frequency variation with ageing process

After computing the frequency values for every mode, the experimental data points were plotted in figure 7.

Figure 7 shows frequency increase for all modes. It is important to note that the low frequency modes show more relative variation than the high frequency modes. It is also noted that all modes in the range of our study have the same tendency or behaviour. During the early stages of ageing there is a slight decrease of the frequency variation which coincides with that shown in the table 4 which then stabilizes over time. Then it shows monotonic increase. After monitoring all resonance frequency modes, it is concluded that monitoring one mode is sufficient for defining the frequency variation during the ageing process.

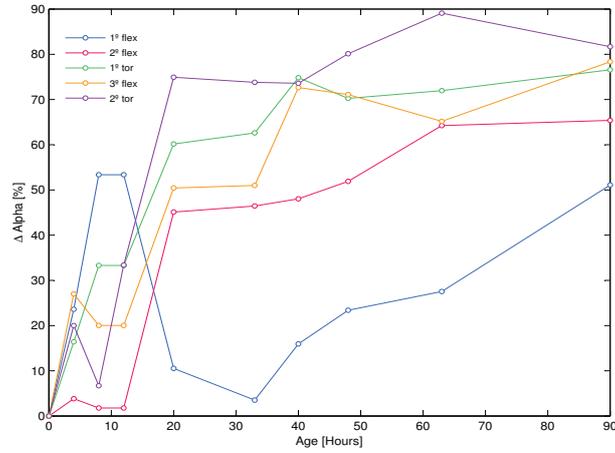
Figure 8: Non-linearity parameter variation with ageing

Non-linearity parameter  $\alpha$  was computed using equation 2. Figure 8 shows the  $\alpha$  variation as the specimen ages. With ageing the percentage change of this parameter is much higher than the linear parameter. Clearly hysteretic parameter is more sensitive to ageing than the linear parameters. One can note that when the age of degradation increases, for most modes the variation of the hysteretic parameter monotonically increases.

2<sup>nd</sup> flexural, 1<sup>st</sup> torsional, 3<sup>rd</sup> flexural and 2<sup>nd</sup> torsional modes show similar behaviour. Generally, when the vibrational mode is at relatively high frequencies, the non linearity parameter derived from that mode is more sensitive to ageing. However signal strengths for 4<sup>th</sup> flexural and 3<sup>rd</sup> torsional modes were too weak to generate

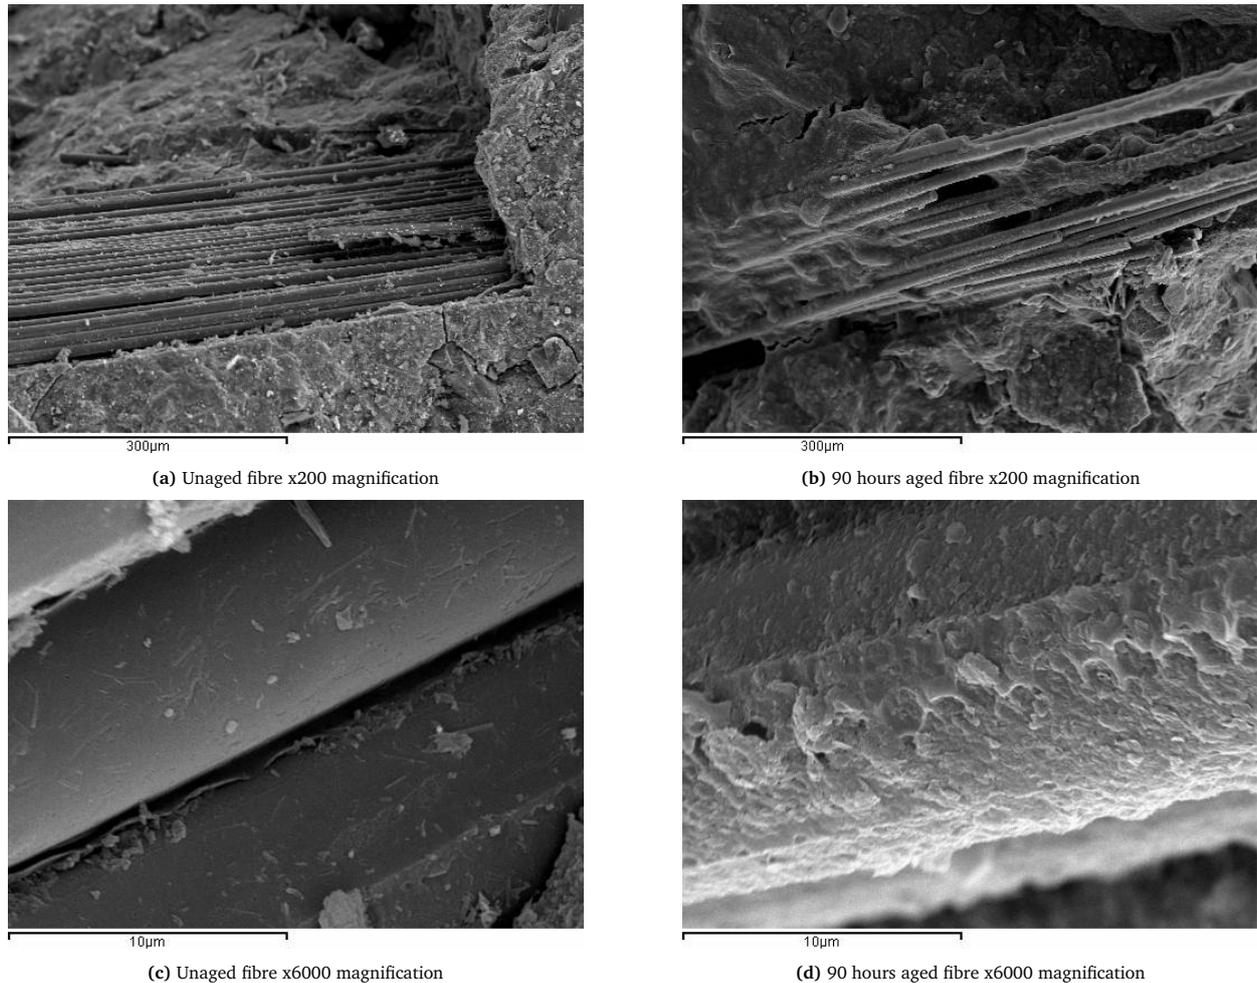
(a) Unaged fibre x200 magnification

(b) 90 hours aged fibre x200 magnification

(c) Unaged fibre x6000 magnification

(d) 90 hours aged fibre x6000 magnification

Figure 9: SEM images of unaged and aged specimens

In order to see the physical condition of the fibres, scanning electron microscopy images were taken at different magnifications (figure 9).

Figure 9a is a x200 magnification of the fibres embedded in the cement matrix 28 days after setting. The fibres were clean and their surfaces were smooth. After 90 hours of ageing similar specimen was analysed under SEM (figure 9b) and a new layer of new products over the fibres were noticed. In x6000 magnification images the smooth surface condition can be clearly seen. Figure 9c shows the initial state of the fibre with the intact surface and figure 9d shows a deteriorated fibre with small voids and damaged surface.
